# NERC Lessons Learned

Donnie Bielak  
Manager, Reliability Engineering

Battery Energy Storage System  
Cascading Thermal Runway

# Catastrophic Failure of 345kV Oil Filled Metering Current Transformer in a Transmission Substation

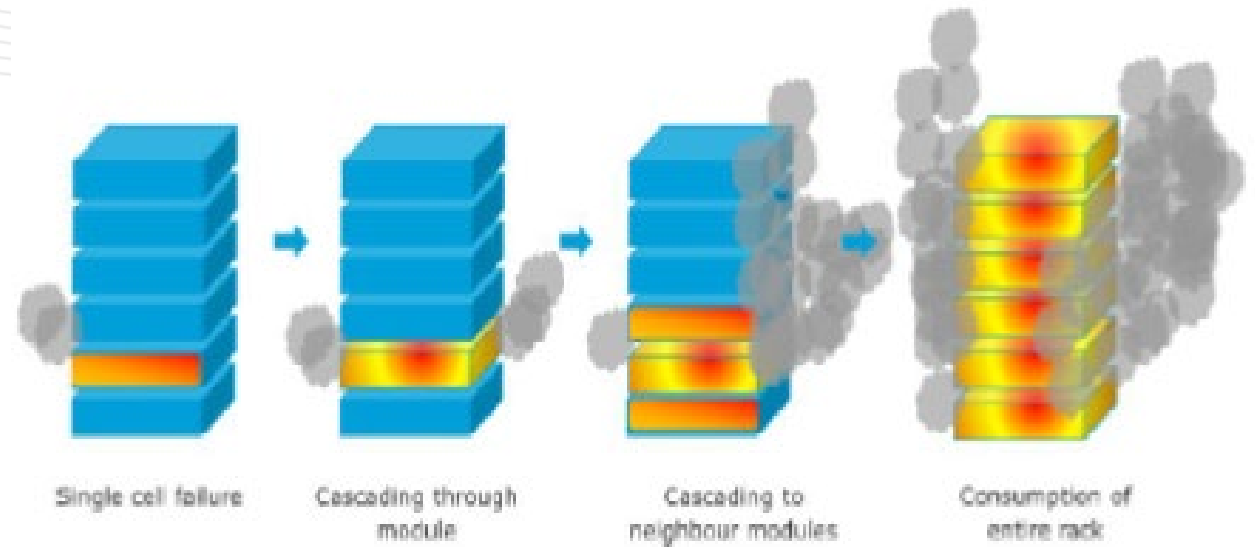
- Remote alarm triggered at 16:55 PST by fire in a BESS
- Explosion at 20:04 PST injured firefighters and significantly damaged the BESS
- Cause of fire identified as a cascading thermal runaway event
- BESS was performing a solar smoothing function
- Battery cell in the BESS experienced sudden voltage drop during charging cycle
- The thermal runaway event activated the smoke detection system and cascaded into neighboring cells and their batteries

*Figure 2: A single cell failure propagated through one Module (Image credit: APS) [1]*

- Improve training, emergency response planning, and procedures for first responders, operations, and maintenance personnel
- Work with suppliers, industry experts, and standards bodies to:
  - Minimize or eliminate cell-to-cell and module-to-module heat transfer to stop thermal runaway
  - Implement fire detection and suppression system designs to fully manage a thermal runaway
  - Implement design changes incorporating monitoring and remote reporting of flammable gas concentrations and implement ventilation systems to mitigate

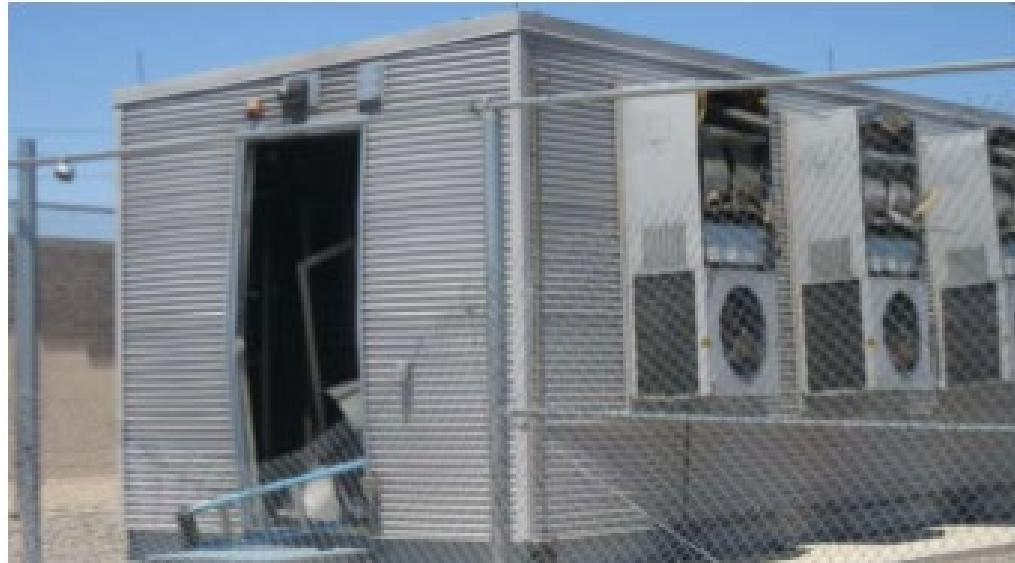
Figure 3: BESS Exterior after event (Image credit: APS) [1]

Modules 1-13 were partially melted and fused from the heat of thermal runaway.

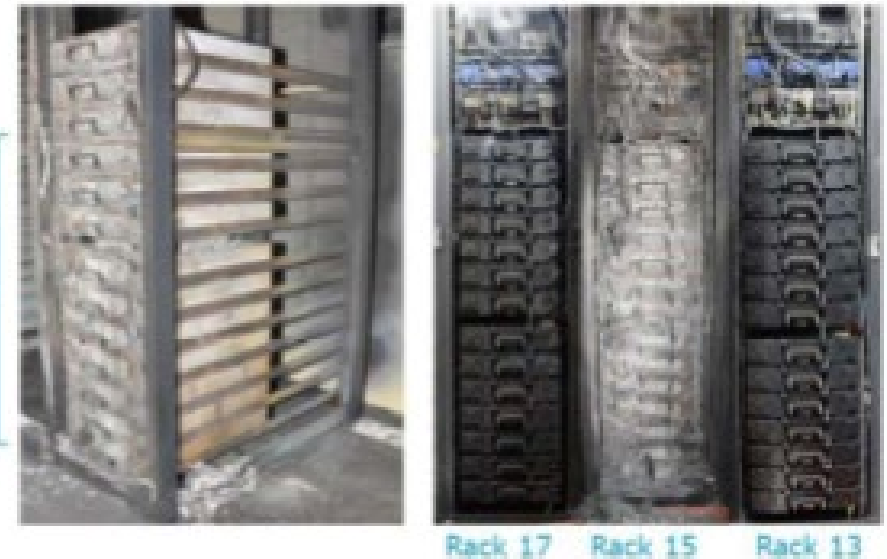
Figure 4: All modules in Rack 15 were severely damaged by thermal runaway while leaving nearby racks mostly intact (Image credit: APS) [1]

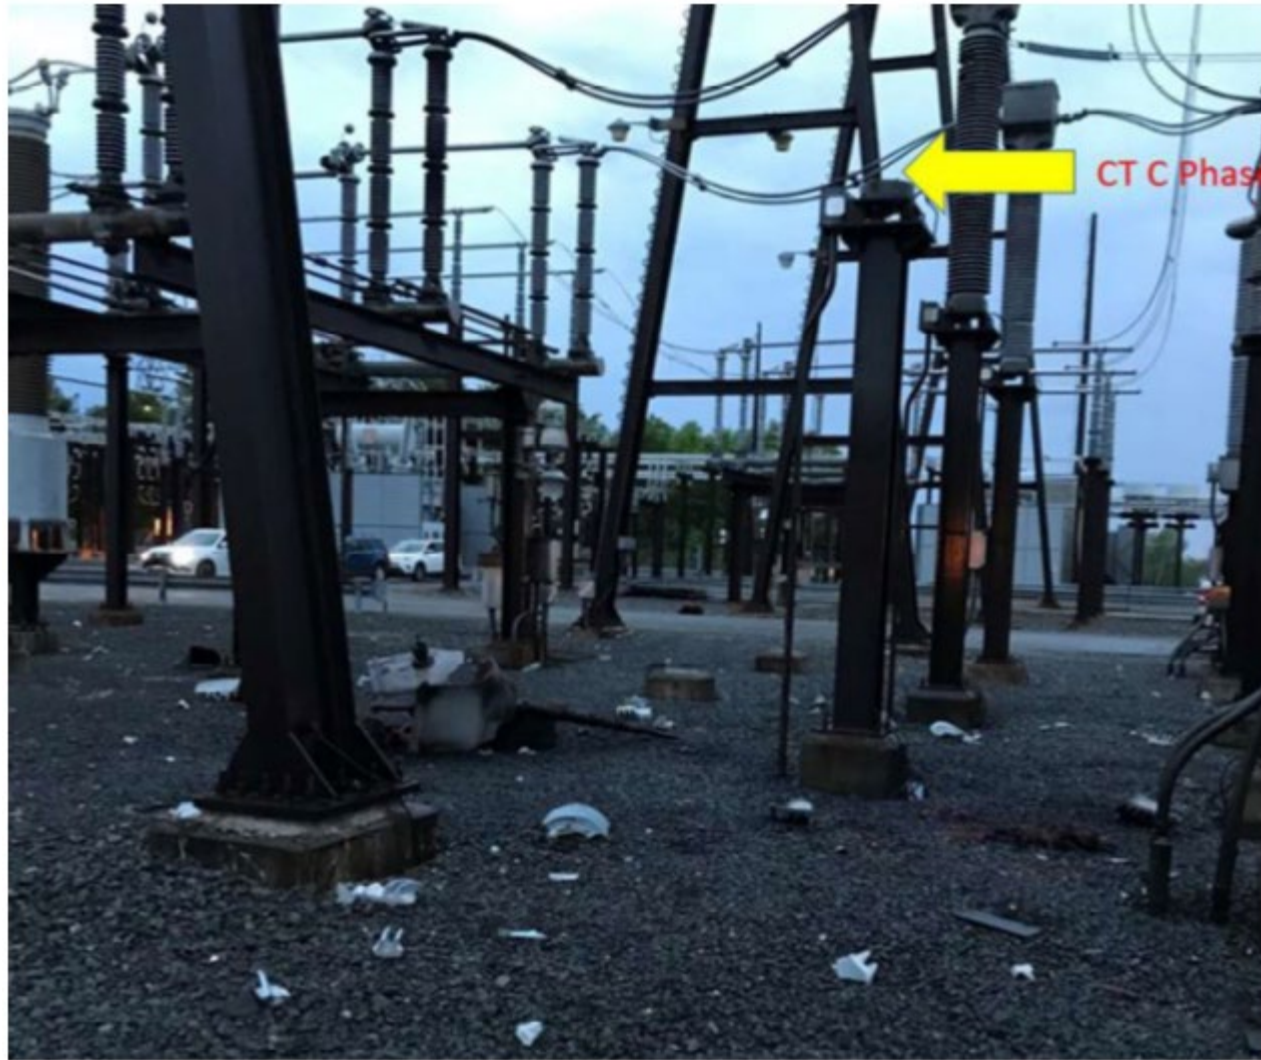
- Catastrophic failure of 345 kV C-phase transformer caused the CT to explode causing fire and spread of glass shrapnel across switchyard
- Fault also led to tripping of 345 kV South Bus, removing Capacitor Bank #2 and inverter based controlled reactive device
- 345 kV Breaker scheduled maintenance led to open-ended Line B
- Entity conducted a root cause analysis

*Figure 7: Switchyard Shrapnel after the explosion [2]*

- Plan was devised to replace all similar CTs
- Entity re-evaluated its maintenance and testing program
- Oil-filled electromagnetic CTs should be evaluated for removal/replacement
- Formalize industry-wide equipment lesson sharing
- Obtain better understanding of failure modes and mechanisms
- Entities should evaluate inspection, maintenance, testing steps and associated frequencies for similar oil-filled equipment
- Use polymer instead of ceramic insulators
- Consider replacement with optical CT
