SRRTEP Committee Western AEP Supplemental Projects

July 24, 2019

AEP Transmission Zone M-3 Process Fayette County, WV

Need Number: AEP-2019-AP023

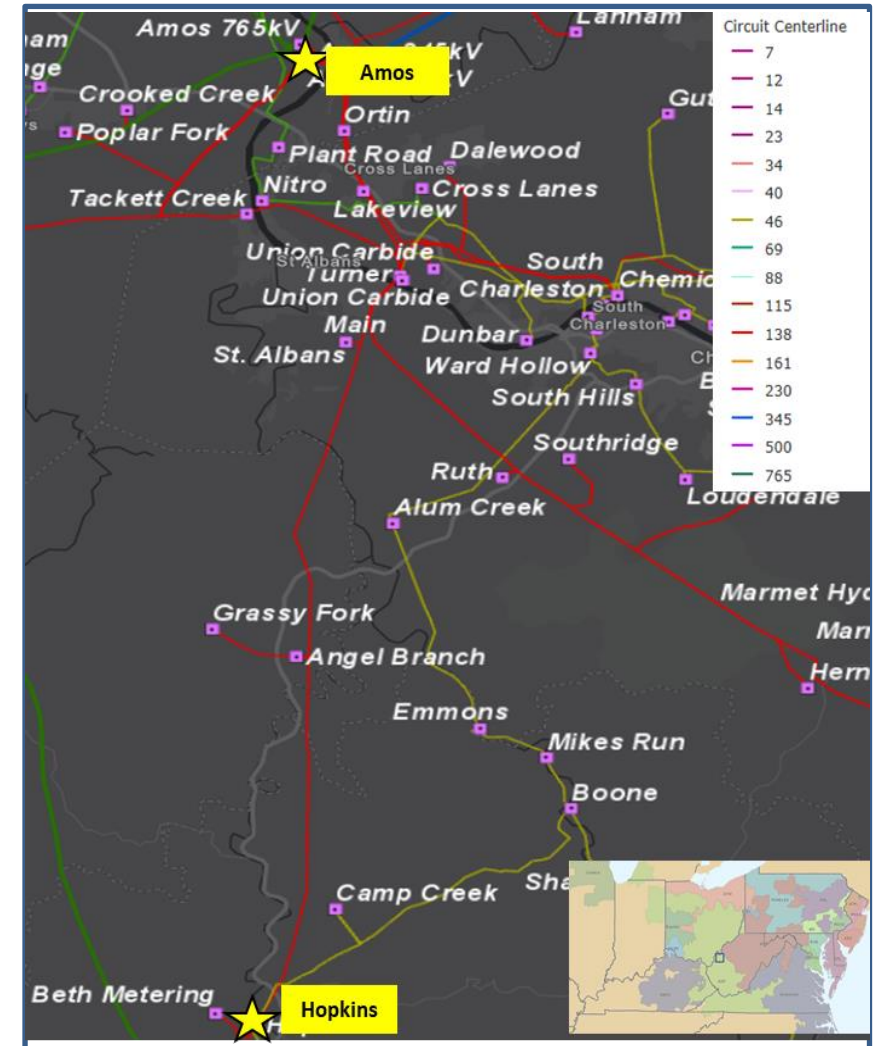
Amos – Hopkins 138 kV (~31.37 miles)

- Majority of the circuit is constructed with 1920s lattice structures
 - The lattice towers used for this line are approximately 94 years old. Structure loading does meet the NESC 250B, 250C and 250D standards for all structures that were analyzed.
 - Steel lattice towers and hardware are currently exhibiting medium to heavy rust
- The shield wire and conductor for this line is 94 years old. Current shielding for the majority of the line does not comply with current standards.

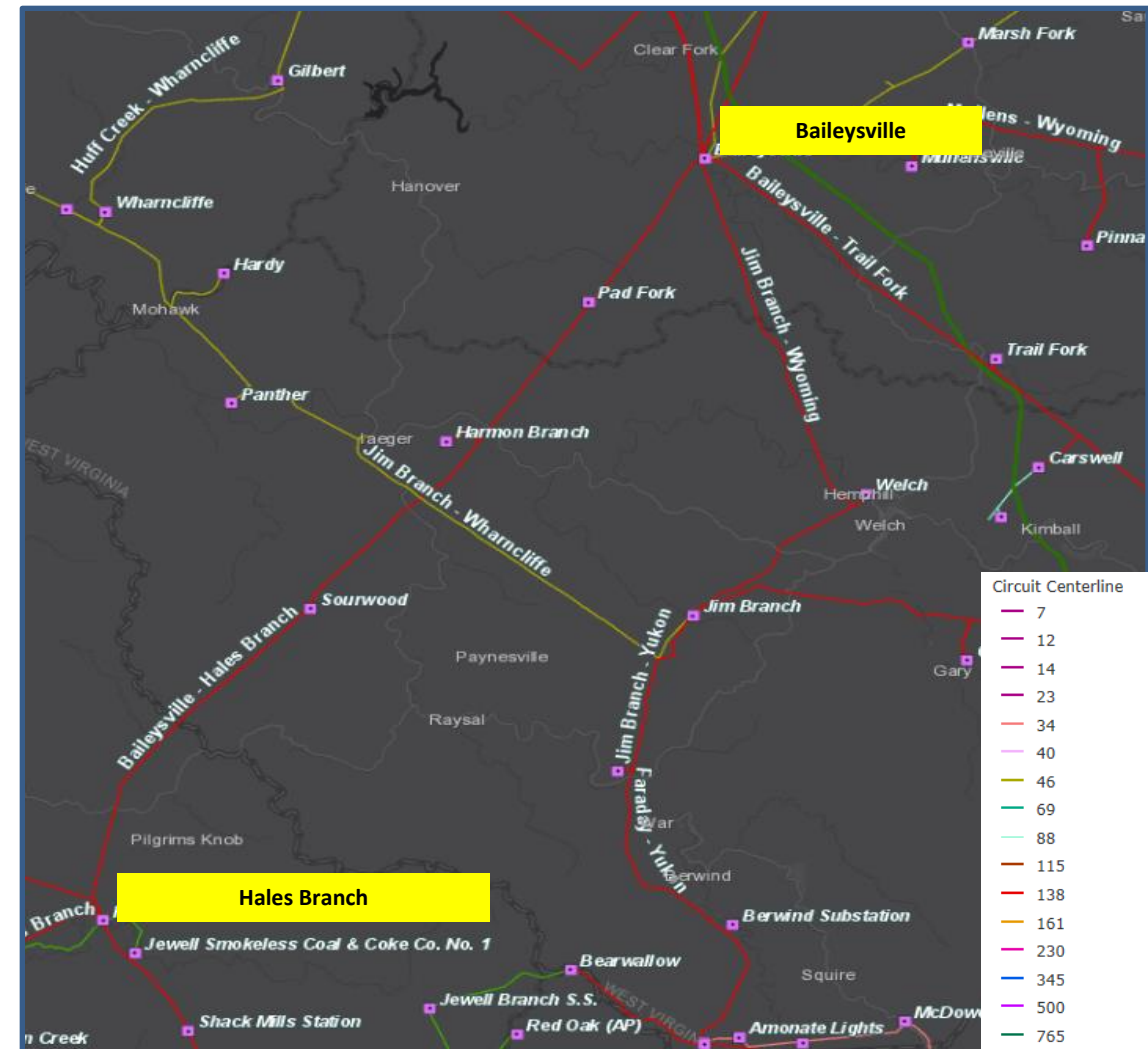
Baileysville – Hales Branch 138 kV (~27.8 miles)

- Majority of the circuit is constructed with 1970s wood structures.
- Between 2015-2018 the circuit experienced 24 momentary outages.
 - All momentary outages are attributed to lightening, insufficient shielding and aging towers as the structures, conductor, hardware, and insulators on the line are displaying issues associated with their age
- The circuit currently has 54 open conditions
 - Open conditions include: Rotten Tops, Woodpecker damage, Split Poles, Corroded Crossarms, Rotten Shells, Broken Ground Lead Wires, and Buildings Encroachment in Right Of Way
- Structures loading does not meet current NESC standards.

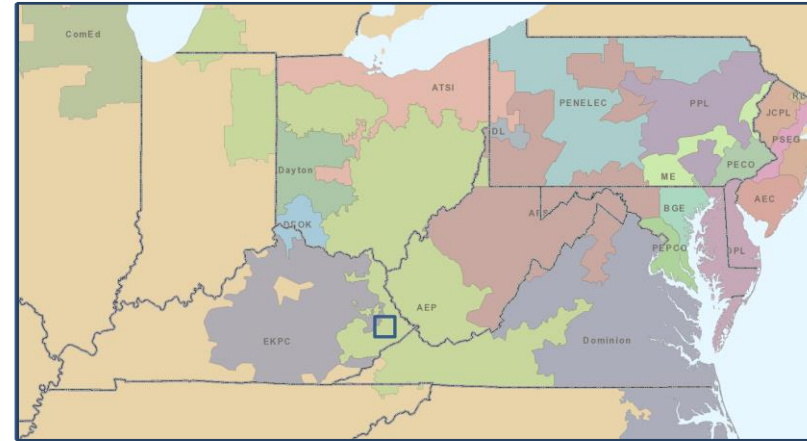
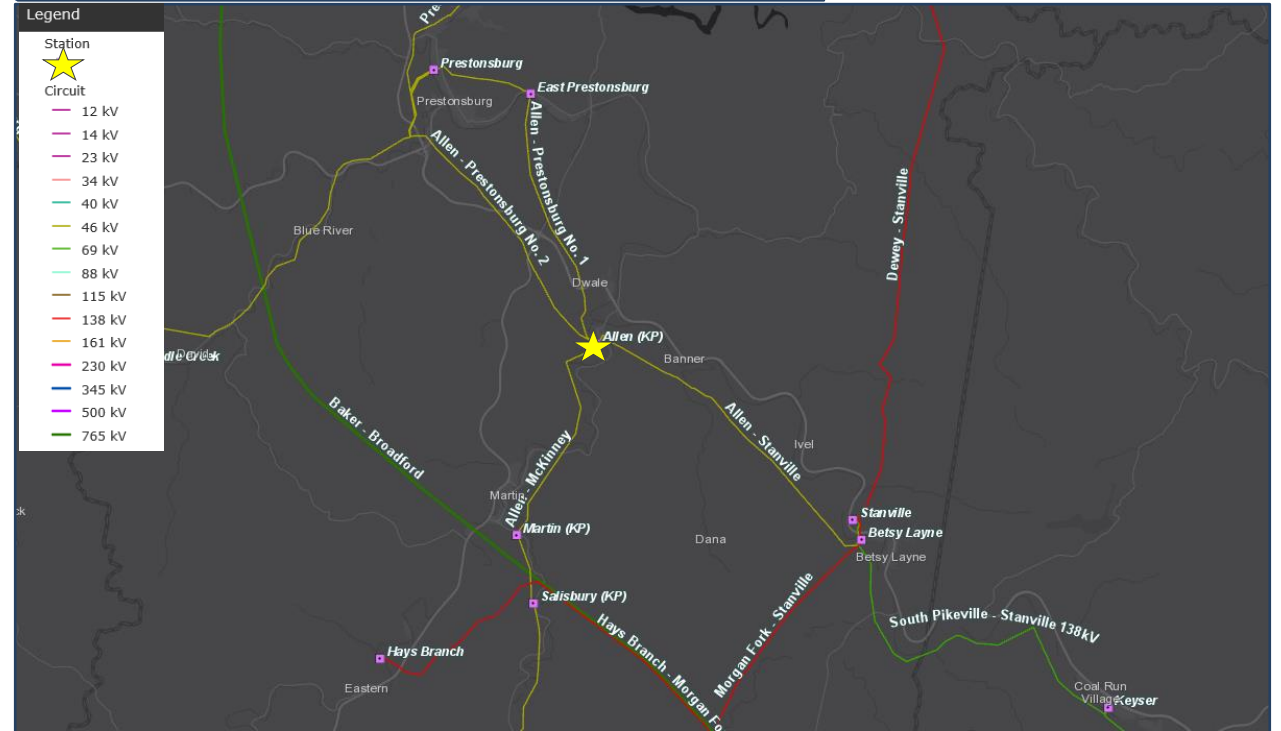
- The existing Allen station has historically experienced severe flooding due to the stations current location in the flood plain. Historical flooding issues have lead to significant deterioration of the stations foundations and structures.

- The 46 kV Circuit Breakers (CBs) A, B, C, & D are oil filled breakers without oil containment manufactured in 1960s. Oil filled breakers have much more maintenance required due to oil handling that their modern, SF6 counterparts do not require. These units comprise 4 of the remaining 12 of the FZO-69-1500P model family on the AEP System. Spare parts for these units are difficult to impossible to procure, and this model type is no longer vendor supported.

- The circuit breakers have experienced the following fault operations, CB A (27), C (20), and D (17). The manufacturer recommendation is 10 fault operations during it's in-service life. In addition, all CBs have documented malfunction records with A, C, and D having at least 1 documented since 2016. These include mainly air leaks, a broken trip latch component, and a trip test switch malfunction. The platform foundations that these are mounted on are crumbling in several locations.

- The 46 kV CS AA is a VBM-69 model type, 1 of 15 remaining on the AEP System. Spare parts for these units are difficult to impossible to procure, and this model type is no longer vendor supported. These circuit switcher models are poor cold weather performers. This unit has 8 documented malfunction records including multiple failures to trip on poles 2 and 3 and one instance in 2011 in which the unit failed to close.

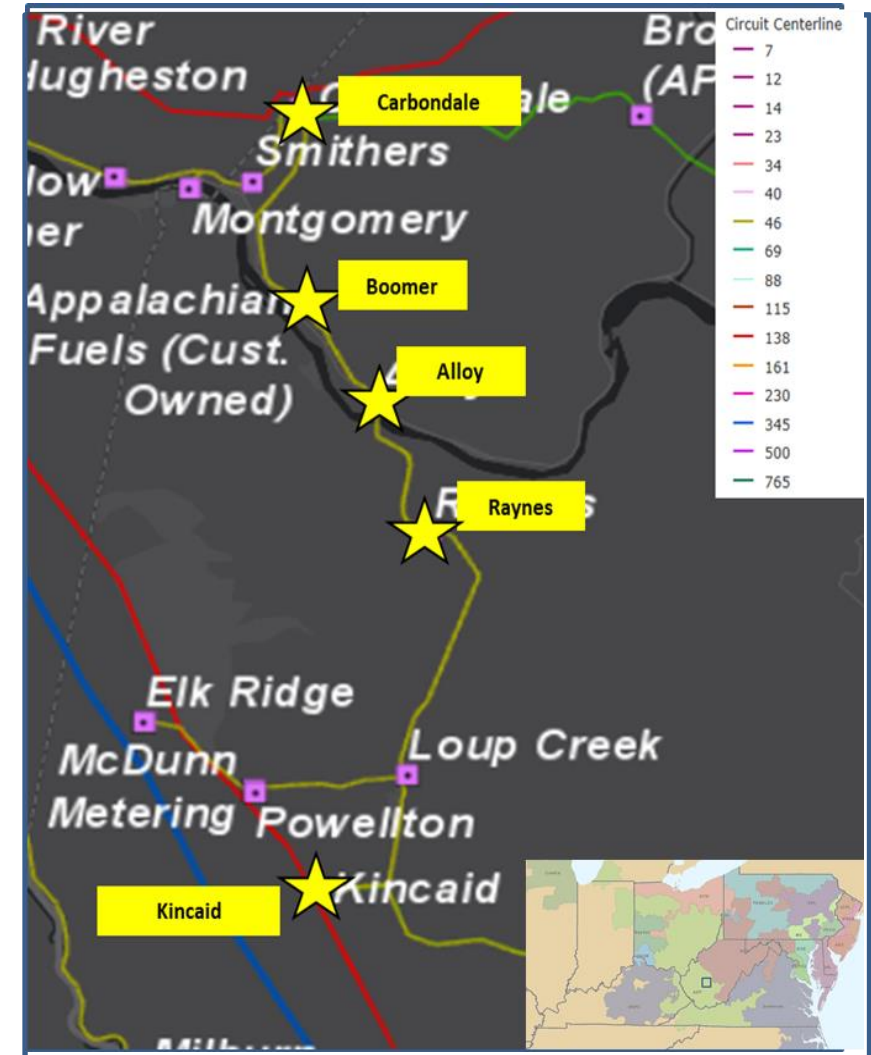
- Majority of the circuit is constructed with 1950s wood and lattice structures
- The conductor is greater than 65 years old. Grounding on this line does not meet current standards.
- Between 2015-2018 the circuit experienced 16 momentary and 6 permanent outage resulting in approximately 140k customer minutes of interruption

- Majority of the circuit is constructed with 1950s wood and lattice structures
- The conductor is greater than 65 years old. Grounding on this line does not meet current standards.
- From 2015-2018 the circuit has experienced 16 momentary and 7 permanent outages resulting in approximately 390k customer minutes of interruption

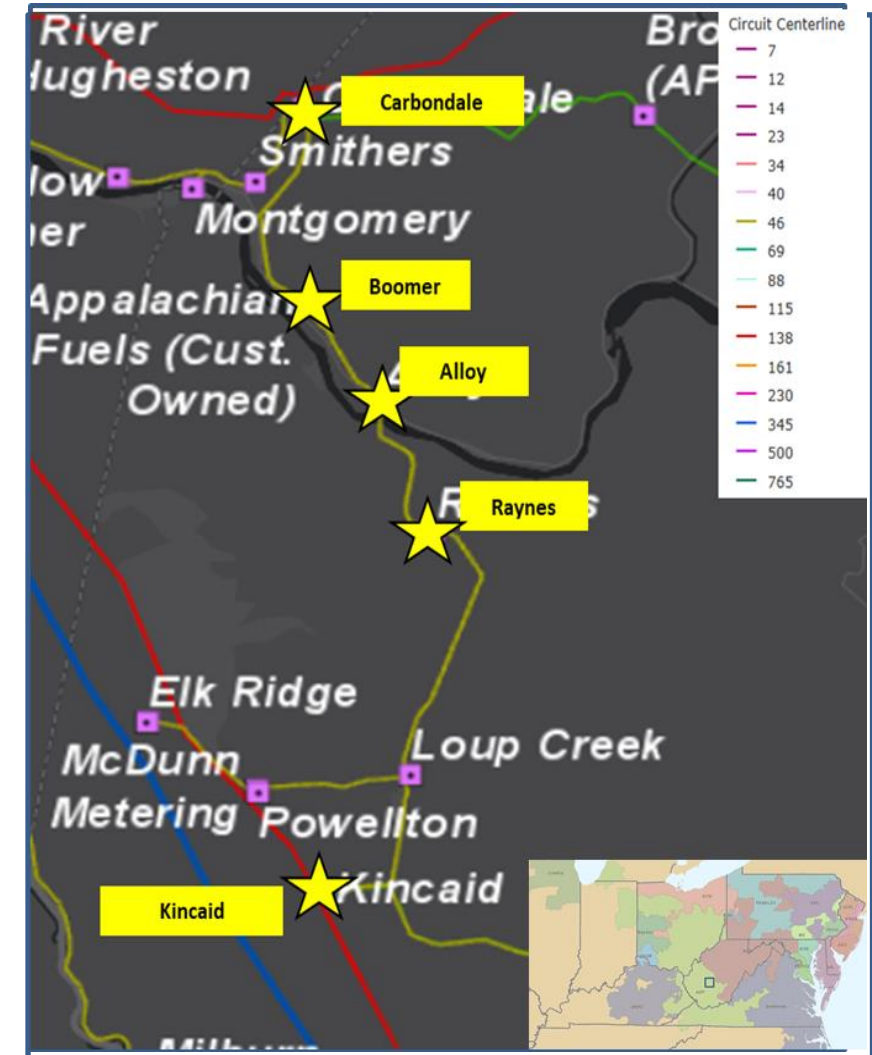
Carbondale 138/69/46 kV Station

- 46 kV and 69 kV CBs A, B, C, D, F and G are all 1968, CF-48-69-2500 type breakers.
 - Spare parts for these units are difficult to impossible to obtain, and this model type is no longer vendor supported

- These breakers are oil filled without oil containment; oil filled breakers have much more maintenance required due to oil handling
 - These breakers have each exceeded the designed number of full fault operations (10). CB-A: 154, CB-B: 49, CB-C: 78, CB-D: 75, CB-F: 94, CB-G: 100

- Carbondale 138/69/46 kV transformer TR-1, manufactured in 1972, has experienced a sharp increase in combustible gas concentrations in January 2016.
 - Numerous gasses have remained at elevated levels, including acetylene at IEEE Condition 4 and ethylene at IEEE Condition 2.

- The concentrations present are strongly correlated to electrical discharges of high energy and thermal faults in excess of 700° C.
 - Despite declining moisture levels and improving interfacial tension, oil power factor levels are on the rise, and dielectric strength is declining. This supports contamination in the oil from the high energy discharges and thermal faults.

- The current MOAB/Ground SW configuration on TR-1 creates a fault in the station to signal the remote end breakers to open; this is a known safety hazard in legacy station designs.

- The 138 kV line section towards Kanawha River terminates directly into the bus which creates a lack of operational flexibility when switching for faults on the circuit.

- Carbondale Substation currently deploys 64 relays, implemented to ensure the adequate protection and operation of the substation.
 - 36 of the 64 relays (56% of all station relays) are in need of replacement.

- 36 of the electromechanical which have significant limitations with regards to fault data collection and retention. Spare parts for these relays are difficult to obtain.

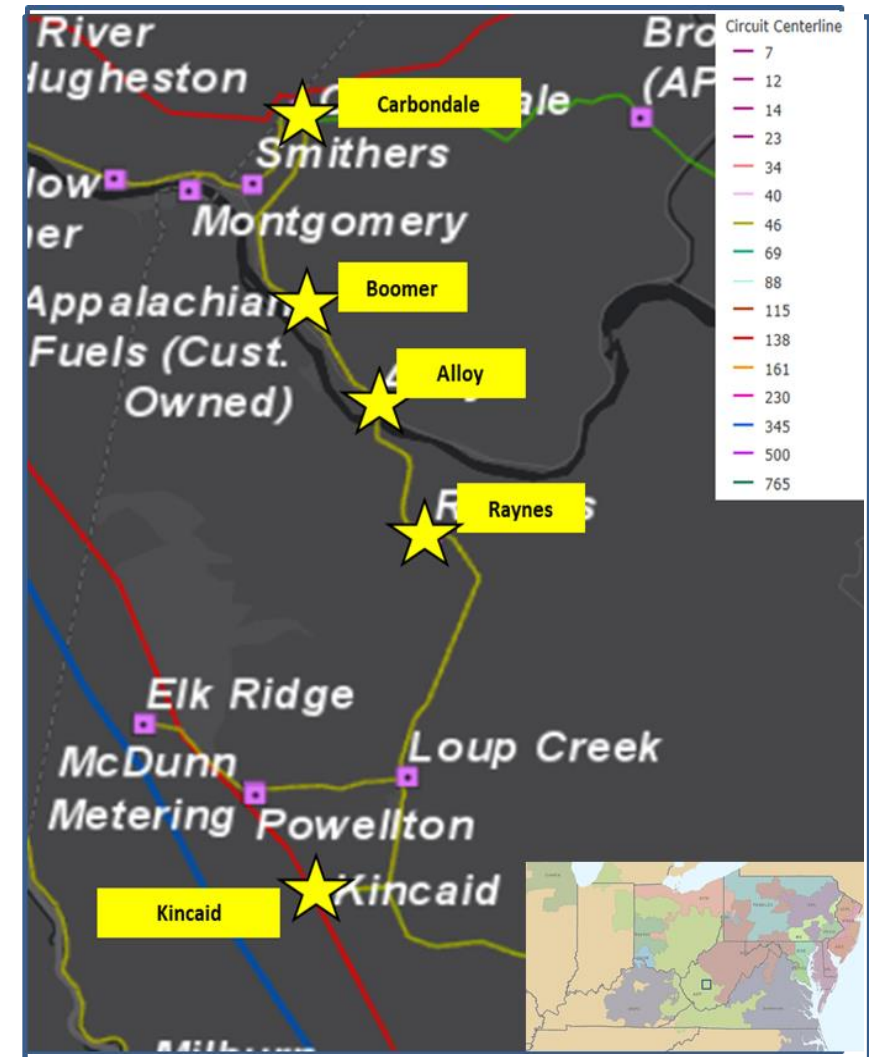
Kincaid 138/69/46 kV Station

- 46 kV CBs A, B, and J are all 1972 FK-72.5-27000-9 type breakers, accounting for 3 of 21 remaining of this model remaining on the AEP system.
 - Spare parts for these units are not available and this model type is no longer vendor supported

- These breakers are oil filled without oil containment; oil filled breakers have much more maintenance required due to oil handling
 - These breakers have each exceeded the designed number of full fault operations (10). CB-A: 61, CB-B: 123, CB-J: 72

- GND transformer PH 1-3
 - All three single phase units of GND TR are experiencing similar health deterioration.
 - There are elevated levels of Acetylene at IEEE condition 2 and Carbon Dioxide at IEEE Condition 2 or 3.

- The presence of excess acetylene may be a product of arcing causing overheating on this unit. High levels of carbon dioxide support this observation.

- In addition, significantly diminished oil interfacial tension corroborates the frequent overheating events. Sludge has likely developed in the oil from particulate formation during arcing and other fault events. This sludge impairs the natural circulation of oil.

- Moisture levels are on the rise which can lead to diminished dielectric strength over time.
- The current 138 kV MOAB/Ground SW configuration on TR-1 creates a fault in the station to signal the remote end breakers to open; this is a known safety hazard in legacy station designs.

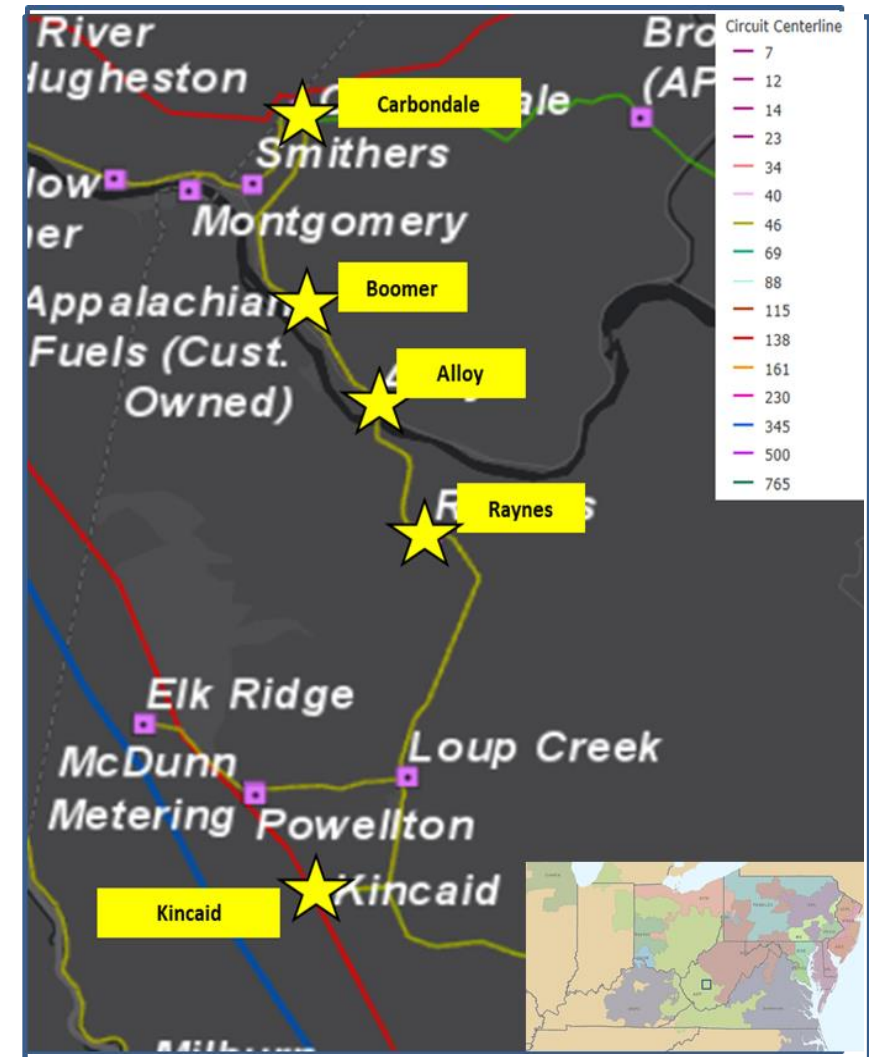
- Kincaid Substation currently deploys 51 relays, implemented to ensure the adequate protection and operation of the substation.
 - Currently, 45 of the 51 relays (88% of all station relays) are in need of replacement.
 - There are 45 of the electromechanical which have significant limitations with regards to fault data collection and retention. Of these relays, 18 are in the top 90th percentile of relays on the AEP system targeted for replacement by PCE.
 - There appears to be little room in the existing control house to accommodate a relay replacement of this suggested magnitude.
- The existing RTU installed at Kincaid is a GE D200MEII/Ethernet and has 2 documented malfunction records

- Customer no longer served from this station, no load at this station.

- Hard taps are difficult to maintain due to required outages or temporary jumper configurations in lieu of a switch.
- Hard taps can also result in extended outages to customers due to the inability to sectionalize faulted facilities.

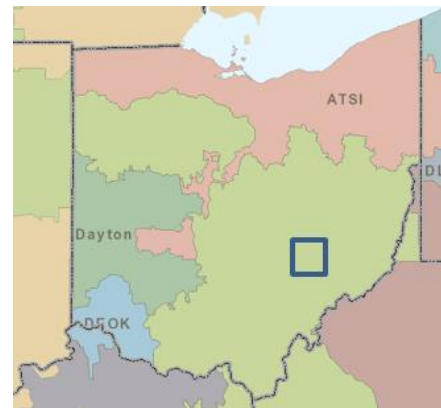
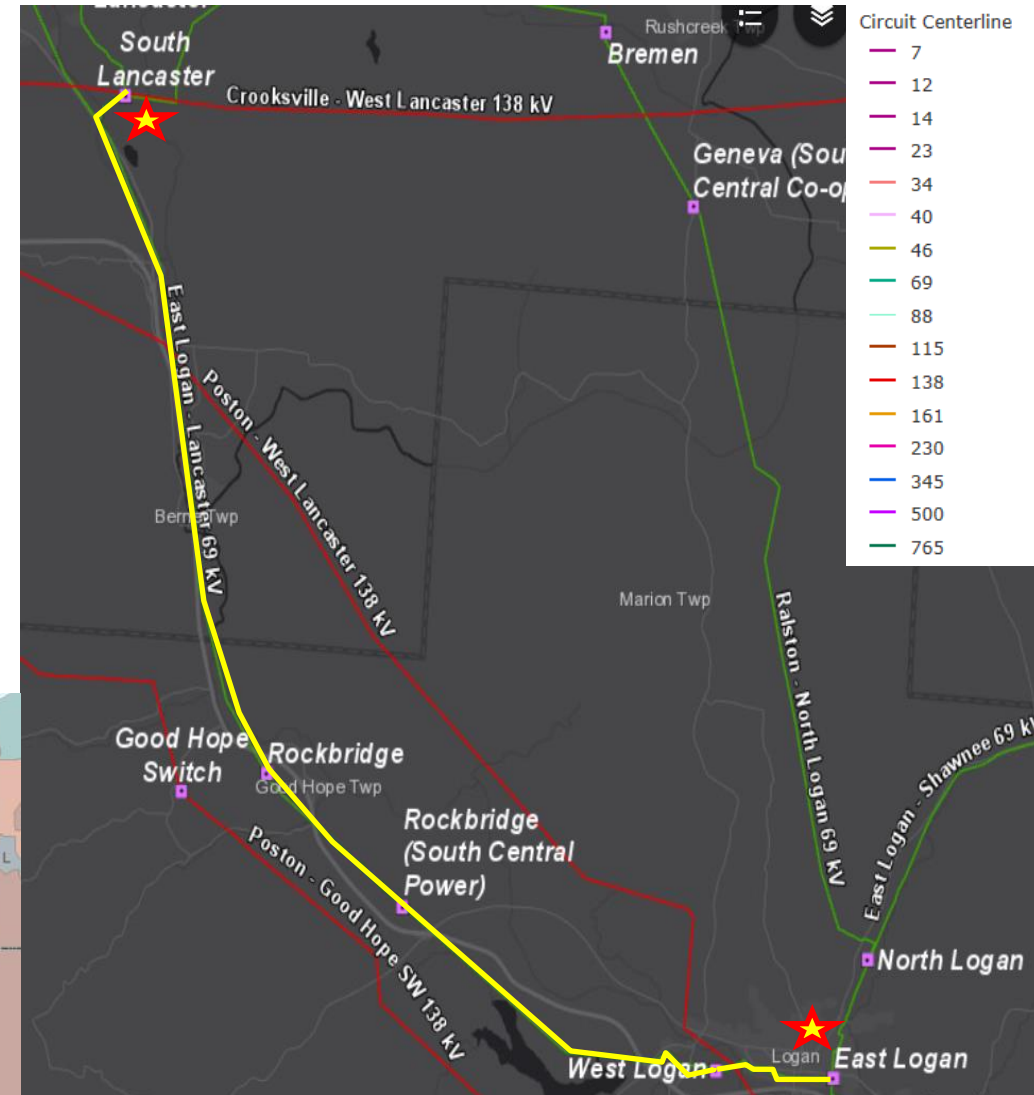
East Logan – South Lancaster 69kV (vintage 1923)

- Length: 16.43 Miles
- Original Construction Type: Steel Lattice/Wood
- Original Conductor Type: 2/0 Copper
- Momentary/Permanent Outages: 43 total outages
- CMI: 872,607 in the last 3 years
- Number of open conditions: 40
 - Open conditions include: Burnt/broken insulators, pole rot, insect damage, damaged conductor

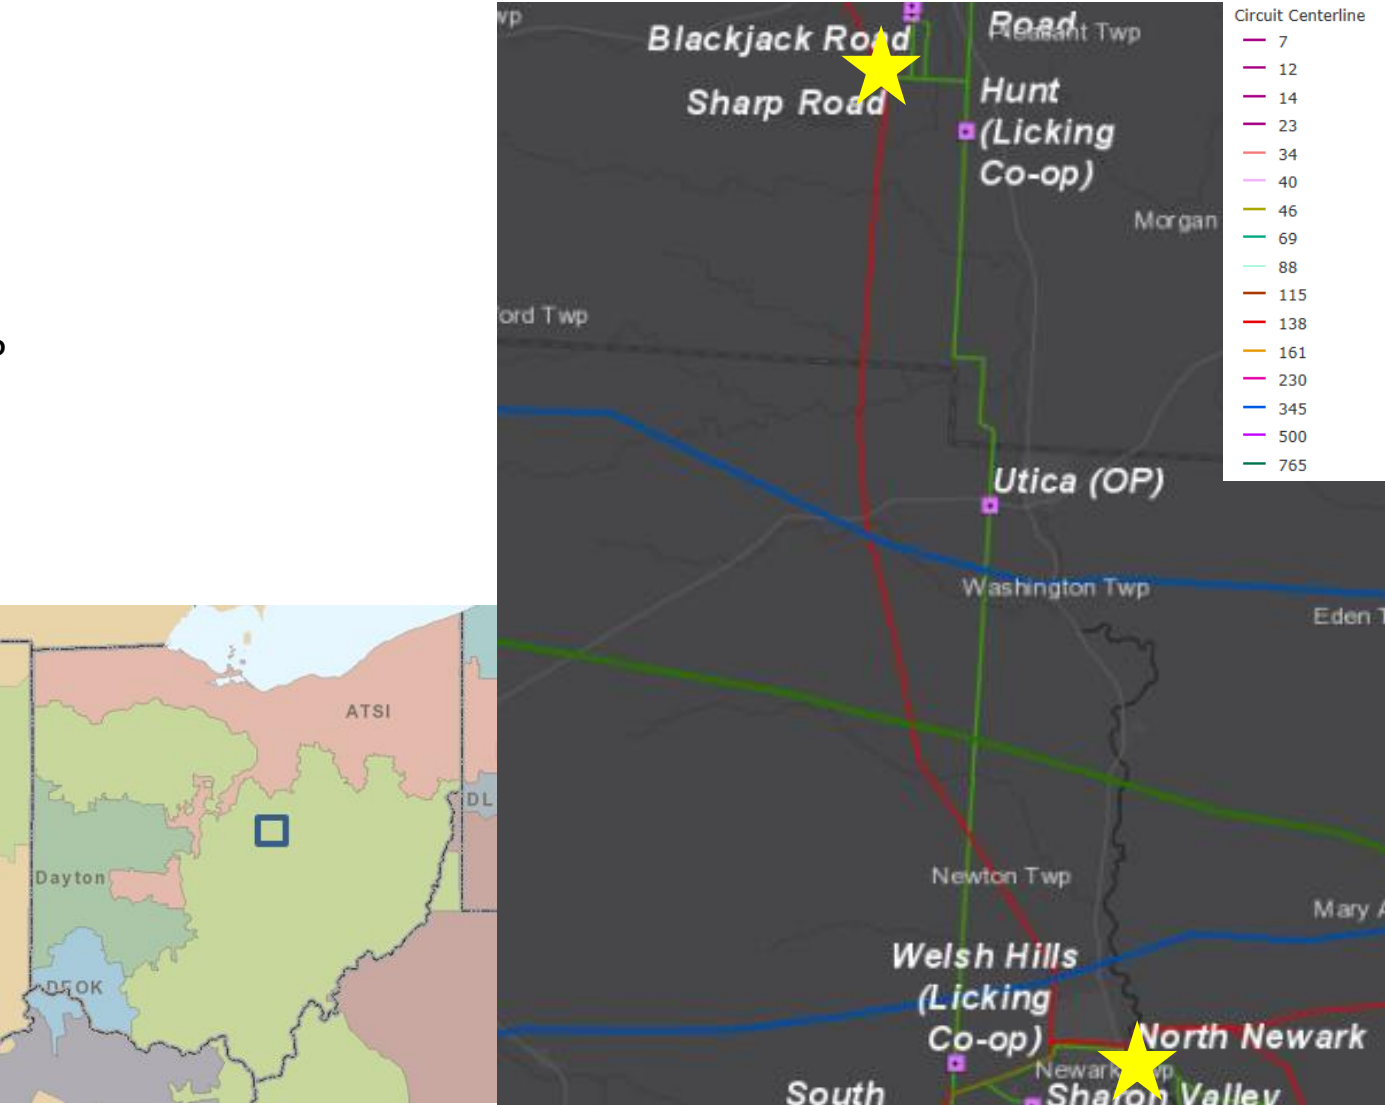
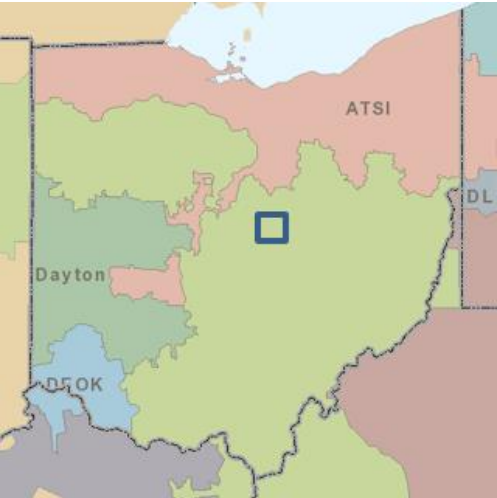
North Newark – Sharp Road 138 kV (vintage 1951)

- Length: 19.38 Miles
- Original Construction Type: Wood Pole
- Original Conductor Type: 477 kcmil Hawk
- Number of open conditions: 68
 - Open conditions include: Burnt insulators, insect damage, pole rot, woodpecker damage

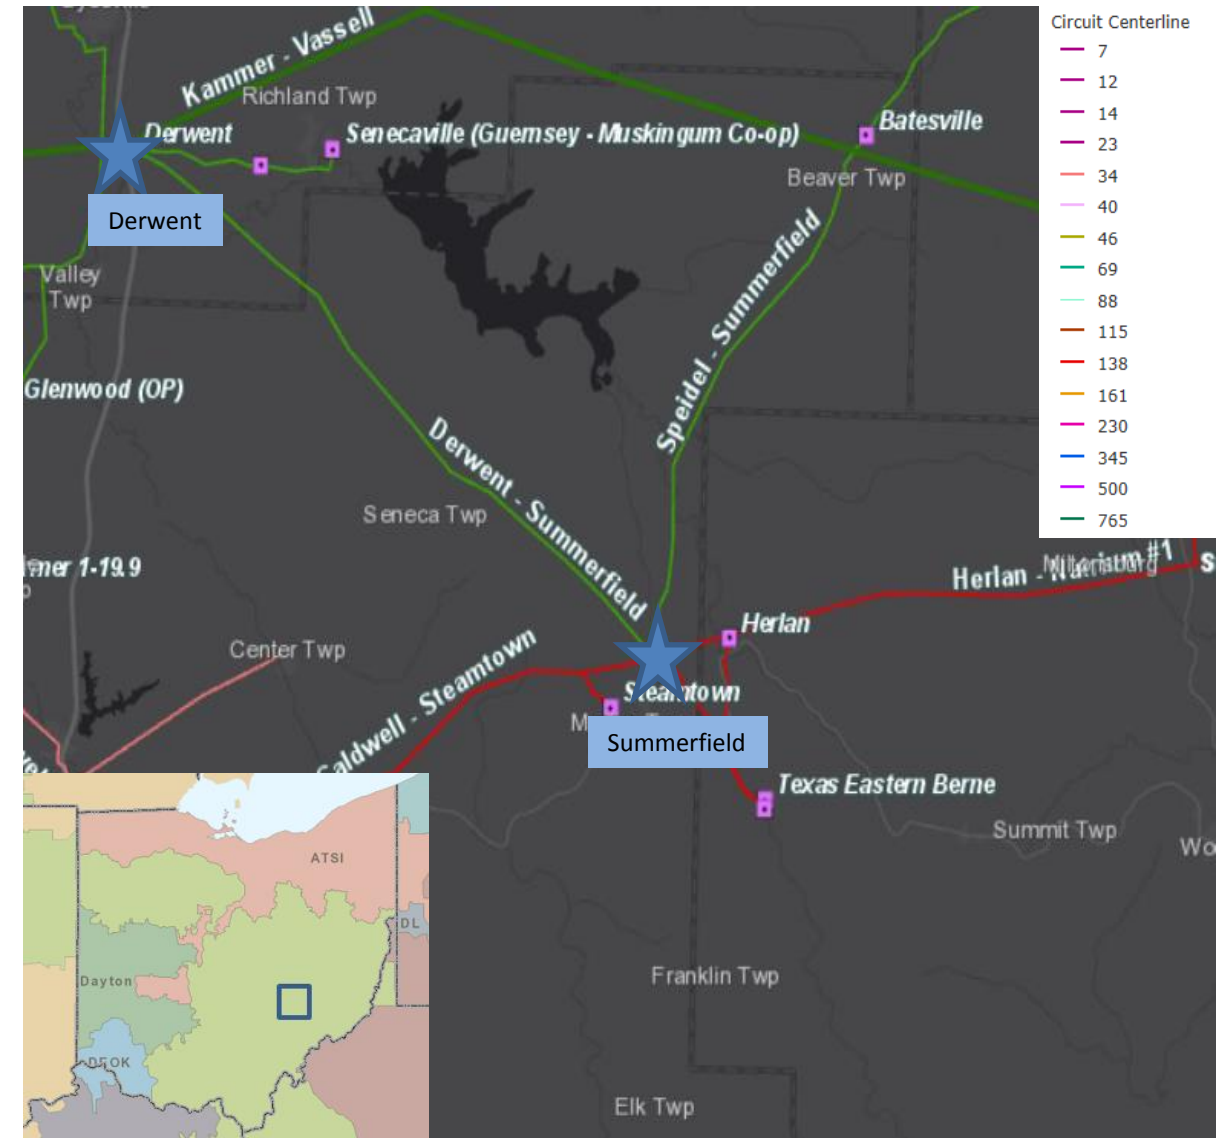
Derwent – Summerfield 69 kV

- Majority of ~~13.8~~ 3.3 mile circuit utilizes wood structures installed in 1962.
- Circuit utilizes 336.4 kcmil ACSR 30/7 Oriole conductor installed in 1962.
- Five momentary and permanent outages over last three years.
- ~~62~~ 20 Open Structure/Conductor conditions
 - Insect damage, woodpecker holes, along with rotted and cracked structures.

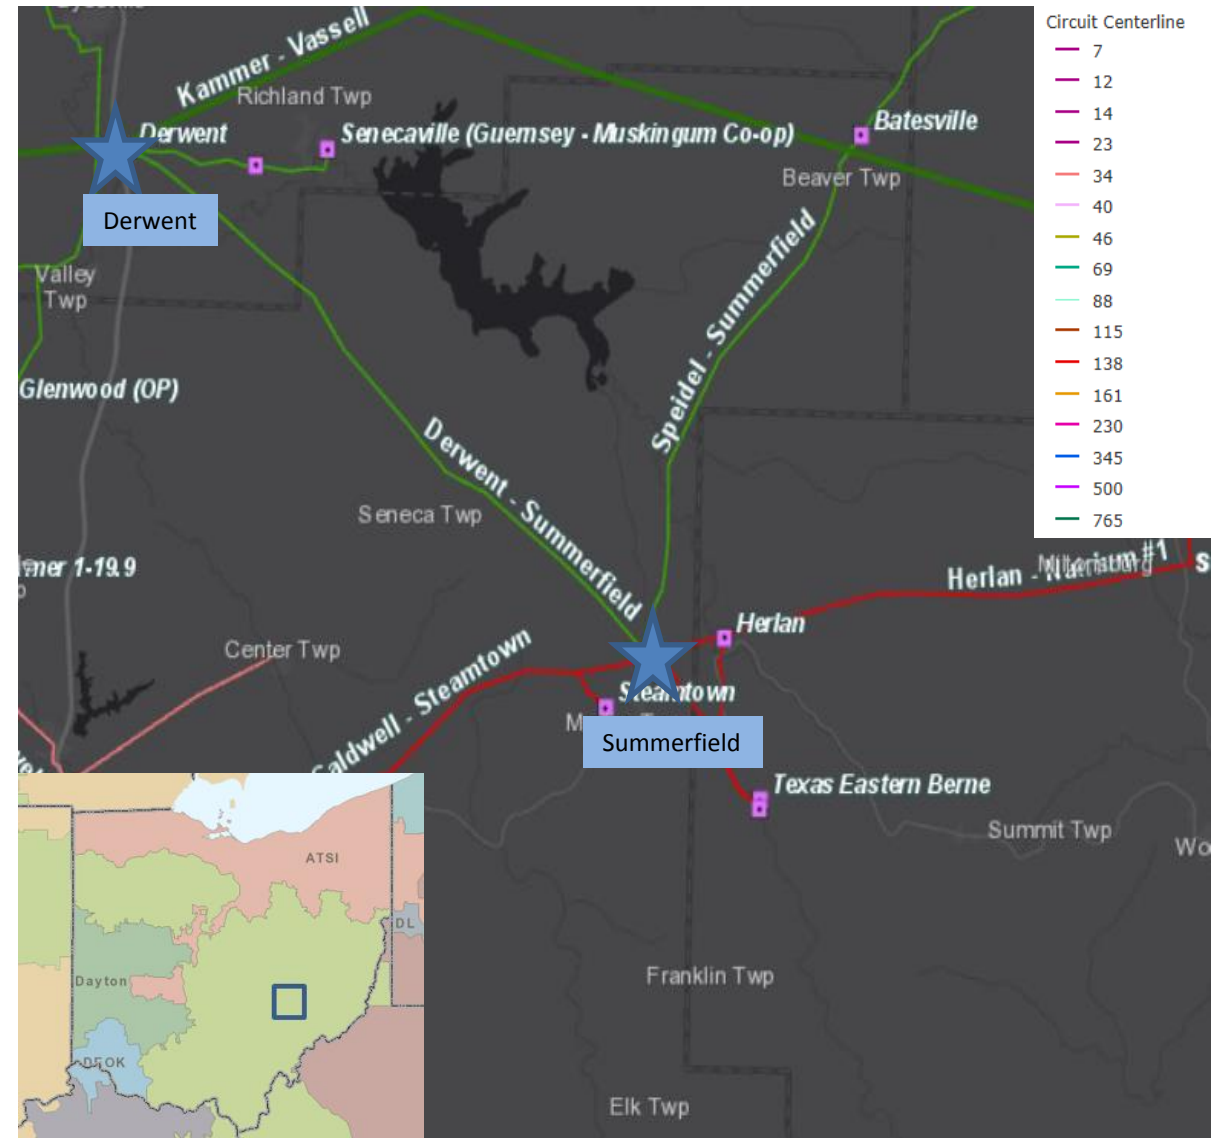
Derwent – Summerfield 69kV

- Majority of 10.5 miles circuit utilizes wood structures installed in 1962.
- Circuit utilizes 336.4 kCM ACSR 30/7 Oriole conductor installed in 1962.
- Five momentary and permanent outages over last three years.
- 42 Open Structure/Conductor conditions
 - Insect damage, woodpecker holes, along with rotted and cracked structures.

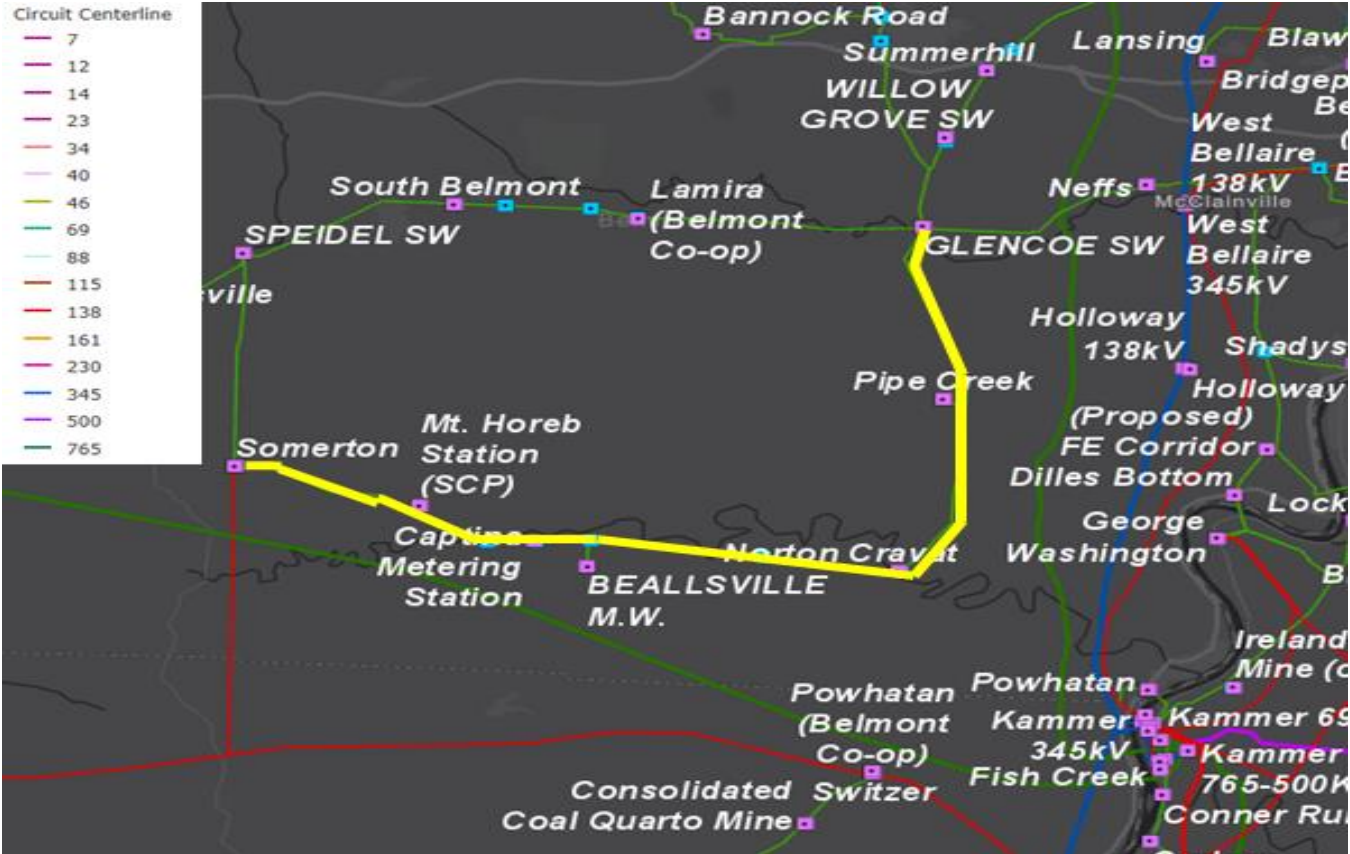
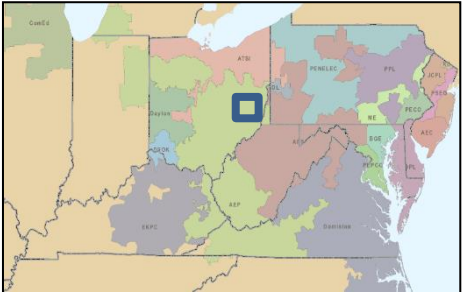
- The Glencoe-Somerton 69 kV circuit is 22.5 miles in length and has numerous condition issues. Within the last 5 years, it has experienced 18 momentary outages (3.6 per year) and 7 permanent (sustained) outages (1.4 per year). The average outage duration has been 13.7 hours. AEP and South Central Power Co-op customers served from this circuit suffered nearly 3.5 million minutes of customer interruption (CMI) during the 2015-2018 timeframe.

- The circuit currently has 148 open conditions (43 structural, 23 on conductor, 5 for shielding/grounding, 24 for hardware, and 53 for forestry/ROW). The majority of the wood poles were installed in 1953 and 1970 (84% of circuit length). The conductor was also primarily installed in 1953 (219 kcmil ACSR) and 1970 (336 kcmil ACSR). The majority of the outage causes have been attributed to T-Line condition issues.

- The two 69 kV delivery points for South Central Power Co-op’s Beallsville and Pipe Creek stations are connected via hard taps (no sectionalizing switches present). This requires an outage to the customer whenever maintenance or emergency repairs must be done on either side of the customer tap.

Rebuild the Glencoe-Somerton 69 kV circuit (22 miles) with single-circuit 795 ACSR conductor.

Replace the Pipe Creek hard tap with a 1200 A-rated 3-way switch (Jacobsburg Switch).

Replace the Beallsville hard tap with a 1200 A-rated 3-way switch (Beallsville Switch).
