# NERC Lessons Learned

Donnie Bielak  
Manager, Reliability Engineering

Battery Energy Storage System  
Cascading Thermal Runway

# Catastrophic Failure of 345kV Oil Filled Metering Current Transformer in a Transmission Substation

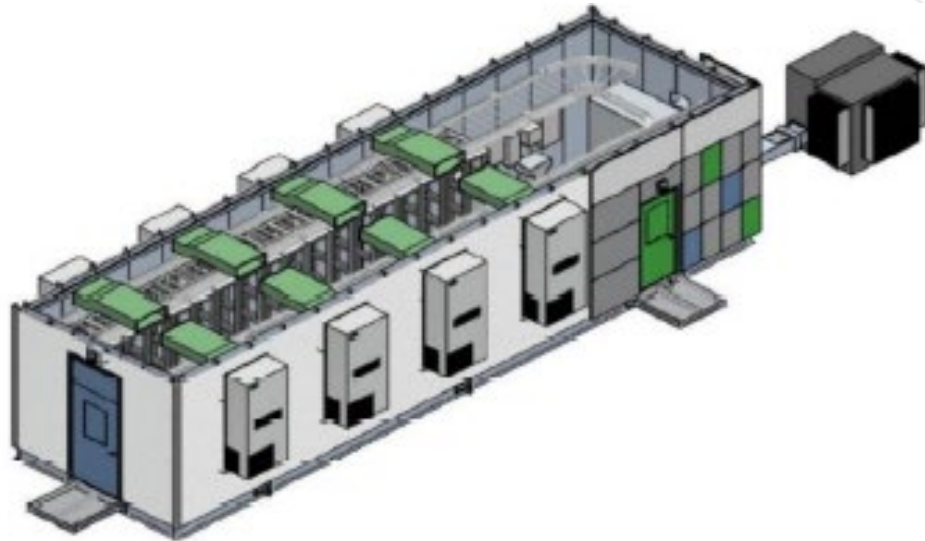
*Figure 1: General Layout of the BESS  
(Image credit: APS) [1]*

- Remote alarm triggered at 16:55 PST by fire in a BESS
- Explosion at 20:04 PST injured firefighters and significantly damaged the BESS
- Cause of fire identified as a cascading thermal runaway event
- BESS was performing a solar smoothing function
- Battery cell in the BESS experienced sudden voltage drop during charging cycle
- The thermal runaway event activated the smoke detection system and cascaded into neighboring cells and their batteries

- Improve training, emergency response planning, and procedures for first responders, operations, and maintenance personnel
- Work with suppliers, industry experts, and standards bodies to:
  - Minimize or eliminate cell-to-cell and module-to-module heat transfer to stop thermal runaway
  - Implement fire detection and suppression system designs to fully manage a thermal runaway
  - Implement design changes incorporating monitoring and remote reporting of flammable gas concentrations and implement ventilation systems to mitigate

- Conduct hazard mitigation analysis
- Develop a pre-incident guide for future training of utility personnel and fire services
- Conduct training, familiarization tours and exercises with your local fire department

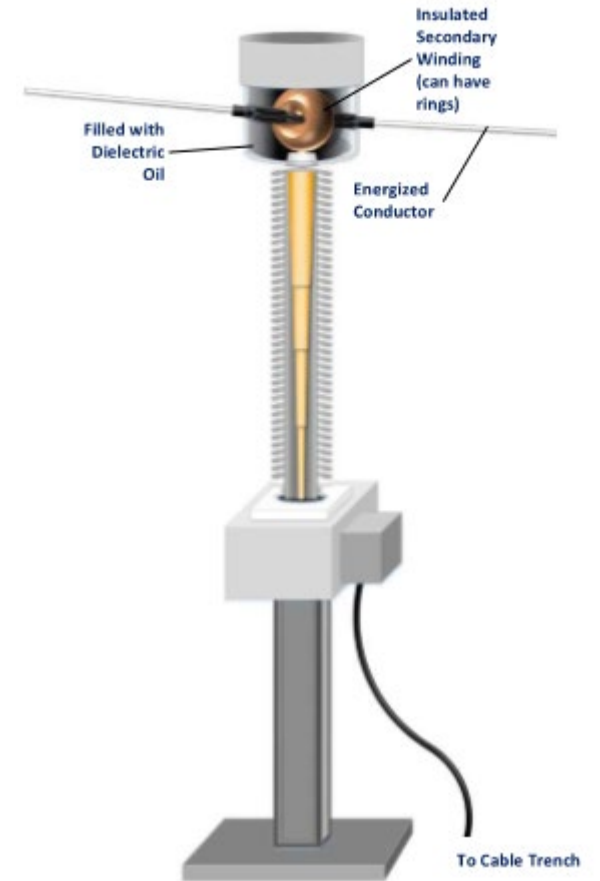
Figure 5: Wire Wound CT Simplified Cutaway [2]

- Catastrophic failure of 345 kV C-phase transformer caused the CT to explode causing fire and spread of glass shrapnel across switchyard
- Fault also led to tripping of 345 kV South Bus, removing Capacitor Bank #2 and inverter based controlled reactive device
- 345 kV Breaker scheduled maintenance led to open-ended Line B
- Entity conducted a root cause analysis

- Plan was devised to replace all similar CTs
- Entity re-evaluated its maintenance and testing program
- Oil-filled electromagnetic CTs should be evaluated for removal/replacement
- Formalize industry-wide equipment lesson sharing
- Obtain better understanding of failure modes and mechanisms
- Entities should evaluate inspection, maintenance, testing steps and associated frequencies for similar oil-filled equipment
- Use polymer instead of ceramic insulators
- Consider replacement with optical CT
