# Sub Regional RTEP Committee PJM Mid-Atlantic Met-Ed

April 26, 2019

# Solutions

# Met-Ed Transmission Zone M-3 Process Multiple Line Rebuild/Rehab Projects

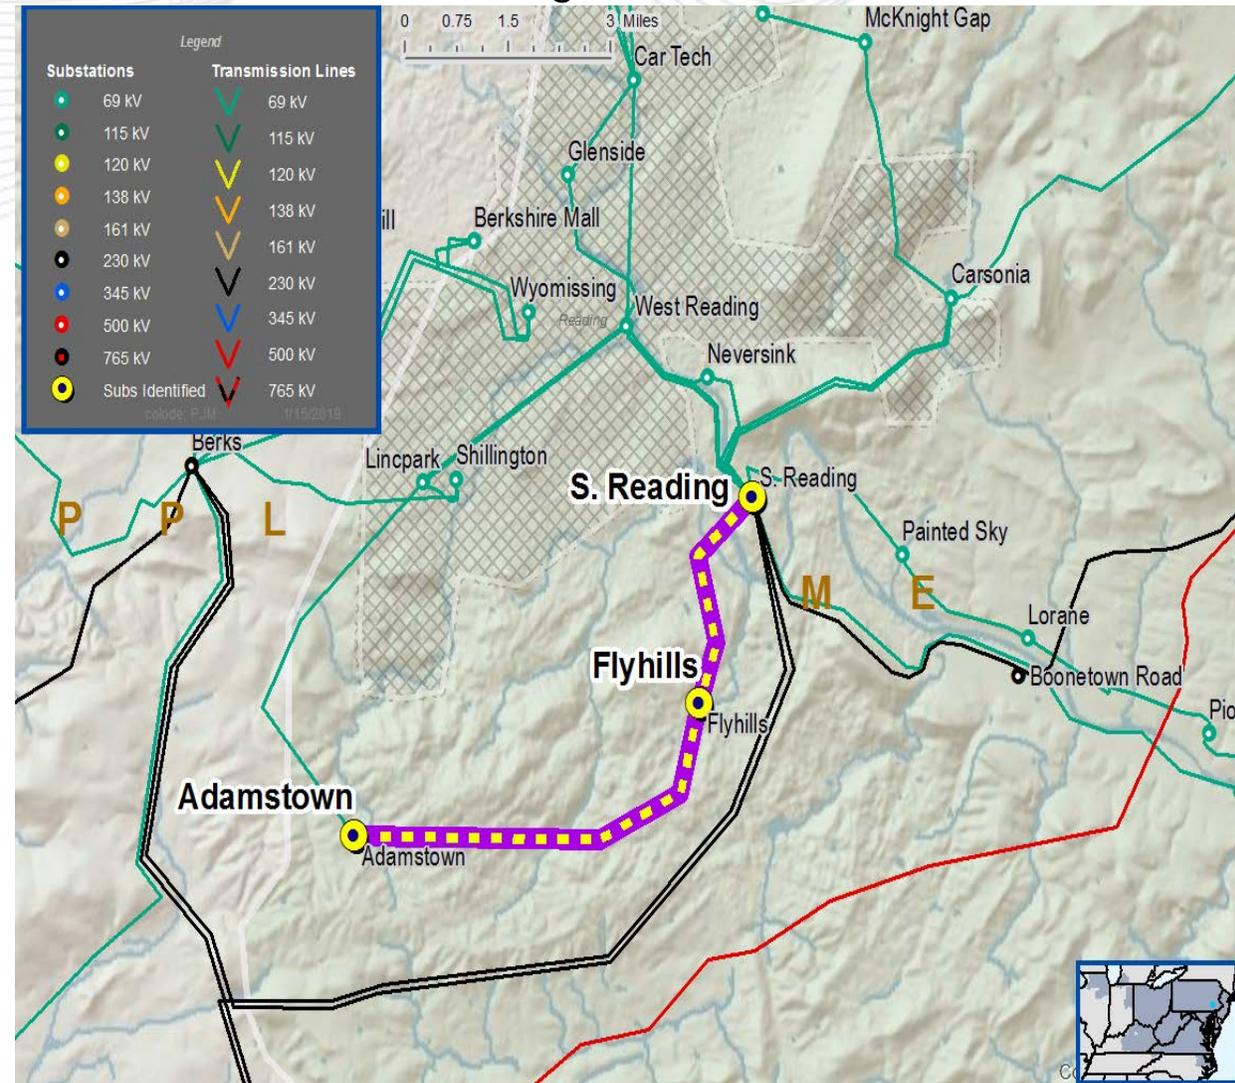
- Rehab/Rebuild Adamstown – South Reading. Reconductor 7.2 miles of the 9 mile line.
  - 5.4 miles of reconductoring on Adamstown-Flying Hills.
  - 1.8 miles of reconductoring on Flying Hills-South Reading.
- Replace substation conductor and drops at Flying Hills

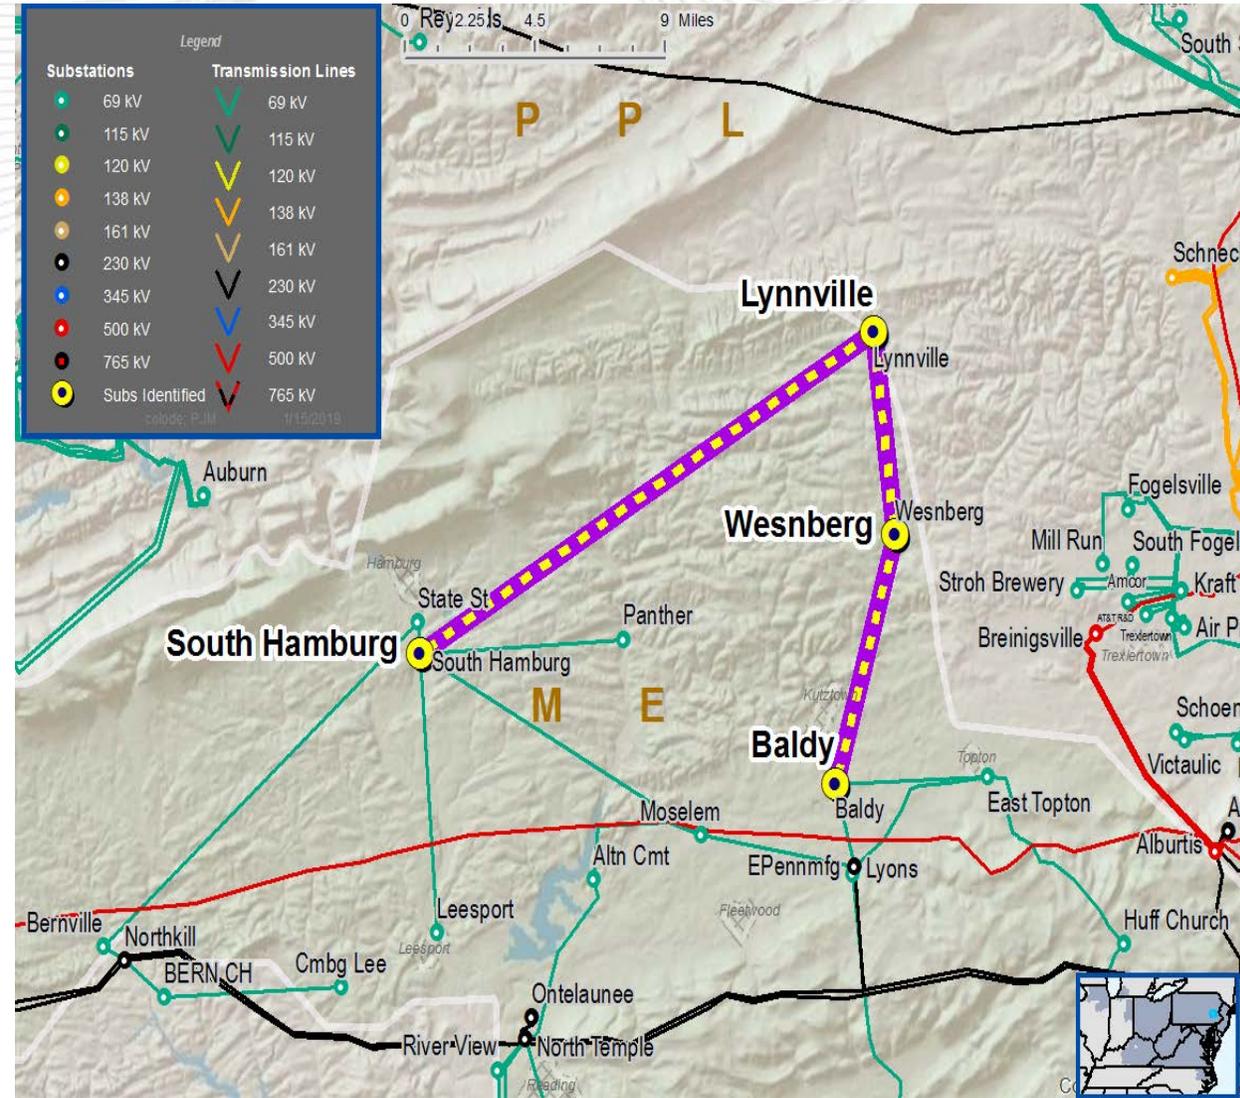
# Met-Ed Transmission Zone M-3 Process Baldy – South Hamburg 69 kV Line Rehab/Rebuild

- Rehab/Rebuild Baldy – South Hamburg (~29.3 miles)
- Replace line relaying and substation conductor at Baldy
- Replace substation conductor at South Hamburg

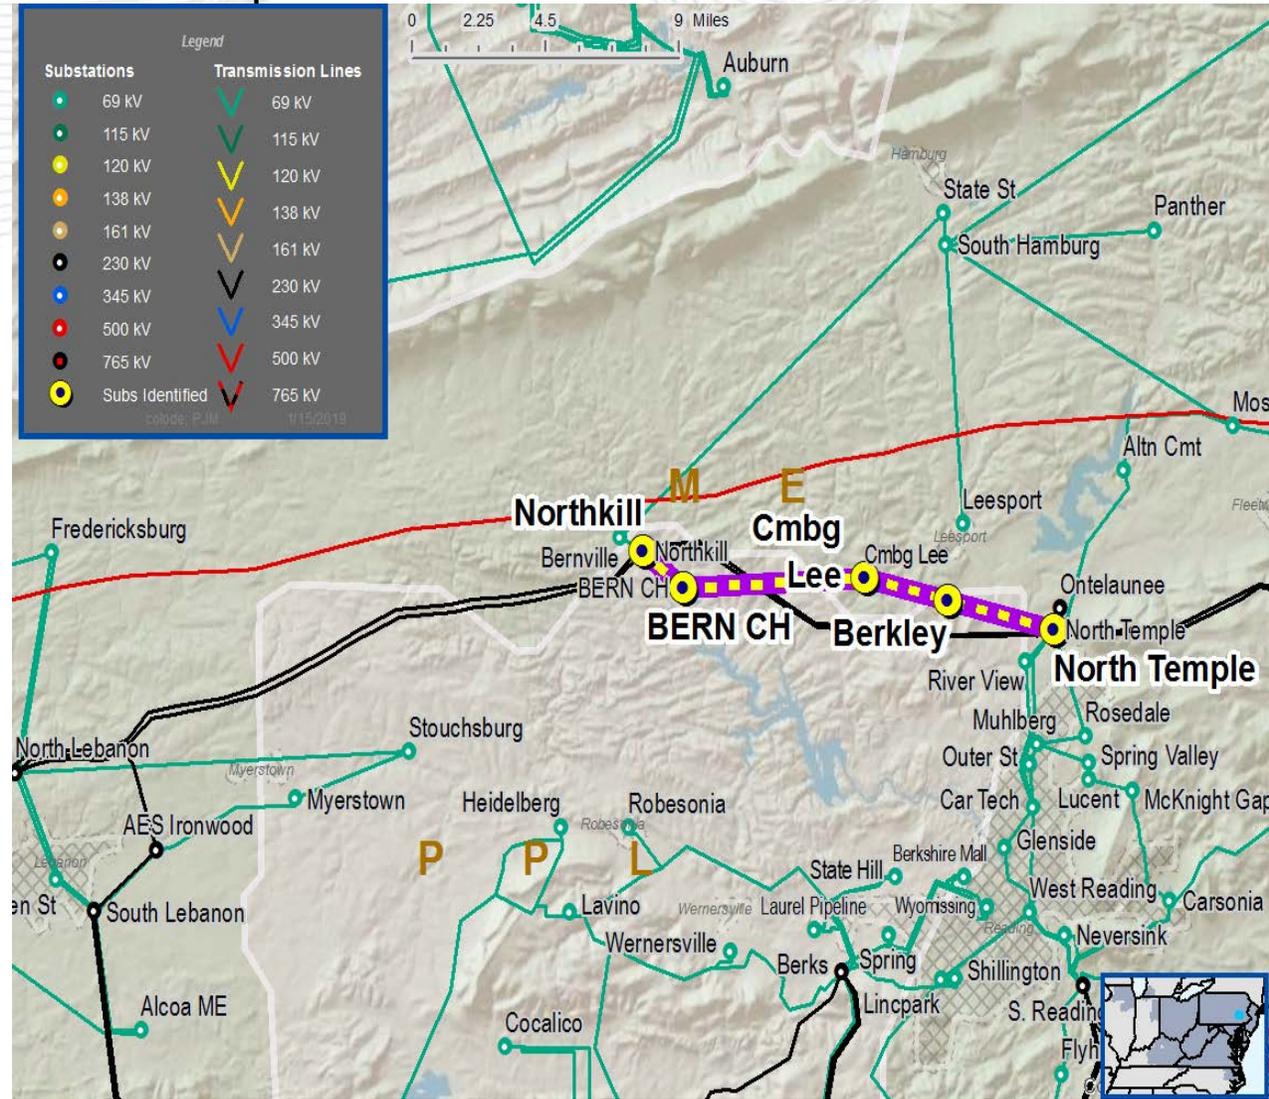
# Met-Ed Transmission Zone M-3 Process North Temple – North Kill 69 kV Line Rehab/Rebuild

- Rehab/Rebuild North Temple – Northkill. Reconductor ~5.8 miles on Cambridge Lee-Bern Church section.
- Replace substation conductor at North Temple

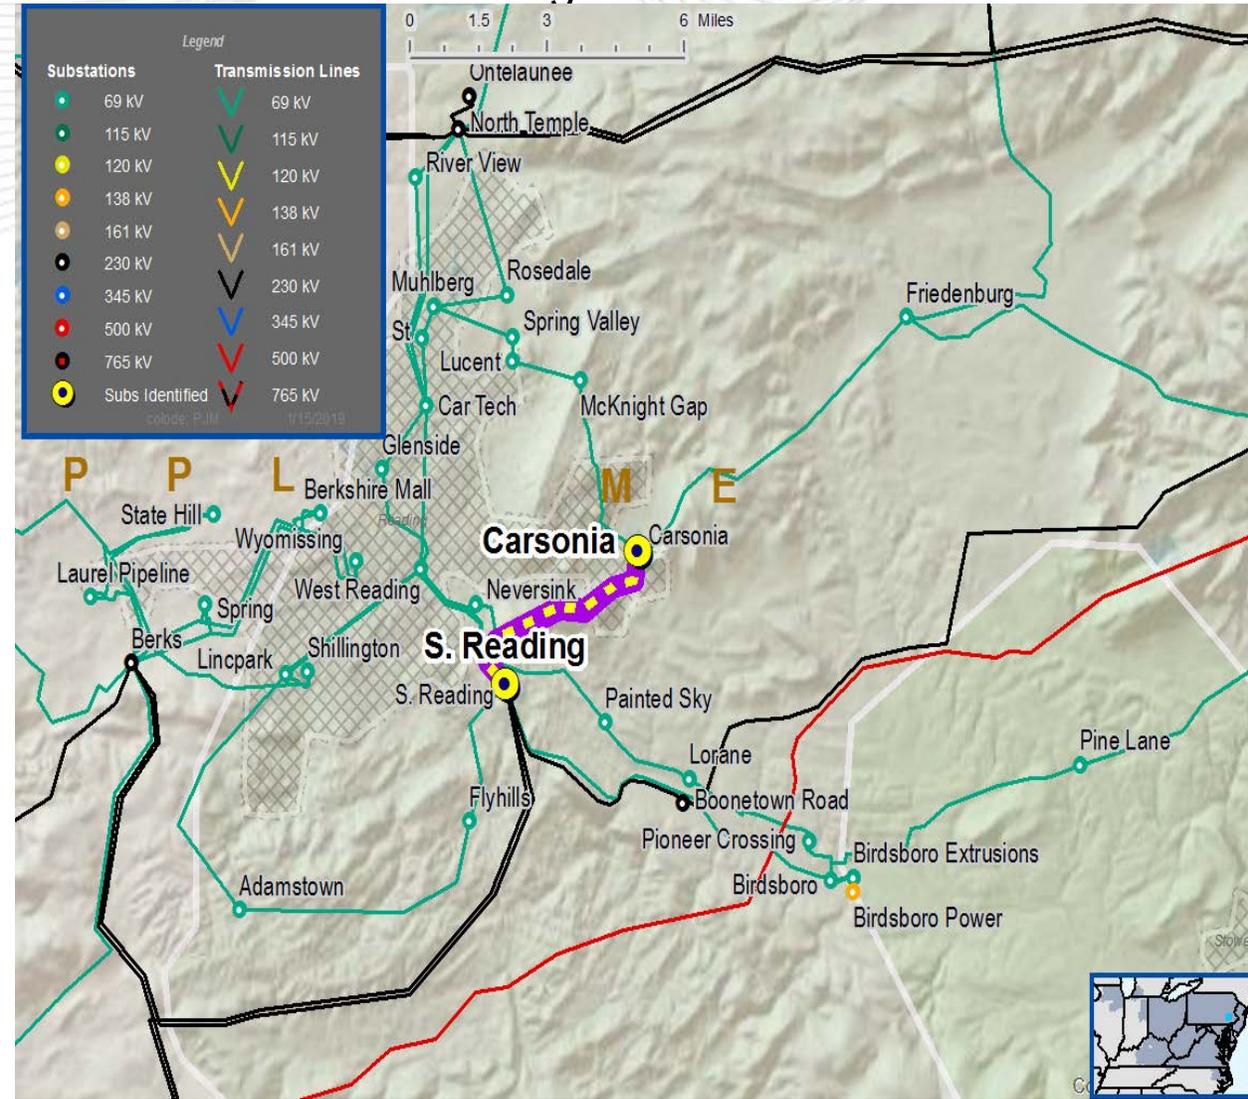
# Met-Ed Transmission Zone M-3 Process Carsonia – South Reading 69 kV Line Rehab/Rebuild

- Rehab/Rebuild Carsonia – South Reading
- Replace substation conductor and line drops at Carsonia.

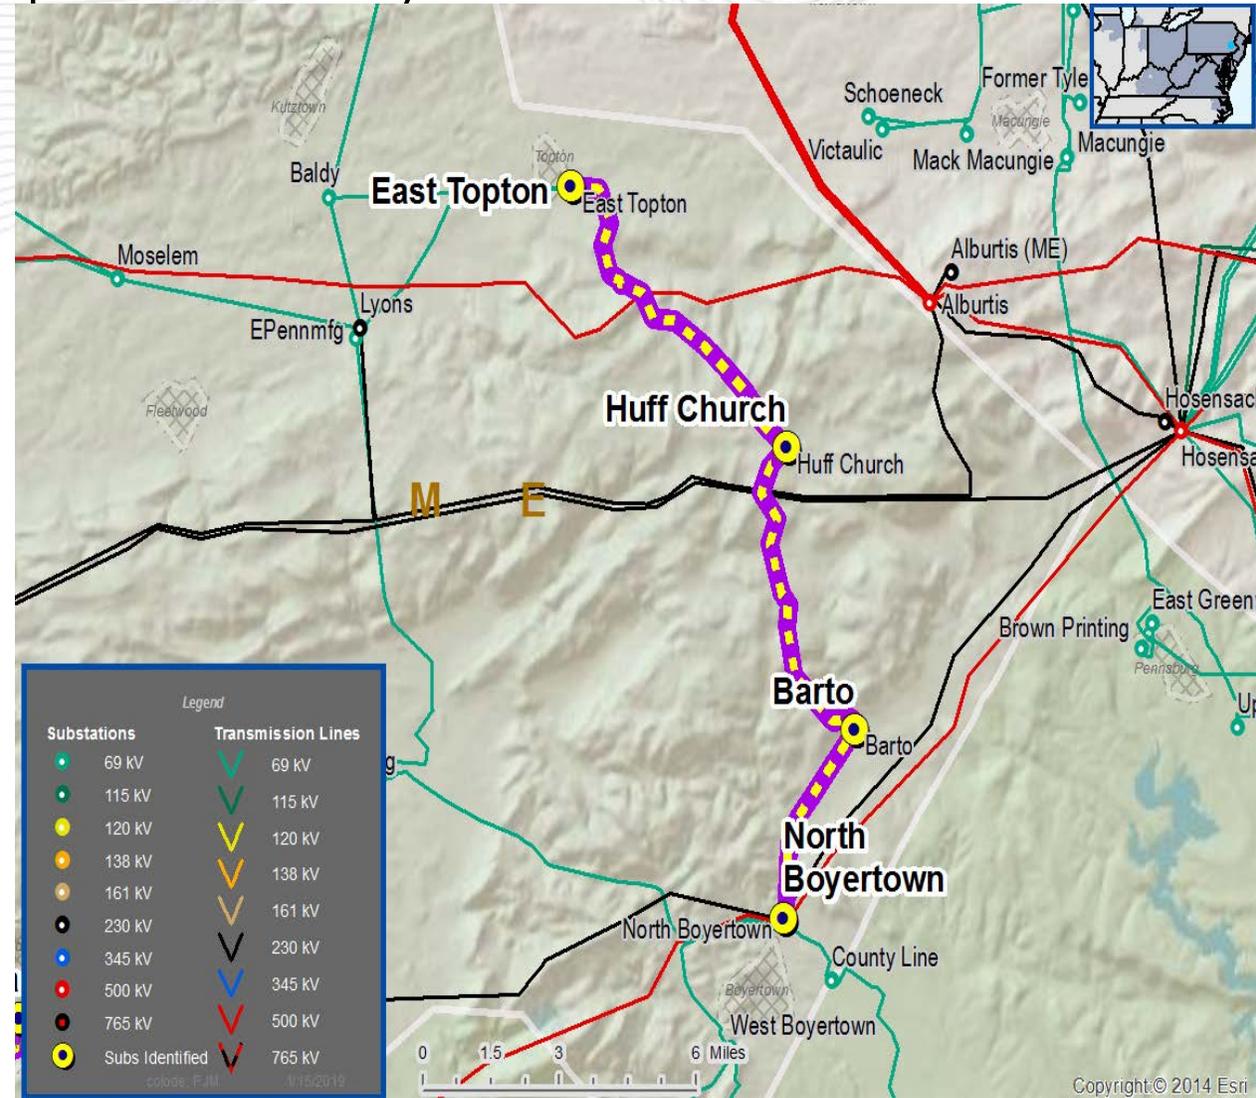
# Met-Ed Transmission Zone M-3 Process East Tipton – North Boyertown 69 kV Line Rehab/Rebuild

- Rehab/Rebuild East Tipton – North Boyertown
- Replace line relaying and substation conductor at East Tipton.

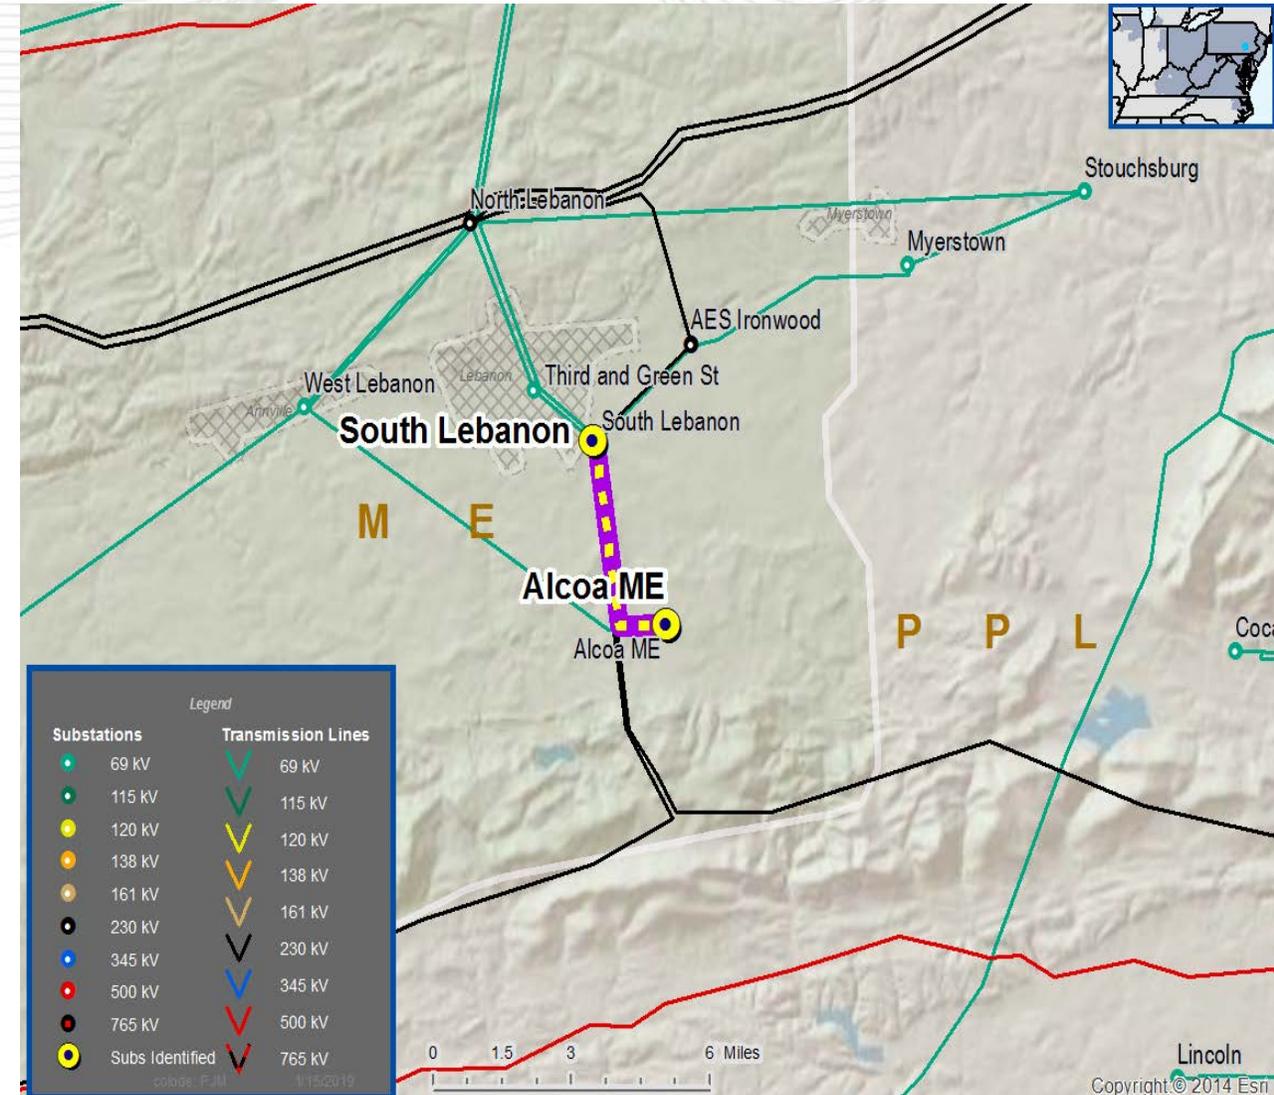
- Rehab/Rebuild Alcoa – South Lebanon
- Replace disconnect switches and relays at Alcoa and South Lebanon

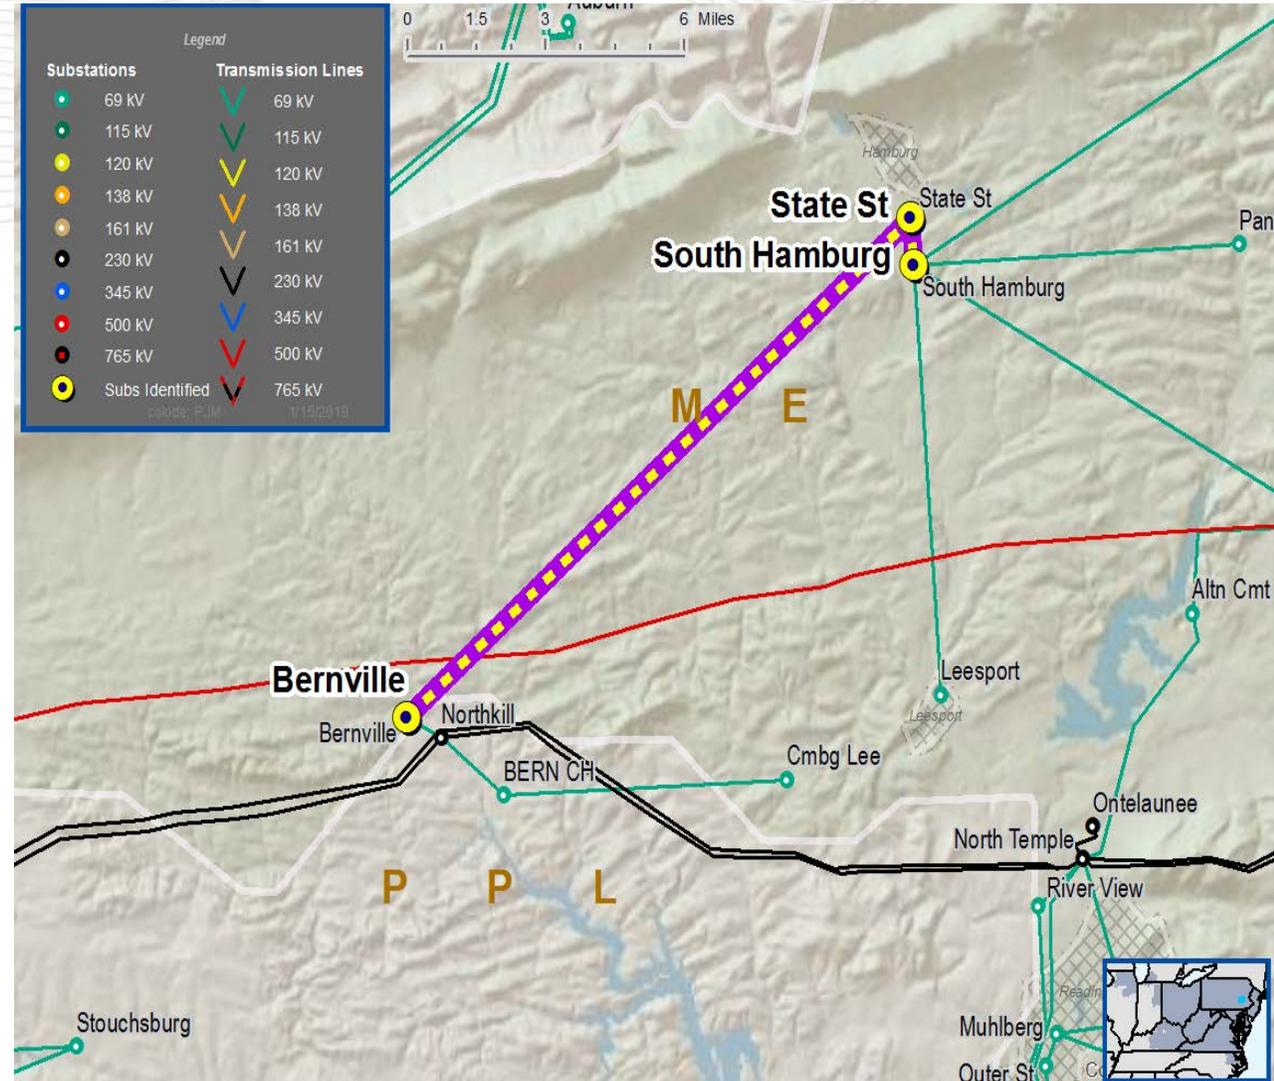
- Rehab/Rebuild Bernville – South Hamburg
- Reconductor Bernville – State Street section
- Replace substation conductor and relays at South Hamburg
- Replace substation conductor at Bernville

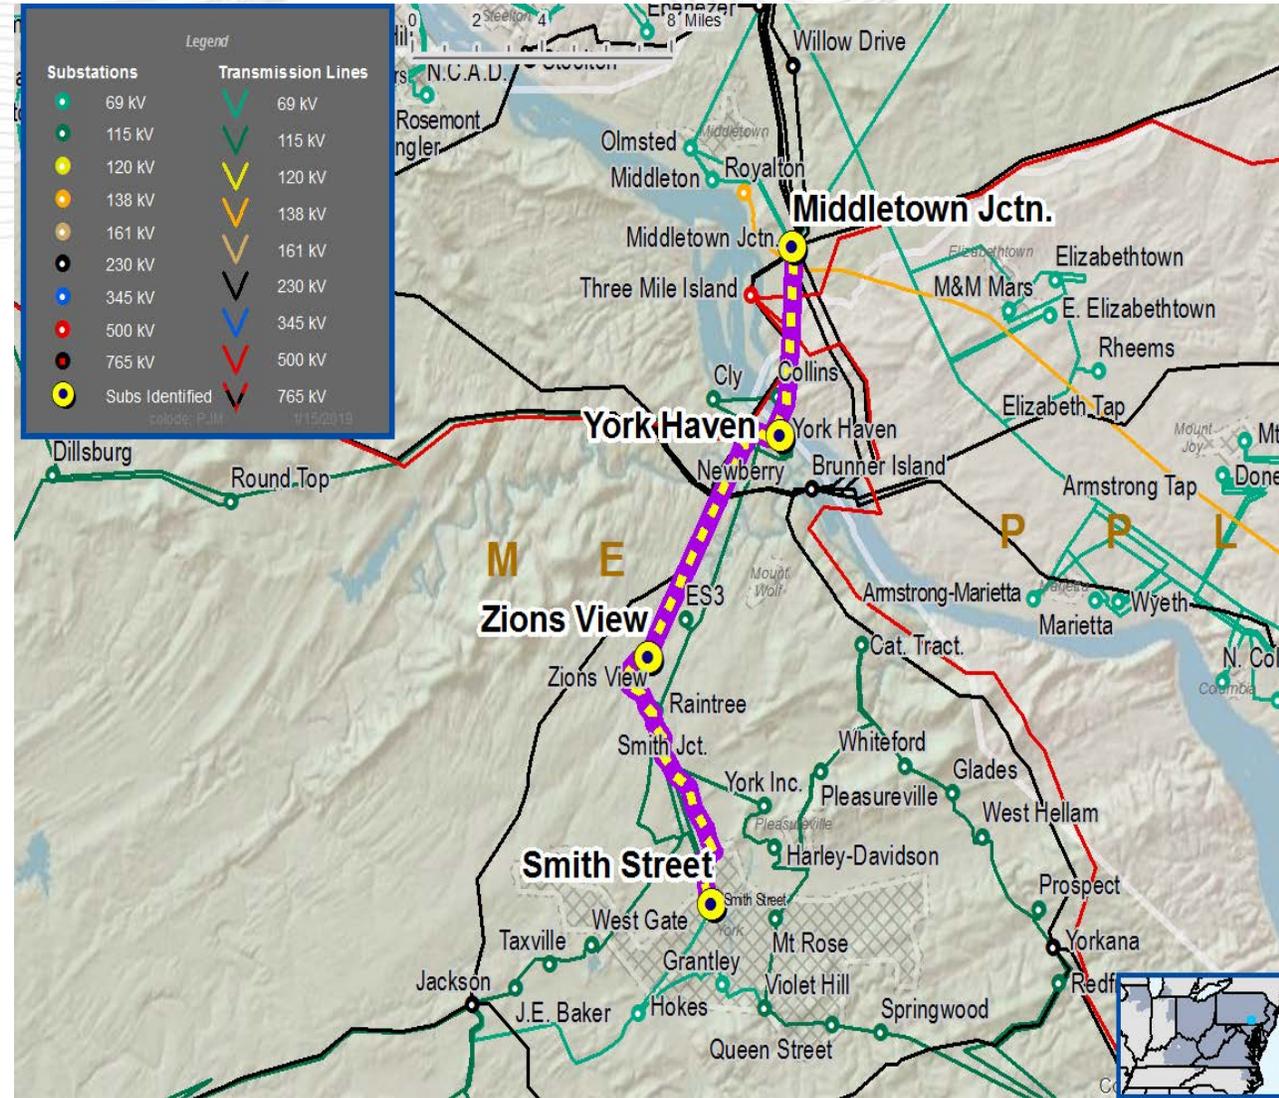
# Met-Ed Transmission Zone M-3 Process Middletown Junction – Smith Street 115 kV Line Rehab/Rebuild

- Rehab/Rebuild Middletown Junction – Smith Street
- Replace substation conductor at Smith Street.

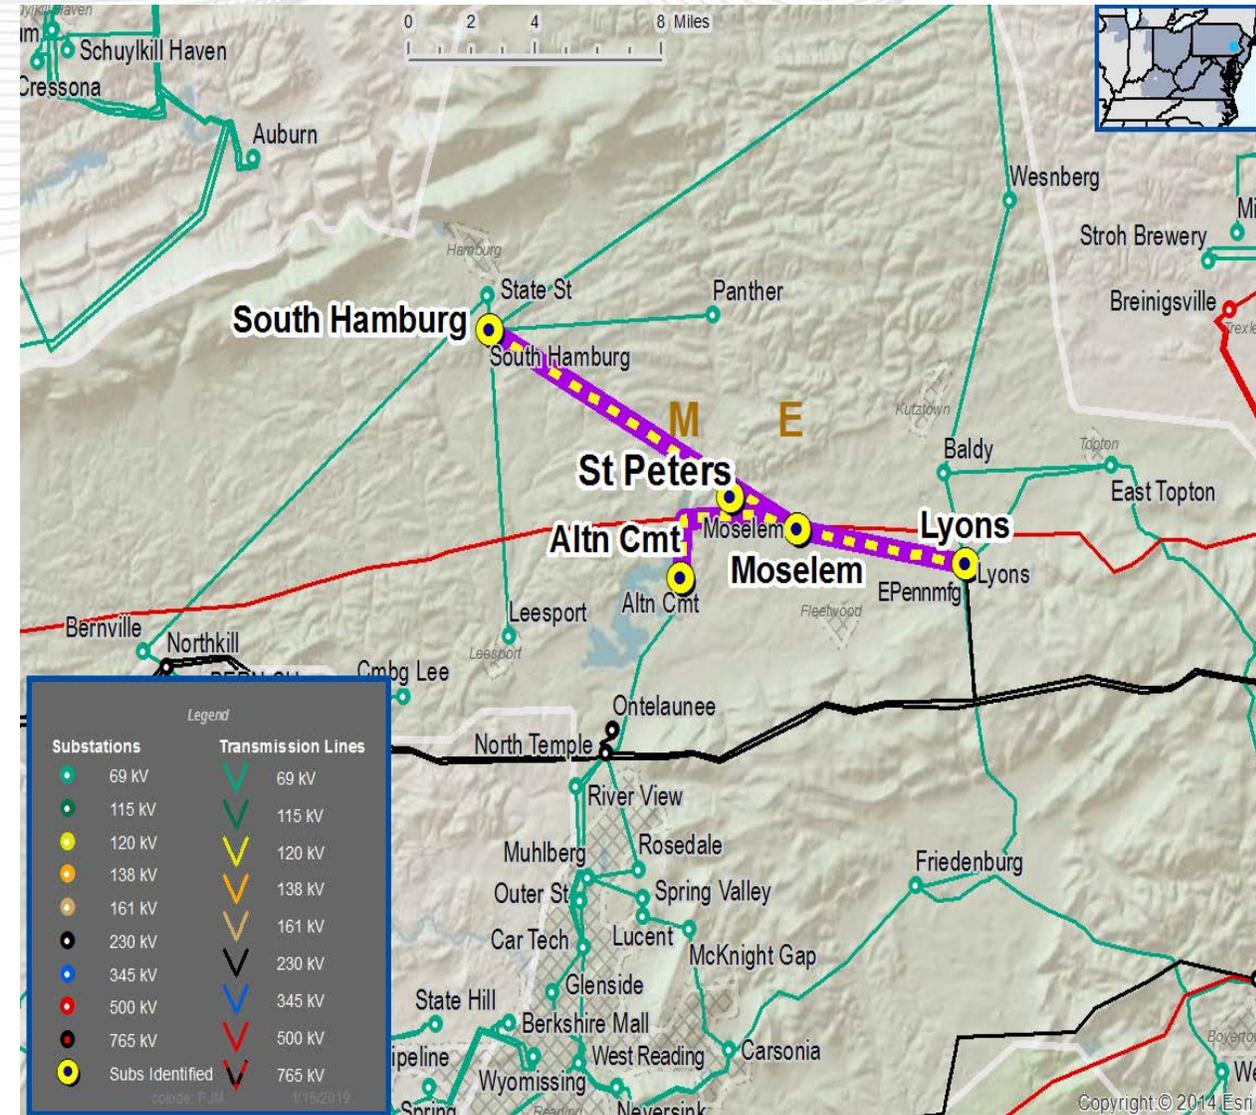
# Met-Ed Transmission Zone M-3 Process Allentown Cement – Lyons – South Hamburg 69 kV Line Rehab/Rebuild

- Rehab/Rebuild Allentown – Lyons – South Hamburg
- Reconductor ~15.2 miles
- Replace substation conductor at South Hamburg, Moselem, and Lyons

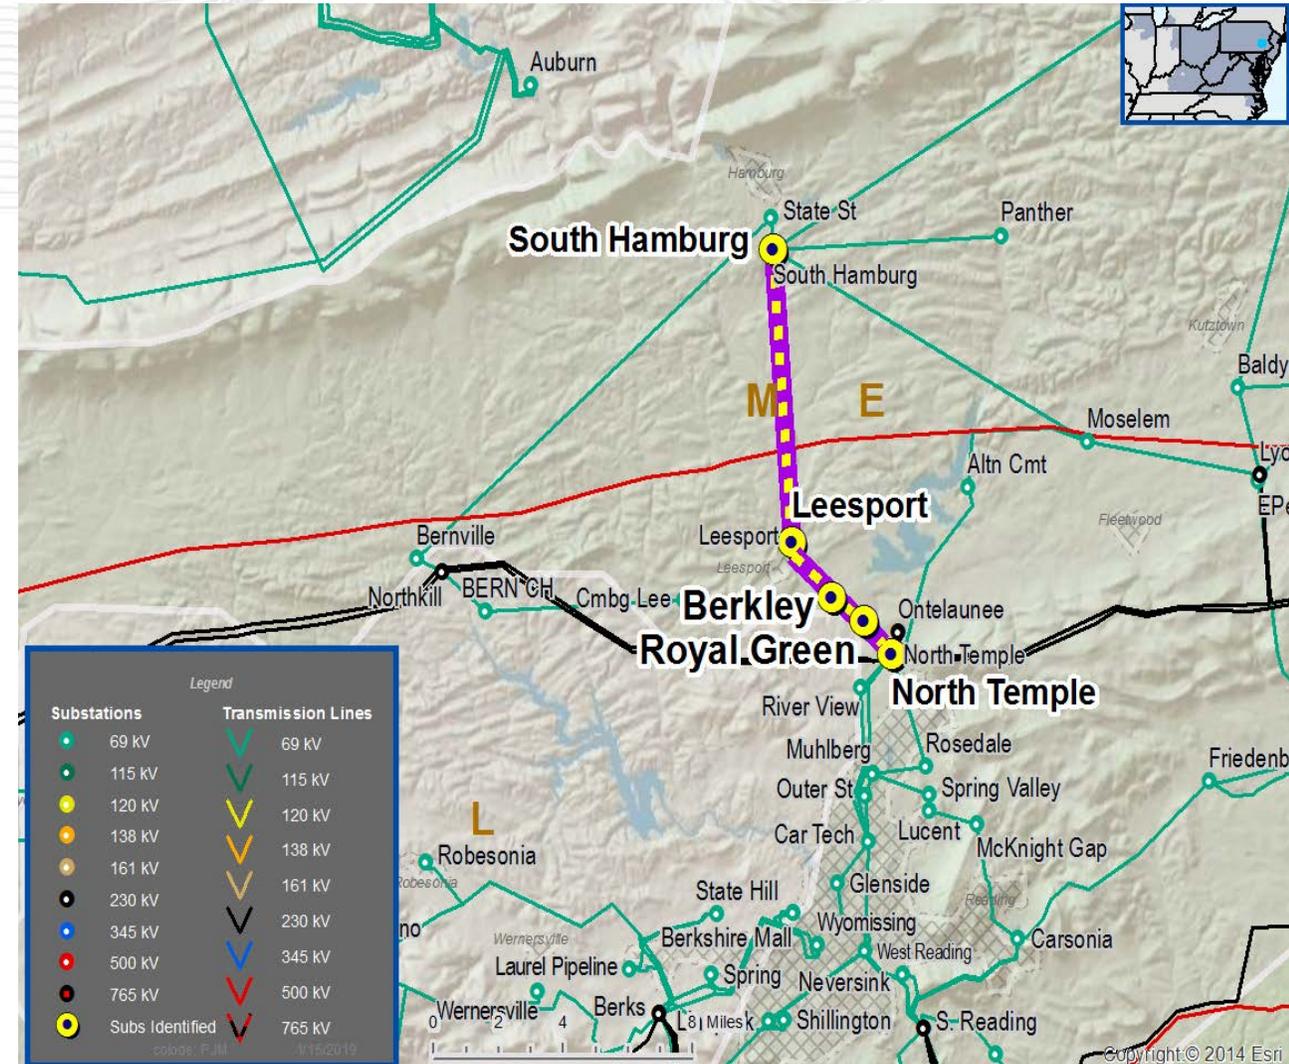
- Rehab/Rebuild North Temple – South Hamburg. Reconductor ~11.86 miles
- Replace Switches at North Temple and Royal Green Tap
- Replace Substation Conductor at North Temple and South Hamburg

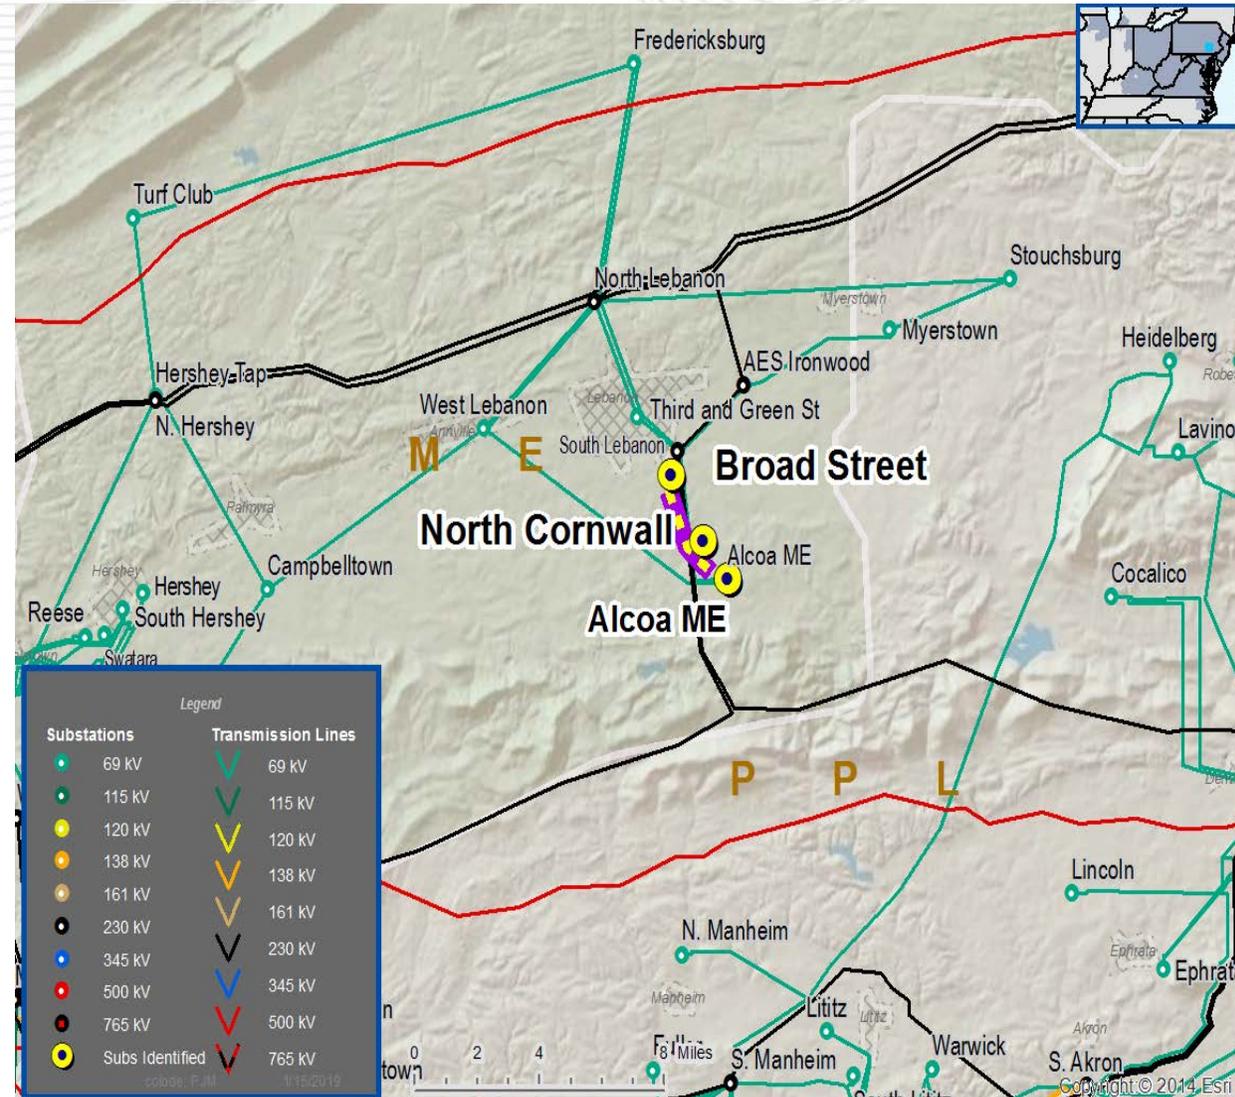
# Met-Ed Transmission Zone M-3 Process Alcoa – Broad Street 69 kV Line Rehab/Rebuild

- Rehab/Rebuild Alcoa – Broad Street
- Replace Substation Conductor and Switches at Broad Street
- Replace Switches at Alcoa

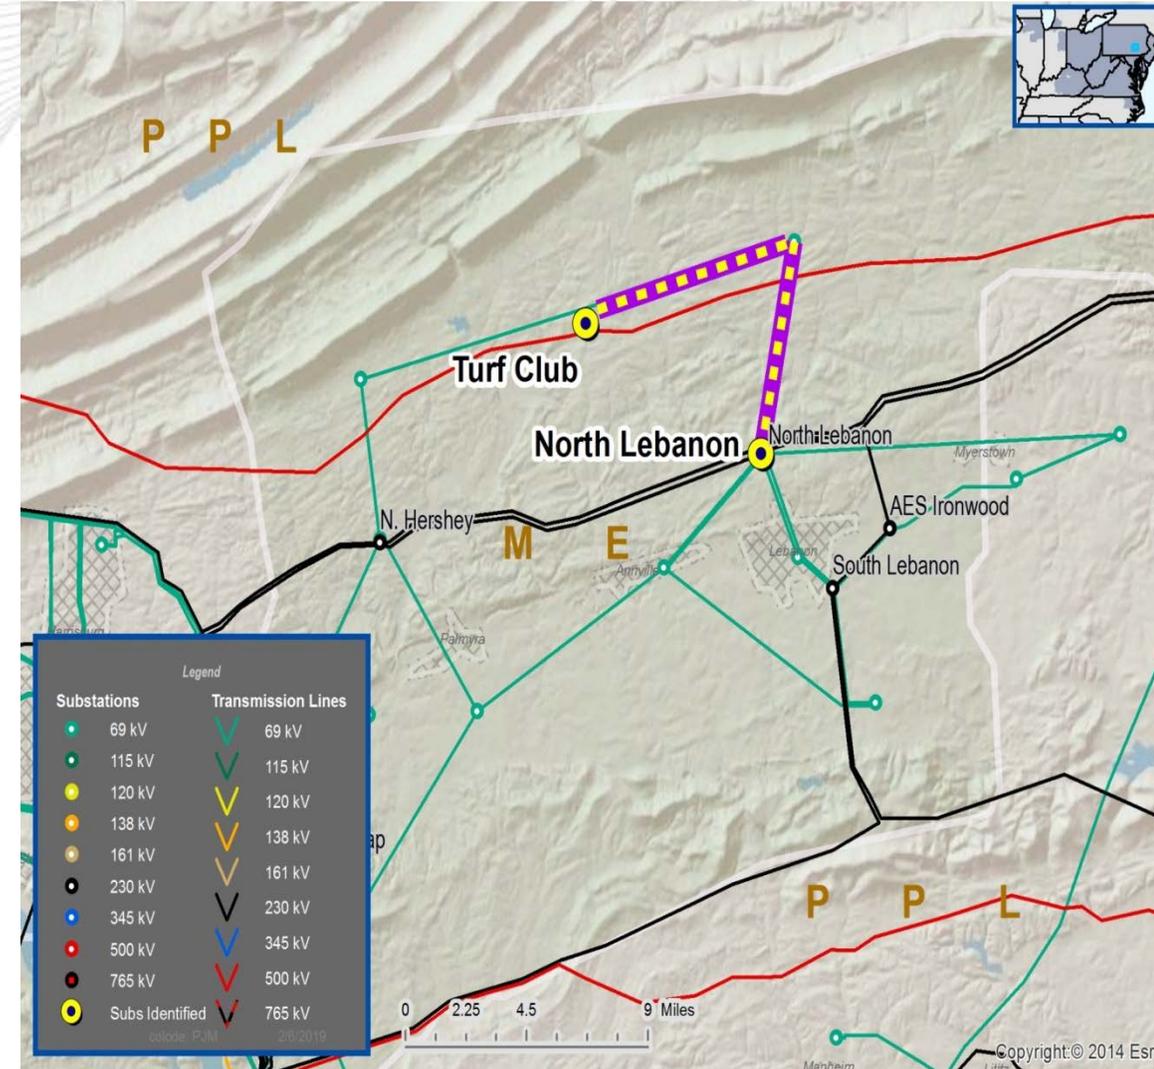
# Met-Ed Transmission Zone M-3 Process North Lebanon – Turf Club 69 kV Line Rehab/Rebuild

*North Lebanon – Turf Club 69 kV line Rehab/Rebuild \$21.1M*

- Rehab/Rebuild North Lebanon – Turf Club
- Reconductor approximately 18.5 miles of Frystown – Turf Club line
- Replace switches at North Lebanon
