Sub Regional RTEP Committee PJM West

November 2, 2017

Second Review Baseline Reliability and Supplemental Projects

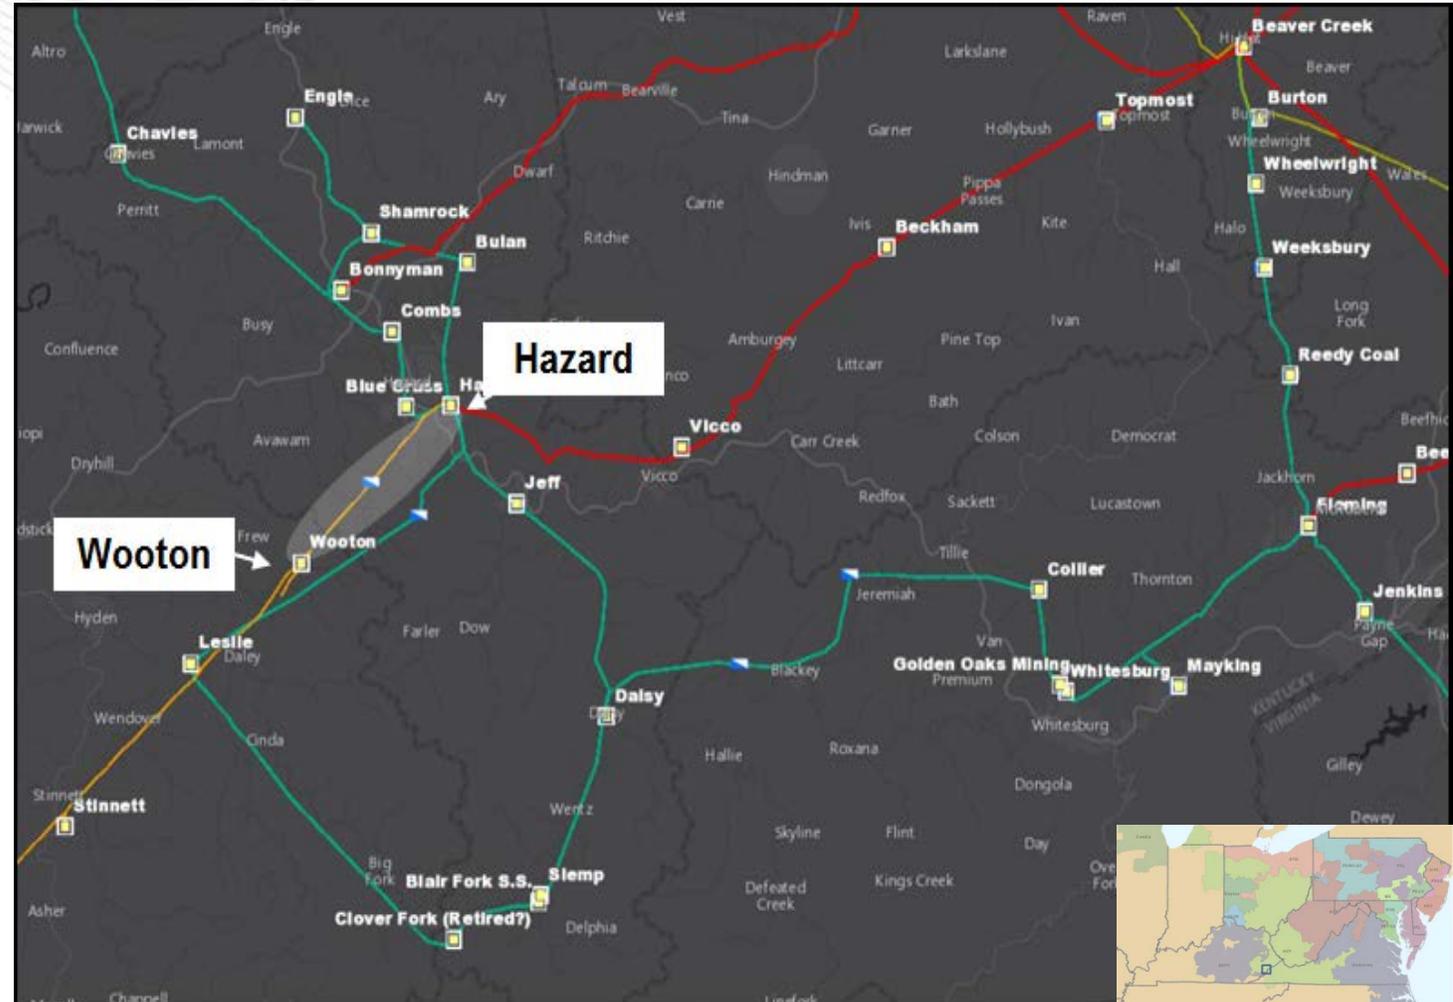
Problem Statement: The Hazard – Wooton 161 kV line overloads under summer and winter peak conditions during generation deliverability analysis performed as part of the 2016 PJM RTEP Window 2. During the 2016 PJM RTEP Window 2, the recommended solution is “Perform a Sag Study of the Hazard – Wooton 161 kV line to increase the thermal rating of the line” (B2761.2, presented on 10/6/2016 TEAC). The results of the sag study determined that 40 of the 45 structures which comprise the line would need to be replaced due to sag clearance issues. Additionally, approximately 6.3 of the 6.5 mile Hazard – Wooton 161 kV line utilizes wood structures from 1943. There are currently a total of 52 category A open conditions along the 6.5 mile long line which is comprised of 45 structures. These open conditions include damaged/rotted poles and damaged guy wires, shield wire, conductor, insulators, and cross arms. Therefore, the conclusion of the sag study is to rebuild the line.

Recommended Solution: Rebuild the Hazard – Wooton 161 kV line utilizing 795 26/7 ACSR conductor (300 MVA rating). (B2761.3)

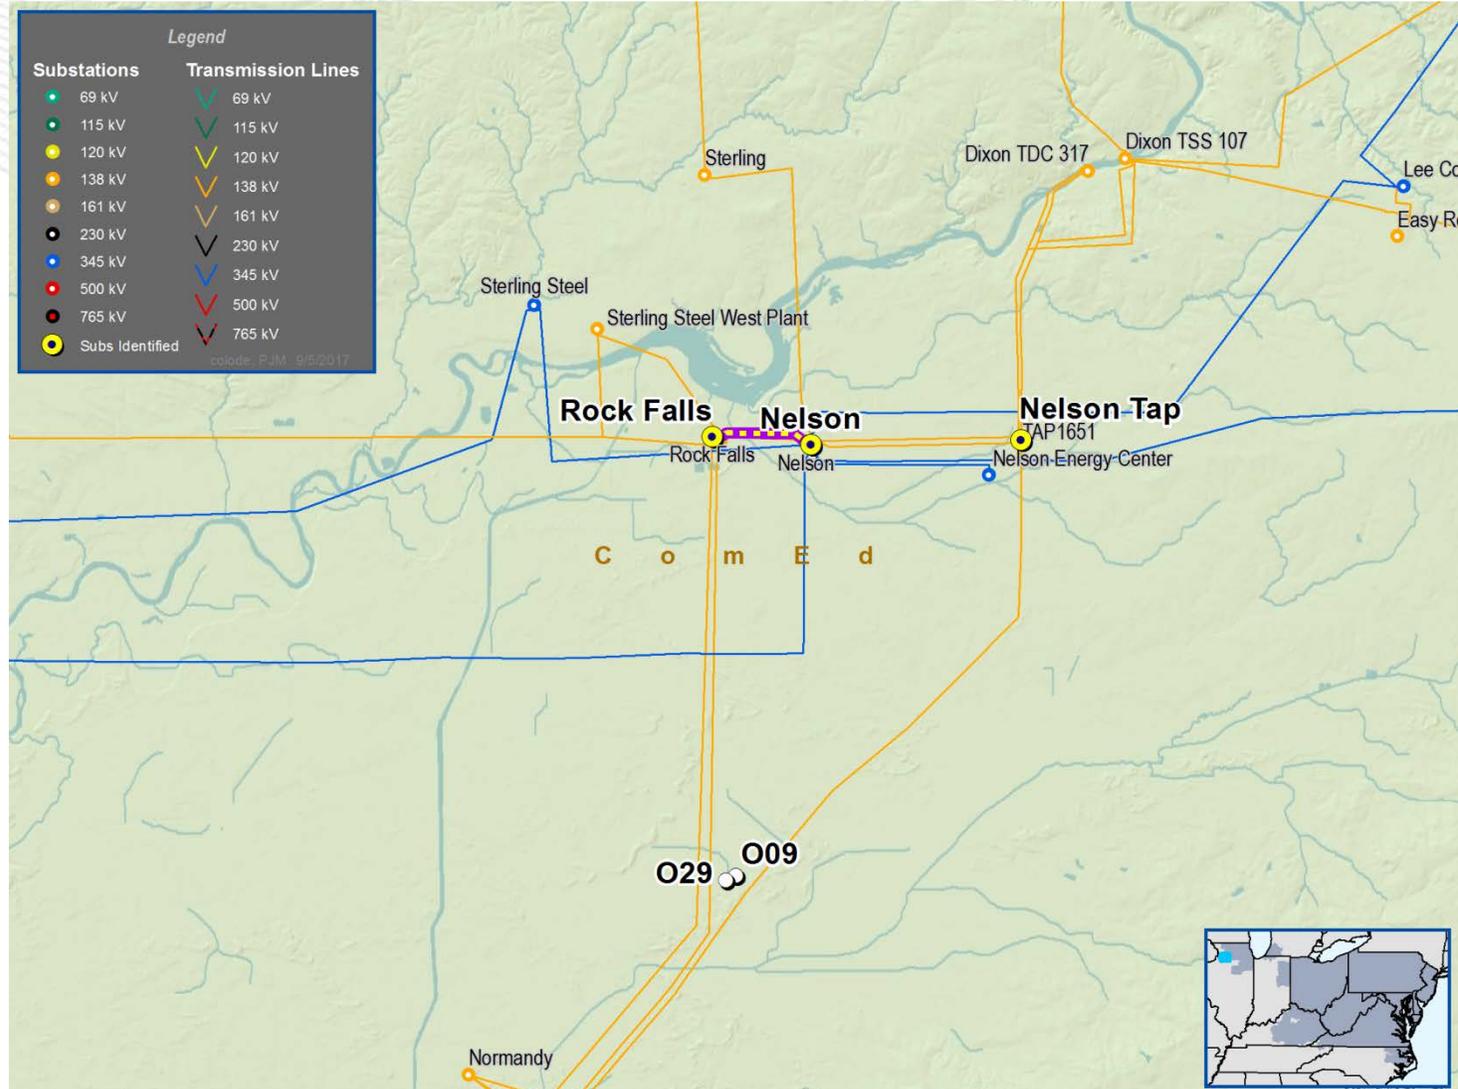
Problem Statement: Queue O-09 and O-29 are back to active from suspension. Rock Falls – Nelson 138KV Red line, Schauff Road (O09&O29) – Nelson Tap 138kV Red line and Schauff Road(O9&O29) – Rock Falls 138kV Red line are overload in base case and multiple single contingencies.

Recommended Solution: Install a new 138kV circuit 18702 from Schauff Road to Rock Falls and install a fourth breaker and a half run at Schauff Road. (B2959)

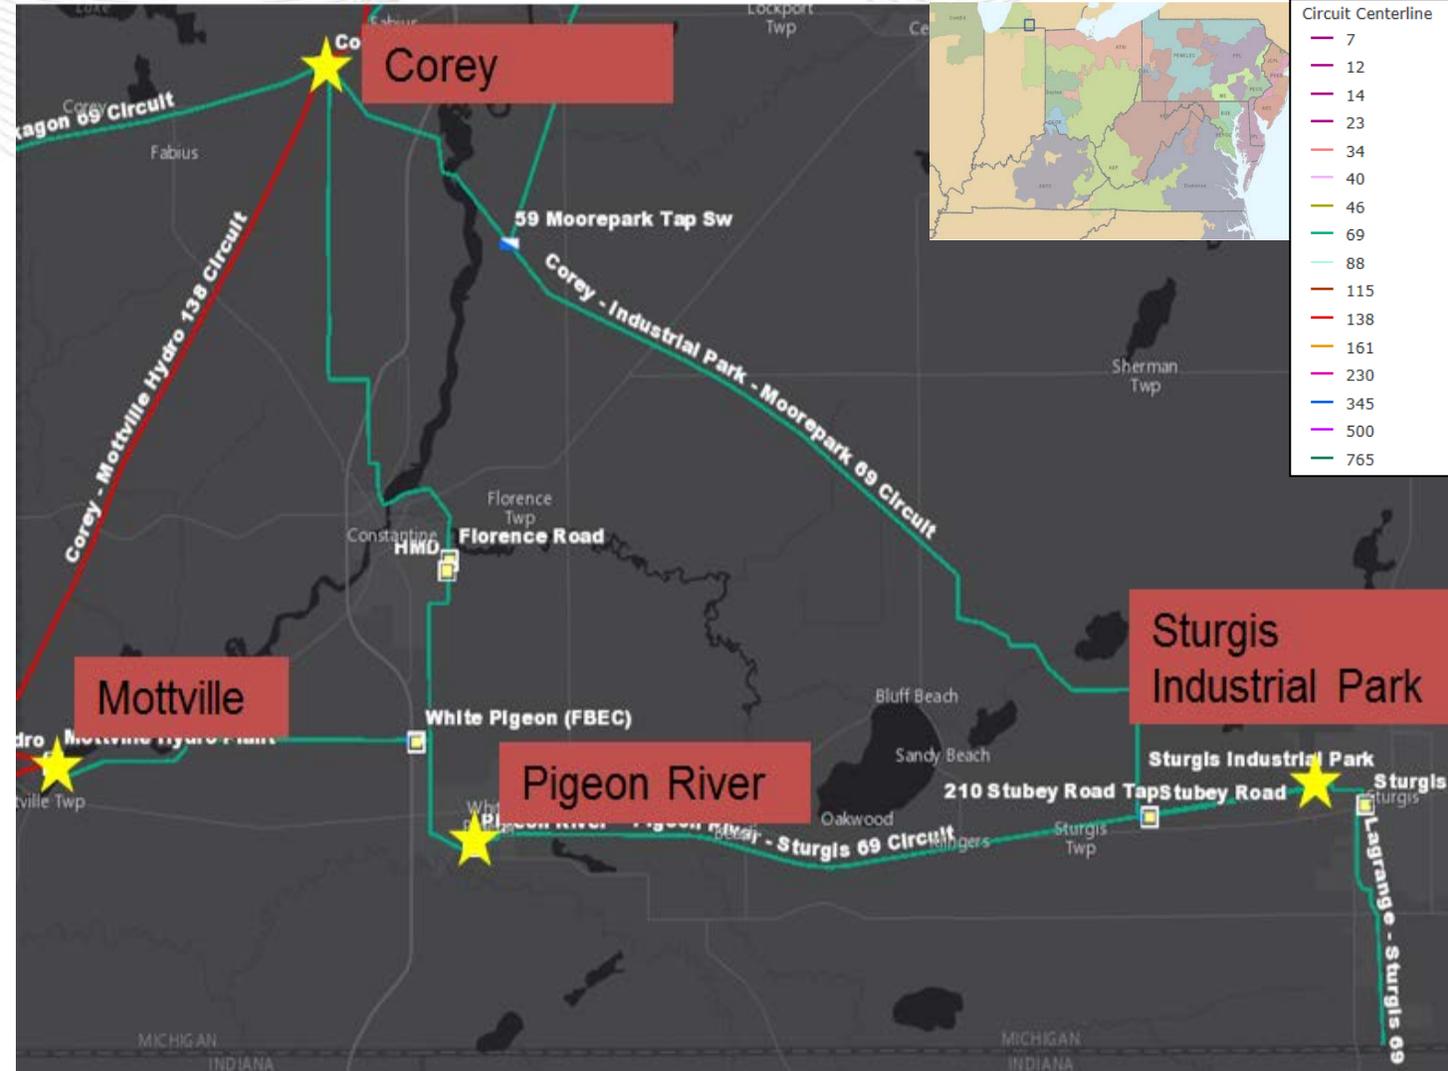
Cancel b2936.2: Pigeon River Station: Replace existing MOAB Sw. 'W' with a new 69kV 3000 A 40 kA breaker, and upgrade existing relays towards HMD station. Replace CB H with a 3000 A 40 kA breaker.

Covert it to Supplemental: Pigeon River Station: Replace existing MOAB Sw. 'W' with a new 69kV 3000 A 40 kA breaker, and upgrade existing relays towards HMD station. Replace CB H with a 3000 A 40 kA breaker. (\$1403)

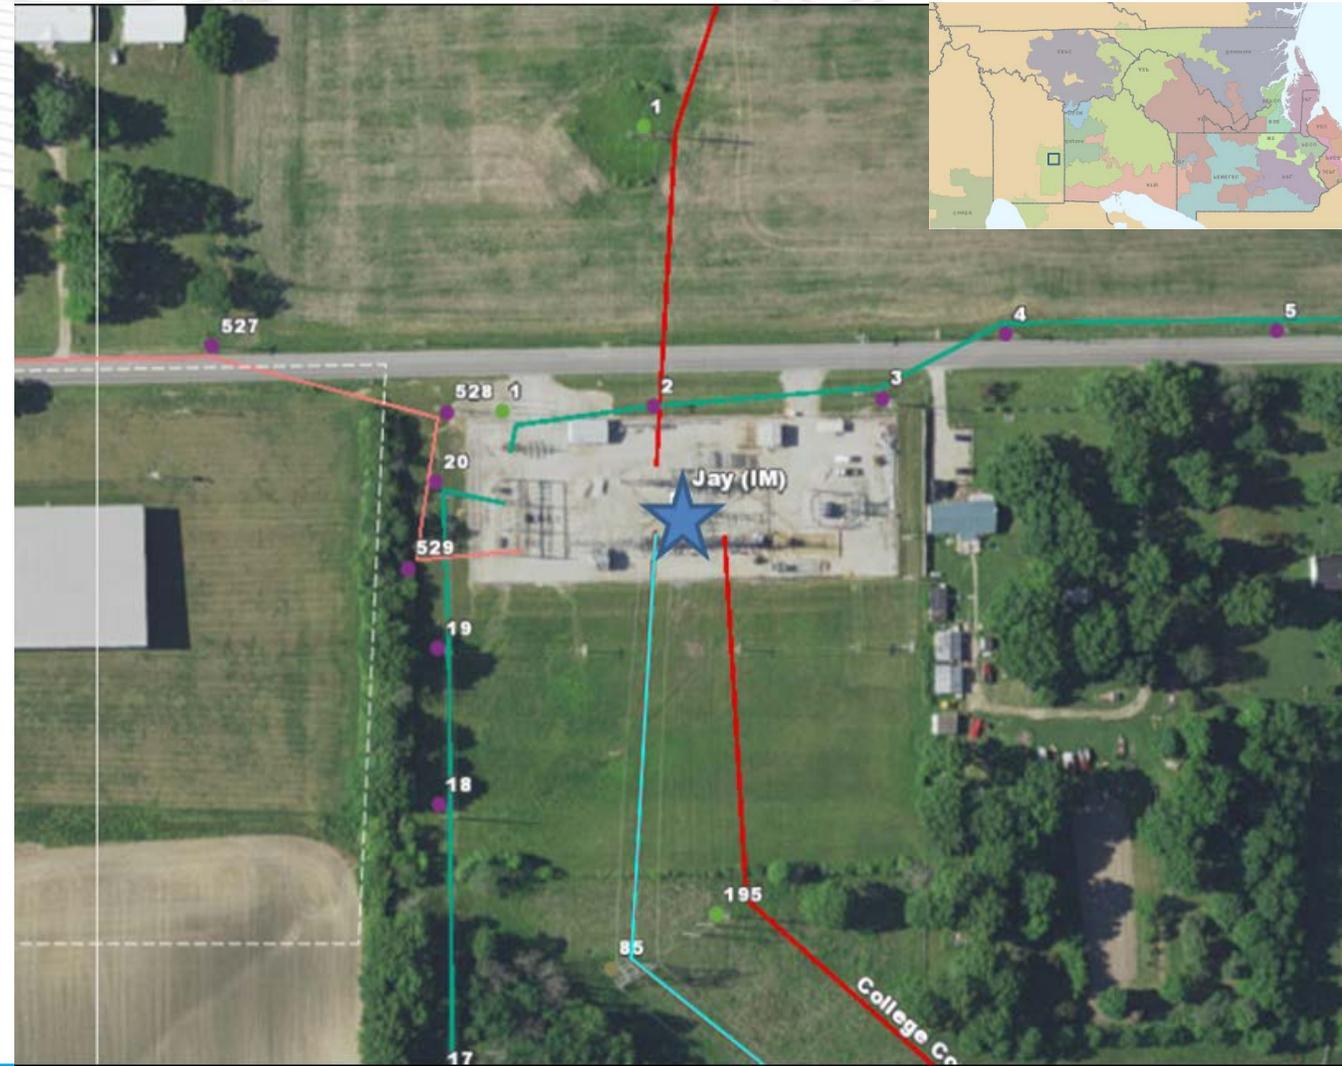
Equipment Material/Condition/Performance/Risk: Breakers 'J' and 'H' at Jay station are vintage 1967 1200 A 21 kA oil medium models with fault counts of 16 and 100 respectively. Oil breaker maintenance has become more difficult due to the oil handling required to maintain them. Oil spills are frequent with breaker failures and routine maintenance and can become an environmental hazard. The drivers for replacement of these breakers are age, number of fault operations, a lack of available repair parts, and PCB content.

At Jay station, replace 69kV breaker 'J' and 'H' with 3000A 40KV breakers and associated equipment.

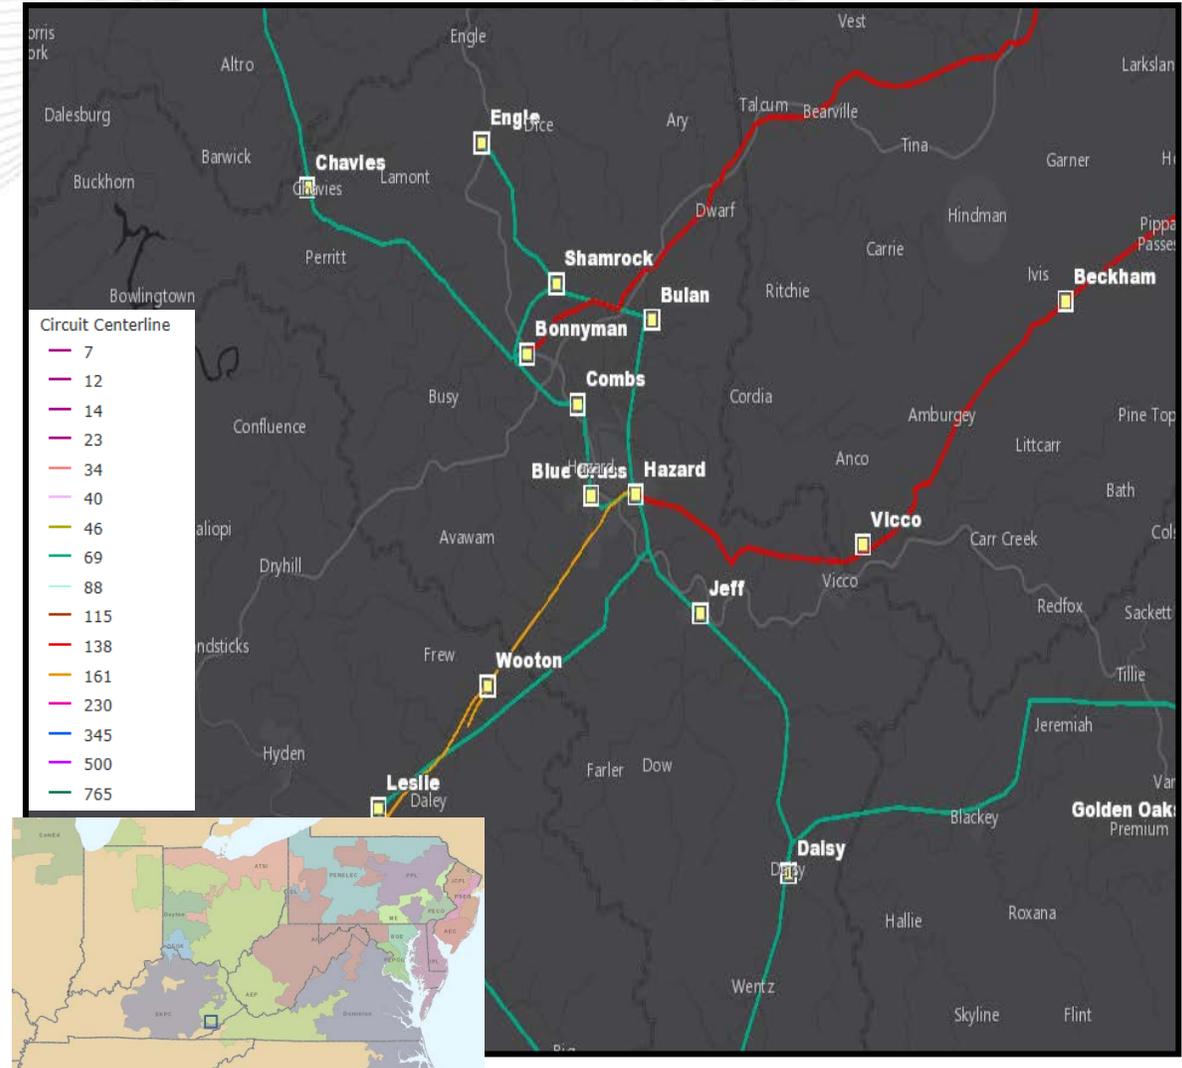
Circuit breakers S (1100A, 11.3kA) and E (1800A, 27kA) at Hazard station are FK type breakers all over 40 years old. Circuit breaker F at Hazard is a 1200A, 31.5kA CG type breaker. These are oil breakers that have come more difficult to maintain due to the required oil handling. In general, oil spills occur often during routine maintenance and failures with these types of breakers. Other drivers include PCB content, damage to bushings and number of fault operations exceeding the recommendations of the manufacturer. Breakers S, E, and F have experienced 82, 184, and 193 fault operations respectively, well above the manufactures recommendation of 10.

Circuit breaker M (2000A, 40kA) will need to be relocated in association with the baseline project to replace the existing 161/138 kV transformer at Hazard station (b2761) **in order to limit outage times**. The breaker is an **SF6-gas breaker**, 29 years old and has experienced 21 fault operations, which exceeds the manufacturer recommendation of 10.

Transformer #1 (1974 vintage, 50 MVA) and #2 (1973 vintage, 130 MVA) show dielectric breakdown (insulation), accessory damage (bushings/windings) and short circuit breakdown (due to amount of through faults). Transformer #1 also shows signs of corrosion on radiators as well as oil leaks.

Circuit Switcher BB a MARK V unit which have presented AEP with a large amount of failures and mis-operations. AEP has determined that all MARK V's will be replaced and upgraded with the latest AEP cap-switcher design standard. Capacitor bank BB will need to be relocated in association with the baseline project to replace the existing 161/138 kV transformer at Hazard station (b2761).

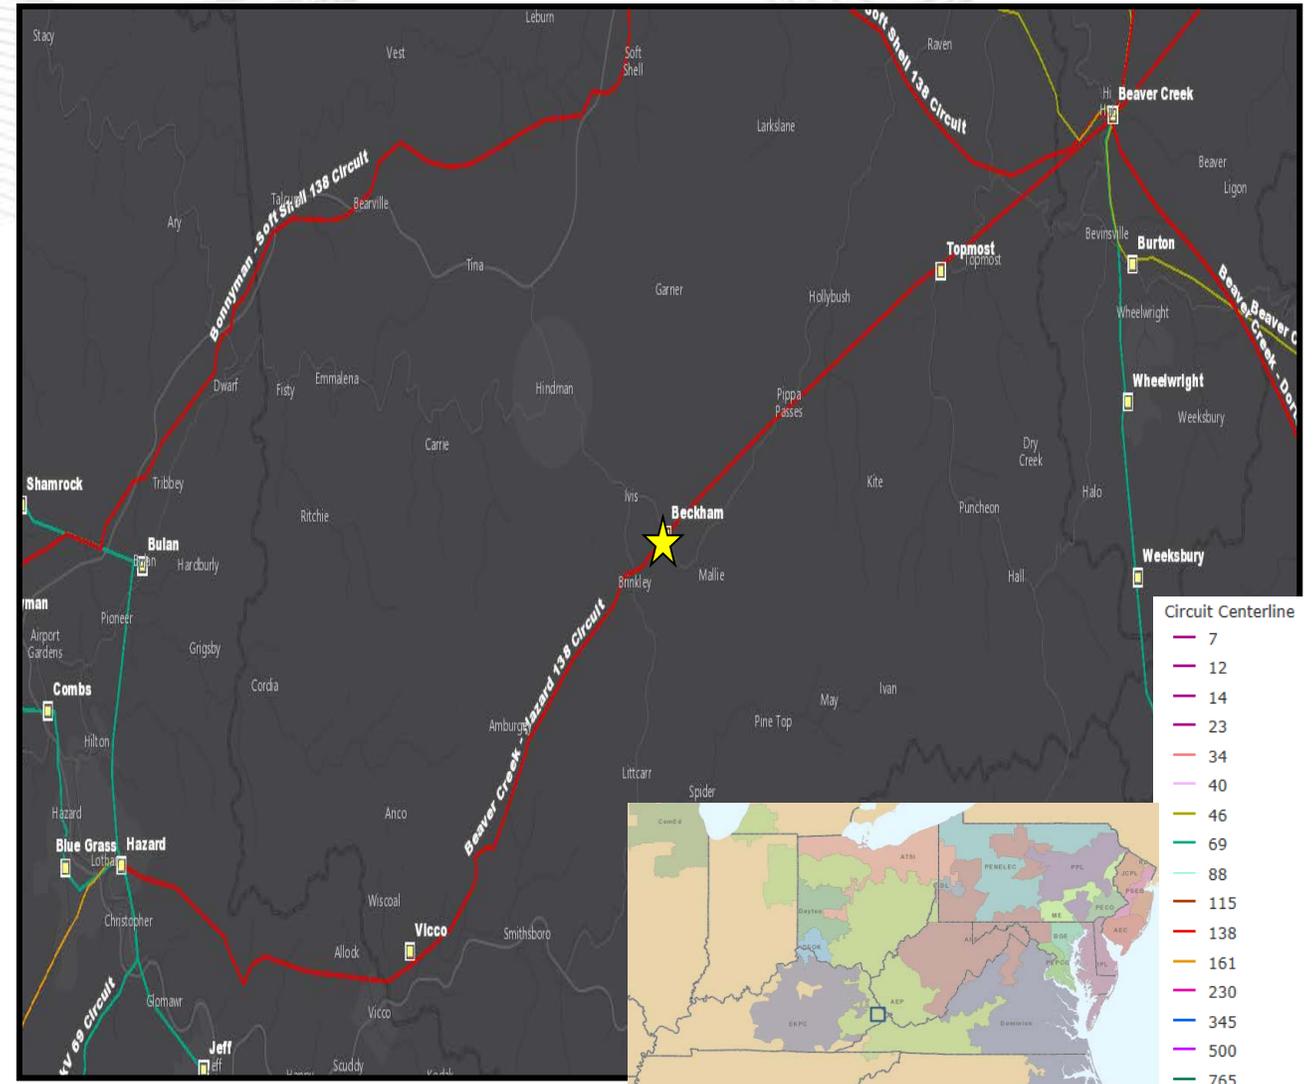
The MPOI calculation (score of 203) performed on Beaver Creek - Hazard 138 kV circuit exceeds the threshold of 200, which supports installing breakers on the line at Beckham station per AEP guidelines. **Additionally, the load in this area is non-transferrable and cannot be picked up in case of a line outage. Therefore, installing two breakers to protect both sides of the lengthy line is recommended.**

Install two new 3000 A 40 kA 138 kV circuit breakers at Beckham station. The circuit breakers will be placed on the line exists towards Hazard and Beaver Creek stations. The existing ground MOAB scheme on the high side of the distribution transformer at Beckham will be replaced by a 138 kV circuit switcher.

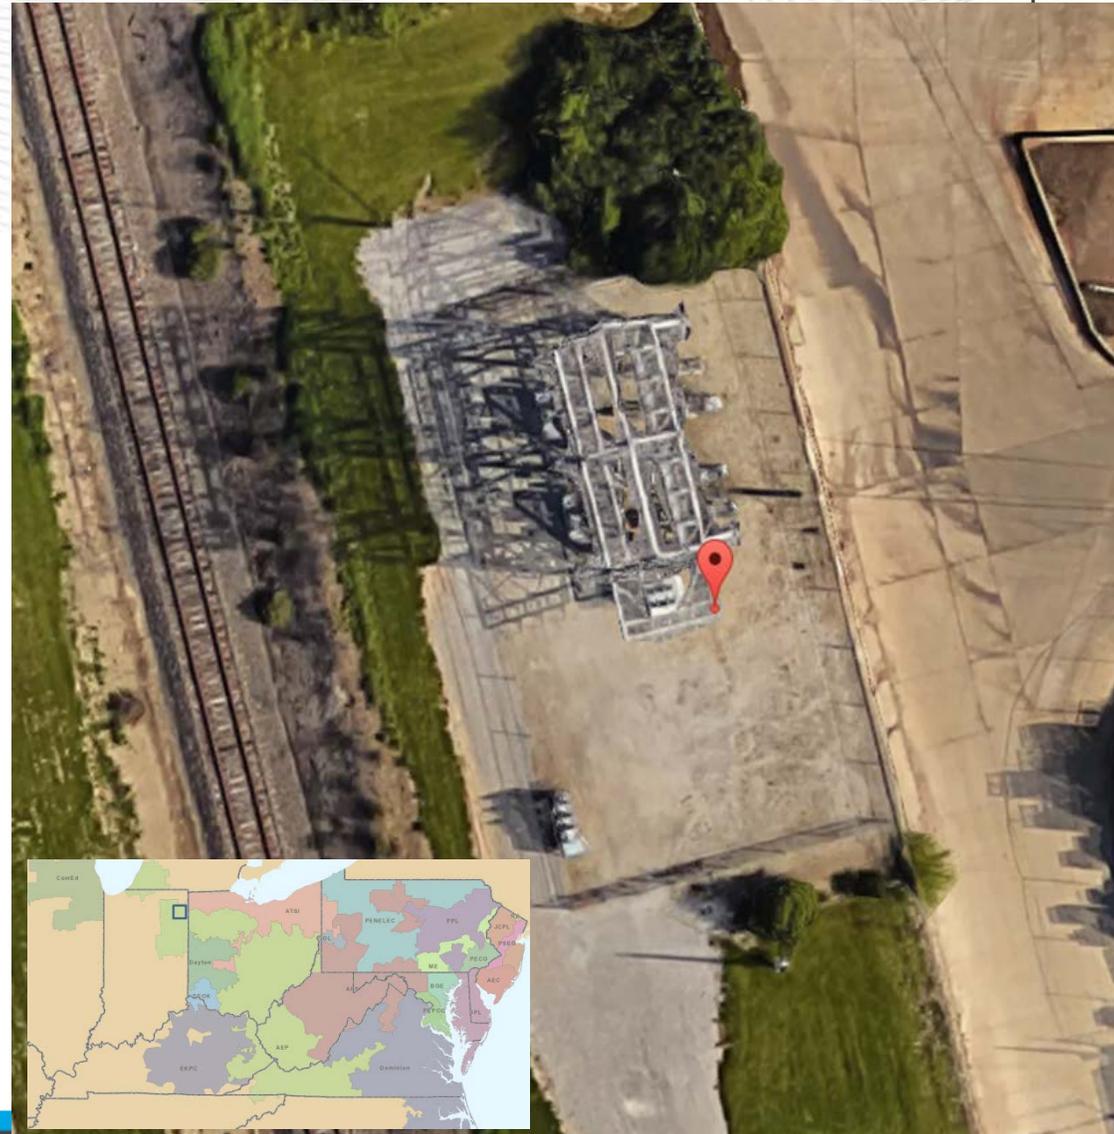
Breaker B at Bass station is a GE FK-339-1000-2 1200A 17kA model manufactured in 1947 that has experienced 24 fault operations, exceeding the manufacturer's recommendation of 10. Factors contributing to the replacement recommendation are age, bushing maintenance issues, no repair part availability and the amount of fault operations. Additionally, the installation of new IEDs would provide increased protection reliability and enhanced oscillography capabilities for fault analysis.

At Bass station, replace 34kV CB "B" with a 1200A 25kA model.

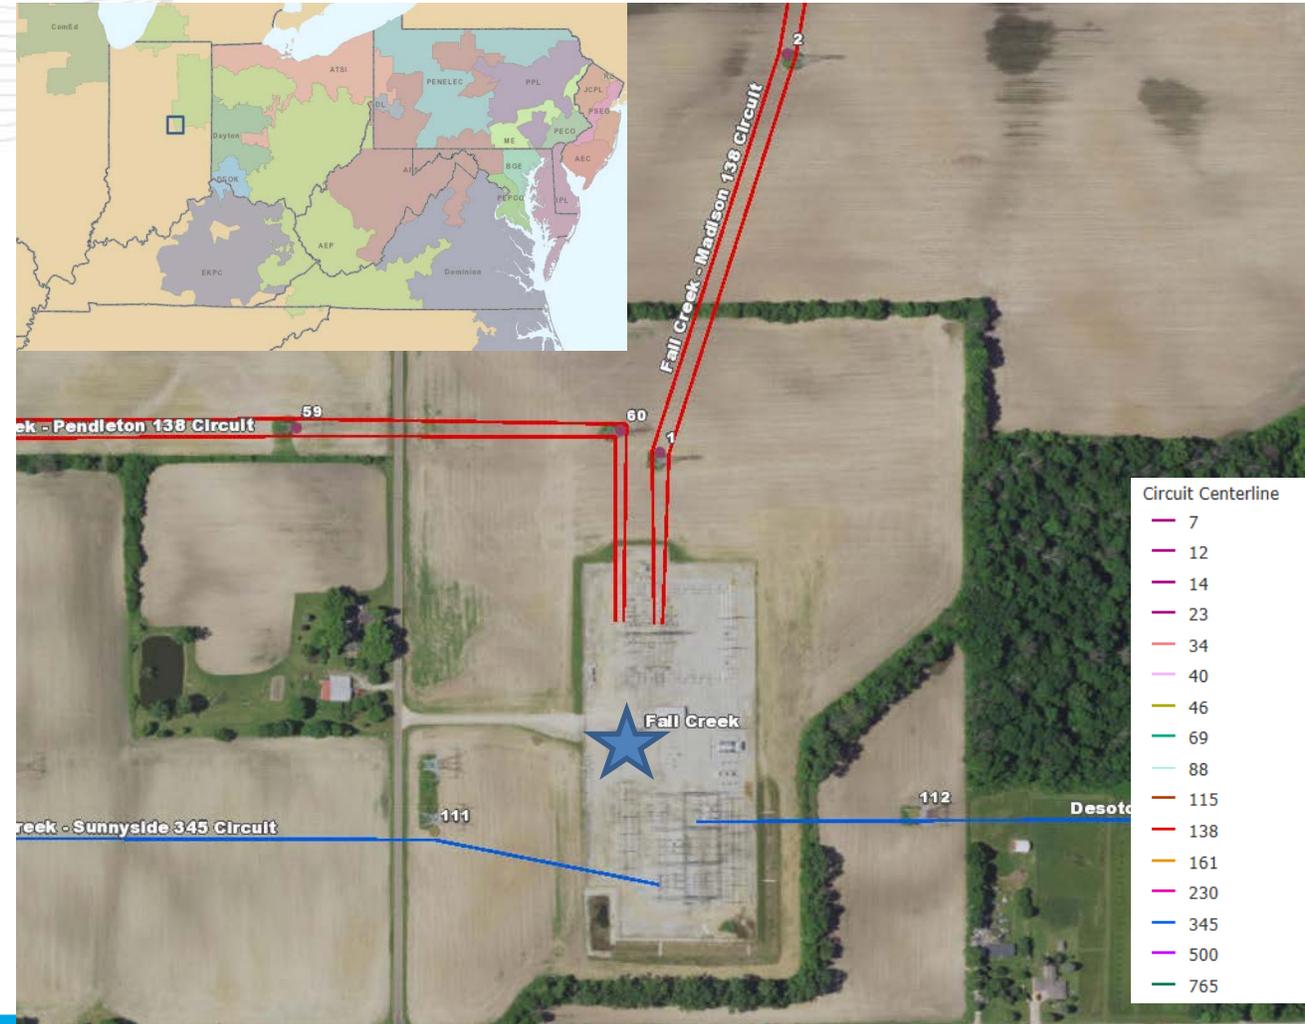
Breakers 'C', 'C2', 'E', and 'E2' are from vintage PK style 3000A 50 kA air blast breakers from 1973. The PK air blast medium breakers have a documented history of exploding violently upon failure and are an identified safety hazard. These breakers have been subject to a large amount of fault operations with Breaker C experiencing 15 operations, C2 experiencing 26 operations, breaker E experiencing 36 operations and breaker E2 experiencing 35 operations. Due to the age, number of operations and condition of these breakers, replacement is required.

Currently the Fall Creek busses are exposed to 6.7 miles of line fault through the Delco Remy 1949 line and 7.5 miles of line fault through the Madison 1940 line. In order to provide the busses protection from these 70+ year old lines breakers are needed. Currently a fault on the Delco Remy or the line requires 5 breakers to operate to clear the fault. The high number of breaker operations required significantly increases the complexity of the protection circuits and increases the likelihood of misoperations and human error.

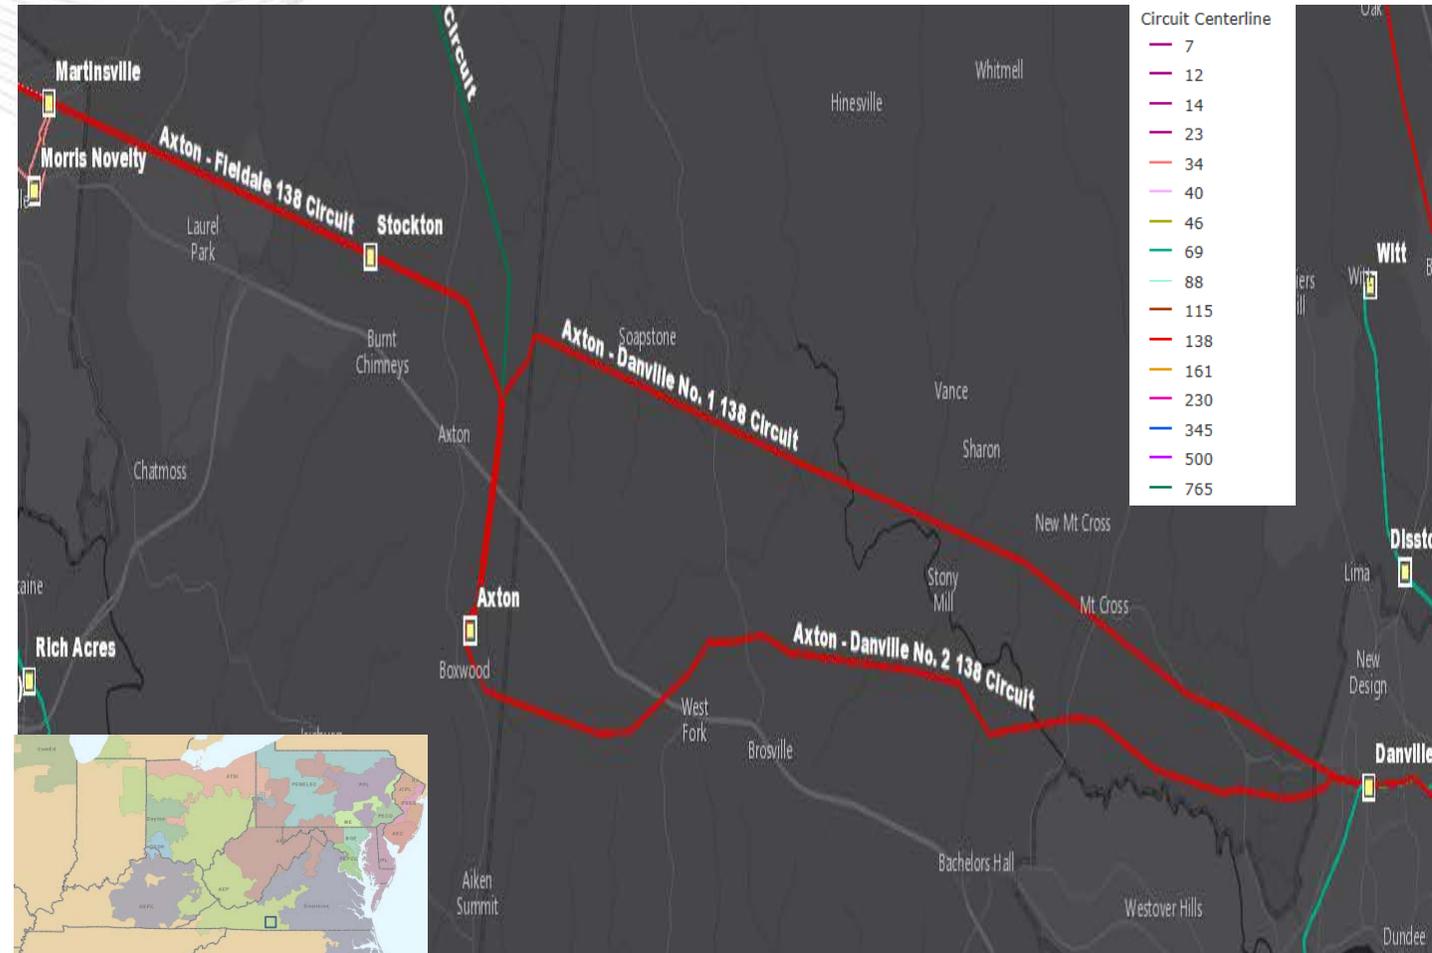
At Axton station, 138kV circuit breakers H, H1, H2 and G are Delle PK-28 50kA type Air Blast breakers. Air blast breakers are being replaced across the AEP system due to reliability concerns, intensive maintenance, and their tendency to catastrophically fail. During failures, sharp pieces of porcelain from their bushings are typically expelled, which can be a potential safety hazard to field personnel. In addition, the ability to get spare parts for these breakers is becoming increasingly difficult. The Manufacturers recommended number of fault operations is 10. Breaker H has experienced 85 fault operations, breaker H1 has experienced 45 fault operations, breaker H2 has experienced 69 fault operations, and breaker G has experienced 32 fault operations. Presently, the backup station service is provided by the City of Danville. This makes us dependent on another utility for reliable station service which is not the best situation. In addition, the station service transformers has begun to show high levels of deterioration and will be replaced with like kind units.

The 138kV Martinsville line breaker(CB - J2) at Axton is being added to prevent the loss of the 138kV Bus #2 due to a fault on the line. This 138kV breaker will also separate two zones of protection for the bus and the line. CB - G1 is being added to prevent the loss of 138kV Danville #2 line and 138kV Fieldale line for a breaker failure (CB - H1).

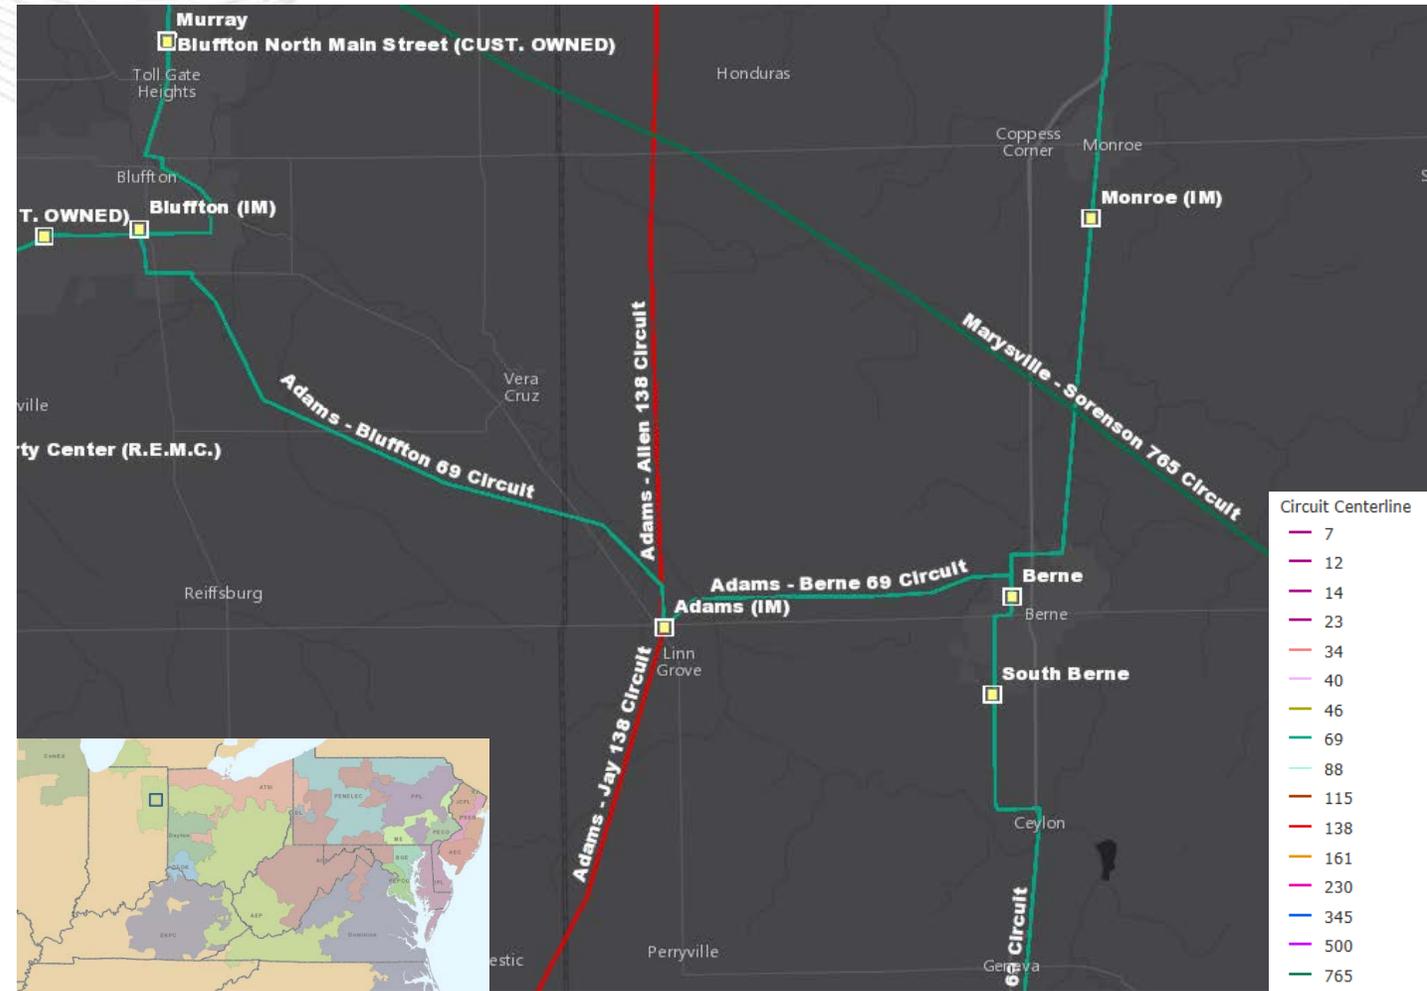
CB's A, B, and C at Berne and Breaker E at Adams are oil type breakers. Oil breakers, in general, have become more difficult to maintain due to the required oil handling. Oil spills occur often during routine maintenance and failures, which can become an environmental concern. Other drivers include age, bushing damage, and number of fault operations.

69kV breakers 'A' and 'B' at Berne are Penn CF 1200A 23kA models manufactured in 1967 and have experienced 16 and 79 fault operations respectively. 69kV breaker 'C' at Berne is a McG CF 1200A 23kA breaker model manufactured in 1970 and has experienced 121 fault operations. 69kV circuit switcher 'AA' being replaced is a S&C model 400A 20kA. 69kV breaker 'E' at Adams is a P.T.CO CF 1200A 21kA model manufactured in 1966 and has experienced 12 fault operations.

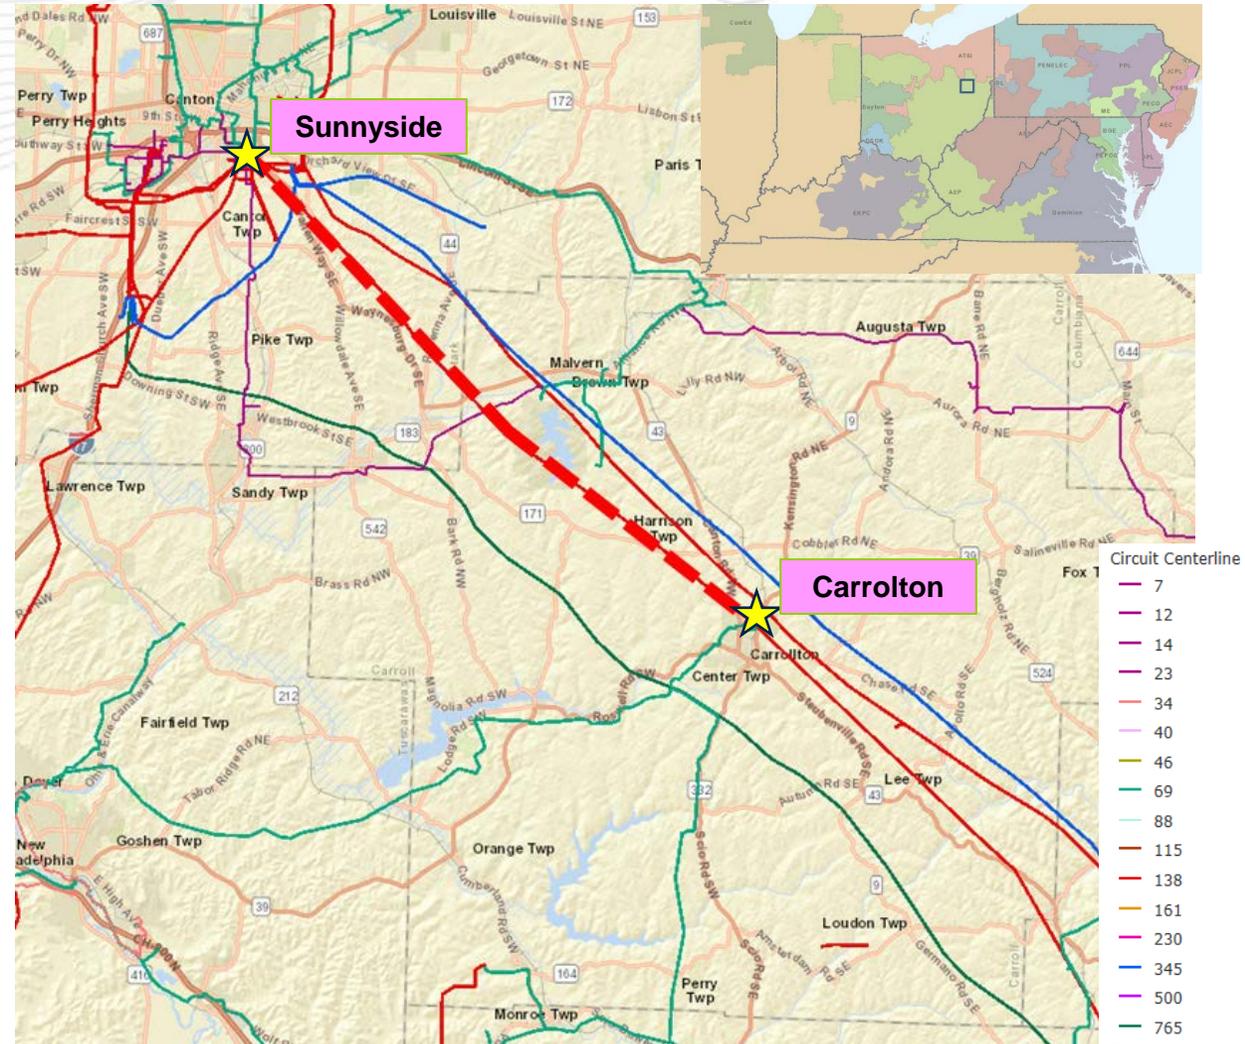
The existing 19.8-mile, 138 kV line section between Carrollton and Sunnyside stations was constructed in 1916 using lattice towers and 6-wired 200 kcmil copper conductor (221 MVA summer rating). There are numerous condition concerns on this line, including rusting towers on 60% of the line, worn insulators and hardware. The copper conductor has become very brittle after 100 years in the field and is difficult for crews to repair. Some towers are sitting in water. Many tower legs under ground have been found to be significantly deteriorated. The circuit has experienced zero minutes of customer interruption, due to not directly serving customers. However, it does serve as an important pathway in transporting power from south to north, from the Ohio River generation to the load center in northeast Ohio. **This area also has high load growth potential due to shale loads in the area. Keeping the existing ROW and line is advantageous to maintaining future flexibility in the area.**

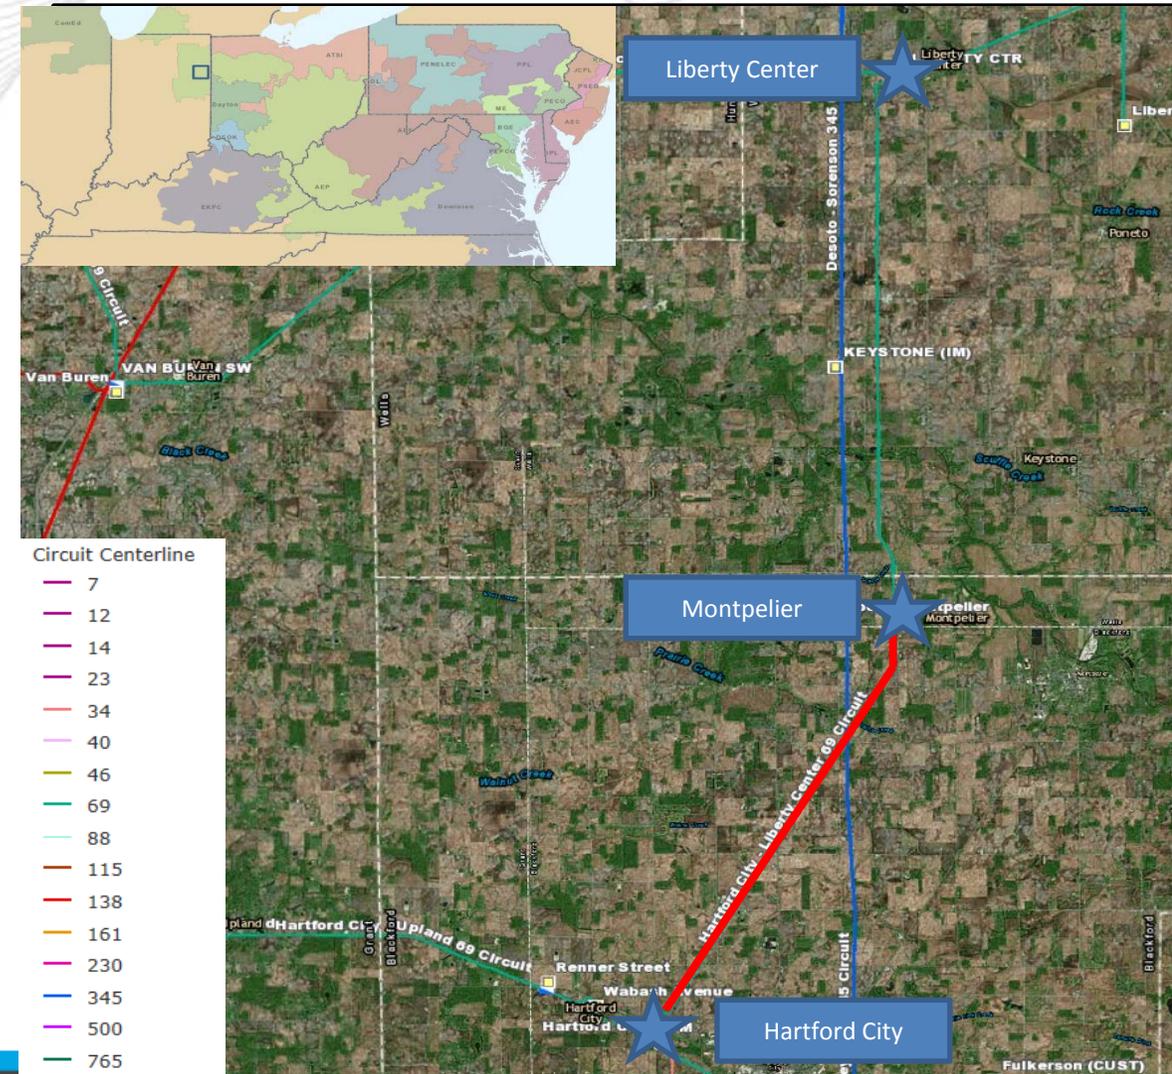
Hartford City CB's O, P, and Q are FK oil type breakers. Oil breakers, in general, have become more difficult to maintain due to the required oil handling. Oil spills occur often during routine maintenance and failures, which can become an environmental concern. Other drivers include age, bushing damage, number of fault operations, and a lack of available repair parts.

Hartford City breakers Q, O and P are FK 1200A 21kA models with 20, 59 and 170 fault operations respectively.

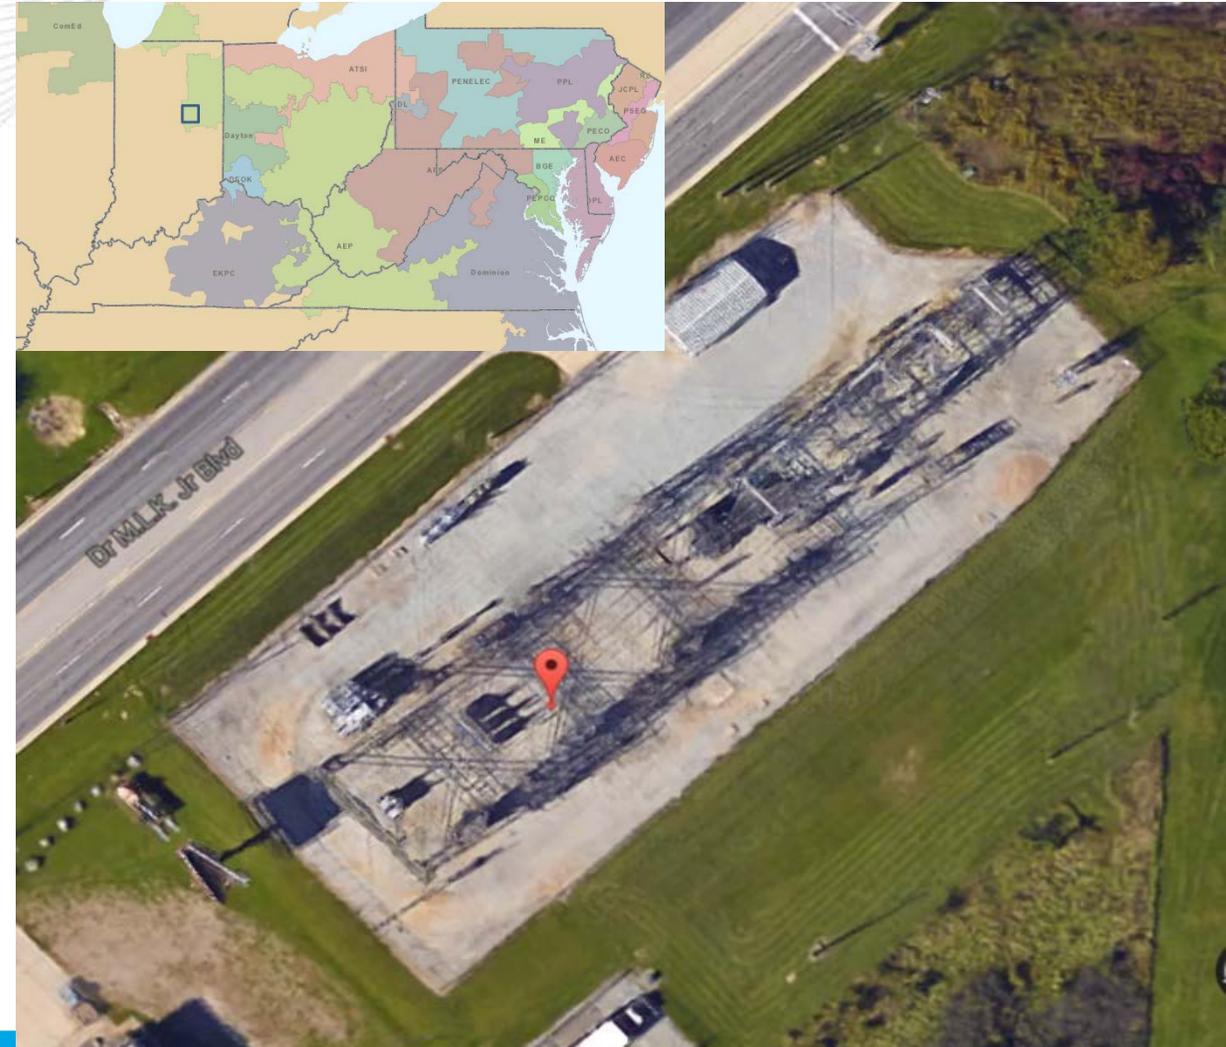
Breakers 'A' and 'B' at Tiffin Center station are 1200A 21 kA oil medium breakers manufactured in 1965 with fault counts of 149 and 73 respectively. Oil breaker maintenance has become more difficult due to the oil handling required to maintain them. Oil spills are frequent with breaker failures and routine maintenance and can become an environmental hazard. The drivers for replacement of these breakers are age, number of fault operations, a lack of available repair parts, and PCB content.

At Tiffin Center station, replace 69kV breaker 'A' and 'B' with 3000A 40kA breakers and associated equipment.

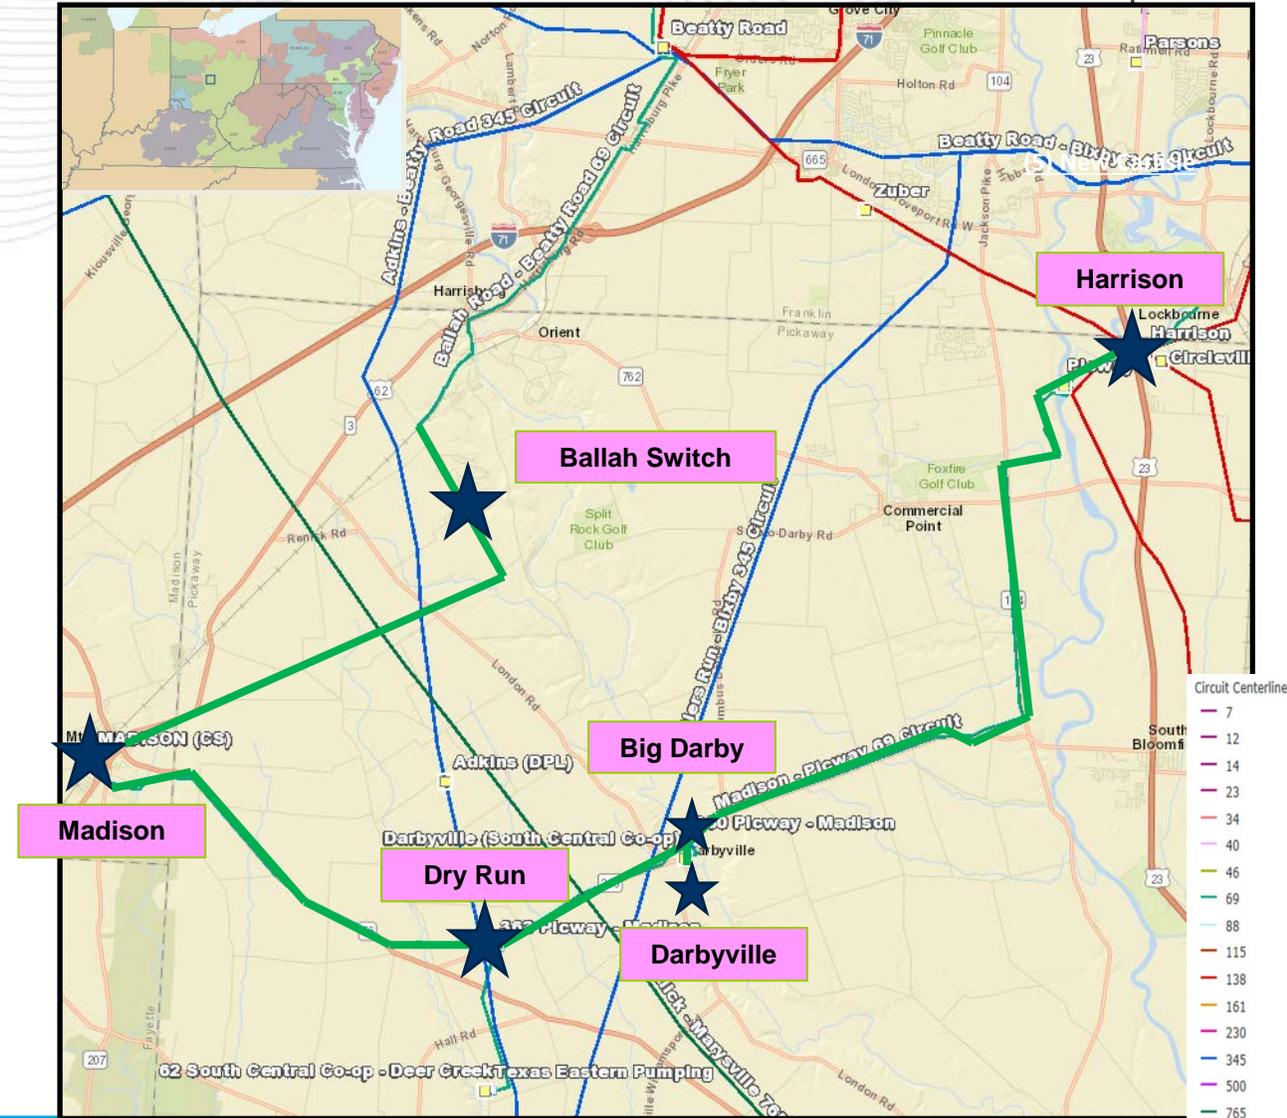
AEP Transmission Zone: Supplemental Madison 69 kV Loop

The Harrison-Madison 69kV circuit (made up of Picway-Madison, vintage 1944 & Picway Harrison, vintage 1969) is in very poor condition and in need of rebuild. 15.29 miles of the 24.2 mile line is 73 years old and 16.4 miles of it is comprised of copper conductor (25 MVA rating). There are 248 known conditions as of the last inspection. Due to the radial nature of the line, it cannot be rebuilt without first completing and closing the loop at Madison station in order to avoid extensive customer outages.

Four circuit breakers at Harrison station are showing signs of deterioration. These breakers were installed in the late 1960's and early 1970's and use oil as the interrupting medium. Oil breaker maintenance has become more difficult due to the oil handling required to maintain them. Oil spills are frequent with breaker failures and routine maintenance and can become an environmental hazard. The drivers for replacement of these breakers are age, bushing damage, no repair part availability, amount of fault operations and PCB content. Fault operation counts at Harrison include 13 on 69kV CB 61, 58 on 69kV CB 62, and 23 on 69kV CB 63, which exceed the manufacturer's recommended limit of 10.

Harrison 138/69kV transformer 1 is also showing signs deterioration. Drivers for transformer replacement include age, dielectric strength breakdown (winding insulation), short circuit strength breakdown (due to the amount of through fault events) and accessory damage (bushings).

At Harrison station, replace the 138/69kV transformer with a 90 MVA. Install 3-69kV CB's with 2,000A 40kA breakers. Install 1-138kV CB with a 3,000A 63kA breaker. Install a 14.4 MVar 69kV capacitor.
