Sub Regional RTEP Committee PJM West

November 2, 2017

Second Review Baseline Reliability and Supplemental Projects

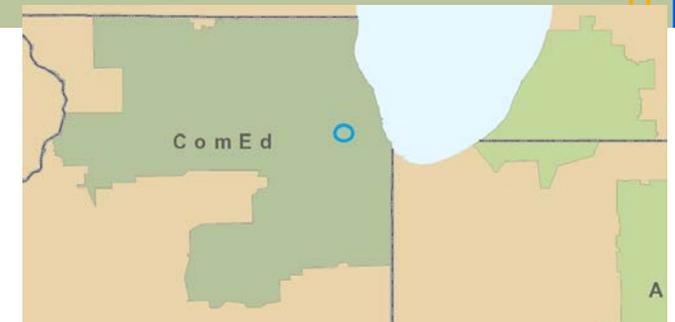
Forced Cooling equipment on the Elmhurst – Franklin Park 138kV line was installed in 1970. Availability of replacement parts is diminishing
O&M costs are increasing

Replace forced cooling equipment that is at end of life for the Elmhurst – Franklin Park 138kV line; Install additional cooling equipment to increase thermal capability of 138kV line
