Sub Regional RTEP Committee PJM West

February 14, 2018

Baseline Reliability and Supplemental Projects

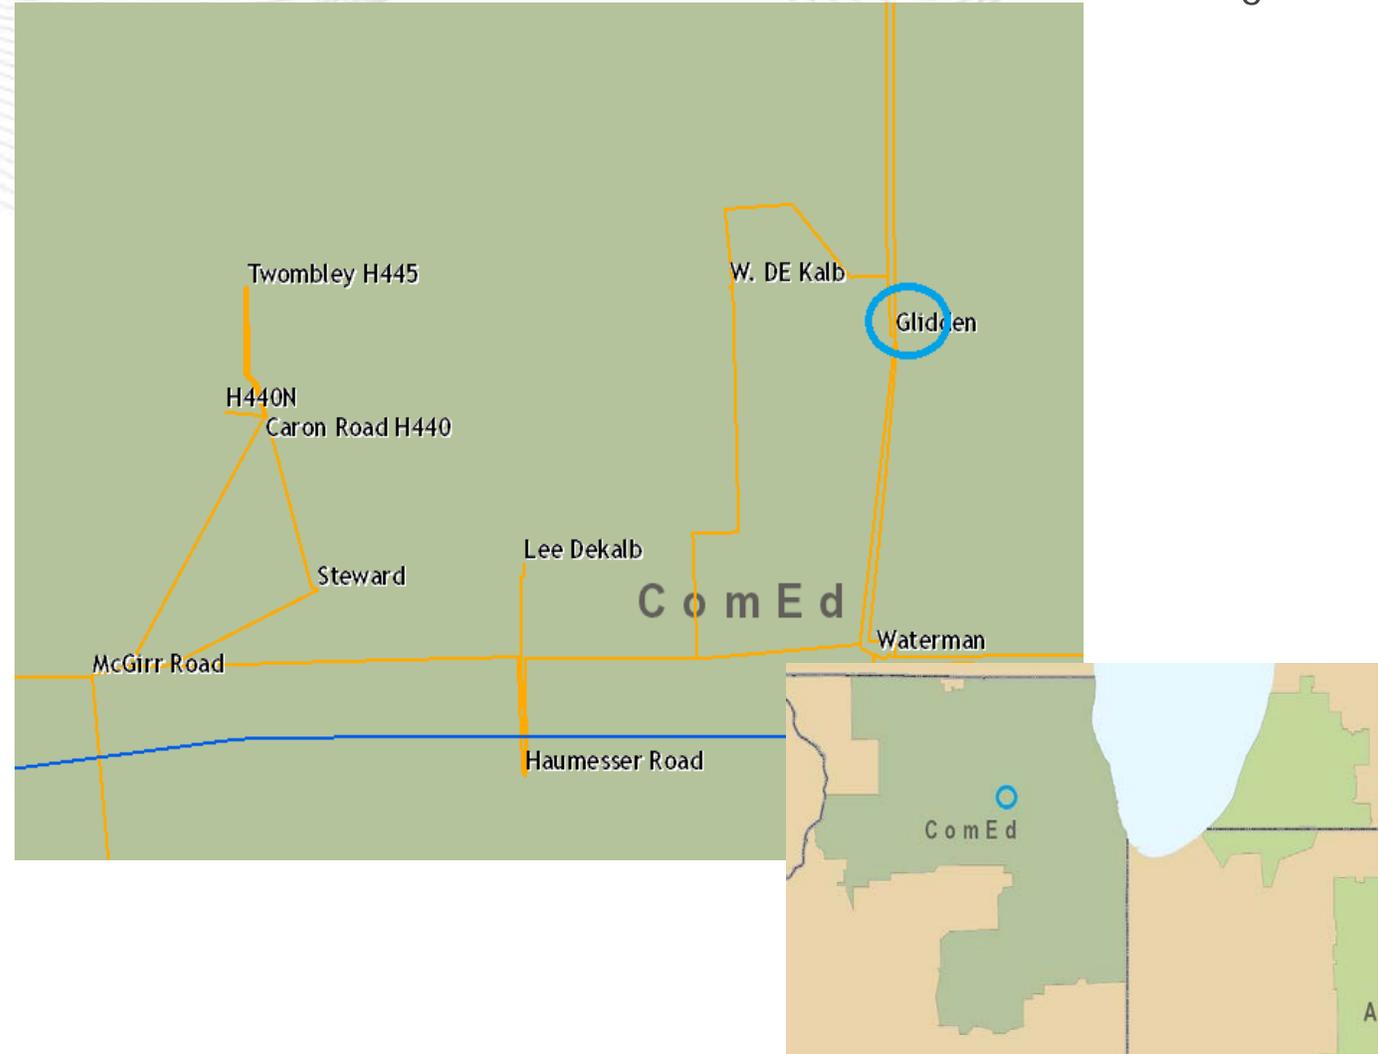
Glidden substation does not comply with ComEd standards
 Single breaker failure will trip the entire station.
 Transformer failure trips two transformers.
 Transformer maintenance requires de-energization of the 138kV bus
 and two transformers

Expand Glidden substation from a straight bus to a ring bus
 Install seven 138kV breakers to create a ring bus
 Install four transformer high side breakers

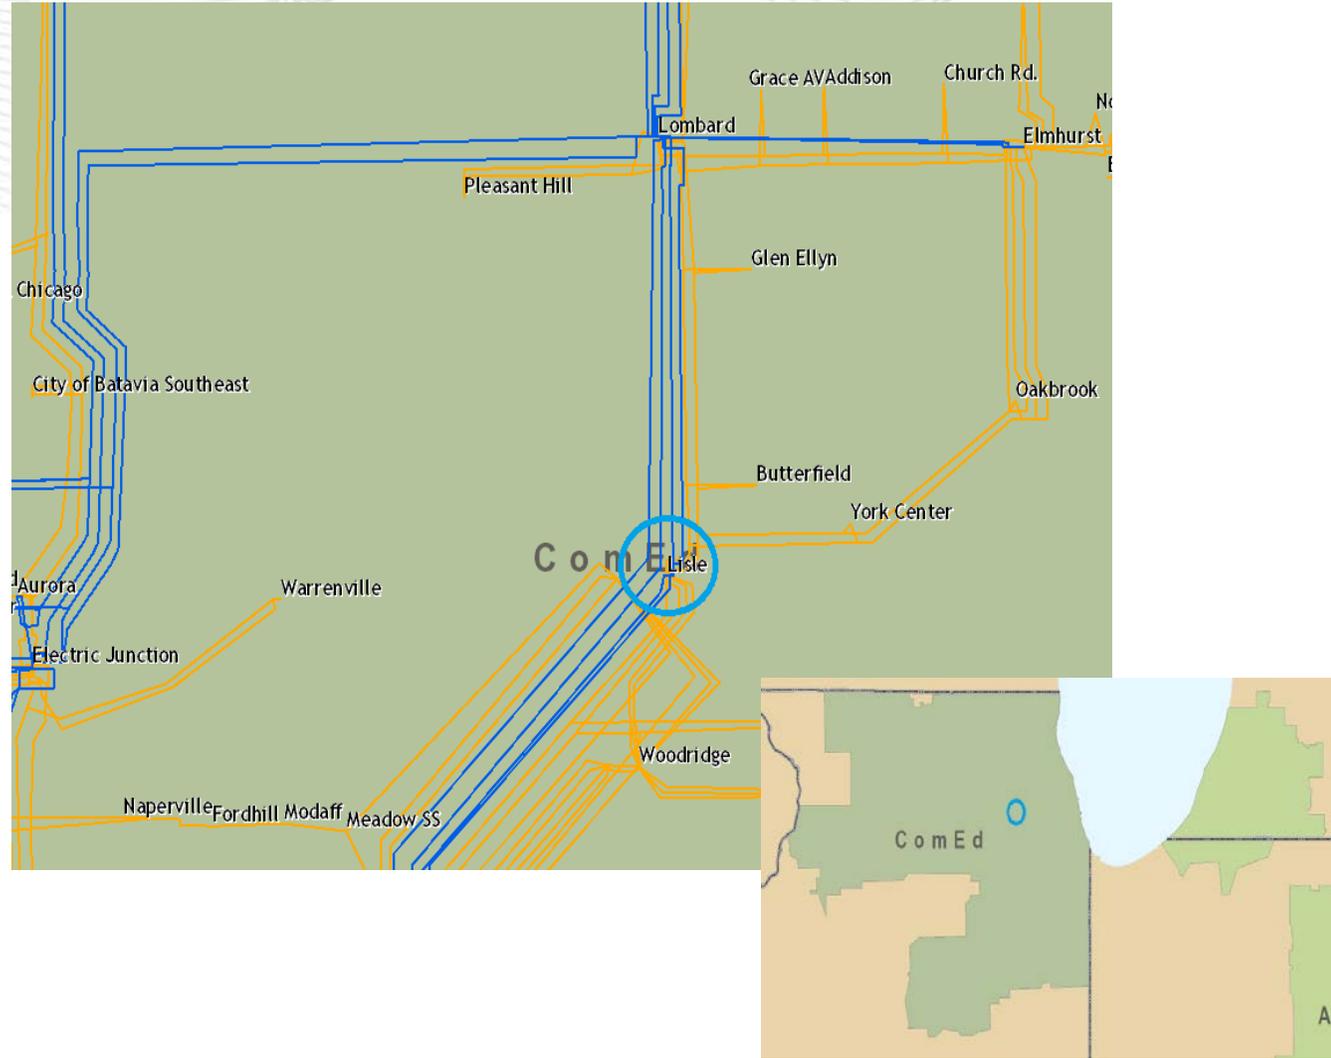
Tertiary cap banks no longer installed on tertiary windings.
Tertiary cap bank failures stress the 345-138kV transformers and have caused transformer failures in the past.

Remove tertiary capacitor banks and install 138 kV capacitor banks
Increase the thermal capability of the 345-138kV autotransformer

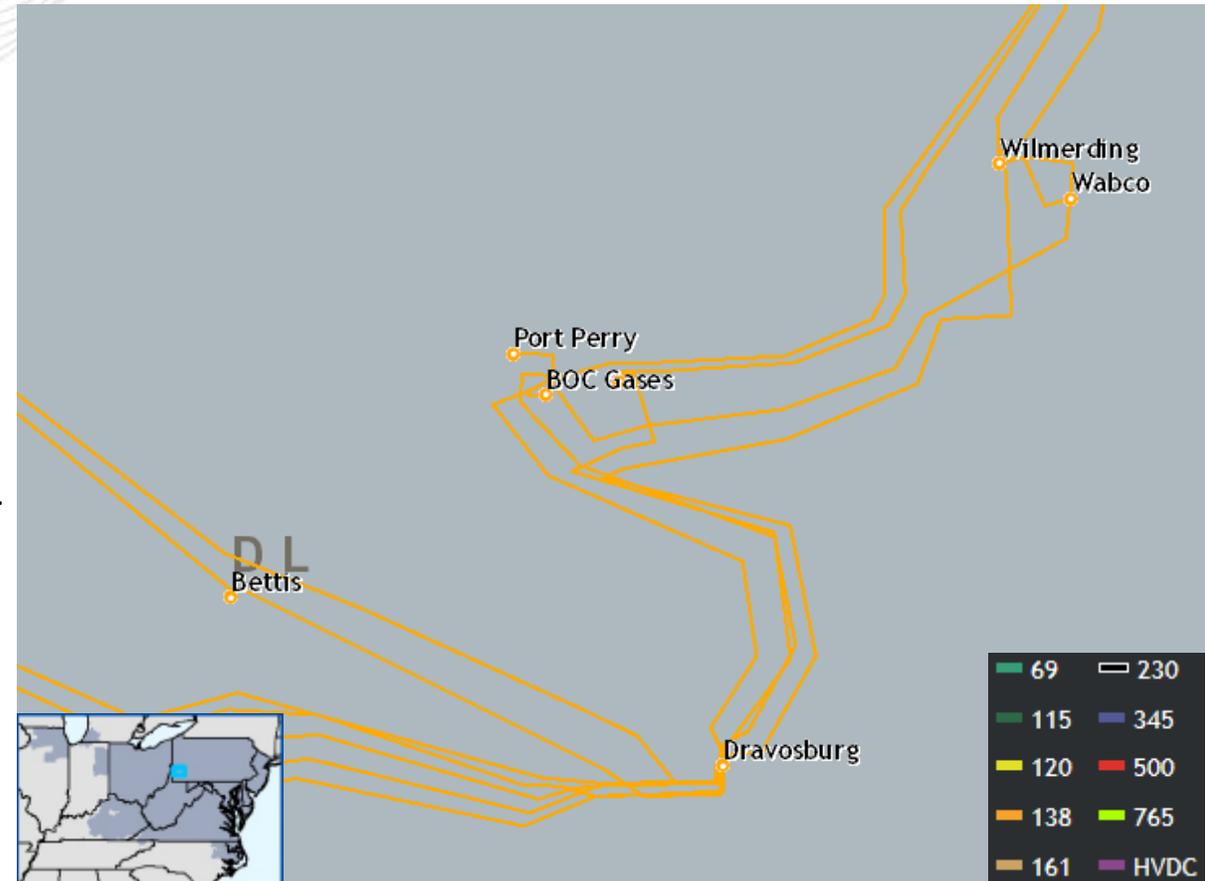
The Wilmerding #86 and #88 138kV breakers were installed in 1968. The #88 breaker feeds a transmission customer and has the potential to remove this customer from service if not replaced. The lifespan of these breakers have been optimized and each are now at the end of their useful lives based on material condition and performance.

Replace Wilmerding SS - #86 138kV Breaker (Present rating: 37.1kA, Future rating: 50kA).

Replace Wilmerding SS - #88 138kV Breaker(Present rating: 37.9kA, Future rating: 50kA).

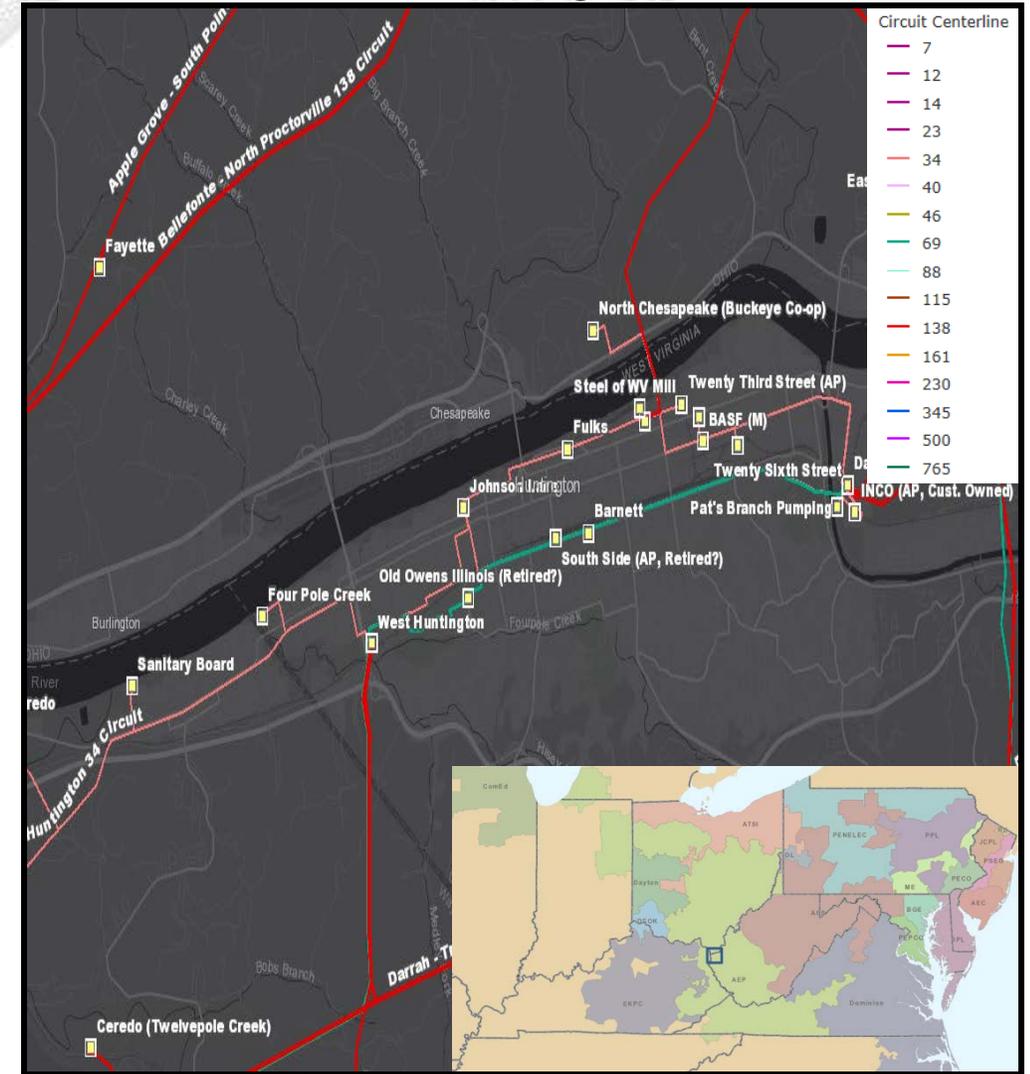
138 kV circuit breakers "D" at West Huntington is FK type breaker that is over 67 years old. It is oil breakers that have become more difficult to maintain due to the required oil handling. There is an increased potential for oil spills during routine maintenance and failures with these types of breakers. Other drivers include PCB content, damage to bushings and number of fault operations exceeding the recommendations of the manufacturer. West Huntington breakers "D" & "E" have experienced 89 and 18 fault operations. The manufacturer's recommendation for this type of breaker is 10.

Replace the existing 1200A 20 kA 138 kV circuit breaker 'D' with a new 3000A 40 kV 138 kV circuit breaker at West Huntington station. (S1377.12)

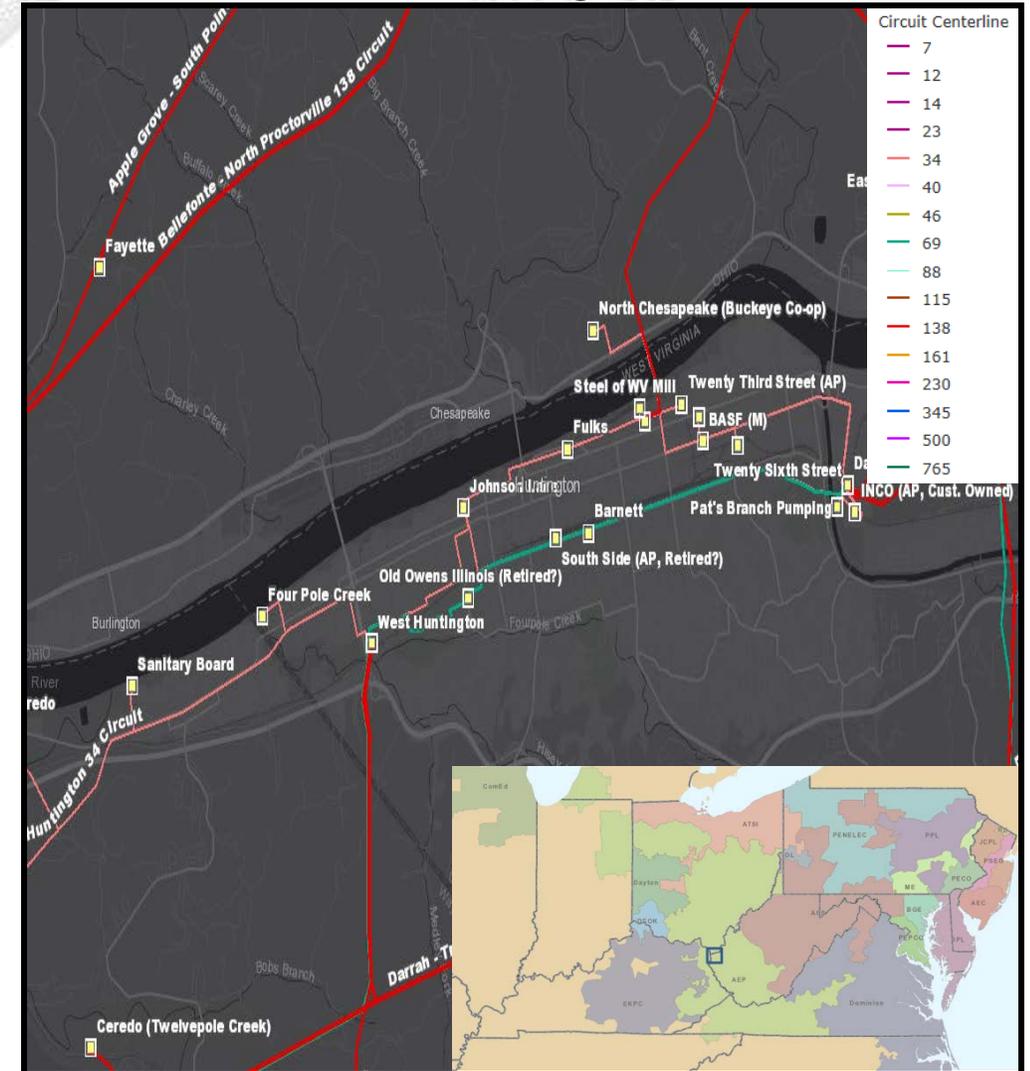
Replace the existing 1200A 20 kA 138 kV circuit breaker 'E' with a new 3000A 40 kV 138 kV circuit breaker. Install three 138 kV 3000 A 40 kA circuit breakers on the high side of the three transformers at West Huntington.

Replace the existing 1800A 27 kA 69 kV circuit breaker 'C' with a new 3000 A 40 kA 69 kV circuit breaker. Replace the existing 1800A 27 kA 34.5 kV circuit breaker 'J' with a new 3000A 40 kA 34.5 kV circuit breaker. Replace the existing capacitor switcher 'AA' with a new circuit switcher.

138 kV circuit breaker "E" at West Huntington is FK type breakers that are both over 67 years old. It is oil breaker that has become more difficult to maintain due to the required oil handling. There is an increased potential for oil spills during routine maintenance and failures with these types of breakers. Other drivers include PCB content, damage to bushings and number of fault operations exceeding the recommendations of the manufacturer. West Huntington breaker "E" have experienced 89 and 18 fault operations. The manufacturer's recommendation for this type of breaker is 10.

69 kV circuit breaker "C" and 34.5 kV circuit breaker "J" at West Huntington are FK type oil breakers that are over 46 years and share the same concerns listed for the 138 kV breakers above. Circuit Breakers "C" & "J" have experienced 23 and 40 fault operations. The manufacturer's recommendation for this type of breaker is 10.

Capacitor switcher "AA" at West Huntington is a VBM type switcher. Joslyn Varmaster VBM-34's have a double stack interrupter design requiring simultaneous operation for rated current interruption; any delay between the two stacks would cause the full electrical stress of the operation to be placed on one stack. This could lead to capswitcher and/or cap bank failure. Like Mark V switchers, new control integration is difficult.

138 kV circuit breakers will be added to the high side of the transformers at West Huntington to separate dissimilar zones of protection.

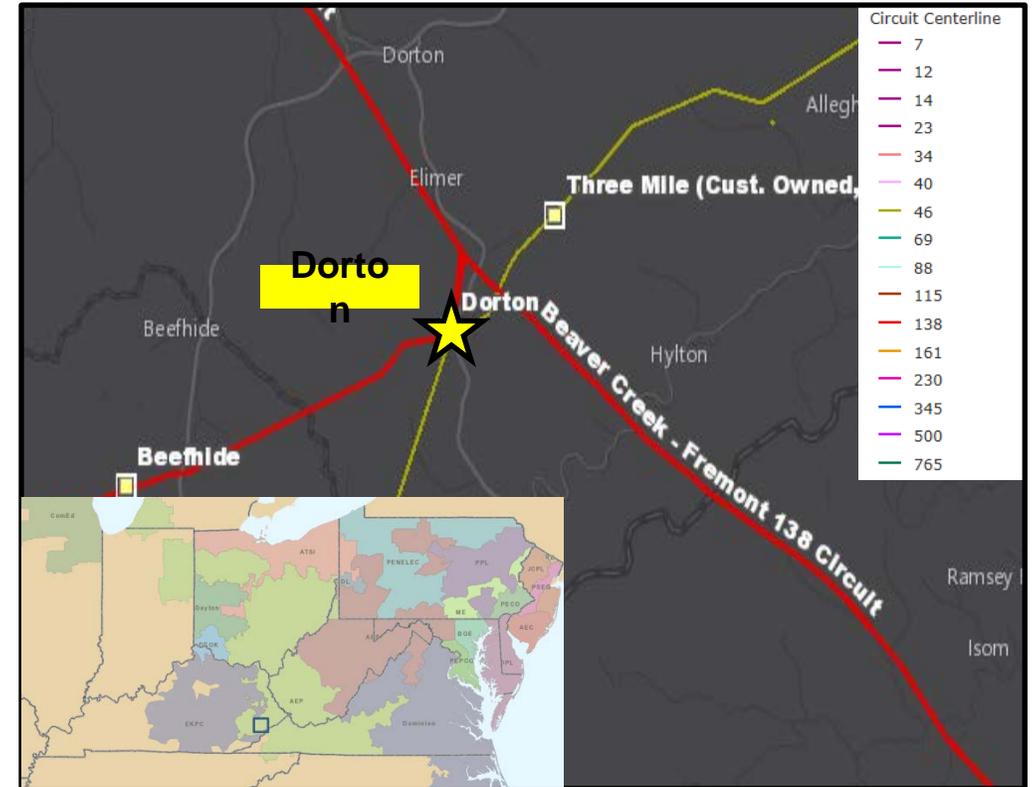
Dorton's 138/46 kV Transformer #1 is 1956 vintage and is showing dielectric breakdown (insulation), accessory damage (bushings/windings) and short circuit breakdown (due to amount of through faults).

Replace the existing 138/46 kV 45 MVA transformer bank with a new 138/69/46 kV 90 MVA transformer bank. A low side 69 kV circuit breaker (operated at 46 kV) will be added to the transformer.

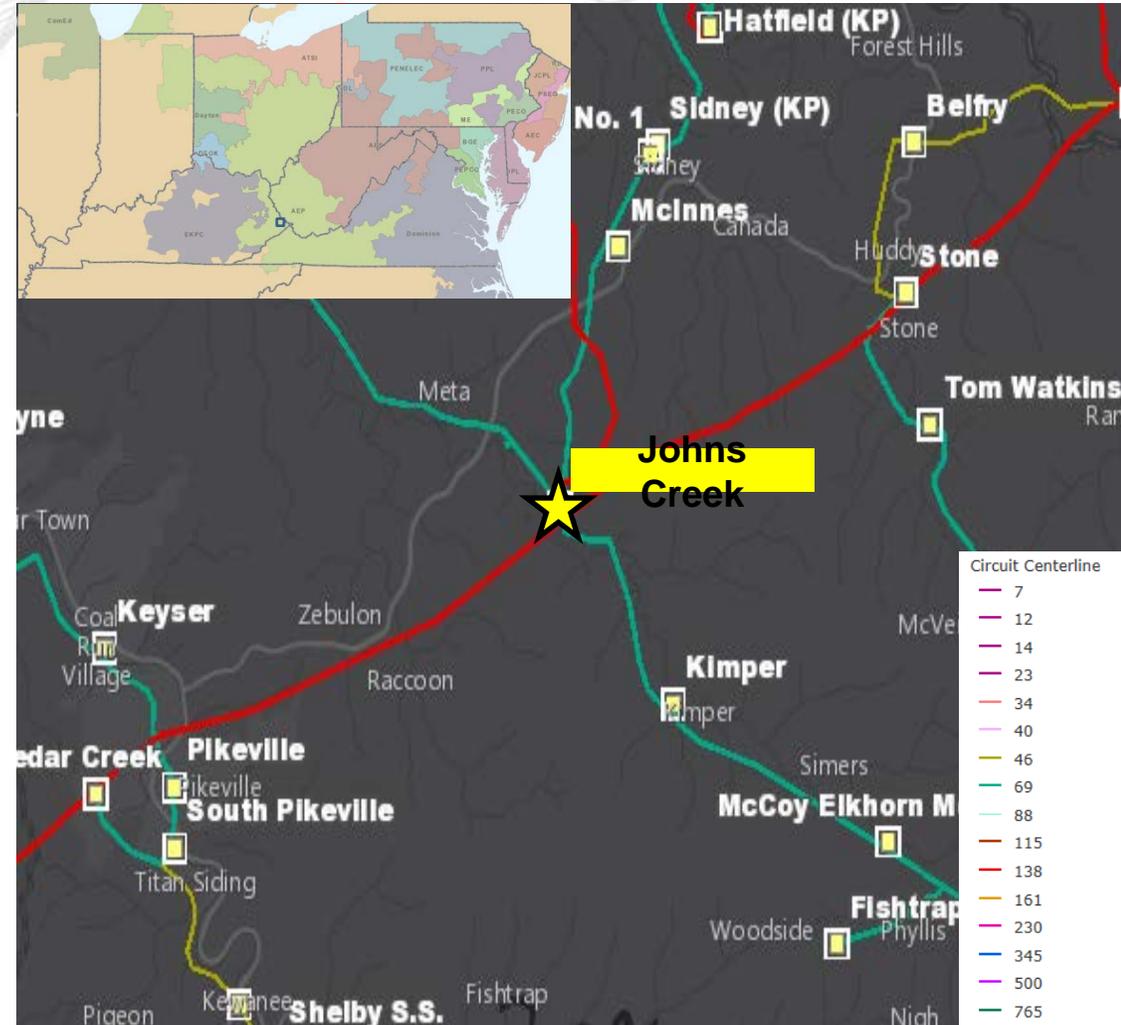
Replace existing 69 kV circuit breaker 'A' with a new 3000 A 40 kA circuit breaker. Replace the existing 138/69/34.5 kV 90 MVA transformer #1 with a new 90 MVA 138/69/34.5 kV transformer. Install a new 20 MVA 138/34.5 kV transformer to remove the distribution load from the tertiary of transformer #1. Install a new 2000 A 40 kA high side circuit switcher on the 138/34.5 kV Transformer. Replace existing capacitor switcher 'AA' with a new 3000 A 40 kA switcher and existing capacitor switcher 'BB' with new 3000 A 40 kA switcher.

Transformer Bank #1 (1980 vintage) has bad high side internal CTs which are not field replaceable. Given the faulty internal CT and the current maintenance issues, the bank is being replaced. Drivers for replacement include short circuit strength breakdown, bushing damage and dielectric strength breakdown (winding insulation). In order to move the 34.5 kV distribution load off the tertiary winding of the existing 138/69/34.5 kV transformer, a new 138/34.5 transformer is being installed along with the new 138/69/34.5 kV transformer.

Circuit Breaker 'A' is an oil breaker that is leaking oil. In addition the breaker has surpassed the manufacturer's recommended fault operations of 10 (135 fault operations).

Capacitor switcher 'AA' does not have pre-insertion inductor and has caused customer protection equipment in the area to trip off line due to voltage surges.

Capacitor switcher 'BB' is a Mark V model which no longer supports modern relaying packages. Mark V's have been historically prone to mechanism failures and are being replaced system wide where possible.

The MOAB/ground switch will be replaced. MOAB/ground switch combinations induce a fault on the system, tripping remote breakers for a transformer fault, reducing the life and increasing relay coordination complexity for the transformer protection.

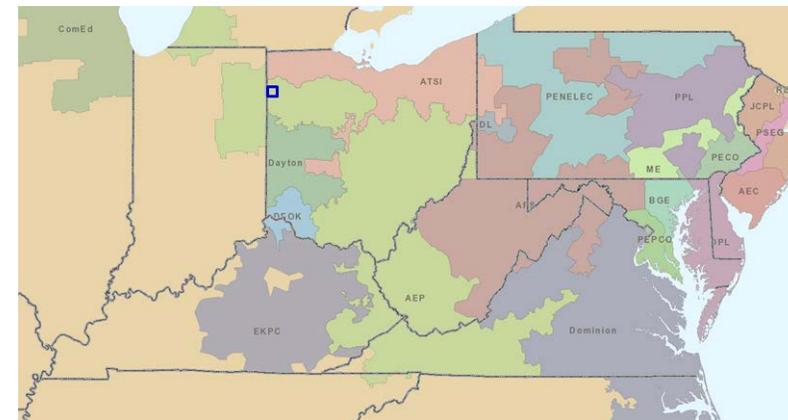
**Existing Mark Center – South Hicksville 69 kV Line is highlighted in green;
Proposed rebuild is highlighted in red.**

The Mark Center-South Hicksville line was originally constructed in 1957 with 336 ACSR conductor (73 MVA rating). There are 119 open conditions on this 8.8 mile long circuit. The existing line is almost entirely crossarm construction with suspension insulator assemblies, which is not the current AEP standard; the existing crossarms and braces are typical for distribution construction, not transmission construction. End splitting and failure is an elevated risk. Many arms fail periodic inspection; quantity failing inspection is abnormally high. Undersized braces are prone to end fittings becoming separated and arms rotating. Some existing wood pole structures have bay-o-nets supporting the shield wire. At least once in the last year the line experienced a cascading failure of multiple poles in a row. Existing grounding is only every other structure. The line is double-circuit construction for several spans near South Hicksville Station. Structure failures in the double-circuit section jeopardize system stability in the Hicksville, OH area, elevating the risk of an area-wide outage. Some of the line has distribution underbuild, which mechanically consumes pole strength. Legacy underlying easement rights for a line of this vintage are typically inadequate by present day AEP Transmission standards.

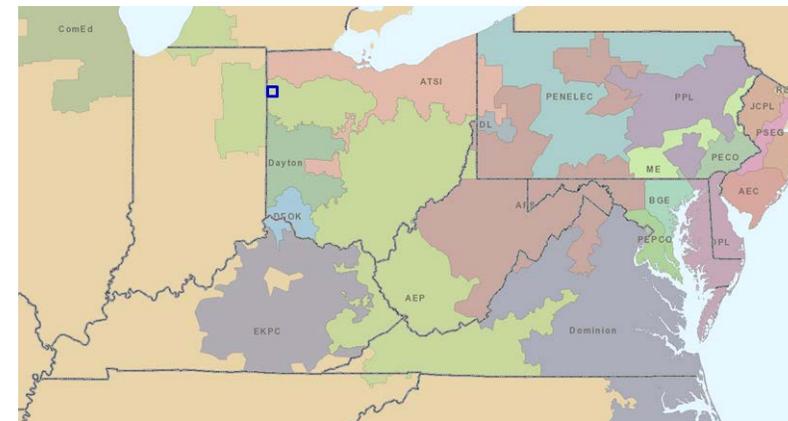
Existing Mark Center – South Hicksville 69 kV Line is highlighted in green;
Proposed rebuild is highlighted in red.

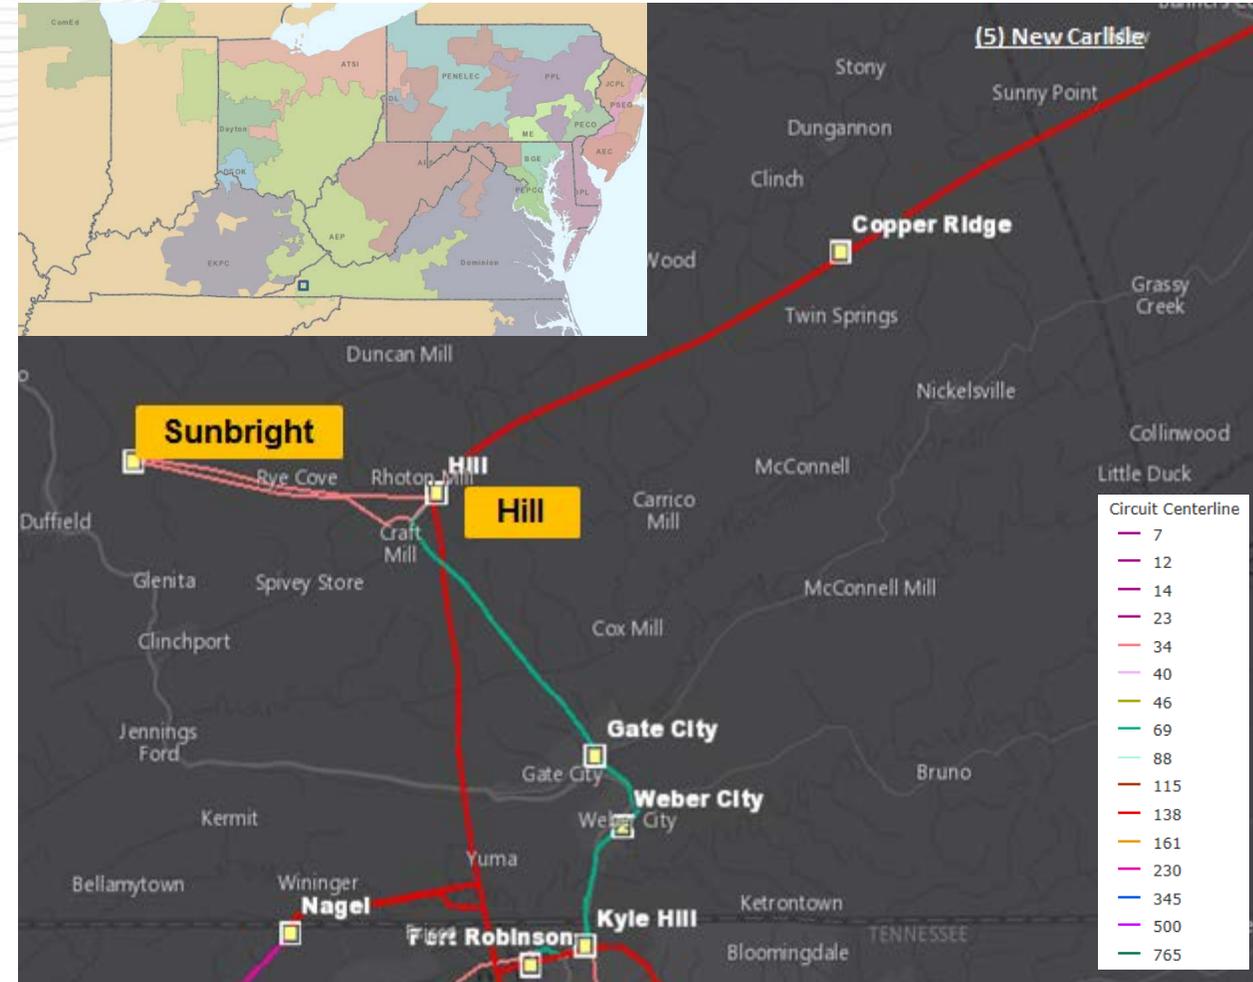
At Hill station, replace 34.5 kV circuit breakers “F” and “G” with new 3000 A 40 kA 69 kV circuit breakers to accommodate the conversion of the Hill – Sunbright circuit to 69 kV. A 69 kV circuit breaker will also be installed on the low side of the transformer 69 kV winding. Estimated Cost: \$1.4M

At Sunbright station, replace the existing 34/12 kV 5 MVA transformer with a new 69/12 kV 25 MVA transformer. Replace existing 34 kV 1200 A 17 kA circuit breakers with new 3000 A 40 kA 69 kV circuit breakers. Estimated Cost: \$0.0M

34.5 kV circuit breakers "A" & "B" at Sunbright and "F" & "G" at Hill Stations are all FK type breakers (vintage 1950's). These are oil breakers that have become more difficult to maintain due to the required oil handling. In general, oil spills occur often during routine maintenance and failures with these types of breakers. Other drivers include PCB content, damage to bushings and number of fault operations exceeding the recommendations of the manufacturer. Sunbright breakers "A" & "B" have experienced 25 and 26 fault operations respectively, which exceeds the manufactures recommended number of operations (10). Hill breakers "F" & "G" have experienced 74 and 35 fault operations respectively, which exceeds the manufactures recommended number of operations (10).

The 34.5/12 kV transformer at Sunbright is 61 years old and has experienced short circuit strength breakdown caused by a large amount of high temperature through fault events. This has led to minor gassing of the unit, and carbonization of the insulating paper. In addition, there is an upward trending of oil moisture content which will begin resulting in downward trending to the oil dielectric strength. Increasing moisture content is a resultant of water ingress through worn gaskets, leaks from the tank, or a breakdown of paper insulation of transformer windings.

Obligation to serve distribution customer. The load on the Sunbright #1 transformer is projected to reach 124 % of its 8.5 MVA capability by winter 2017/18. The increase in loading is due to a 2 MVA addition to the Duffield Industrial Park in 2017. The Sunbright – Hill double circuit is already built to 69 kV standards.

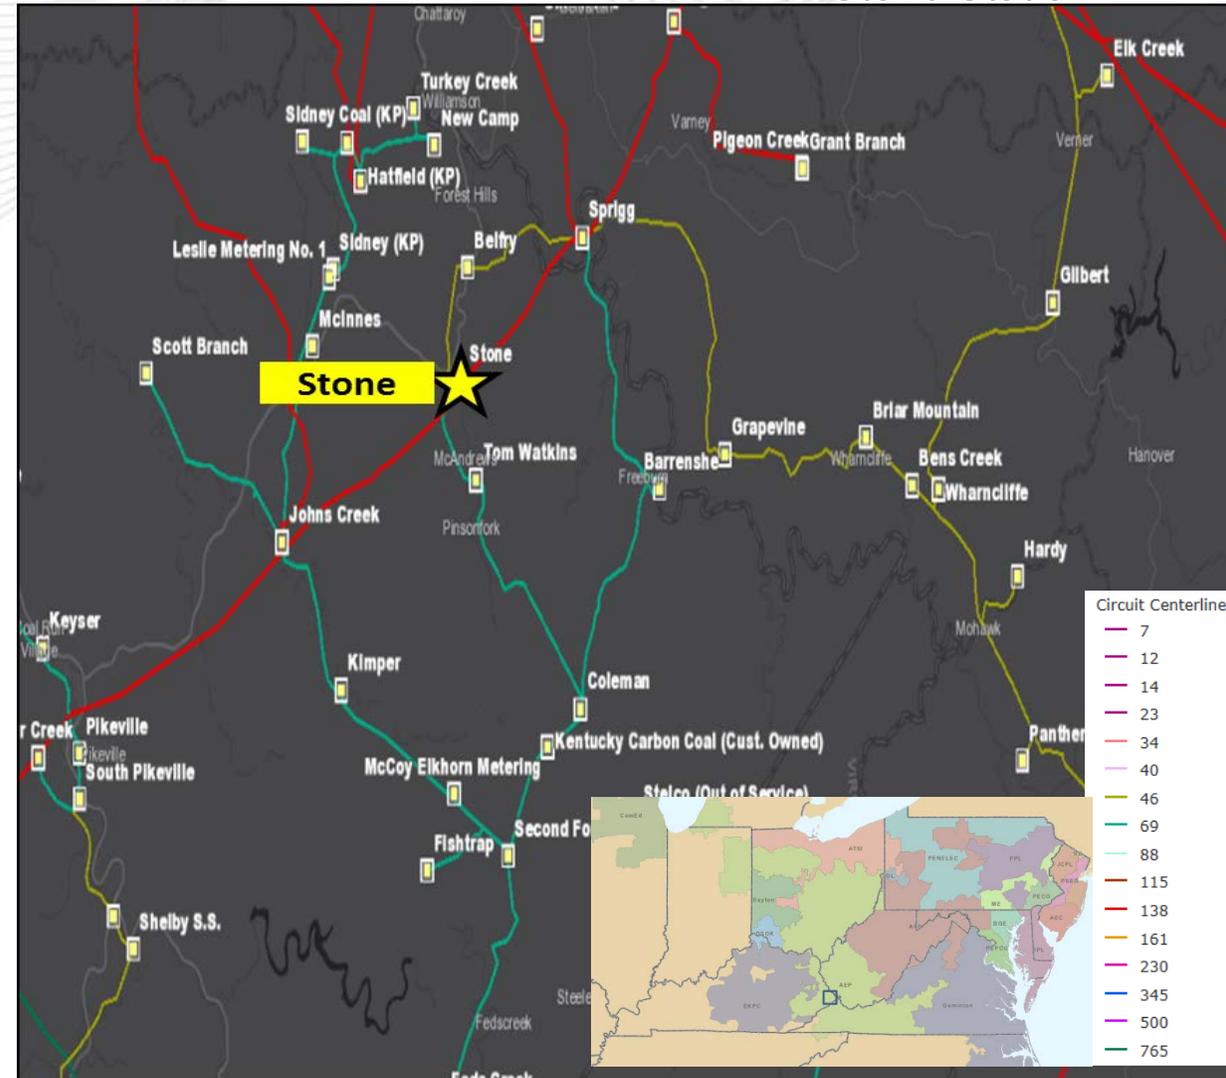
The 138/69/46 kV 50 MVA transformer at Stone station has failed beyond repair and requires replacement.

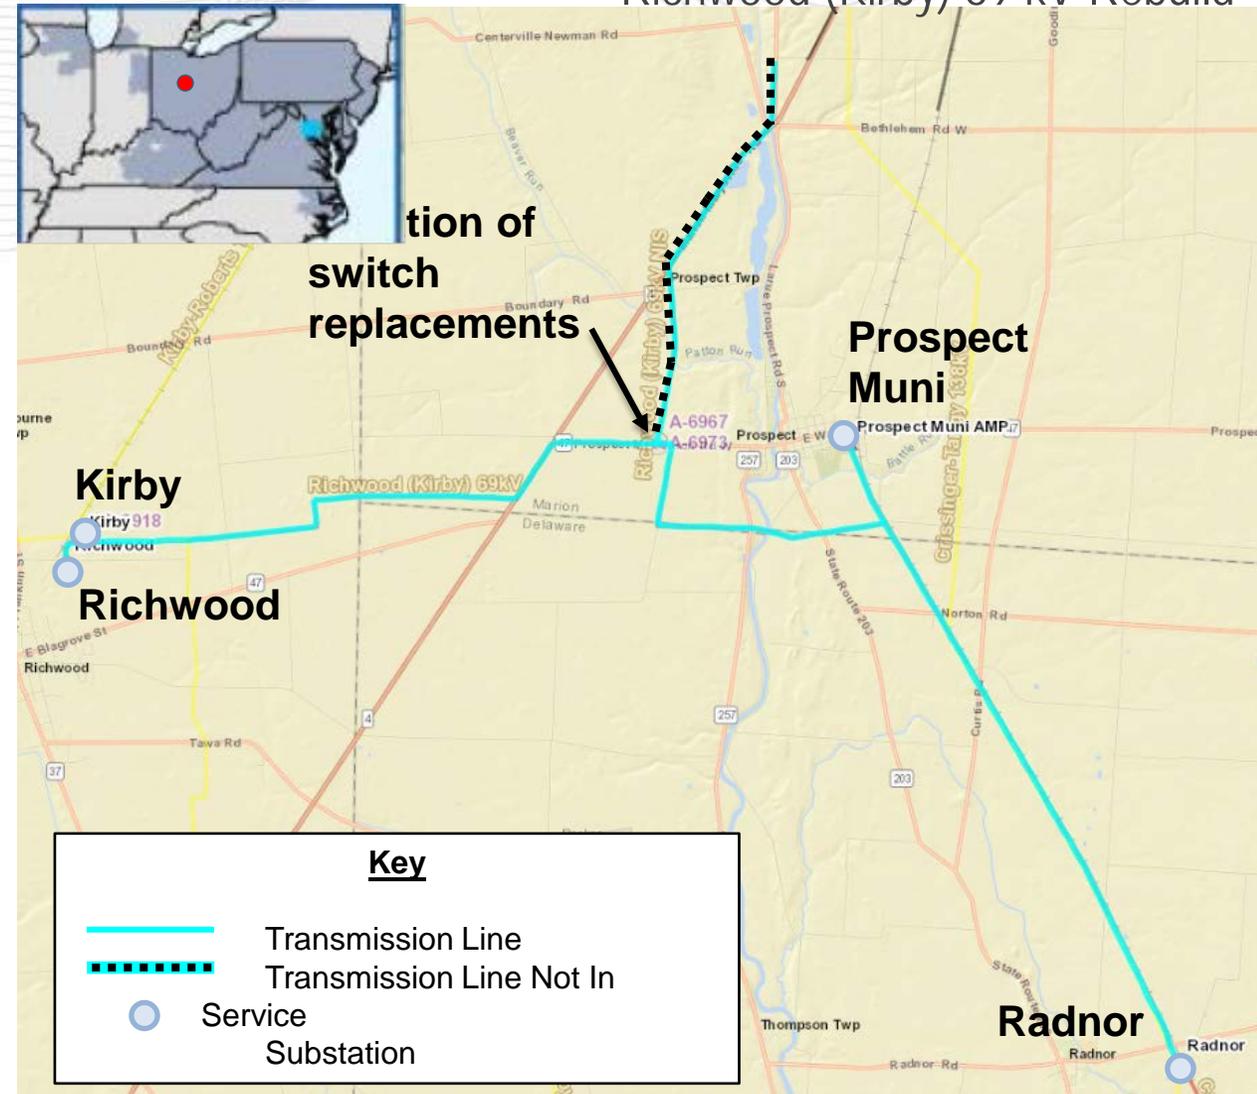
- Rebuild 12.6 miles of single circuit 3/0 ACSR Kirby-Radnor 69 kV line with 336 ACSR and replace existing two-way switch with two (2) separate one-way switches. (\$1477)

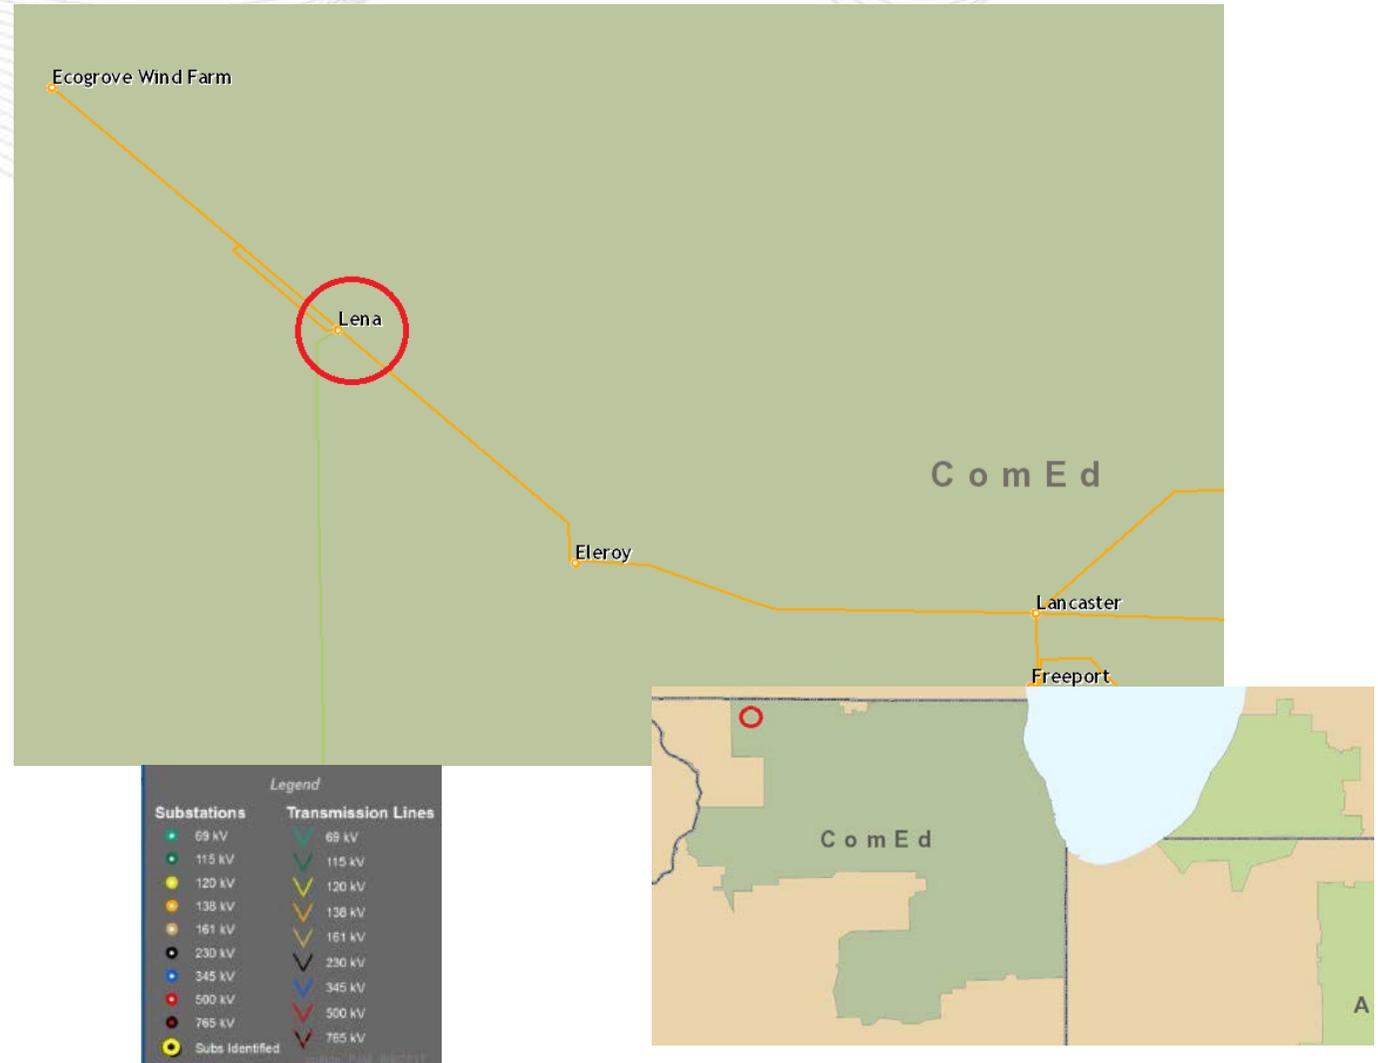
Need Additional 34kV transformation capacity in Lena area.
Lena contain one 138-34kV transformer. A transformer failure requires Freeport station to pick up all the Lena load. Second transformer allows Lena to support all load for a transformer failure.

Install a new 138-34kV transformer with high side and low side breakers at Lena, Expand the 34kV switchgear, Replace line circuit switchers with 138kV breakers, Install new 138kV bus tie breaker (**\$1480.1**)
Normally close 138kV line 11904 into Lena, the 11904 circuit switcher is normally open and Normally open the new 138kV bus tie breaker (**\$1480.2**)

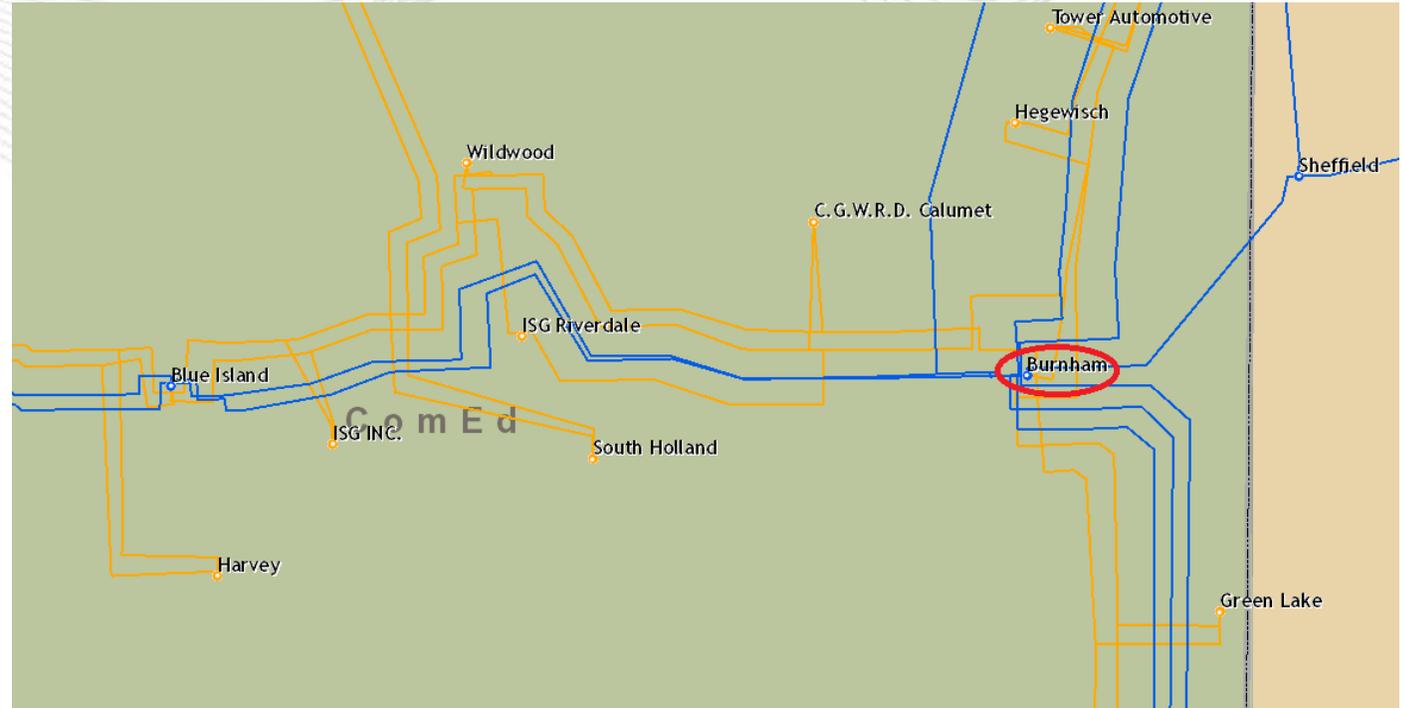
138kV line 17714 (Burnham - Wildwood) wave trap needs to be replaced due to material condition.

Replace the wave trap at the Burnham substation for 138kV line 17714 (Burnham - Wildwood) **(\$1481)**

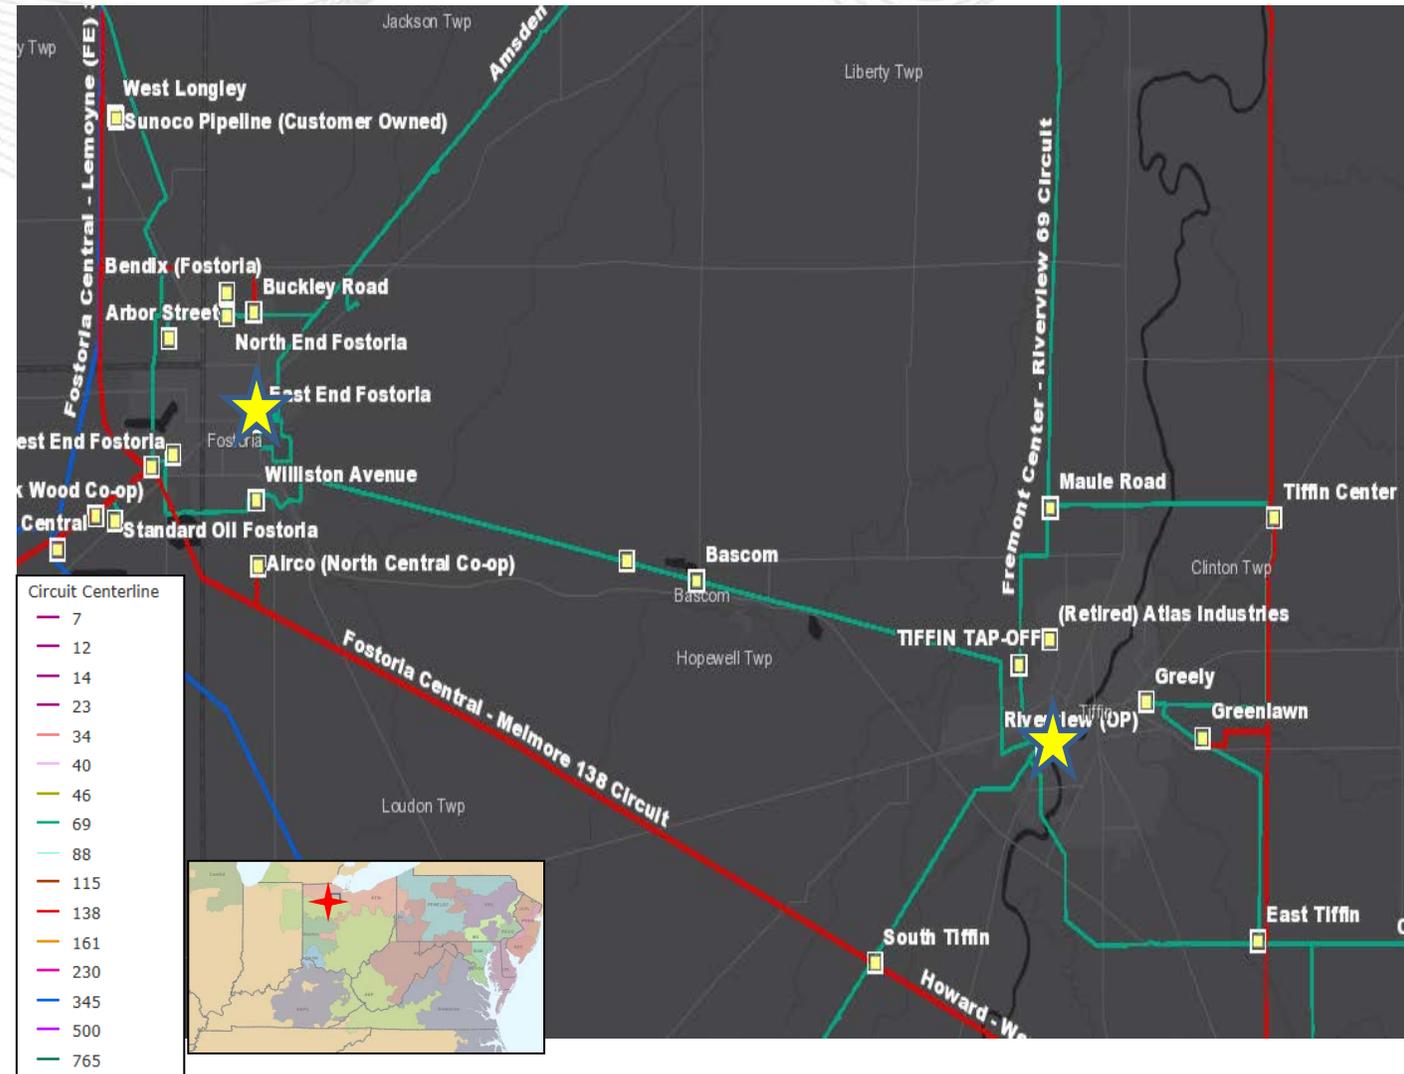
The existing 12.8 mile, 69 kV line section between East End Fostoria and Riverview was originally constructed in 1912 using wood pole & lattice structures with #1 Copper and 3/0 Copper conductor (31 MVA rating). There are 81 open conditions on this line. The line has also experienced 50,680 Customer Minutes of Interruption (CMI). As part of the line rebuild, the switching structures for Bascom will also be replaced.

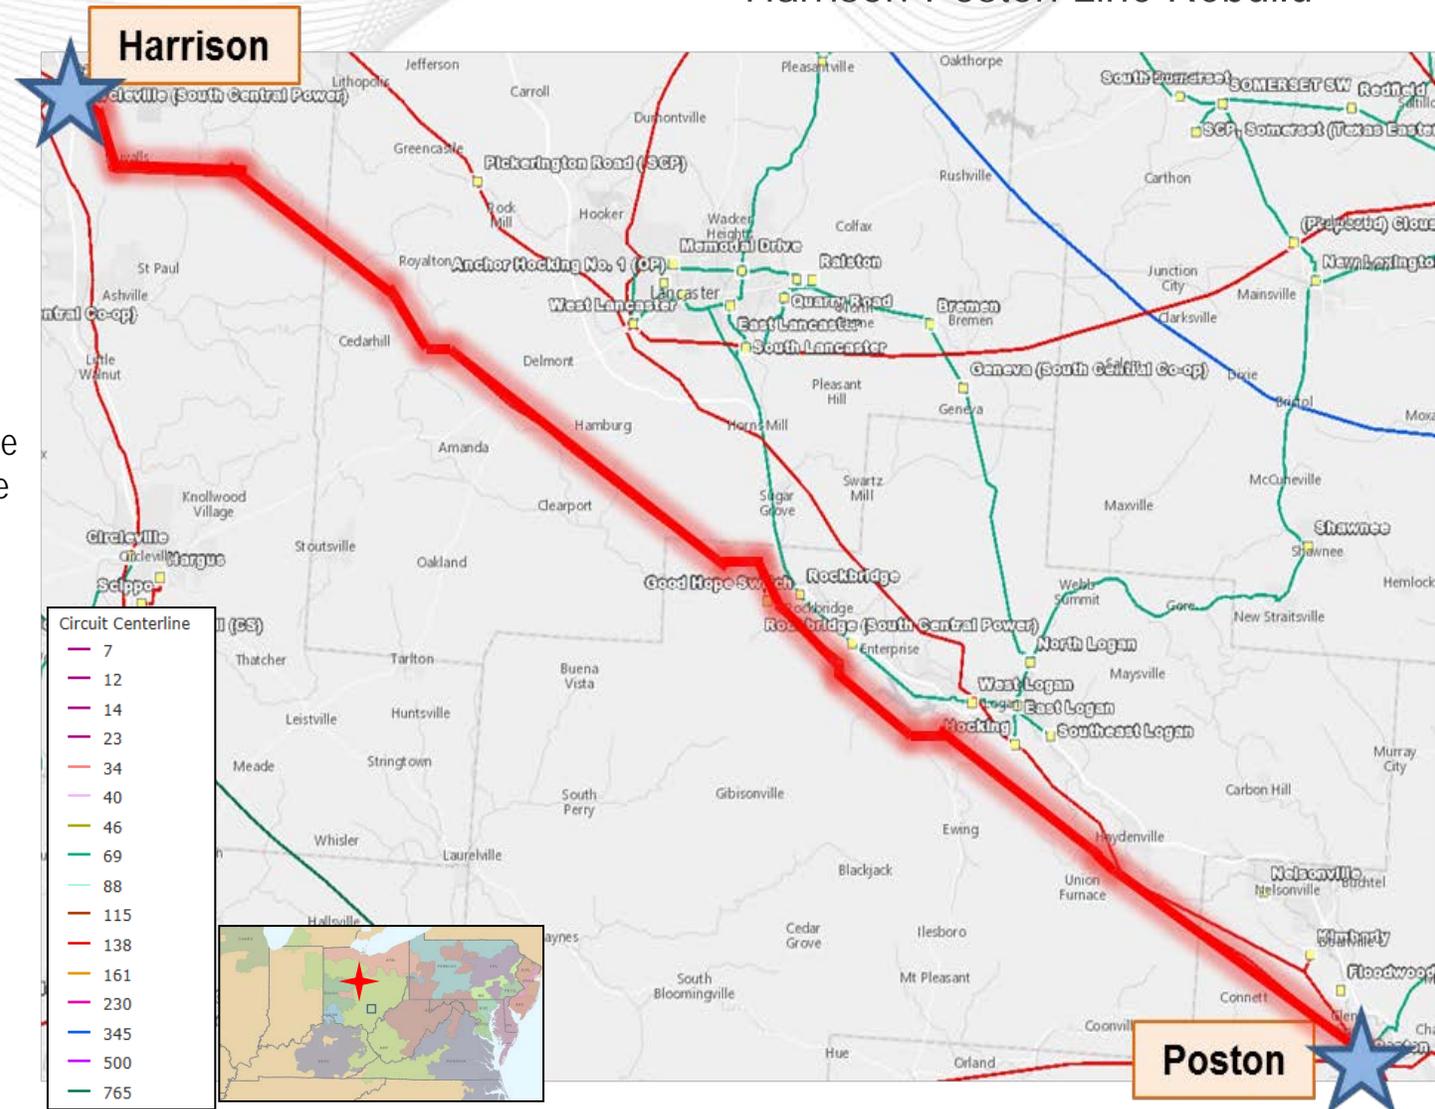
The Poston - Harrison 138 kV Line is 54.4 miles long and was built in 1953 utilizing wood pole H-Frame structures and 636 ACSR conductor (223 MVA rating). The existing 138 kV line is in need of major repair. The poles and crossarms are deteriorated so severely that they have become a hazard to effective maintenance practices. There are 269 open conditions spread along the entire distance of this line.

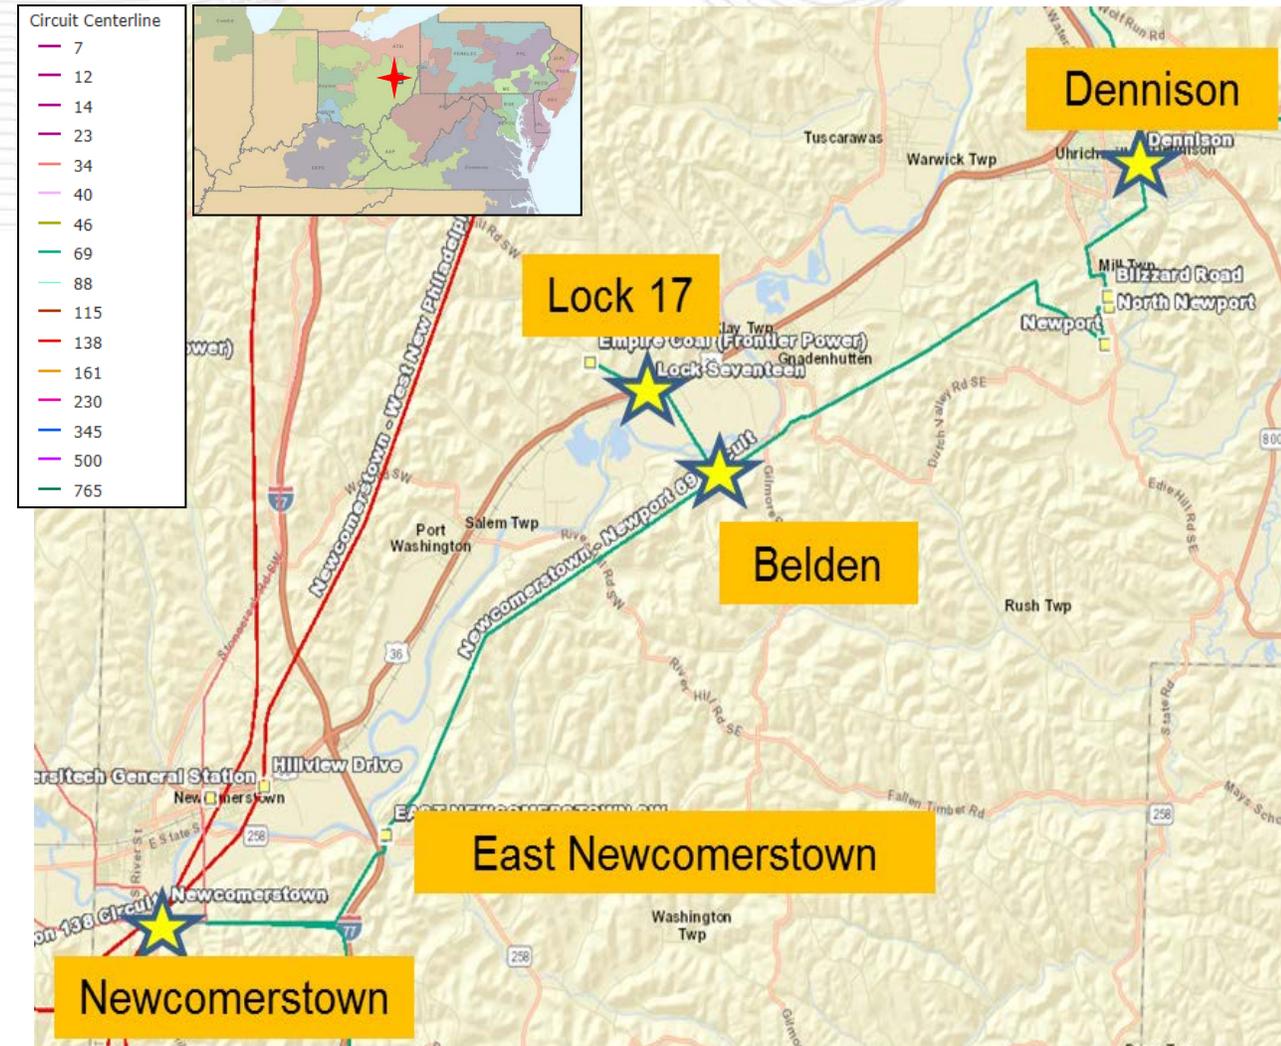
At Lock 17 69kV station, add a 69kV station bay structure and 2- 69kV MOAB switches. Relocate the 69kV cap bank and expand to 10.8 MVAR. Replace the transformer protection with a circuit switcher **(S1488.3)**. Estimated Cost : \$1.3M

Replace East Newcomerstown 69kV Switch with a new 2-way switch. Retire Belden 69kV switch. **(S1488.4)** Estimated Cost : \$0.2M
