Sub Regional RTEP Committee PJM West

February 14, 2018

Baseline Reliability and Supplemental Projects

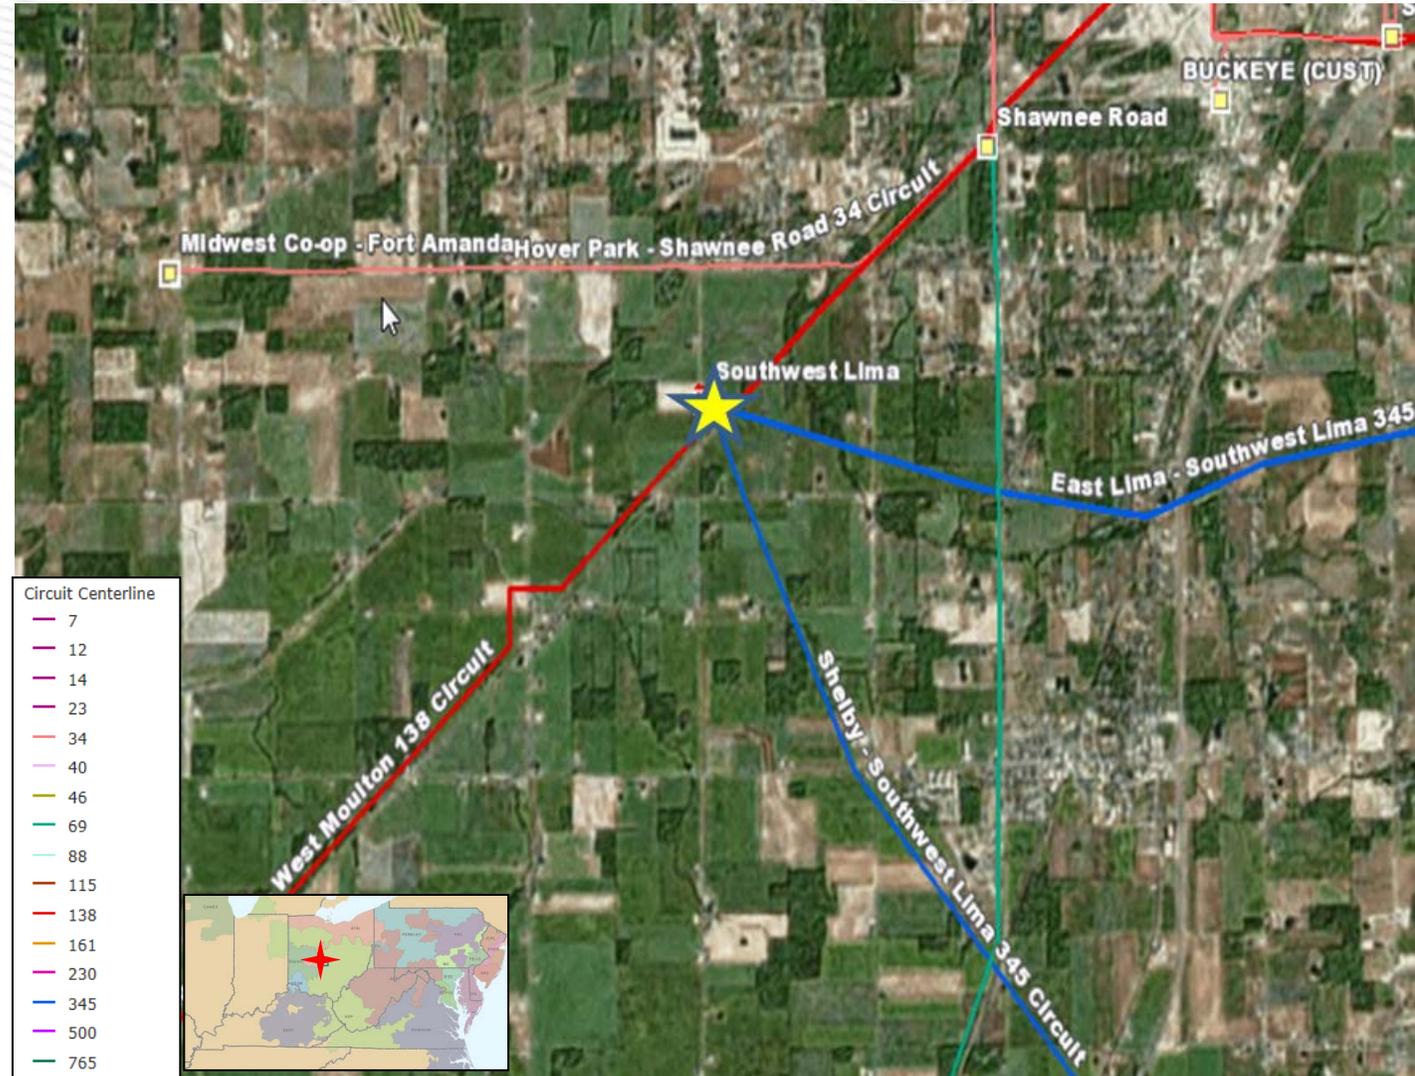
At Southwest Lima station, circuit breakers J, J1, J2 and K are all 138 kV 40 kA air blast, PK-type breakers manufactured in 1969. Air blast breakers tends to fail violently and when they do bushings usually explode which expel shards of ceramic and could potentially harm anyone at the station. In addition, PKs are no longer supported by vendors and cannot be integrated to modern relaying packages. Breaker K2 is an SF6 type 145-PA. Even though PAs are SF6, they have started giving the field problems due to significant seal issues in their design that result in low SF6 gas pressure. Field crews have tried repairing these breakers but after seal issues pop up it is very difficult to return the breaker to 100% operation. SF6 has been added in the past, with little to no improvement on the condition on this breaker type. Fault operation counts for CB J2, J, and K2 are 20, 25, and 39 respectively.

Replace existing 138 kV breakers J, J1, J2, K, and K2 at Southwest Lima with new 138 kV 3000 A 63 KA breakers. (S1489)

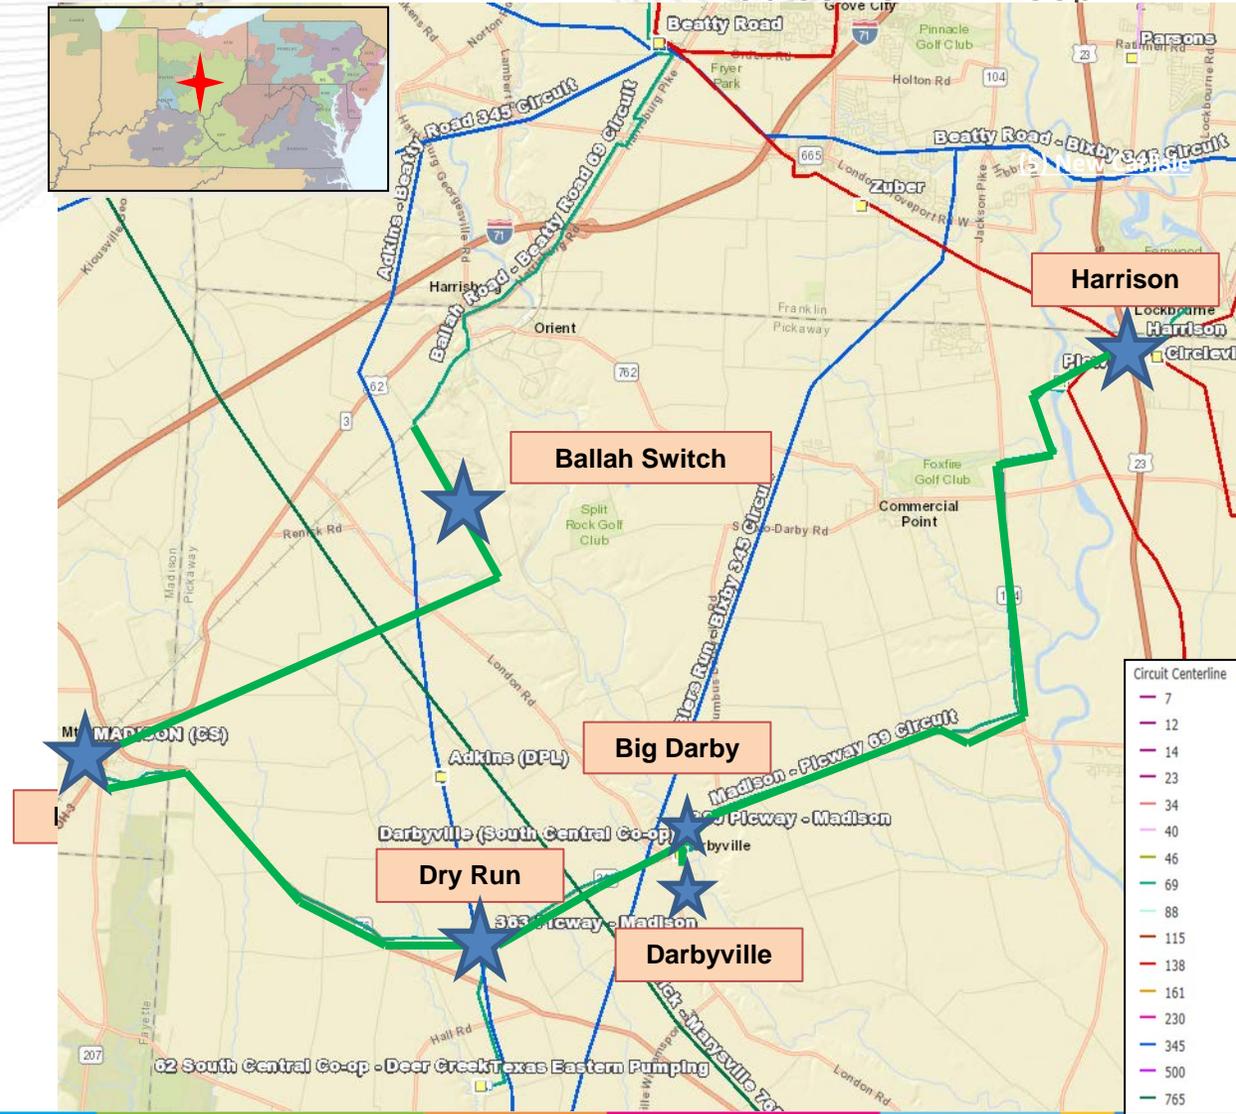
The Harrison-Madison 69kV circuit (made up of Picway-Madison, vintage 1944 & Picway Harrison, vintage 1969) is in very poor condition and in need of rebuild. 15.29 miles of the 24.2 mile line is 73 years old and 16.4 miles of it is comprised of copper conductor (25 MVA rating). There are 248 known conditions as of the last inspection. Due to the radial nature of the line, it cannot be rebuilt without first completing and closing the loop at Madison station in order to avoid extensive customer outages.

The transmission line operations crew receives multiple call outs on this line, and it's construction makes it difficult to repair. There are also co-op customers and a pipeline customer served off this line that are affected when the line is outaged.

Four circuit breakers at Harrison station are showing signs of deterioration. These breakers were installed in the late 1960's and early 1970's and use oil as the interrupting medium. Oil breaker maintenance has become more difficult due to the oil handling required to maintain them. Oil spills are frequent with breaker failures and routine maintenance and can become an environmental hazard. The drivers for replacement of these breakers are age, bushing damage, no repair part availability, amount of fault operations and PCB content. Fault operation counts at Harrison include 13 on 69kV CB 61, 58 on 69kV CB 62, and 23 on 69kV CB 63, which exceed the manufacturer's recommended limit of 10.

Harrison 138/69kV transformer 1 is also showing signs deterioration. Drivers for transformer replacement include age, dielectric strength breakdown (winding insulation), short circuit strength breakdown (due to the amount of through fault events) and accessory damage (bushings).

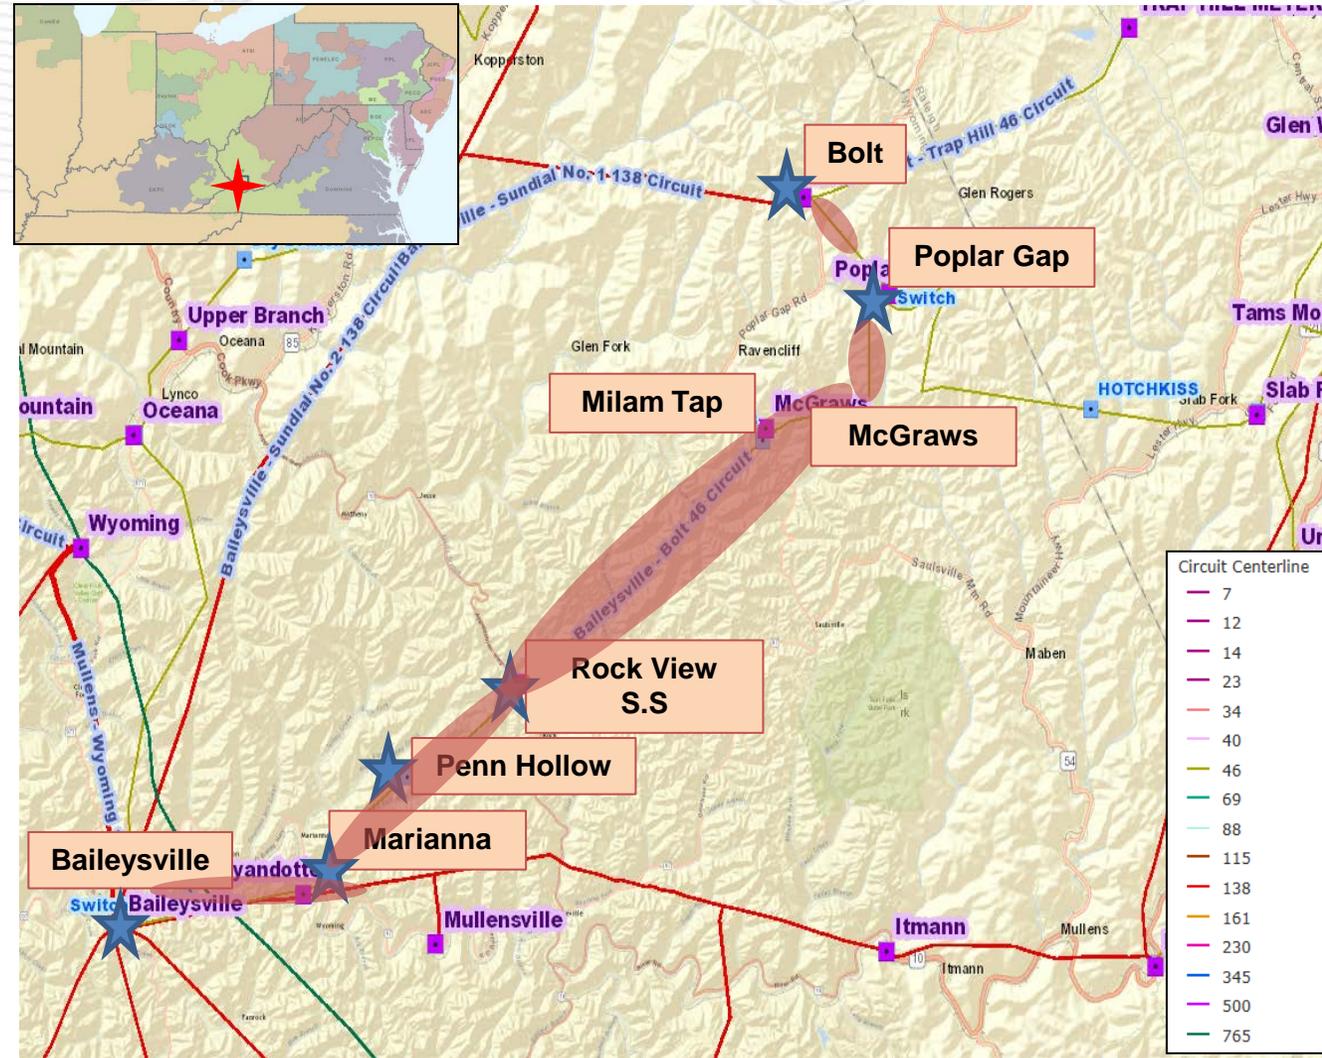
At Baileysville Station, replace 46kV bus/risers and switches on circuit breaker E. (S1497.2) Estimated Cost: \$0.6M

At Marianna Station, replace the existing switches with a 1200A phase-over-phase switch and replace the bus/risers. (S1497.3) Estimated Cost: \$0.0M

At Rock View Station, replace the existing switches with a 1200A phase-over-phase switch. (S1497.4) Estimated Cost: \$0.4M

At Poplar Gap Station, replace the existing switches with a 1200A phase-over-phase switch. (S1497.5) Estimated Cost: \$0.6M

The Baileysville – Bolt 46 kV circuit has experienced 4.5 million customer minutes of interruption from 2013 to 2016. Approximately 16 miles of the 19 mile long circuit utilizes wood pole structures from the 1940s with 3/0 and 4/0 ACSR conductor (29 MVA rating). In addition, this line has a shield wire along only 13% of the structures and lightning strikes are a frequent occurrence. There are currently 39 category A open conditions along the circuit. These open conditions include damaged/rotted poles and cross arms. Our circuit breaker guideline justifies installing a breaker at McGraws Station towards Baileysville Station with a Momentary/Permanent Outage Index (MPOI) calculation of 273, above the 200 threshold.

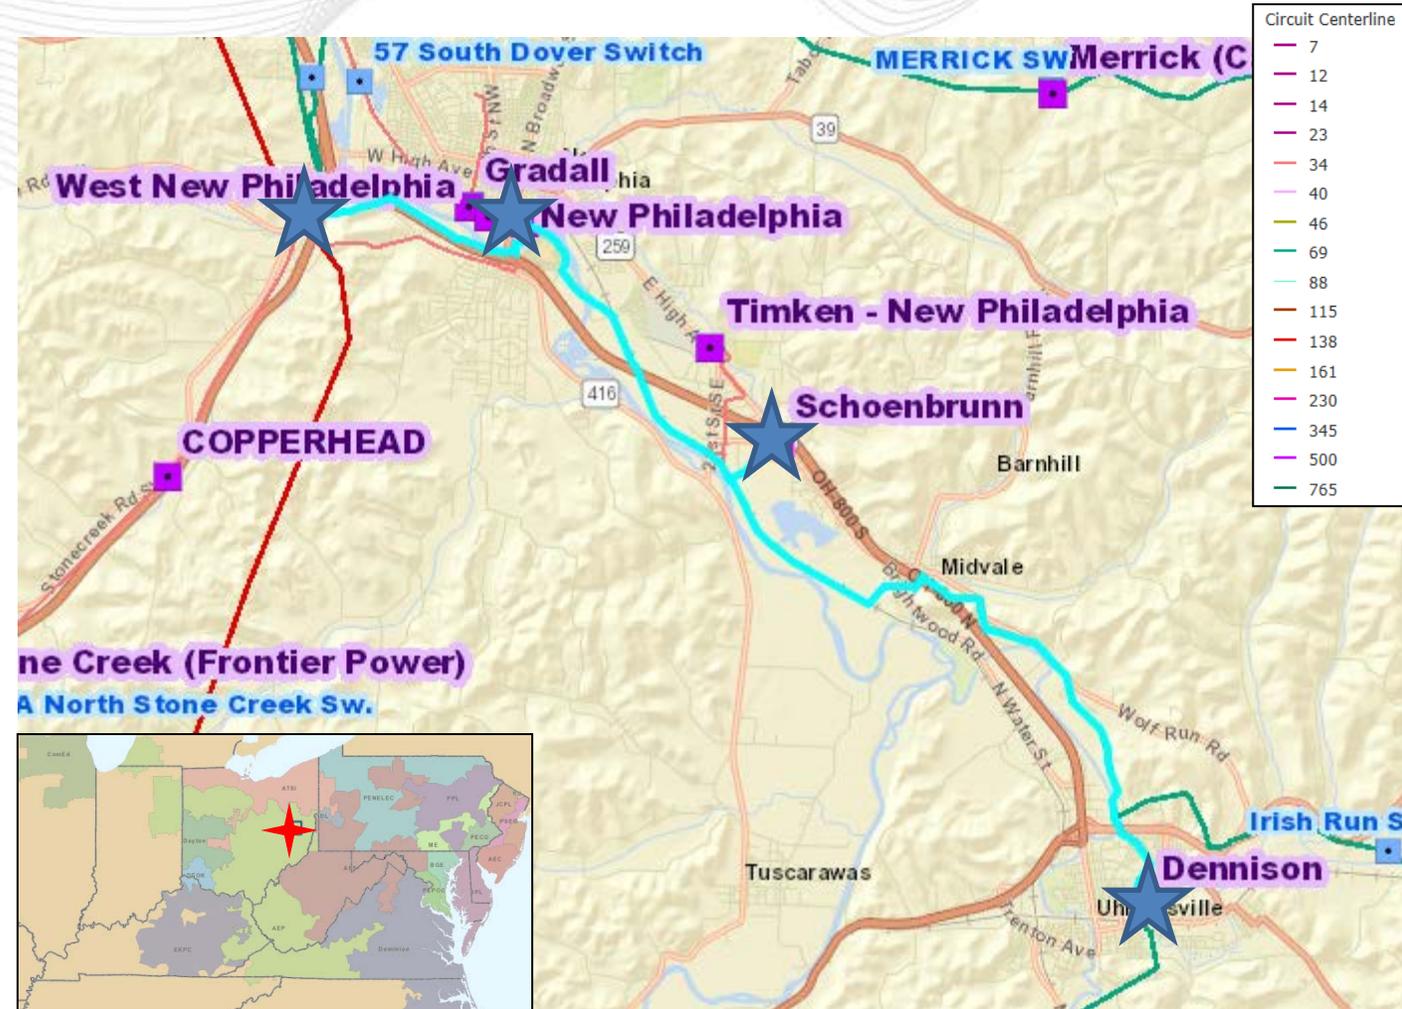
Breaker L at West New Philadelphia station is a McGraw-Edison oil breaker manufactured in 1962. In general, oil breakers have become increasingly difficult to maintain due to the oil handling associated with them. Oil spills occur frequently with failures and while performing routine maintenance, which, is an environmental hazard. Additionally, breaker L has experienced 104 fault operations.

Malfunctioning MOAB flip-flop switching scheme at New Philadelphia has been inoperable since 2012. Lack of SCADA at Schoenbrunn & New Philly limits system operator’s ability. RTU’s will be installed at both stations, to provide real-time power flow data (voltage, currents, MW/MVAR) to system operators.

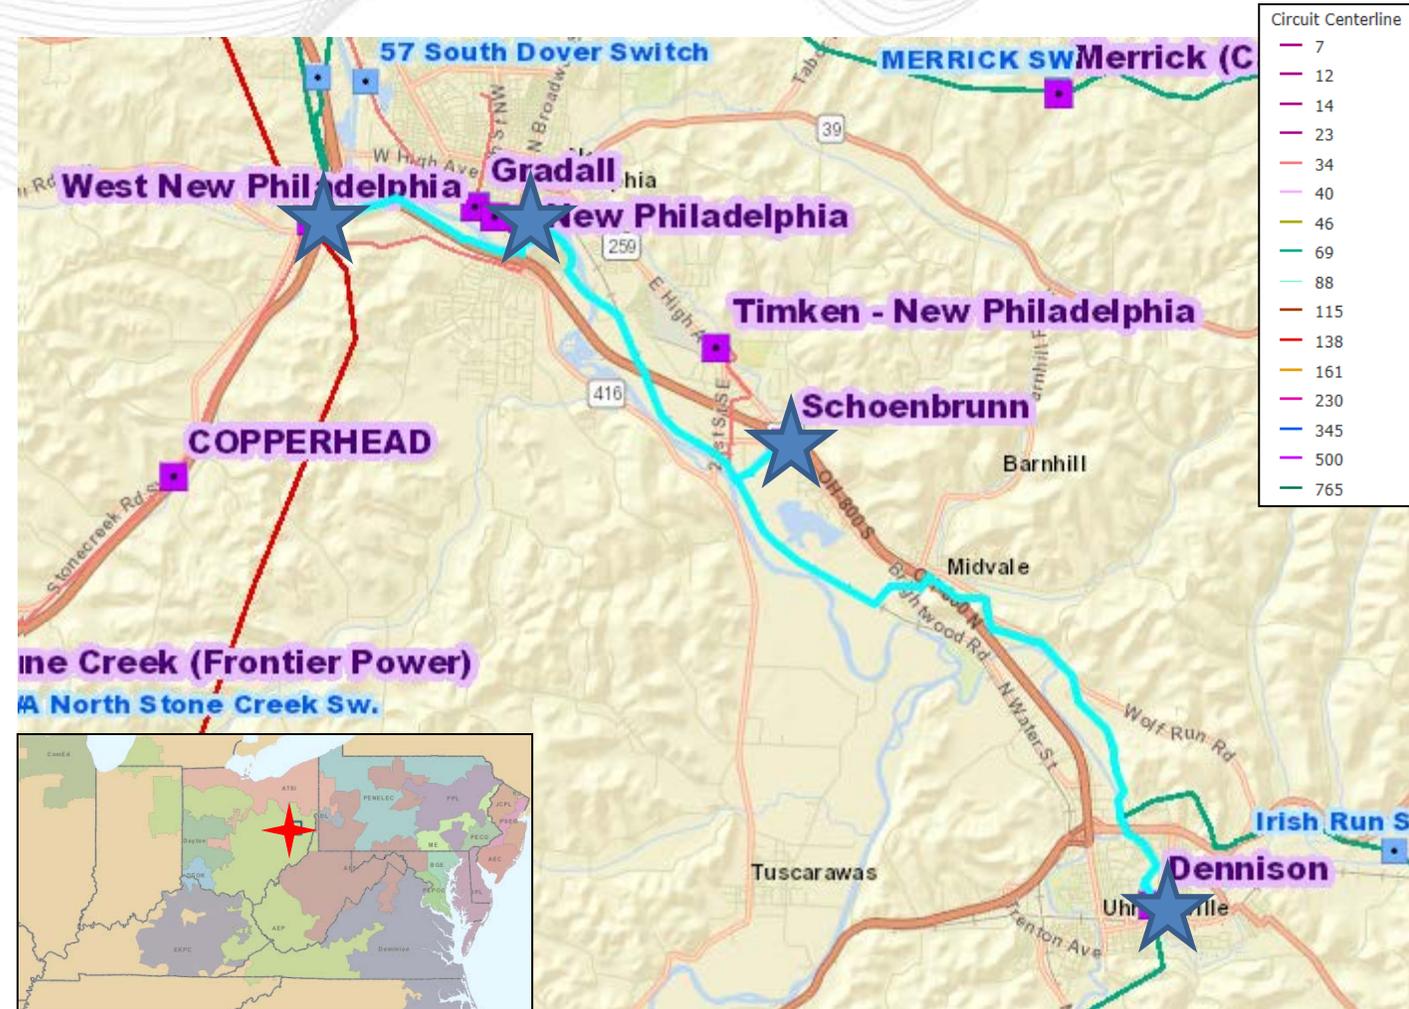
At West New Philly 69kV station, upgrade relaying toward Dennison; replace 69kV circuit breaker 'L' (to Beartown); install a breaker on the low-side of the 138-69kV transformer. **(S1499.2)** Estimated Cost: \$2.6M

At New Philly 69-34kV station, replace inoperable 69kV MOAB flip-flop switching scheme with breakers and relays. Upgrade RTU & expand SCADA functionality. Install a distribution bus-tie breaker. **(S1499.3)** Estimated Cost: \$1.2M

At Schoenbrunn 69-12kV station, replace 69kV MOAB/ground-switch transformer protection with circuit switcher protection scheme. Add RTU & SCADA. Install 69kV bay with 2- circuit breakers. **(S1499.4)** Estimated Cost: \$1.7M

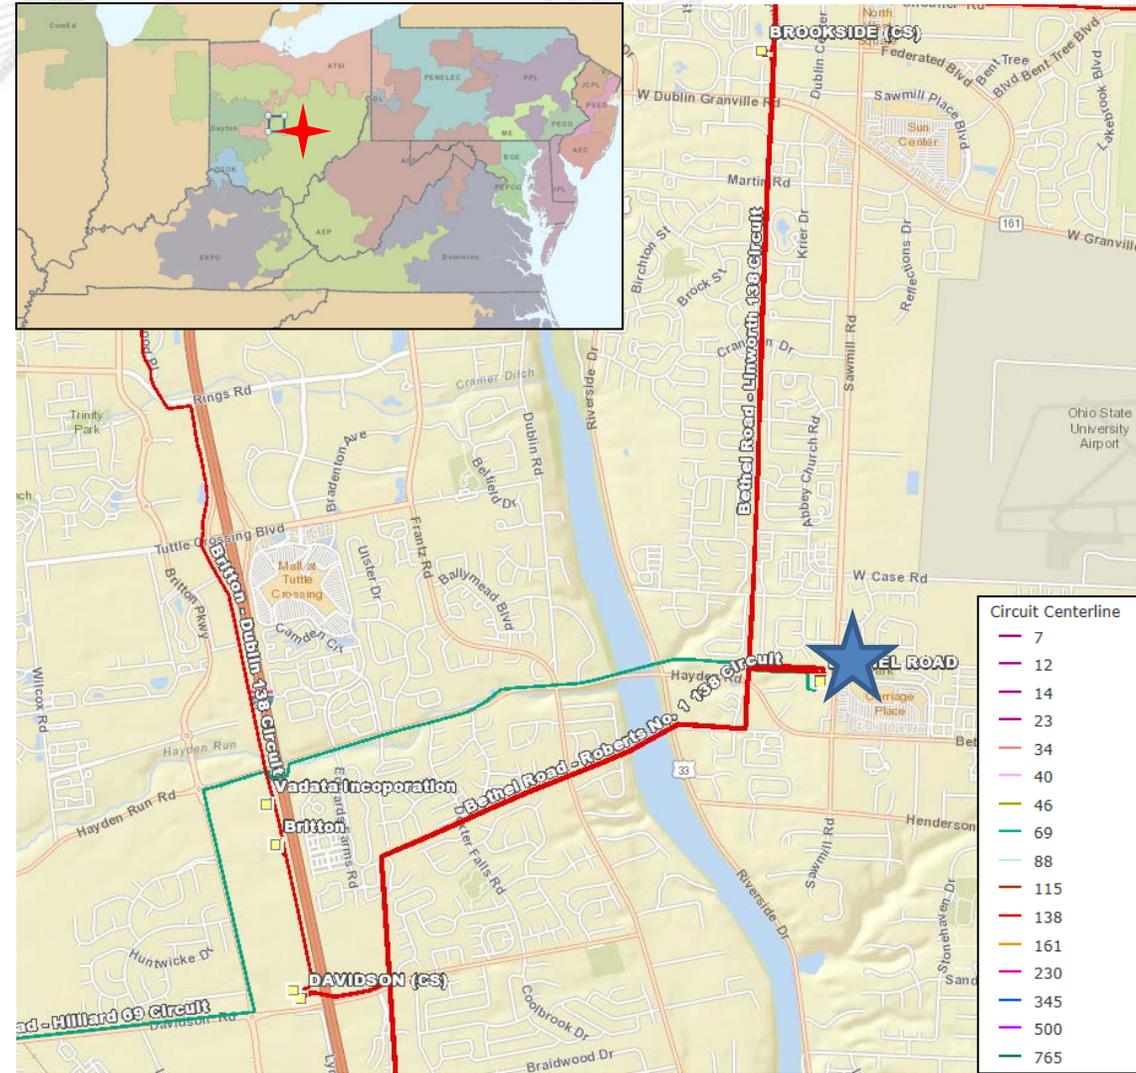
The Distribution transformers #1 & #2 are both large units with load transferability both at the distribution bus and at the distribution circuit level. XF#1 is nearly 40 years old with no automated high side protection and XF#2 only utilizes a MOAB for high side protection. In the existing configuration, failure of either unit will interrupt part of the transmission 138kV through path and failure of both XF's will fragment the 138kV ring bus.

Bethel Road station: Replace 4-138kV 1600A 40kA CB's and associated disconnect switches with equipment rated for 3000A 40kA. Replace various 138kV switches and miscellaneous hardware for rehab needs. Install new DICM with multiple relay packages and remote relaying. Install 450 ft of plastibeton trench, 300ft of conduit, 500 ft of 4/0 copper grounding. Install 3-3ph sets of CCVT's. Install 2-138kV distribution transformer ckt switchers (\$1500)

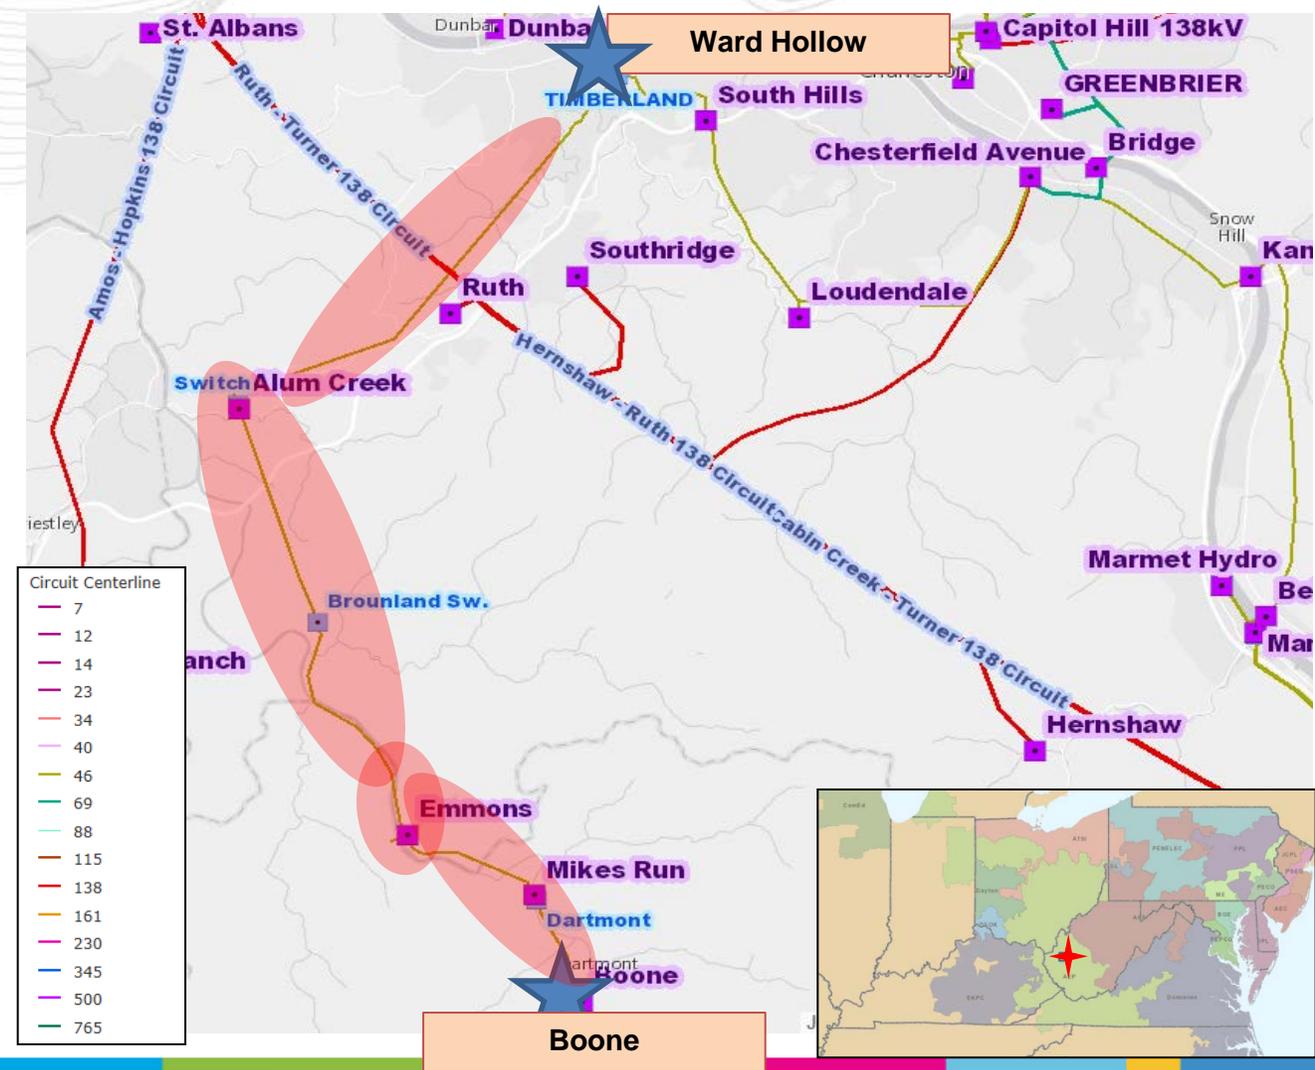
From 2013 – 2016, the Boone – Ward Hollow 46 kV circuit has experienced 8 Permanent and 5 Momentary outages resulting in 393,000 customer minutes of interruption. Over 90% of the structures that make up the approximately 17.5 mile circuit were installed in 1920 with 2/0 Copper conductor (27 MVA rating) and only 21% of the circuit is shielded for lightning protection. These service interruptions are due to a lack of shielding. Additionally, there are 35 current open A conditions consisting of pole, conductor and hardware damage.

Rebuild ~17.5 miles of the Boone – Ward Hollow circuit utilizing 795 26/7 ACSR (86 MVA rating) at 69 kV standards (operated at 46 kV). Switching structures at Mikes Run, Emmons, and Alum Creek will be replaced with a standard 3-way Phase Over Phase Switch. Retire Timberland Switching Station. (\$1501)

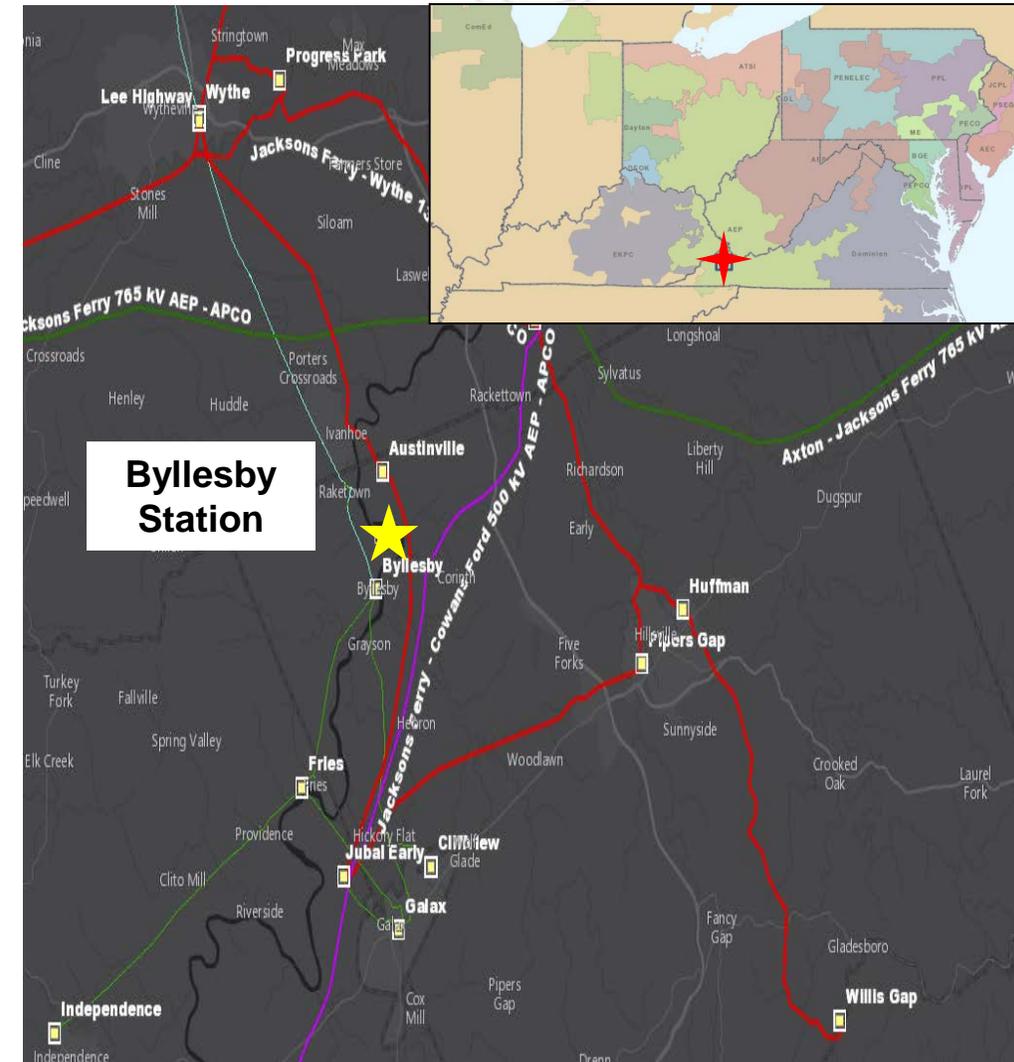
Replace existing Byllesby 69 kV 1200A 17.5kA circuit breaker "B" with 3000 A 40 kA breaker.
 Replace existing 69 kV Byllesby 1200A 21 kA circuit breaker "D" with 3000 A 40 kA breaker.
 (\$1502)
