Sub Regional RTEP Committee Western Region AEP

October 26, 2018

Need Number: AEP-2018-IM002
Process Stage: Needs Meeting 10/26/18
Process Chronology: Needs Meeting 10/26/18
Supplemental Project Driver: Equipment Condition/Performance/Risk
Specific Assumptions Reference: AEP Guidelines for Transmission Owner Identified Needs (AEP Assumptions Slide 8)

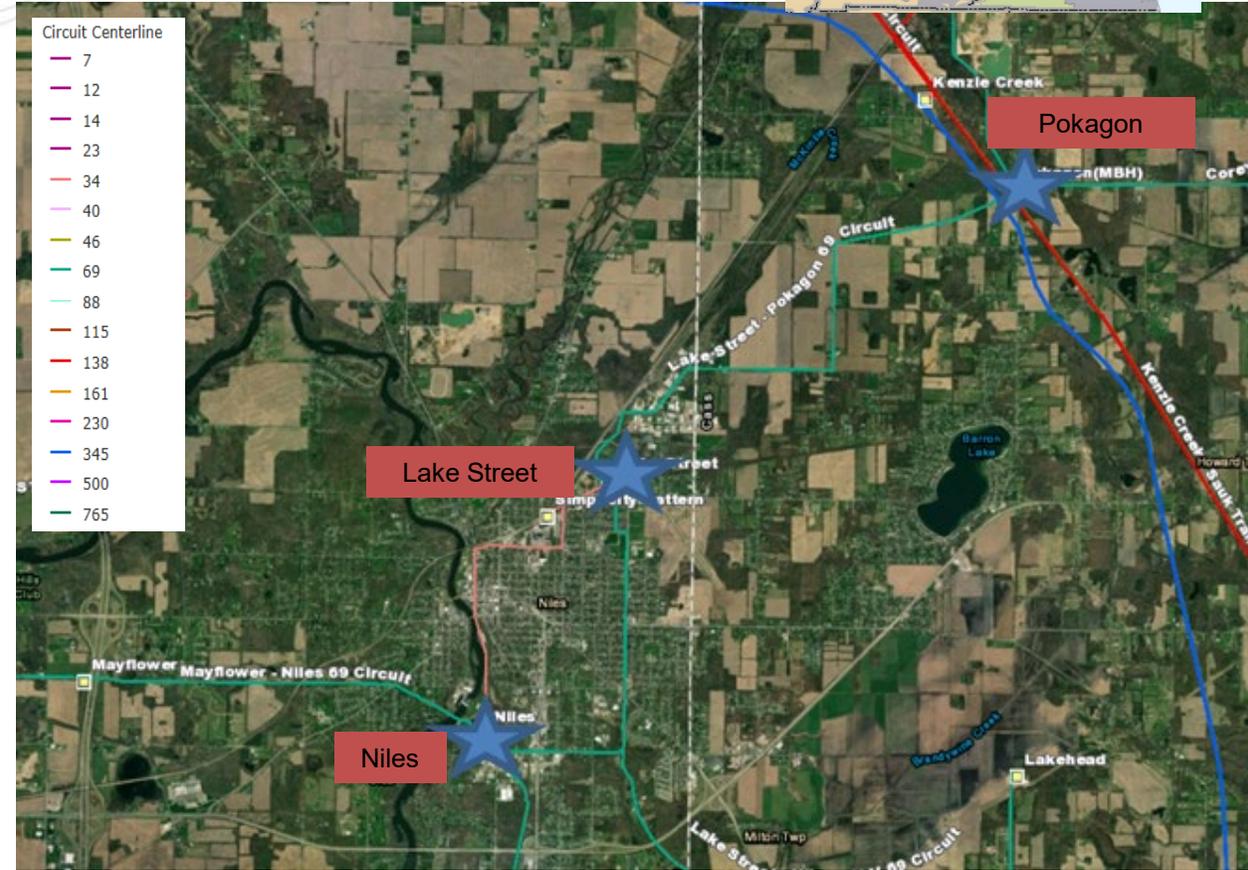
Problem Statement:

The Pokagon Station

- CBs J, E, and H are oil filled breakers without oil containment
- Fault operations: CB E(28), CB H(61) - Recommended (10)

Lake Street Station

- CBs A and H are oil filled breakers without oil containment
- CB H is a GE FK type which are known to fail violently
- Fault operations: CB A(24), CB H(13) – Recommended (10)
- Transformer 1 – 1969 vintage
 - CO2 IEEE level 3
 - Moisture level high and rising
 - Wood tie supports

Niles Station

- CBs A, B, M, and N are oil filled breakers without oil containment
- CB M and CB N are GE FK type which are known to fail violently
- Fault operations: CB A(30), CB B(42), CB N(21) – Recommended (10)
- Transformer 2 – 1969 vintage
 - CO2 IEEE level 3
 - Moisture level high and rising
 - Wood tie supports

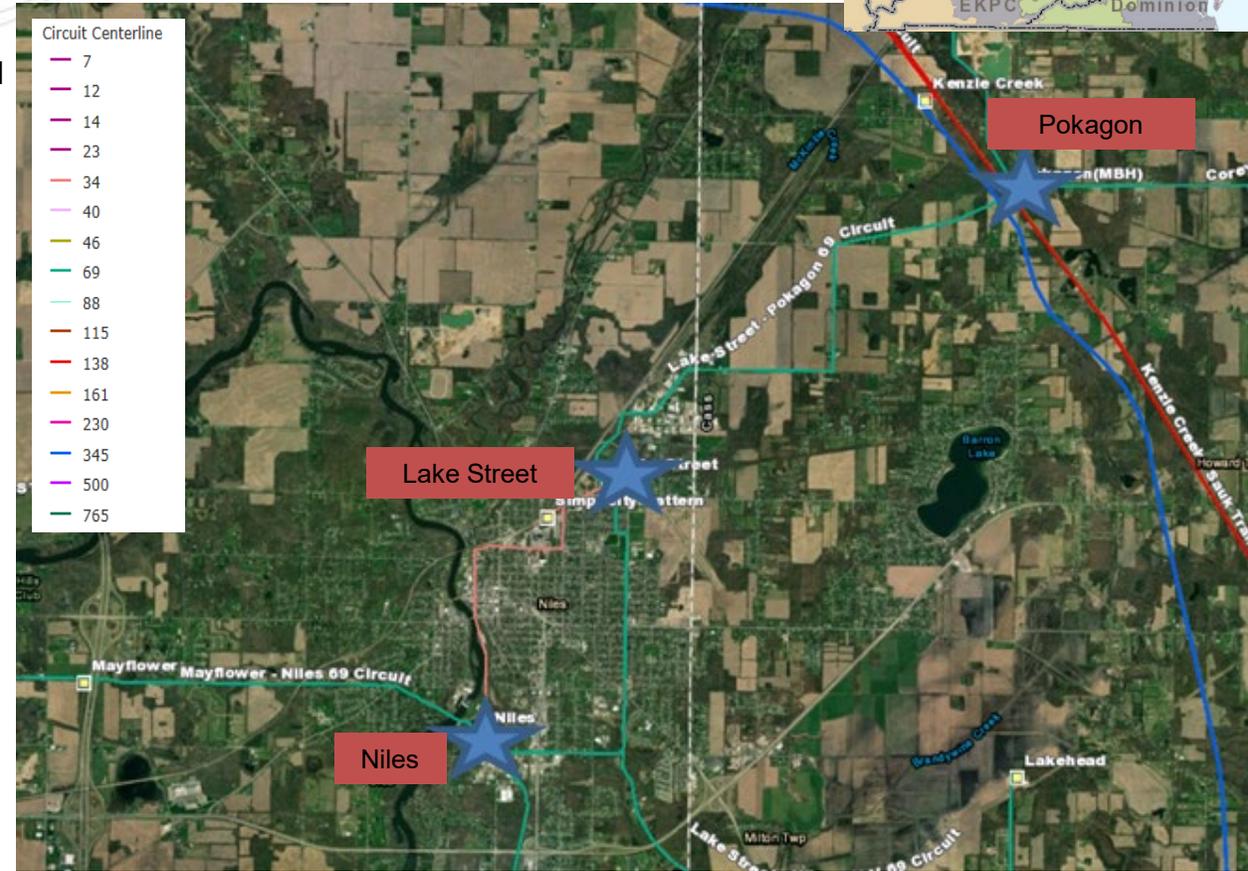
Lake Street – Niles 69kV circuit

- 1960's wood cross arm construction
- Poor shielding condition
- Lakehead Pumping Tap has open conditions on 30% of structures
- Total open conditions – 54

Lake Street – Niles 34.5kV circuit

- 1965 wood pole construction
- Total open conditions – 51
- 40% of structures with open conditions
- 97% of line original wood poles
- Wooden cross arm with cap and pin insulator construction
- No shield wire

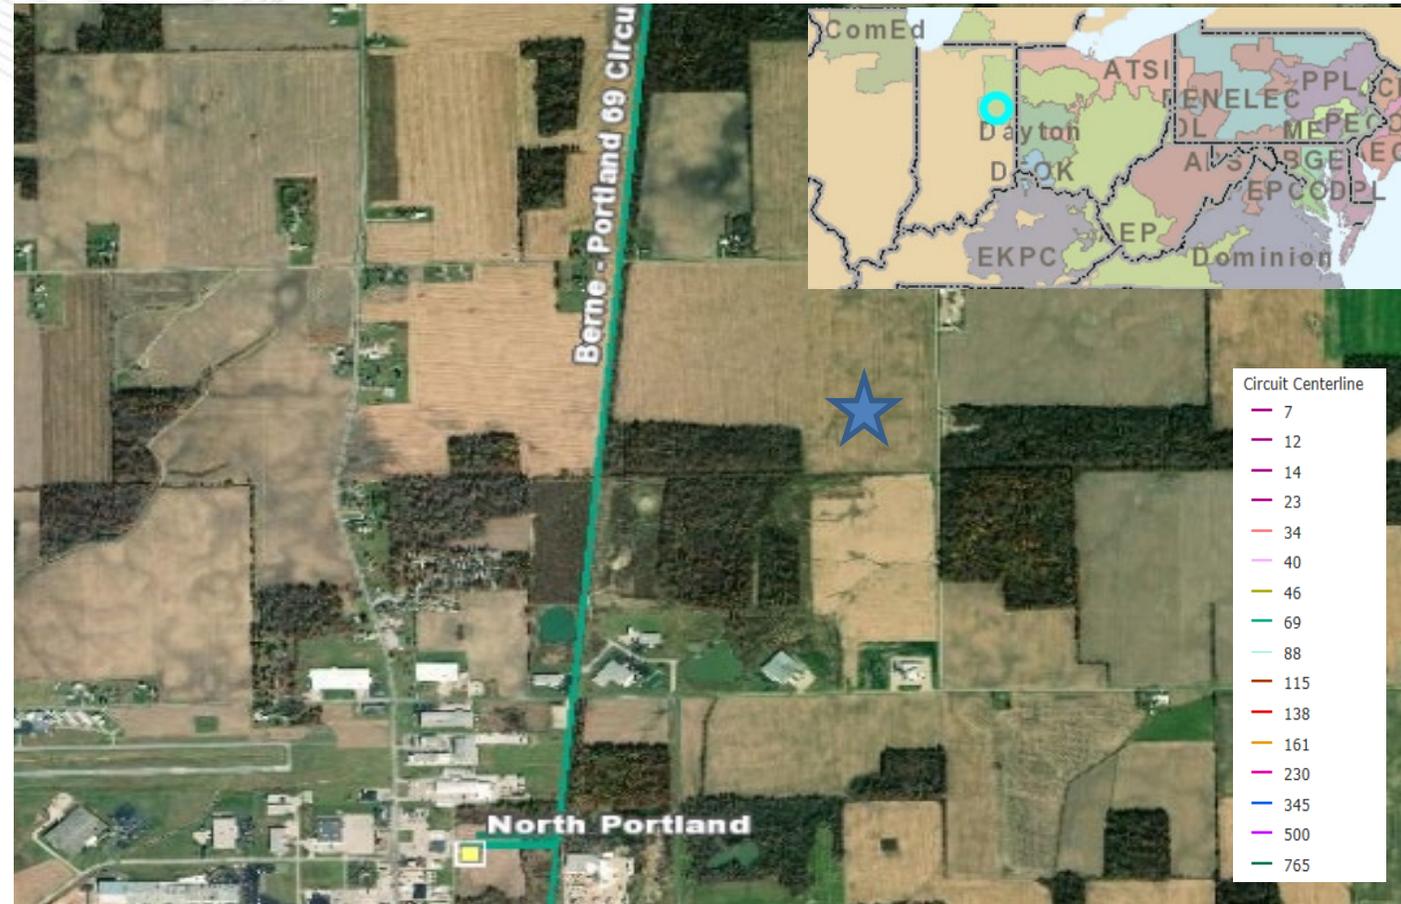
A customer has requested connection of a 2.3MVA load off of the Berne – Portland 69kV line.

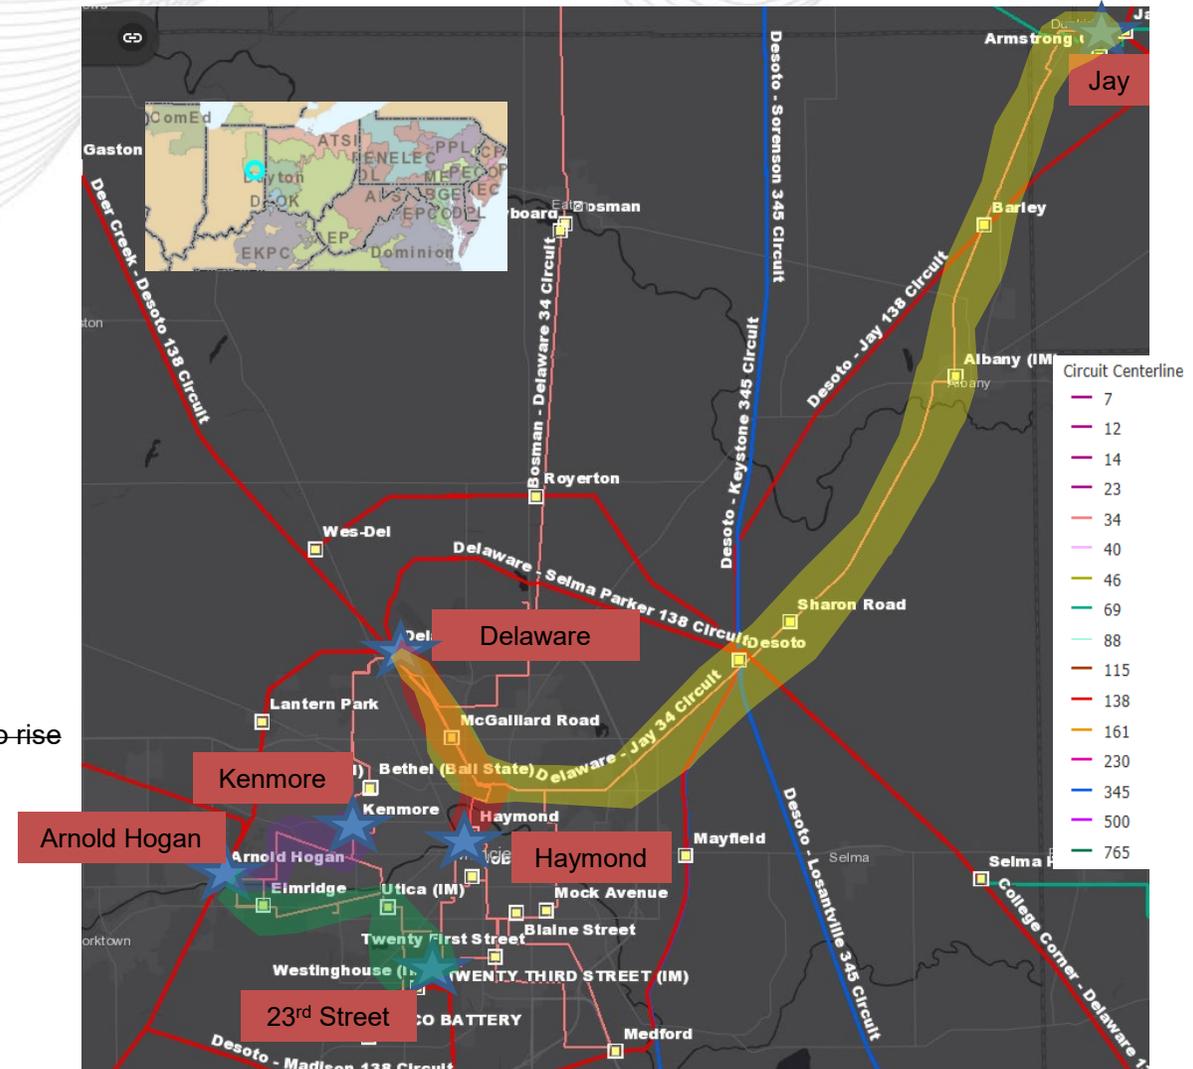
- 1963 wood crossarm construction
- 3/0 copper and 4/0 ACSR
- Subject to 20 open A conditions
- Subject to 26 open B conditions
- In the past 10 years, 47 structures have had active maintenance performed. This is expected to increase as line ages.

- 1948 wood 5-circuit construction
- 3/0 Copper
- 22 open A conditions
- 13 open B conditions

- 1920's Vintage wood crossarm construction
- 1/0 Copper conductor
- 100 structures had to undergo active maintenance in the last 10 years and this trend is expected to rise as the line ages.
- 55 open A conditions
- 33 open B conditions
- 556,661 CMI

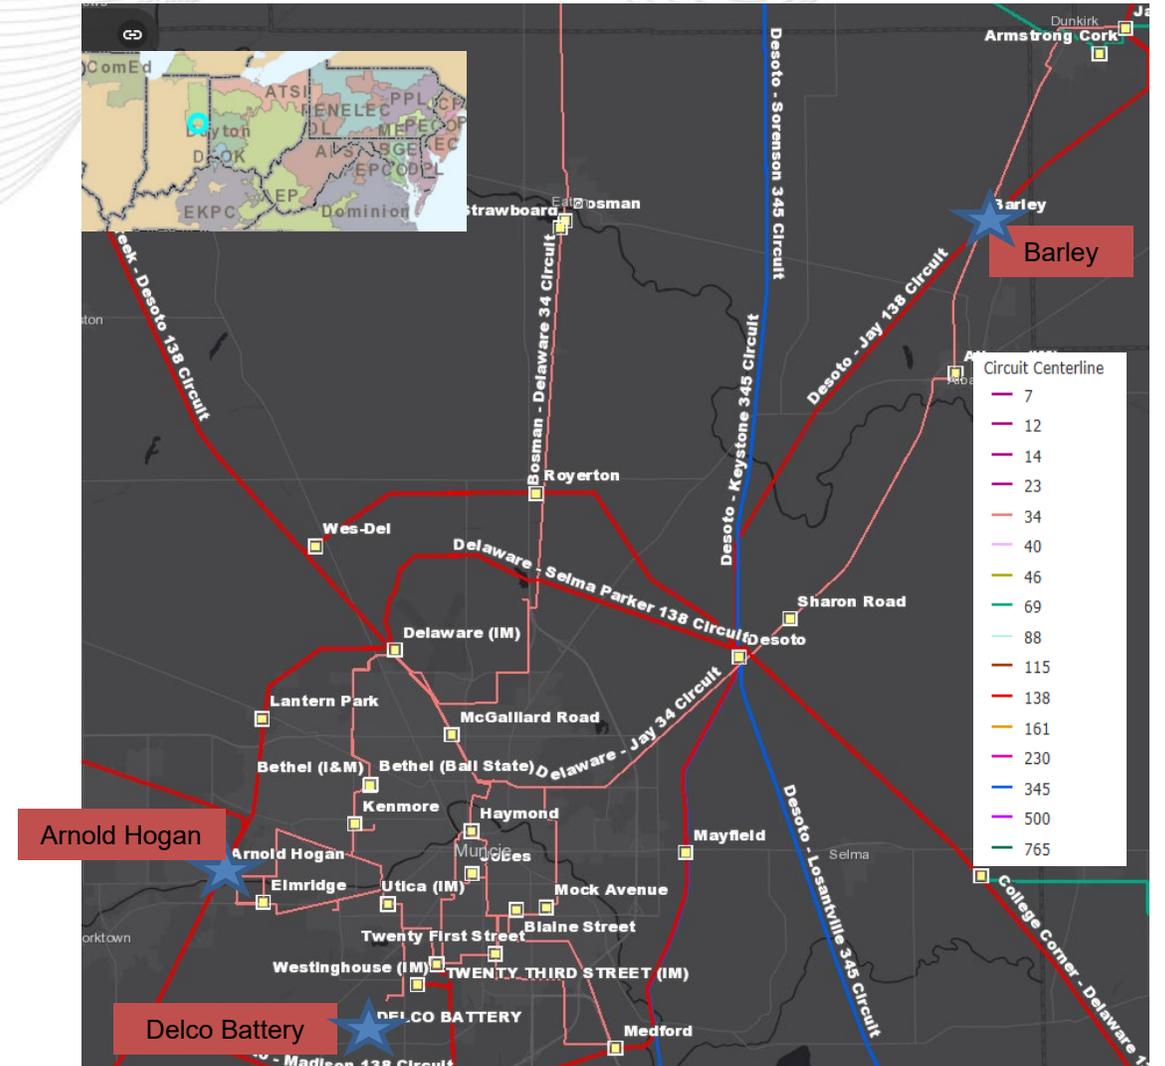
- AEP Distribution has requested a new delivery point off of the 138kV line near Barley station.

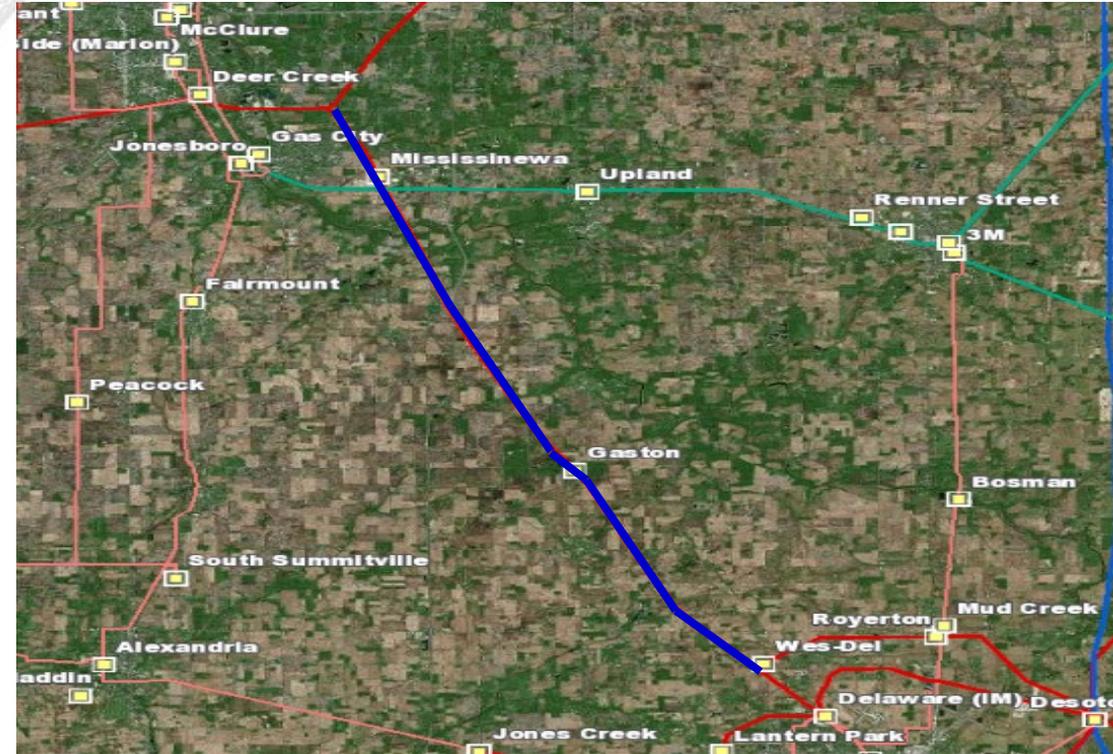
Portions of Deer Creek – Delaware

- 1920's vintage steel lattice line.
- 397.5 ACSR Double Circuit
- 439 open structure and conductor category A and B conditions

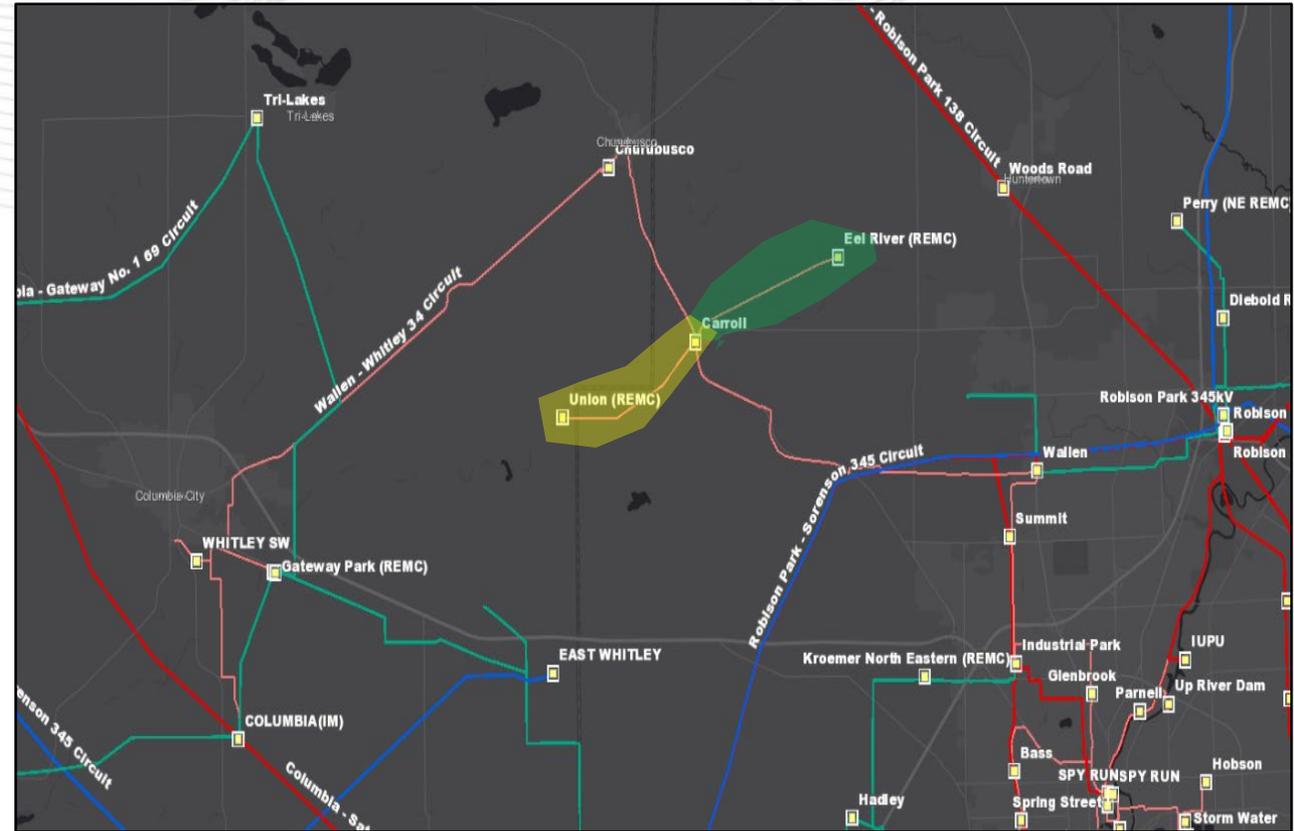
Currently, two delivery points to Northeastern REMC (Eel River and Union Stations) are served radially out of Carroll Station by two separate 4 mile 34.5 kV radial lines, leaving each delivery point susceptible to single event outages.

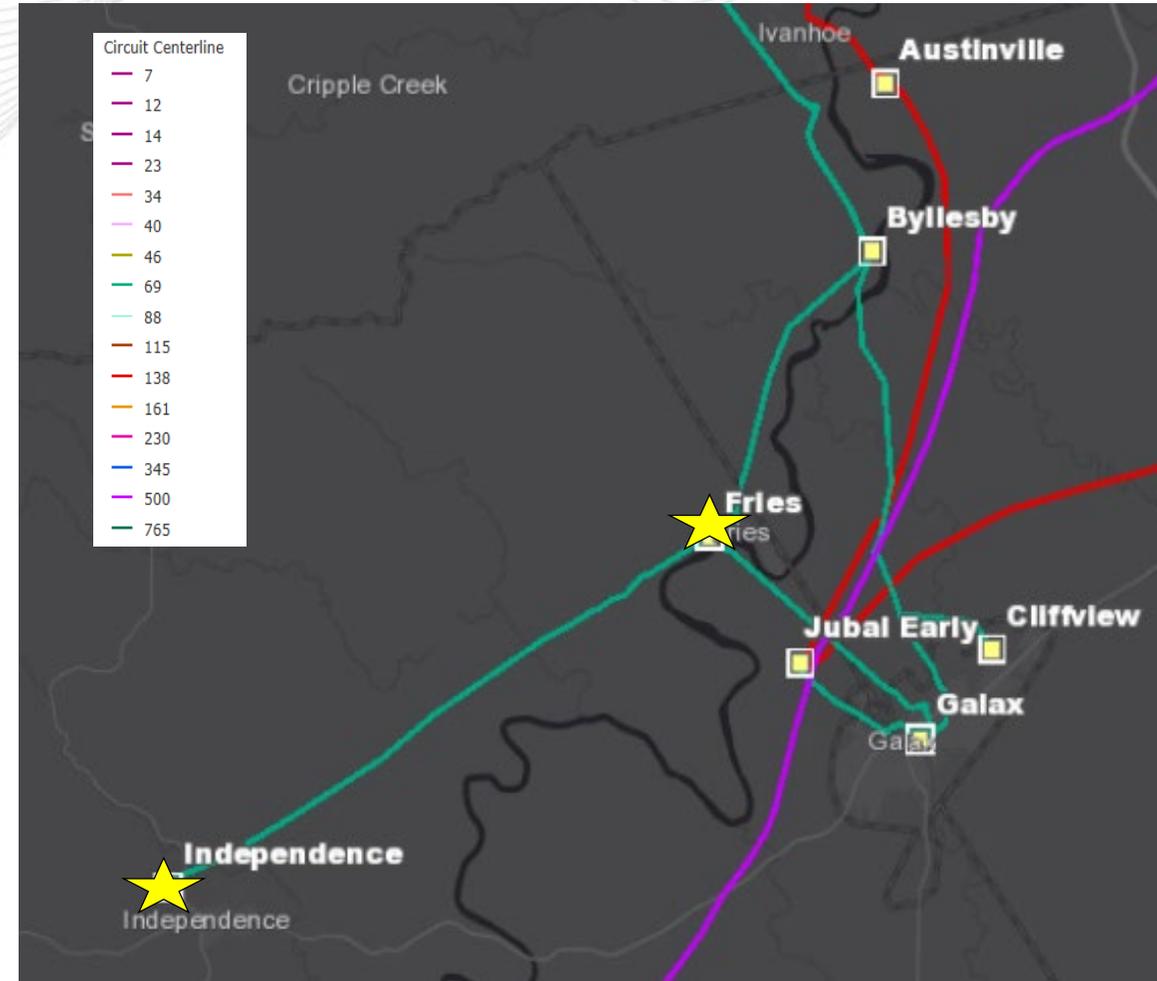
The Fries – Independence 69kV line is an 11 mile long radial line and maintenance cannot be performed due to a lack of outages available on the line. Approximately 20 MVA is served out of Independence during winter peak conditions and is dropped for outages on this circuit. From 2013-2018, the Fries – Independence 69 kV circuit has experienced 5 permanent outages and 4 momentary outages, resulting in approximately 5.7M customer minutes interrupted. Fries – Independence 69 kV line has 23 open conditions associated with the structures that make up the line. Conditions include woodpecker damage and rot top. Majority of the circuit utilizes 1950s wood structures

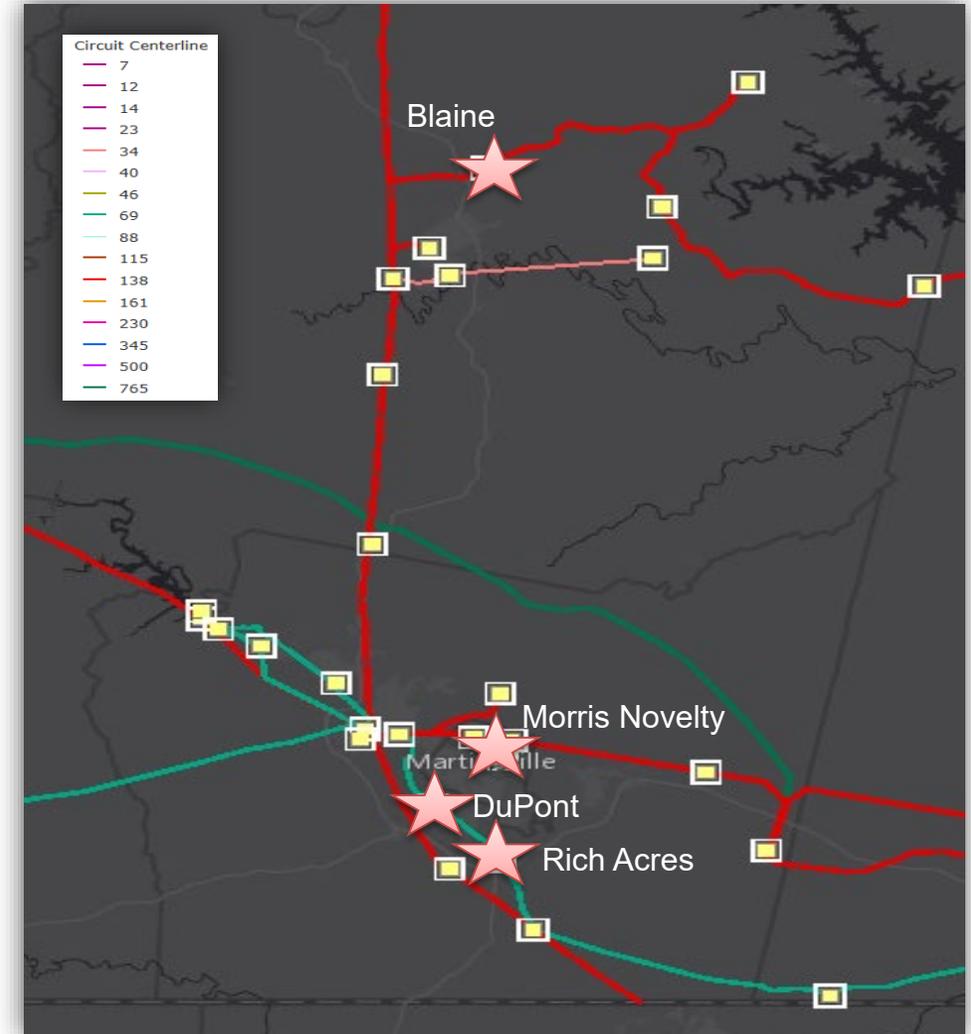
DuPont Station: 69 kV circuit breakers 'A' (8 operations), 'B' (38 operations) and 'C' (14 operations) are GE 'FK' oil-filled breakers which have little to no replacement parts and were installed in 1960, 1959 and 1968 respectively. In general, oil breakers have become increasingly difficult to maintain due to the associated oil handling. Oil spills are frequent with failures and routine maintenance, which is an environmental hazard.

Morris Novelty: 34 kV circuit breaker 'E' and 'F' are GE 'FK' oil-filled breakers which have little to no replacement parts. In general, oil breakers have become increasingly difficult to maintain due to the oil handling associated with them. Oil spills are frequent with failures and routine maintenance which is also an environmental hazard.

Rich Acres: Because of pilot wire retirement on this line, a new circuit switcher on transformer #1 will be needed to coordinate with new line relays on the Fieldale – Ridgeway 69 kV line.

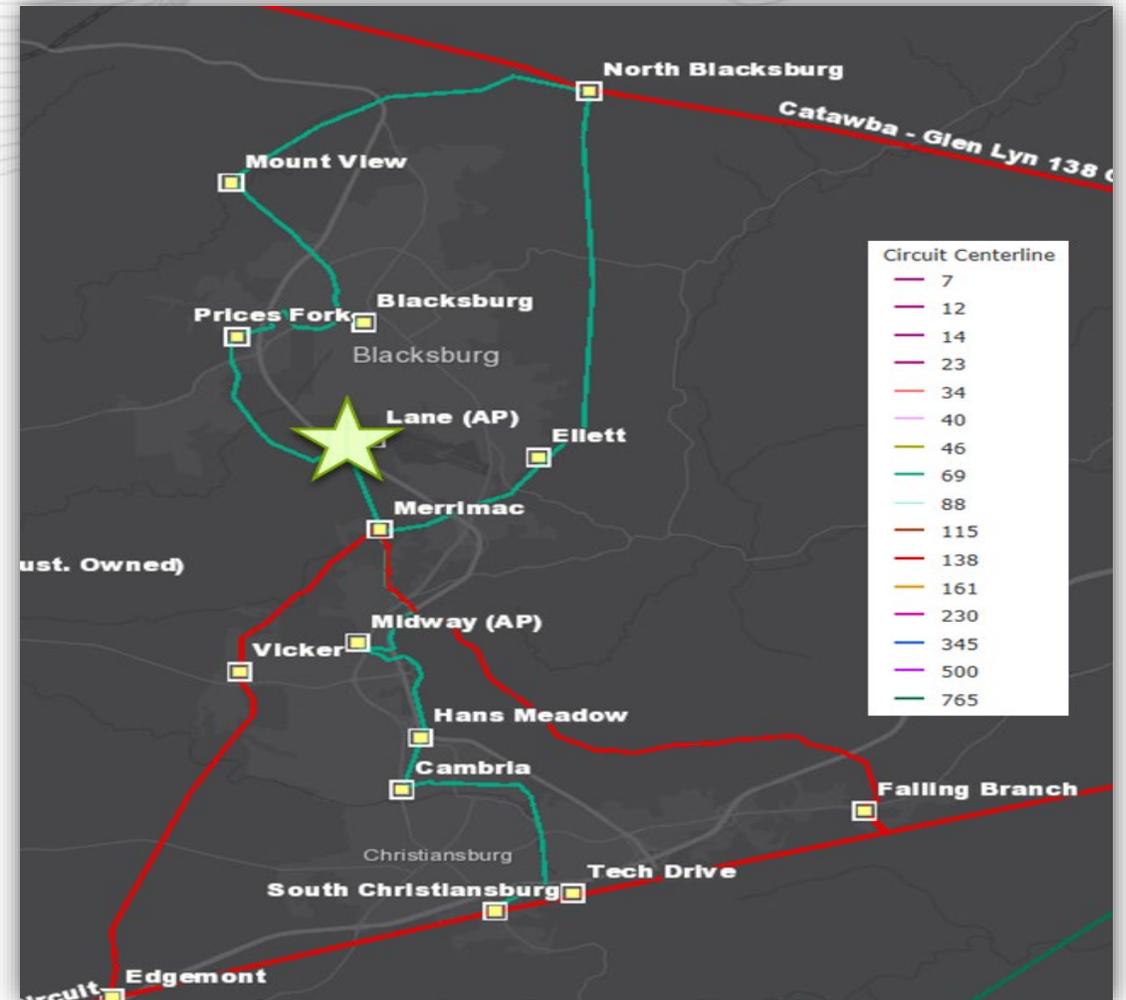
Customer Service:
 Virginia Tech Electric Service (VTES) requested a new 69 kV delivery point from AEP's Lane substation located in Blacksburg, VA to serve 5 MW of new load.

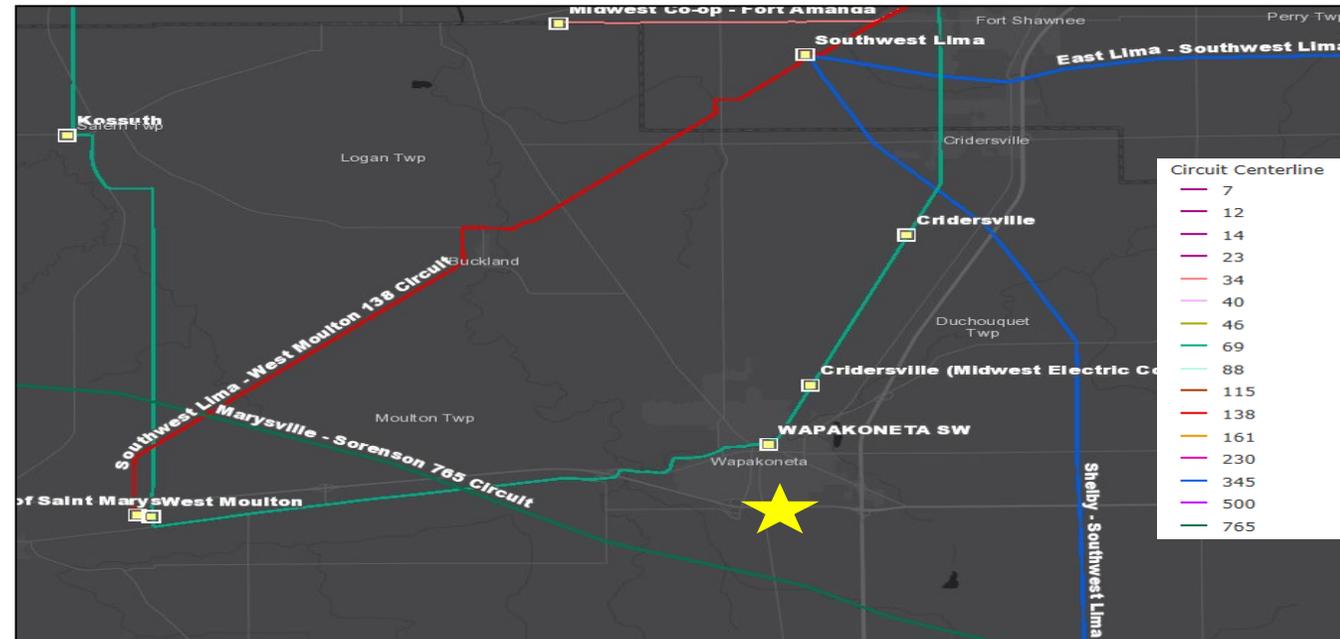
Obligation to serve a new 80 MW customer load request near the City of Wapakoneta. Two additional customers have inquired about service in this area totaling 48 MW.

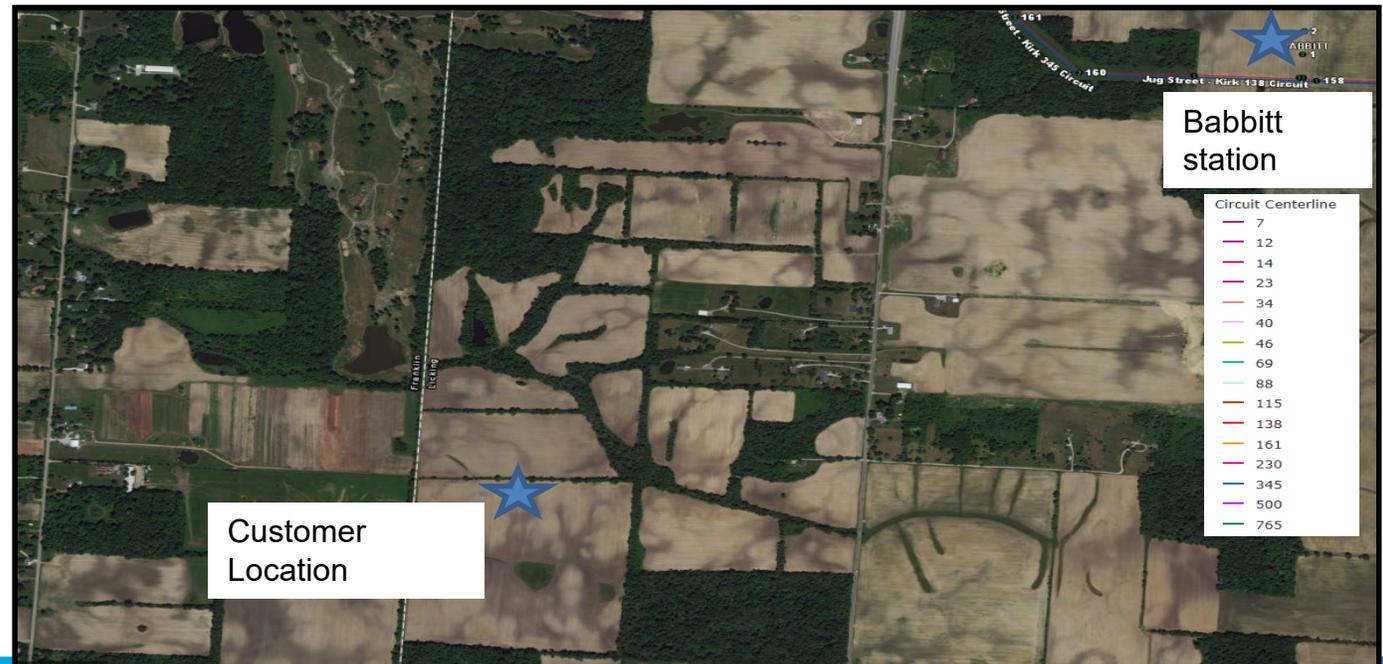
A new customer has signed an agreement requesting service for 150 MW load by 2/15/2020.

- Customer is located approx. 1.5 miles southwest of AEP's Babbitt station.
- Customer indicates their load could grow to 720 MW in the next 5-10 years.

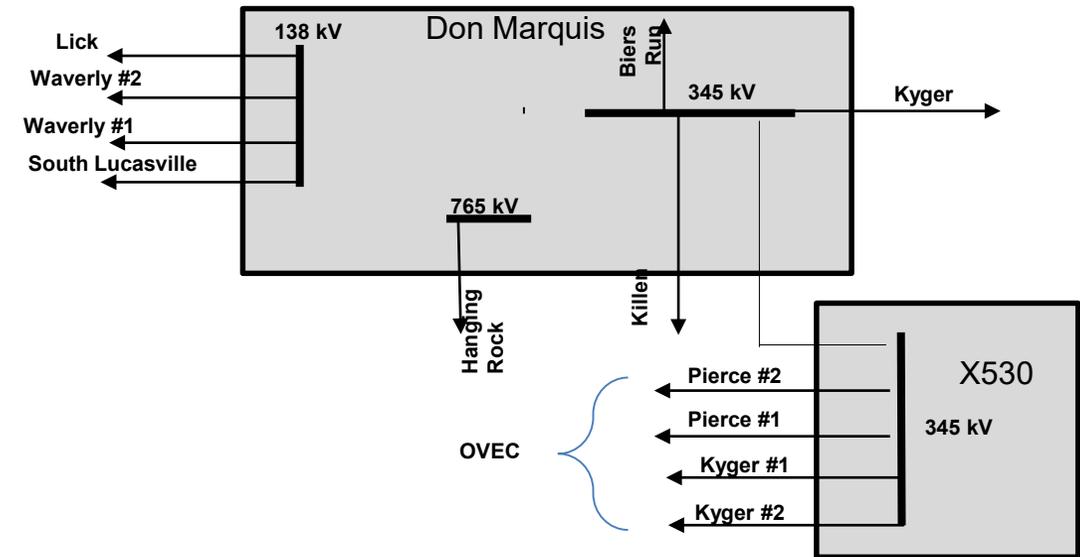
The US Department of Energy has informed AEP of its intention to retire its existing X-530 345 kV Station, adjacent to AEP's Don Marquis Substation. The DOE has requested a new 138 kV delivery point at the same location.

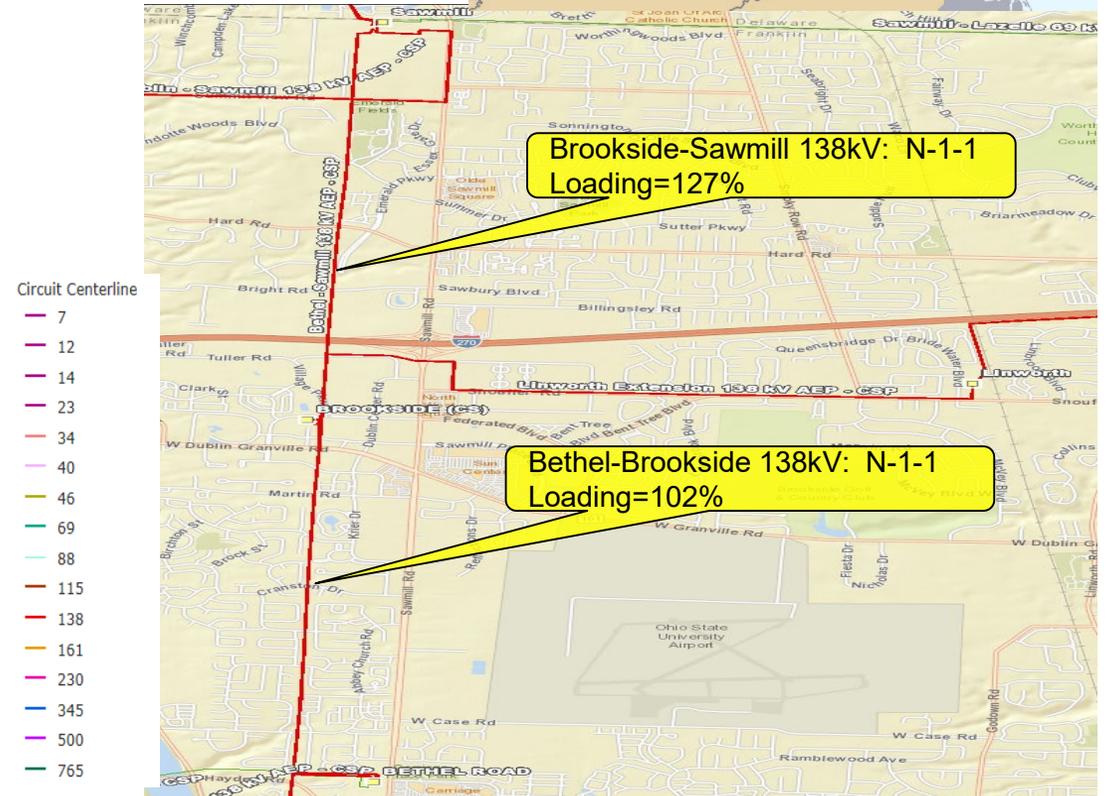
AEP has received requests for increased demand in the Dublin, Ohio area. Analysis shows Bethel – Sawmill 138 kV will be a constraint. Consequent inspection identified clearance violations along the Bethel – Sawmill 138 kV line. AEP has de-rated the thermal capacity of the line to mitigate potential safety issues.

AEP believes that the loading issues exist today due to the recent 30% de-rate of the line. Newly connected customer loads are scheduled to ramp up, significantly contributing to area thermal concerns.

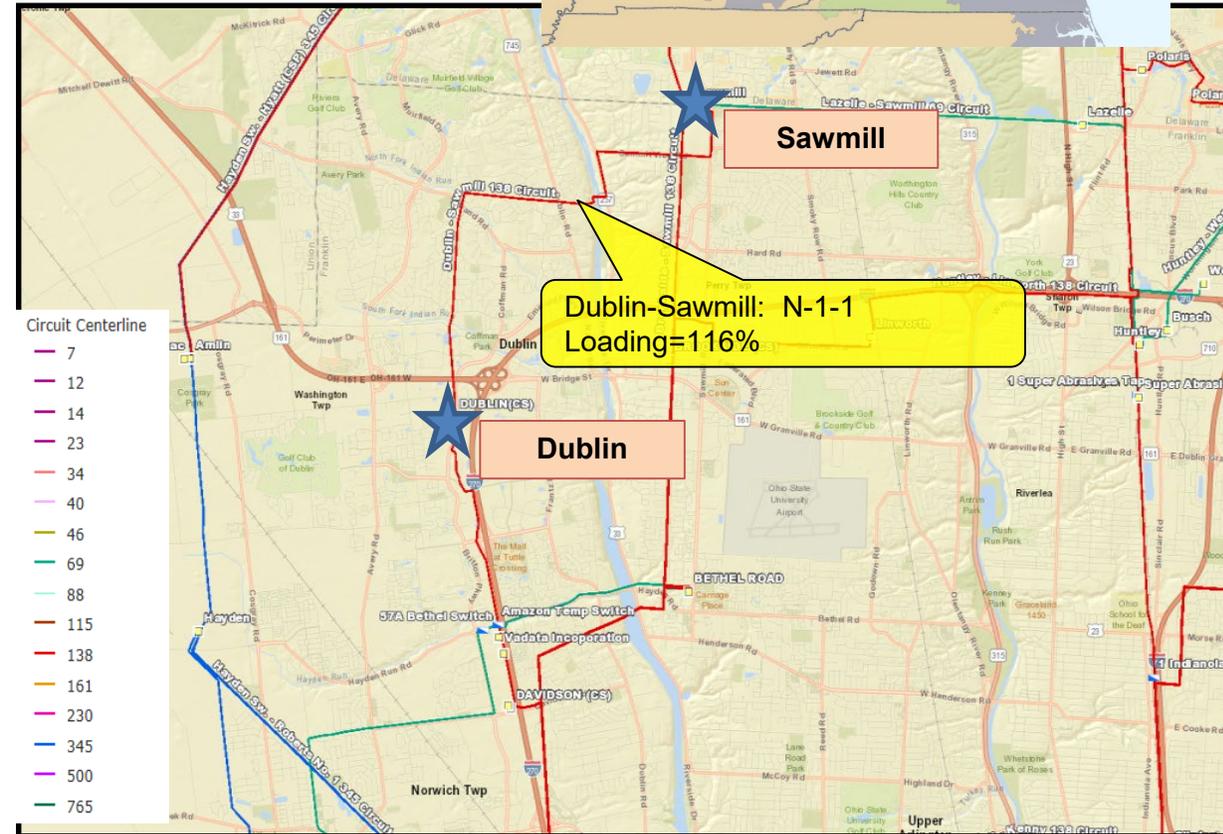
- The Dublin-Sawmill 138kV circuit will experience loading of 116% under N-1-1 conditions involving the loss of Bethel-Davidson 138kV & Davidson-Roberts 138kV circuits. With load growth in the area, we anticipate this line to overload starting in 2022.
- AEP-Ohio has requested a third 138kV source to Dublin station to maintain acceptable reliability levels for the load at risk.
- Dublin Station serves 75 MVA of peak demand with minimal load transfer capability. Dublin station serves some critical loads.
- Newly connected customer loads are scheduled to ramp, significantly contributing to area thermal concerns.

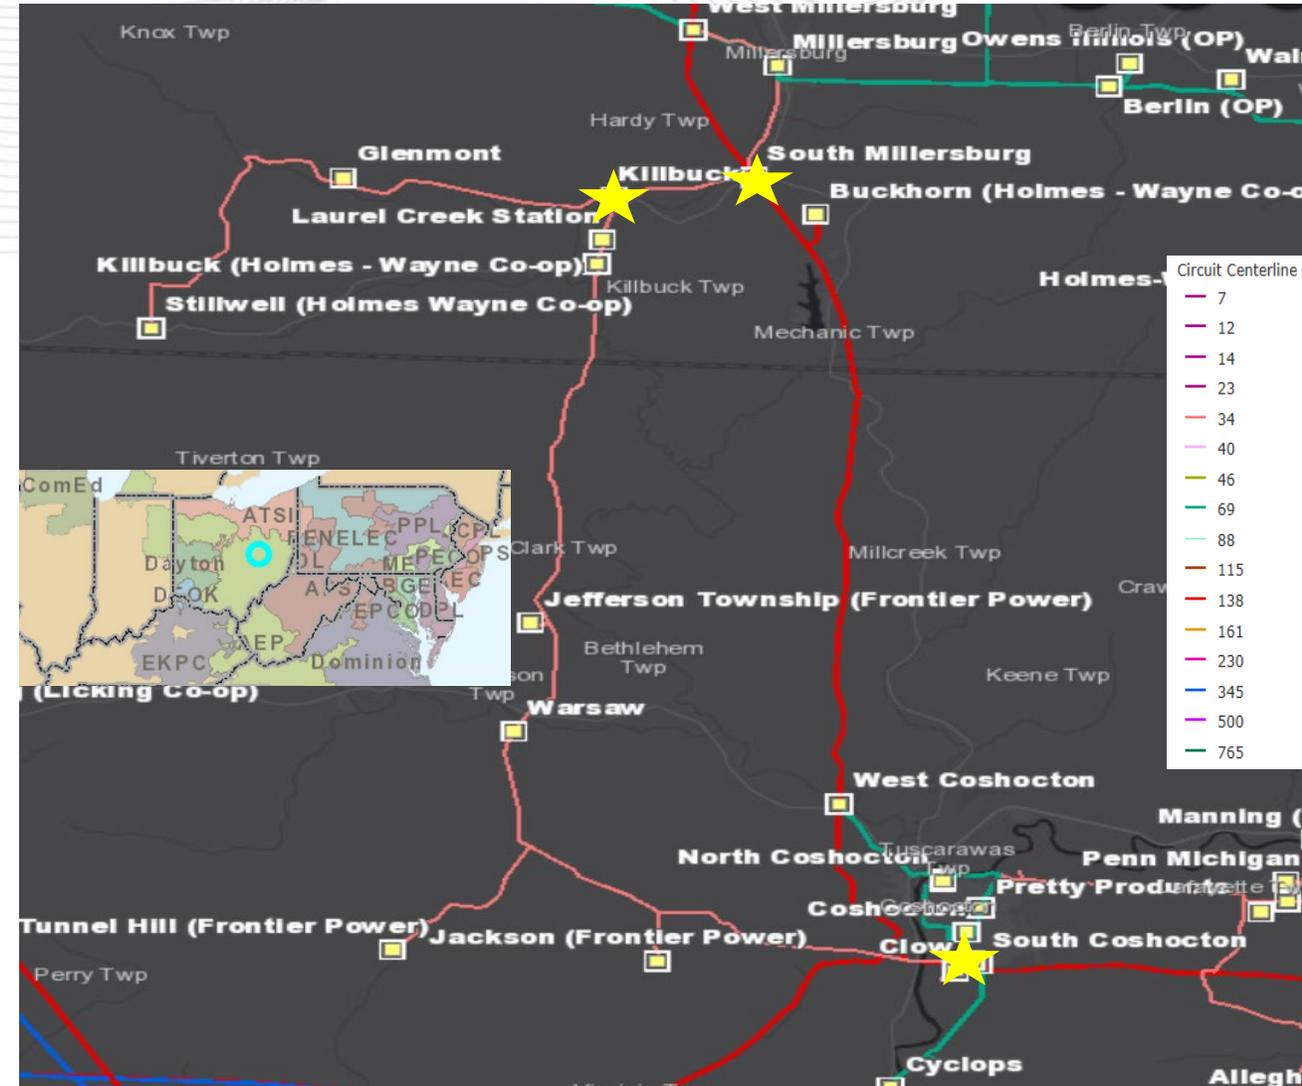
The Killbuck – South Coshocton 34 kV line (30.18 mi) was constructed in 1926 using wood pole structures and conductor ranging from 3/0 Copper (23 MVA rating) to 336.4 ACSR (37 MVA rating). There are 144 open A conditions on this line, including rotten cross-arms, burnt/broken insulators, and loose/broken conductor hardware. The Killbuck – South Coshocton 34 kV line has experienced over 1 million CMI over the past three years.

The Killbuck – South Millersburg 34 kV (2.59 mi) line was constructed in the 1920's using wood pole structures with 336.4 ACSR (36 MVA rating). There are 53 open A conditions on this line, including rotten cross-arms, burnt/broken insulators, and loose/broken conductor hardware. The Killbuck – South Millersburg 34 kV line has experienced over 1 million CMI over the past three years.

At South Coshocton 69 kV circuit breaker 'K' (fault ops 18), 34.5 kV circuit breakers 'A' (fault ops 3), 'B' (fault ops 7), 'C' (fault ops 72), 'D' (fault ops 0), 'E' (fault ops 0), and 'G' (fault ops 2) are 'FK' oil-filled breaker (vintage 1946 -1973). These oil type breakers have extensive maintenance and oil handling requirements. There is a potential for oil spills during fault operations and maintenance. The FK model is no longer supported by the manufacturer making spare part availability scarce.

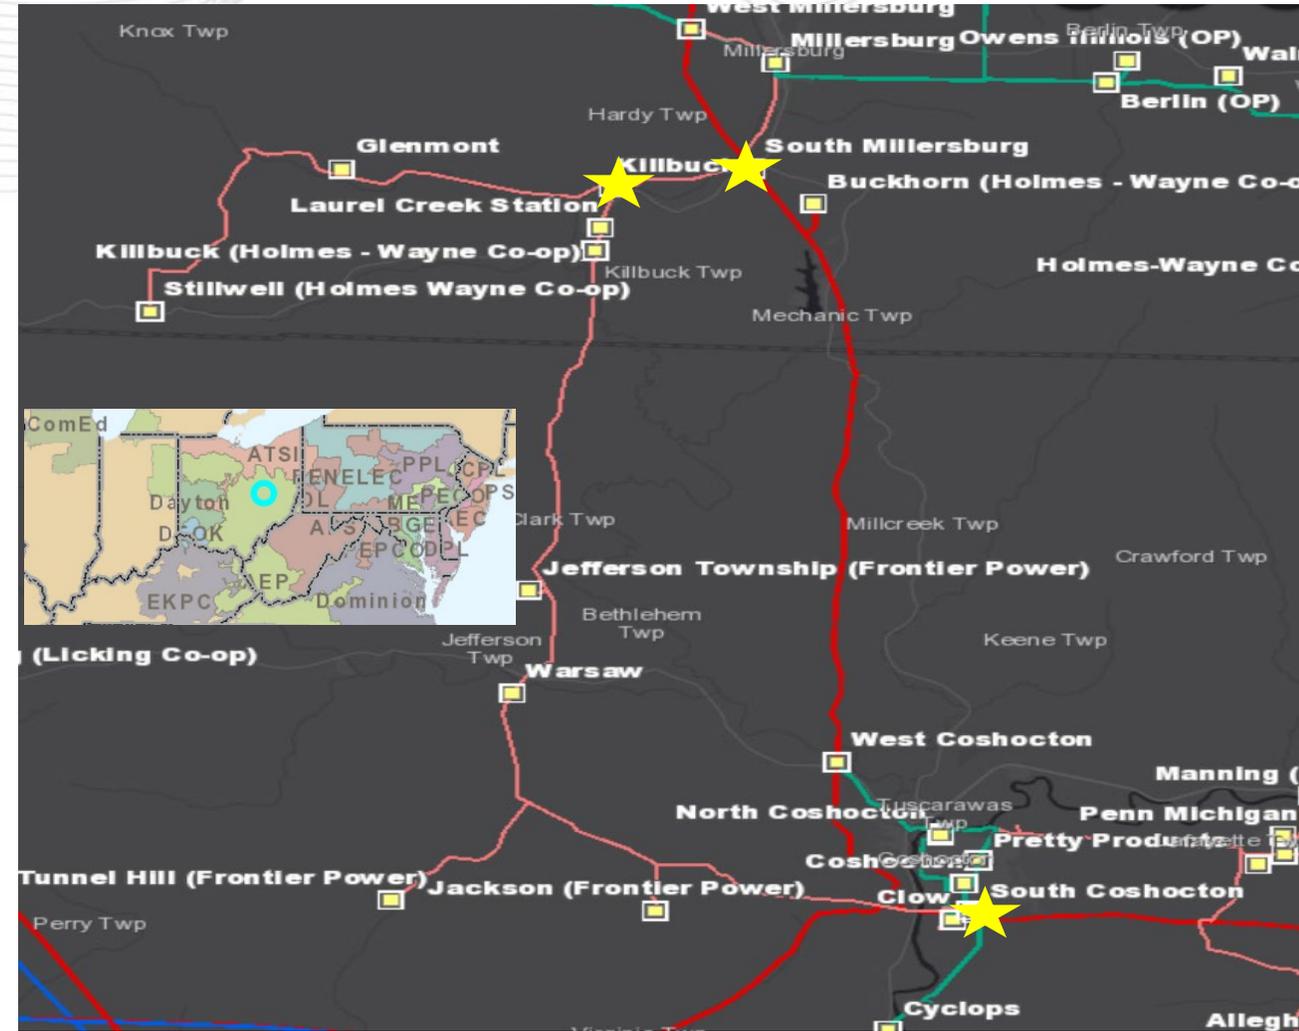
Circuit Centerline

The South Coshocton 138 kV circuit breaker 'H' has had 11 malfunctions, 3 of which are confirmed to be related to low gas. This HS145-3000 model is prone to low gas malfunctions. The South Coshocton 138/34.5 kV transformer's dielectric strength has declined for the past seven years. Concentrations of CO2 are elevated as well. These conditions indicate that the insulating paper is deteriorating.

The South Millersburg 34.5 kV circuit breakers 'A' (fault ops 3) and 'B' (fault ops 21) are 'FK' oil-filled breakers (vintage 1951 and 1953 respectively). These oil type breakers extensive maintenance and oil handling requirements. The FK model is no longer supported by the manufacturer making spare part availability scarce.

The South Millersburg 138/34.5 kV transformer has elevated moisture levels for at least seven years with a recent sharp increase. The dielectric strength has corresponding decreased since 2016. Concentrations of CO2 are also elevated.

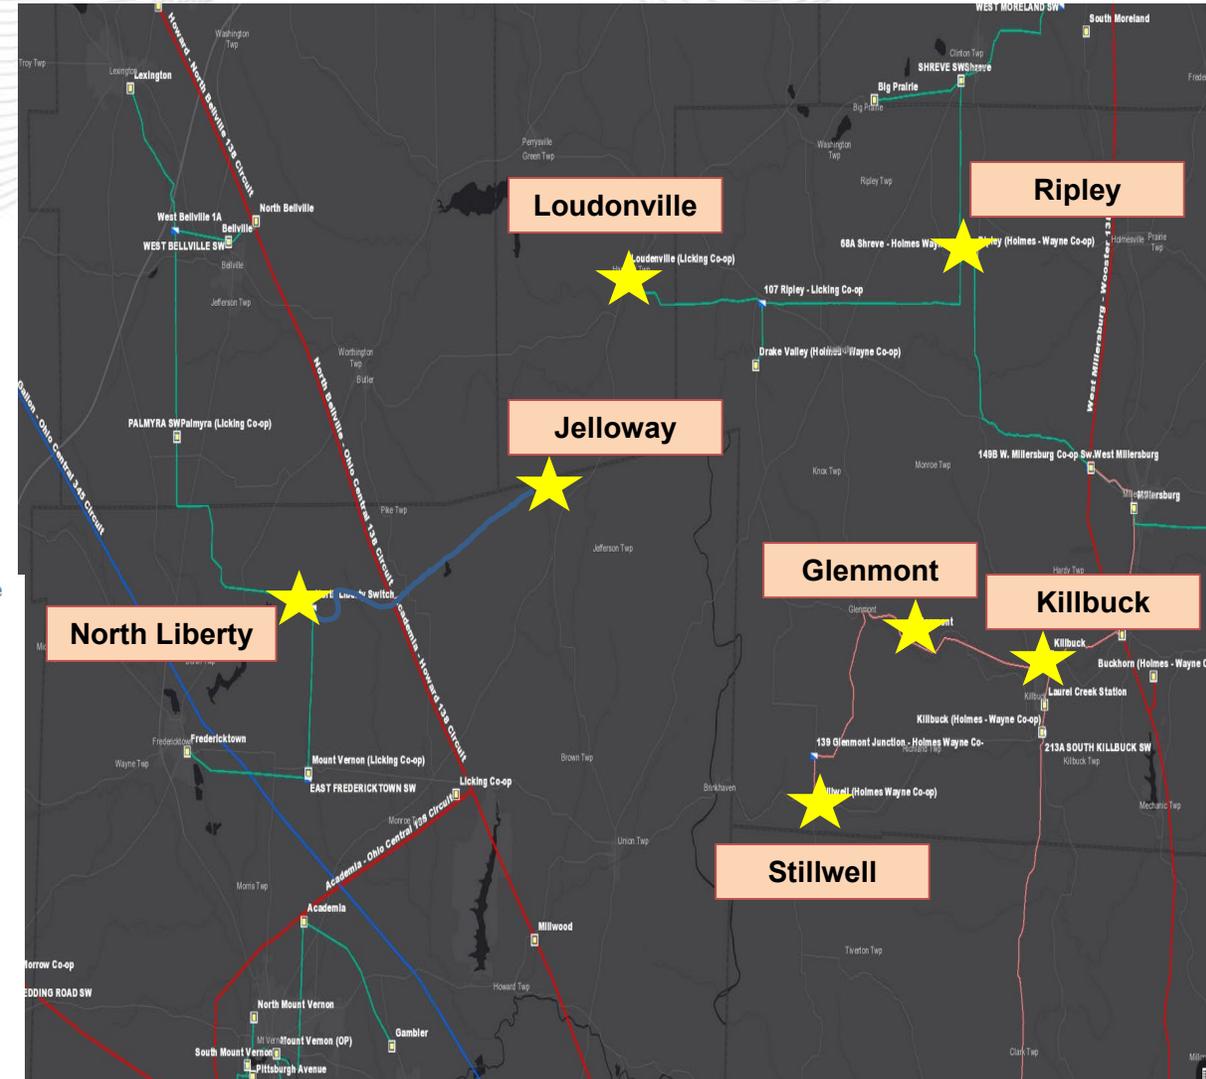
Licking and Holmes-Wayne members are currently served via a radial 69 kV (24.1 mi) line. The North Liberty to Jelloway radial line is 9.50 miles and the Ripley to Loudonville radial line is 14.16 miles. Their total load is 8.73 MVA and they have experienced 1.13 million CMI over the last three years.
