Sub Regional RTEP Committee Western Region AEP

October 26, 2018

Need Number: AEP-2018-IM002
Process Stage: Needs Meeting 10/26/18
Process Chronology: Needs Meeting 10/26/18
Supplemental Project Driver: Equipment Condition/Performance/Risk
Specific Assumptions Reference: AEP Guidelines for Transmission Owner Identified Needs (AEP Assumptions Slide 8)

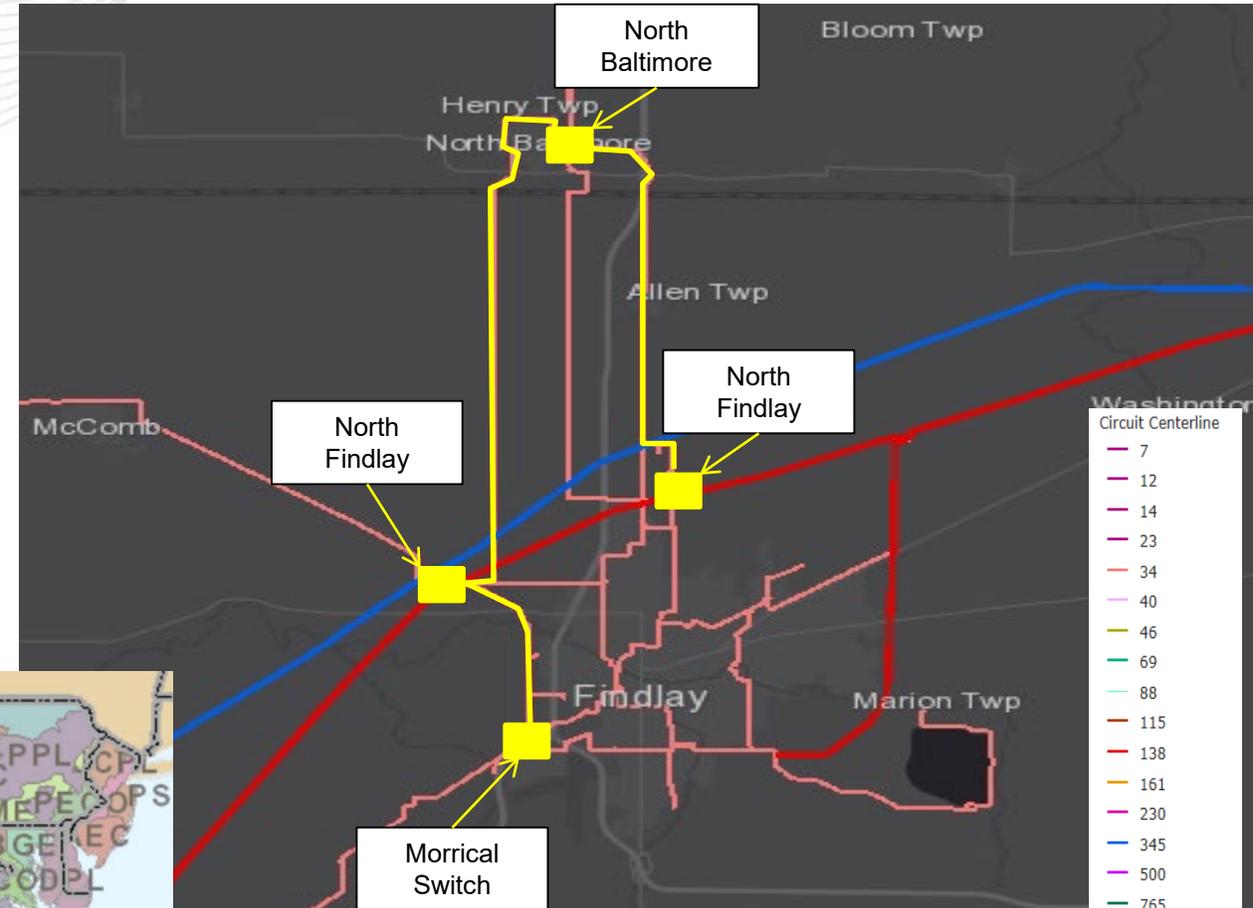
The 138/34kV transformers and 34kV circuit breakers at New Liberty, North Baltimore, and North Findlay Stations have significant asset renewal needs. Between these three stations (17) 34.5kV circuit breakers/ circuit switchers have been identified as needing replacement, 15 of which are oil filled (vintage 1950's) and have seen a high number of faults operations. Short circuit capability is also a concern for many of these 34.5 kV breakers at the New Liberty and North Findlay.

- 34.5kV CB A

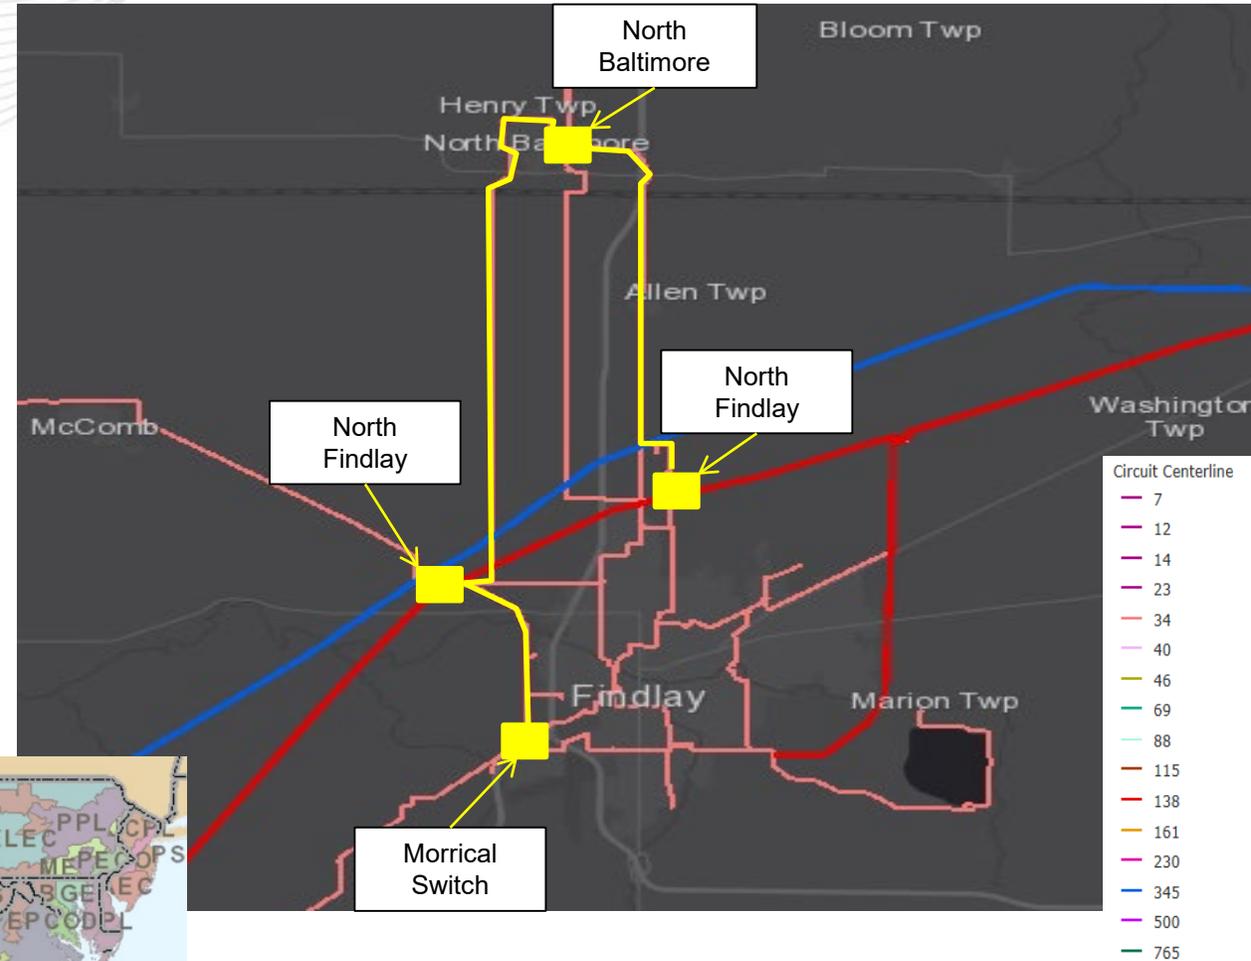
- Evaluation of the station has shown the wooden bay structures, the 34.5kV circuit breaker and all existing relaying (electromechanical) at the station are in need of replacement.

New Liberty – North Baltimore 34.5kV: The 10 mile circuit is a combination of 4/0 ACSR and 336 ACSR (circa 1940) with wood structures (Predominately pre-1980's). The line section has 30 open A conditions.

North Findlay – North Baltimore 34.5kV #1: The 8 mile circuit identified is predominately 4/0 ACSR (circa 1961) with small portions of 2/0 Copper, 336 ACSR, 556 ACSR, and 795 ACSR. This line has predominantly wood structures (ranging from 1920's – 2000's) with 14 open A conditions.

New Liberty – Findlay Center 34.5kV: This 3.3 mile line has a combination of 4/0 Copper, 336 ACSR, and 556 ACSR (circa 1934-1964) with wood structures and 10 open A conditions.

There is an existing 34.5kV three terminal line at Morrival Switch and hard taps at in the area that increase outages to customers in the area (Totten and Centrex).

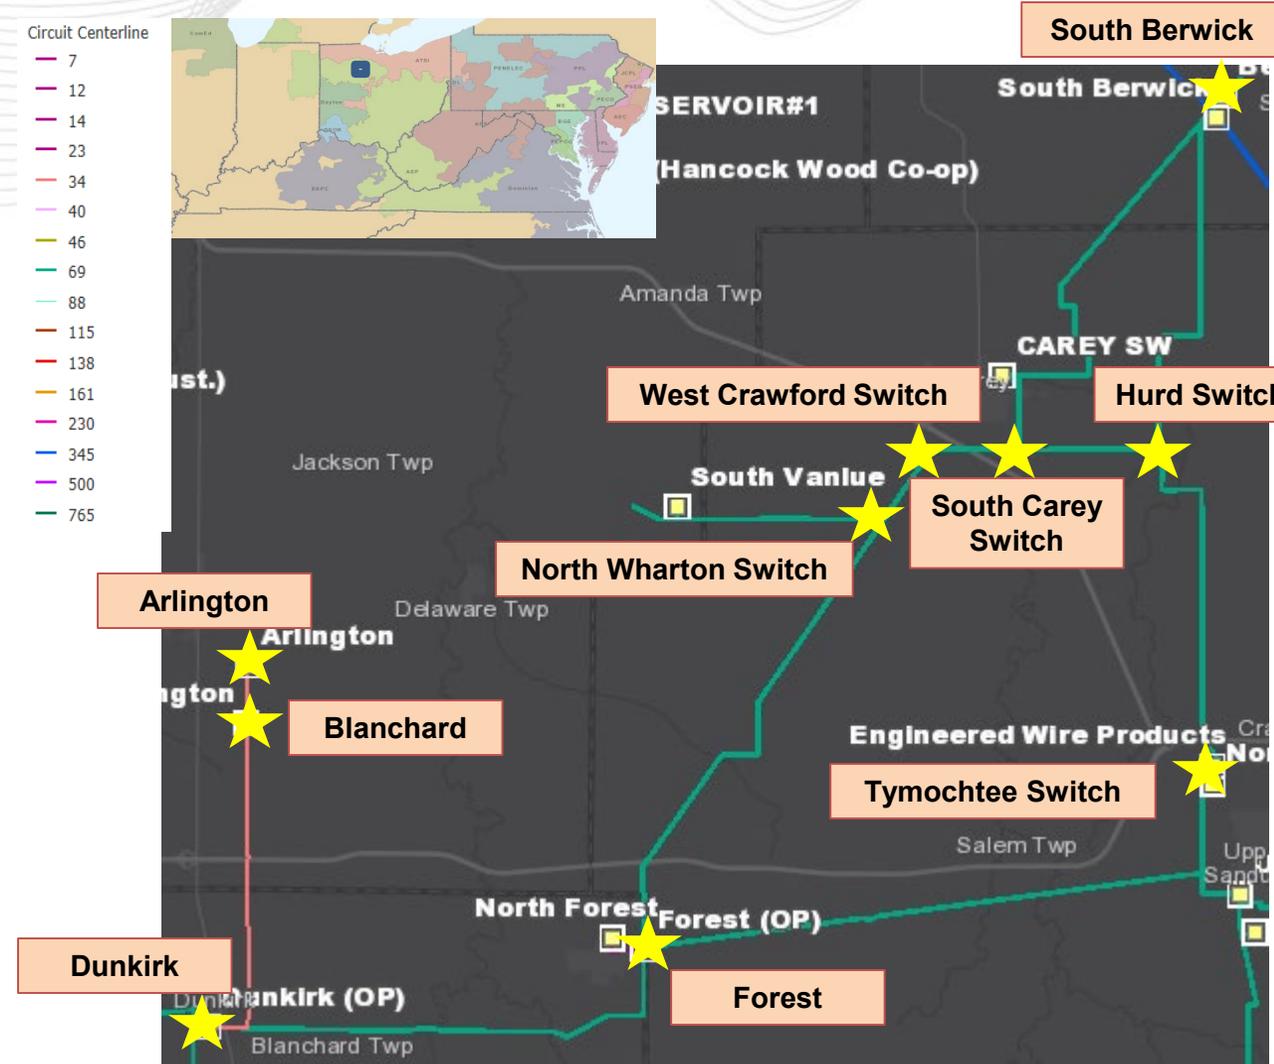
- There are 10 open A conditions on the Arlington – Dunkirk 34.5 kV line (~ 7.29 miles) & 29 open A conditions on the Forest – South Berwick 69 kV line (~29.3 miles).

- The City of Carey has reliability concerns, where both feeds to the city can be lost for a single outage.
- Hancock-Wood Co-op has reliability and maintenance concerns due to radial loads at Arlington and Blanchard Stations.

- Arlington – Dunkirk Circuit:
 - Peak Load Impact: 6.57 MW
 - CMI (2015 – 2018): 162,840
- Forest – South Berwick Circuit:
 - Peak Load Impact: 7.68 MW
 - CMI (2015 – 2018): 1,713

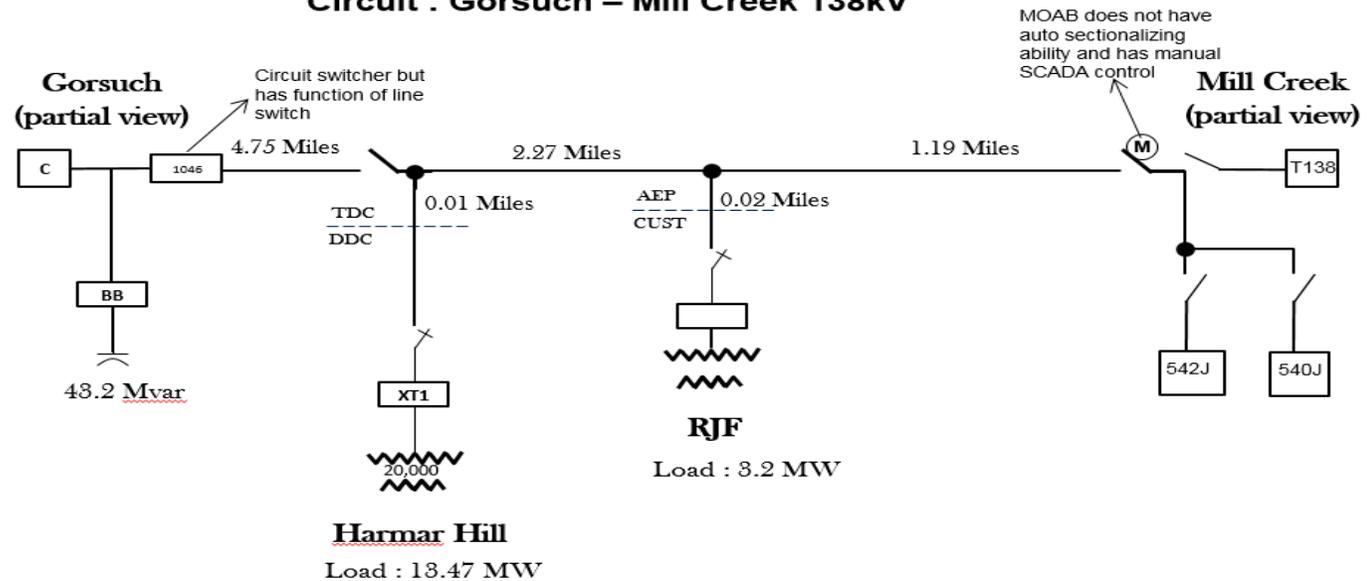
Circuit : Gorsuch – Mill Creek 138kV

RJF is a customer owned substation that is served off a 138kV hard tap. Harmar Hill is served from a tap with a one way switch that is currently inoperable. Any line work along between Mill Creek and Gorsuch causes considerable outages to both customer loads. There is limited transfer capability at Harmar Hill and no transfer capability for RJF. AEP's internal guidelines justify sectionalizing on this line (FOI: 10.17).

Mill Creek will be replaced by a new substation Devola as part of an unrelated project (S1125).

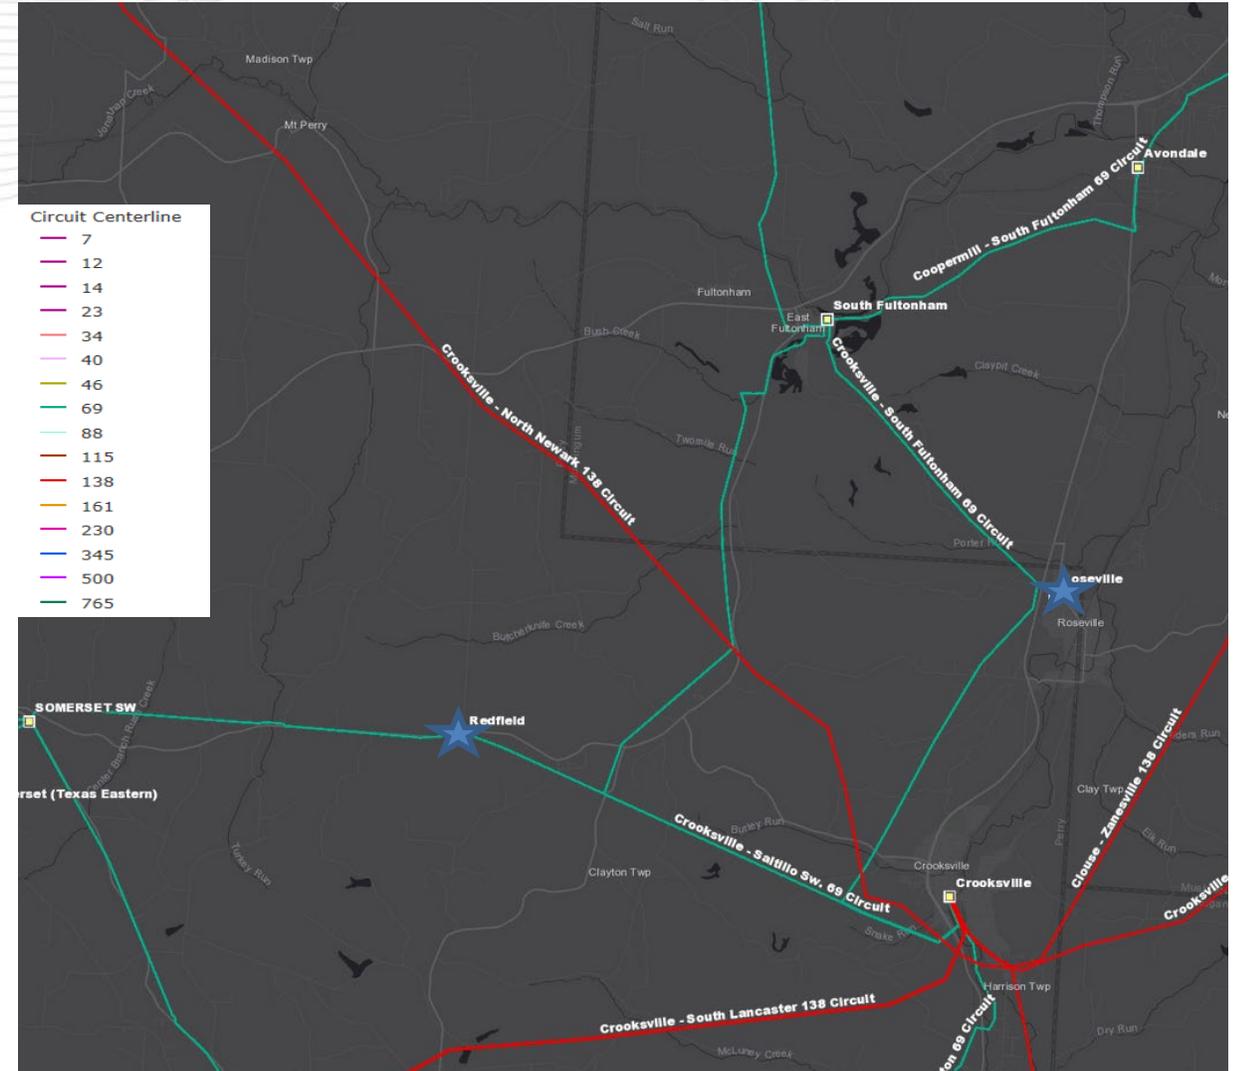
- **Customer Service #1:** AEP Ohio has requested a new more reliable connection that is closer to their load center. In addition, the existing Redfield Distribution equipment is in need of rehab. The existing 69 kV Redfield Station has experienced 1,730,000 CMI over a three year period. Requested in-service by date is 06/01/2019.
- **Customer Service #2:** AEP Ohio has requested improved reliability at their Roseville 69 kV delivery point. The current load is 3.2 MVA with a projected load near 5.5 MVA. Currently for an outage at Roseville Station, the load cannot be transferred to adjacent Station under peak conditions. **Moved to AEP-2018-OH034**

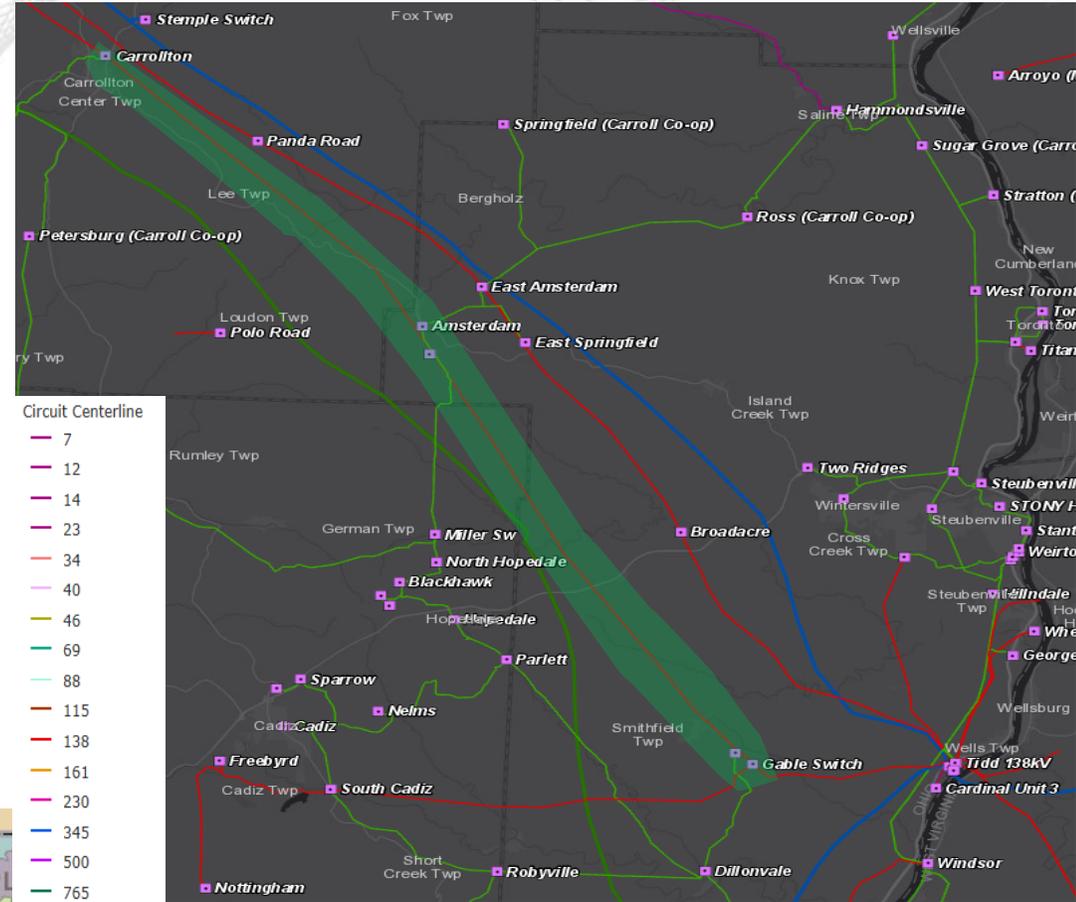
The Gable-Carrollton (vintage 1917) 138kV circuit (29 miles) is in poor condition and is a reliability risk to the transmission system. The circuit consists of lattice towers and 6-wired 200 kcmil copper conductor. After a century in the field, the lattice towers have degraded significantly, with heavy rusting and broken tower legs. The copper conductor has become very brittle and is difficult for crews to repair. Some towers are sitting in water. The suspension insulators and hardware are also heavily worn.

The circuit has 39 open conditions, with the majority being structural issues (e.g., degraded tower parts & broken insulators). The circuit has experienced 4 outages in the last 3 years (2016-18), including a 50-hour outage due to broken conductor.

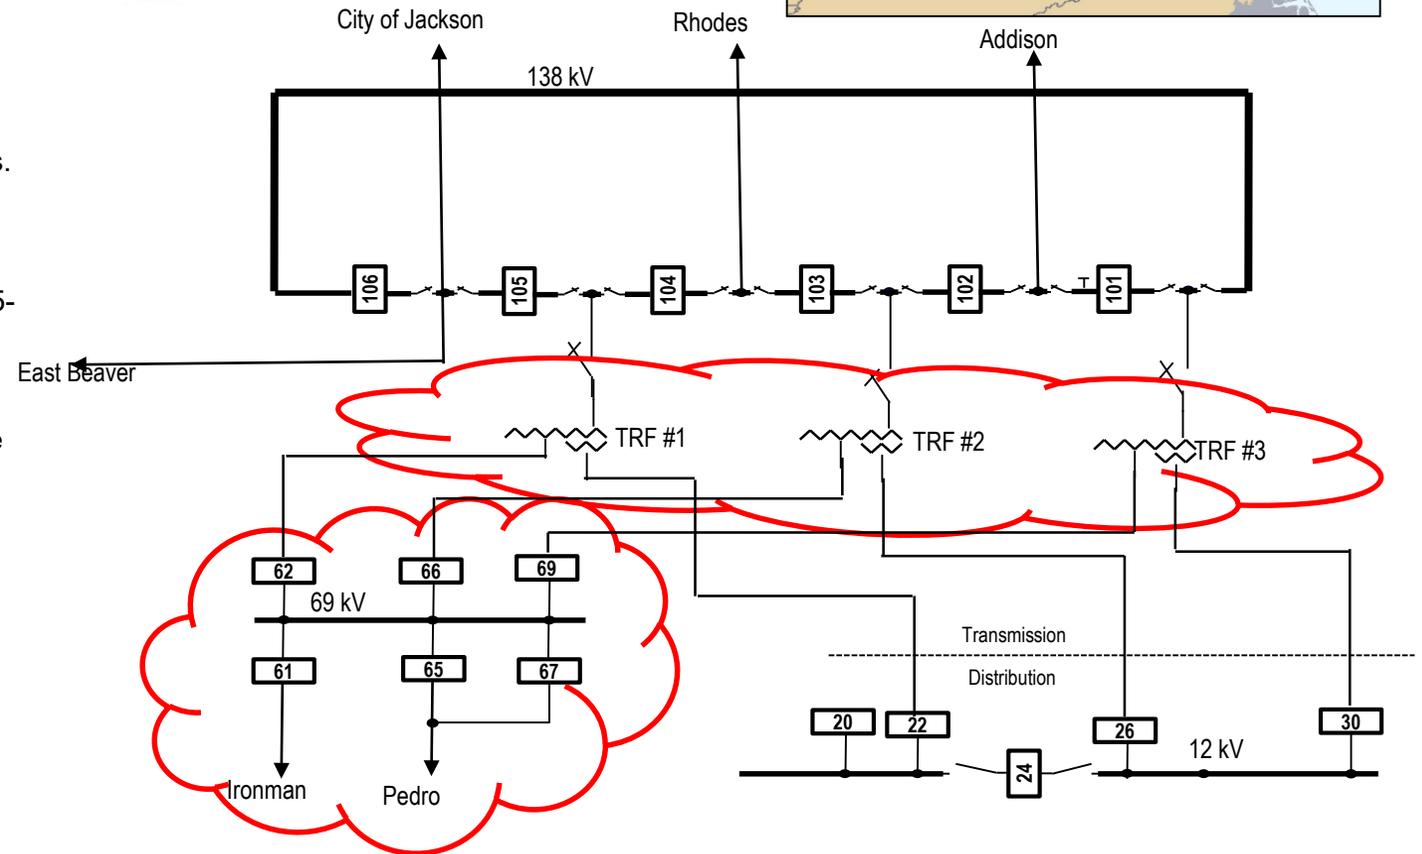
At Lick substation there are six 69 kV circuit breakers with condition issues. CB's 61, 62, 65, 66, 67, and 69 are oil type breakers that were manufactured between 1956 - 1967. There is a potential for oil spills during routine maintenance and fault operations. In addition, spare parts are difficult to obtain. The breakers' fault operation counts are as follows: {61-126, 62-11, 65-26, 66-8, 67-19 and 69-4}. For most of these breakers, the number of fault operations exceed the manufacturers recommended number of 10.

There are three 138/69 kV, 18 MVA transformers at Lick. T#1 is a Westinghouse transformer manufactured in 1956. Transformers #2 and #3 are both GE transformers manufactured in 1950. All three transformers have maintenance issues with their LTCs and have significant oil leaks. In addition, loss of two of the transformers can load the remaining transformers tertiary winding above it's rating.

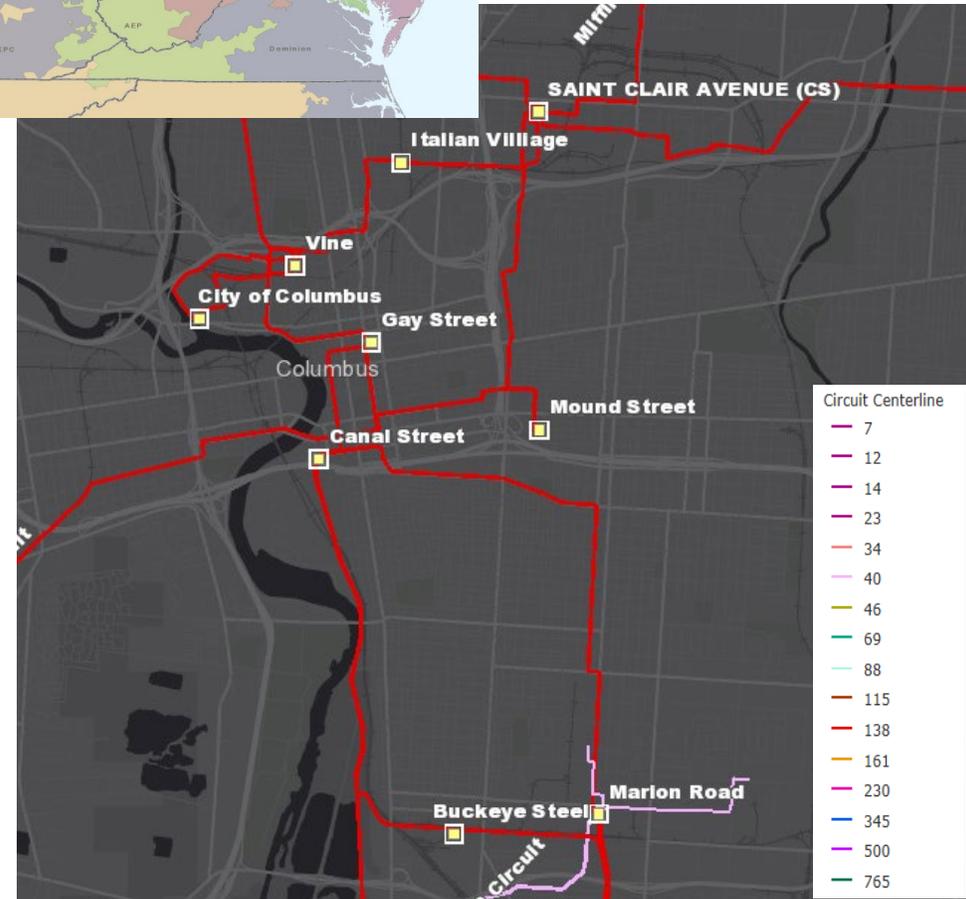
The 138kV CB-101 at Mound Street is the last remaining oil breaker at the station. This oil breaker doesn't have oil containment. Oil breaker maintenance has become more difficult due to the oil handling required to maintain them. Oil spills can occur with breaker failures and routine maintenance which has the potential for an environmental risk. This breaker is a model that has identified reliability concerns due to past failures and lack of spare part availability.

This CB separates two transformers that serve critical hospital loads. A failure could cause a sustained outage to the entire facility.

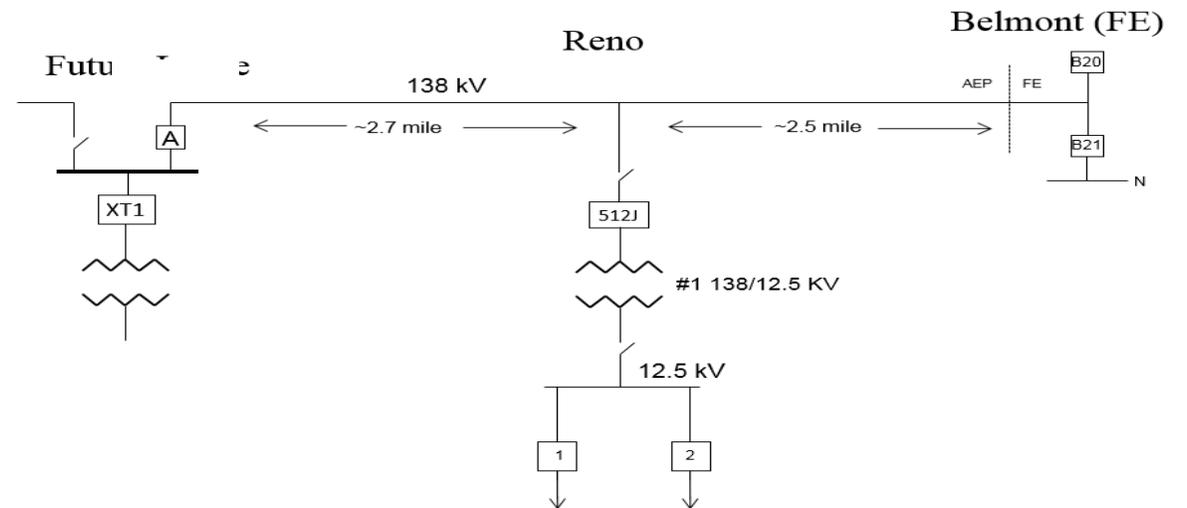
Reno Substation is served off a 138kV hard tap. If there is an outage, planned or unplanned on the line sections between Belmont and Levee, the Reno load will be dropped. There is partial transfer capability for Reno during light load periods only. Levee Station cannot take all Reno's load because the distribution circuits are over five miles between the two stations dictated by geography.

The nearby 23 kV Wade station is being retired as part of an unrelated project. Levee Station will take a portion of Wade's load and the remaining load will be served from Reno Station.

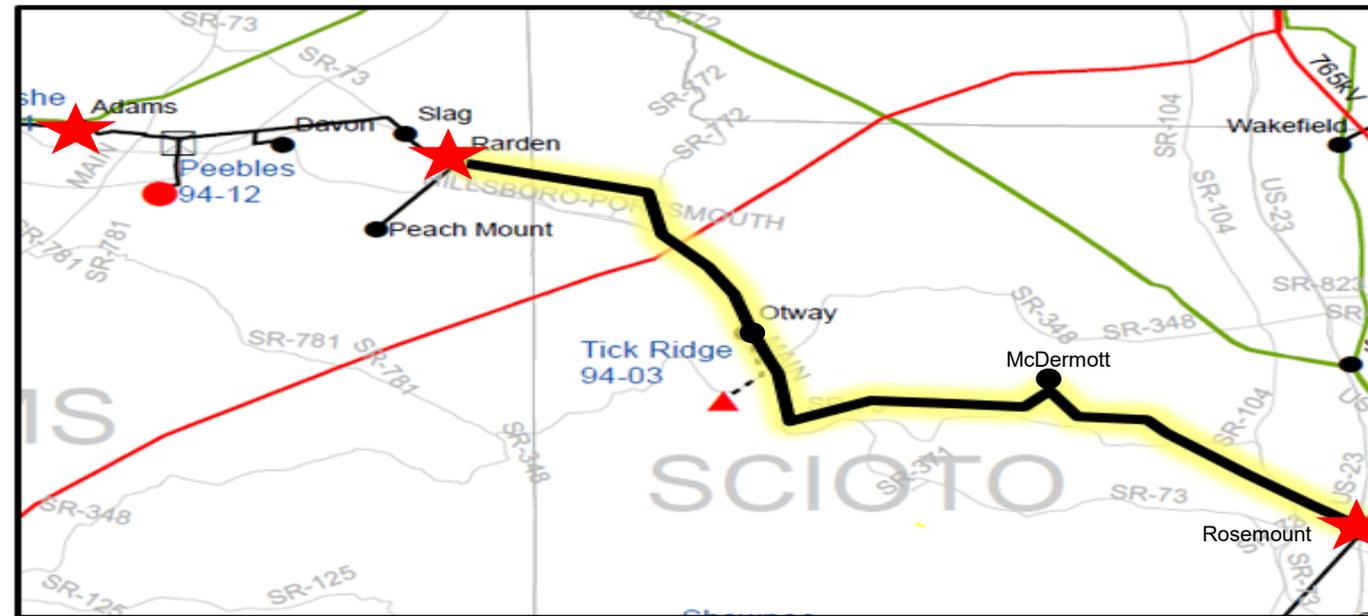
- Rarden and Rosemount Stations are connected by a 34.5 kV line with four 34.5/12 kV substations and several distribution customers served directly from the line. The total load served along this 24 mile line is 26/30 MVA (summer/winter).
- There is a normal-open point near Otway.
- The area suffers from reliability issues due to the rugged terrain and remote access. Customers have experienced over four million customer minutes of interruption over the past three years.
- The area's peak load can exceed the source transformers (Rarden and Rosemount). The 336 AAC conductor has already been overloaded (115% on 2014).
- The two 69-34.5 kV transformers at Rarden are protected with high-speed ground switches which can cause through-faults on the transmission system.

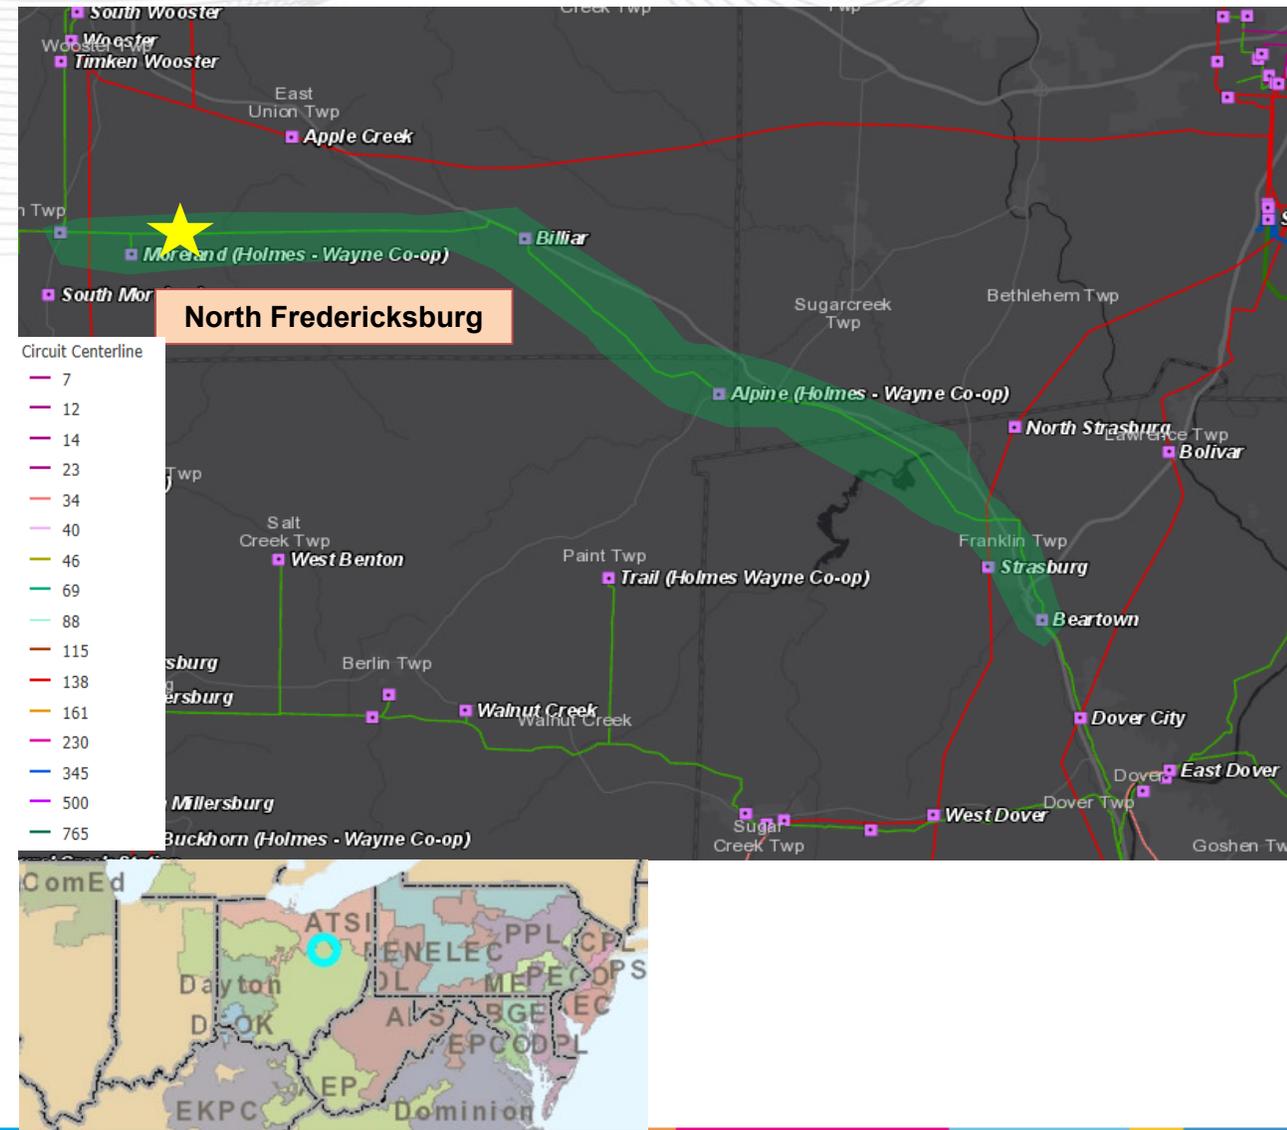
The ~~Beartown—Moreland~~ Beartown- West Wilmont 69kV ~~circuit~~ section is ~~28.2~~ 10.5 miles long and serves ~~2~~ 1 AEP Ohio distribution station and ~~2~~ 1 Holmes-Wayne Co-op station in northeast Ohio. Over the past several years, the circuit has experienced below-average reliability. For the 2017-2018 YTD period, it has experienced 7 sustained outages, an additional 8 momentary interruptions, and 2 emergency repair incidents on the entire circuit. The majority of the outages were due to T-Line structural issues and forestry.

The ~~circuit~~ section has a reported CMI of 2.0M between 2014 – 2018 and currently has ~~218~~ 52 open conditions (~~177~~ 25 Category A, ~~36~~ 25 Category B, 5 Forestry). Examples of the conditions include: rotted poles, missing ground-leads, and damaged conductor. During the 2010-2018 period, 112 prior conditions were repaired/addressed ~~on the circuit as a whole~~.

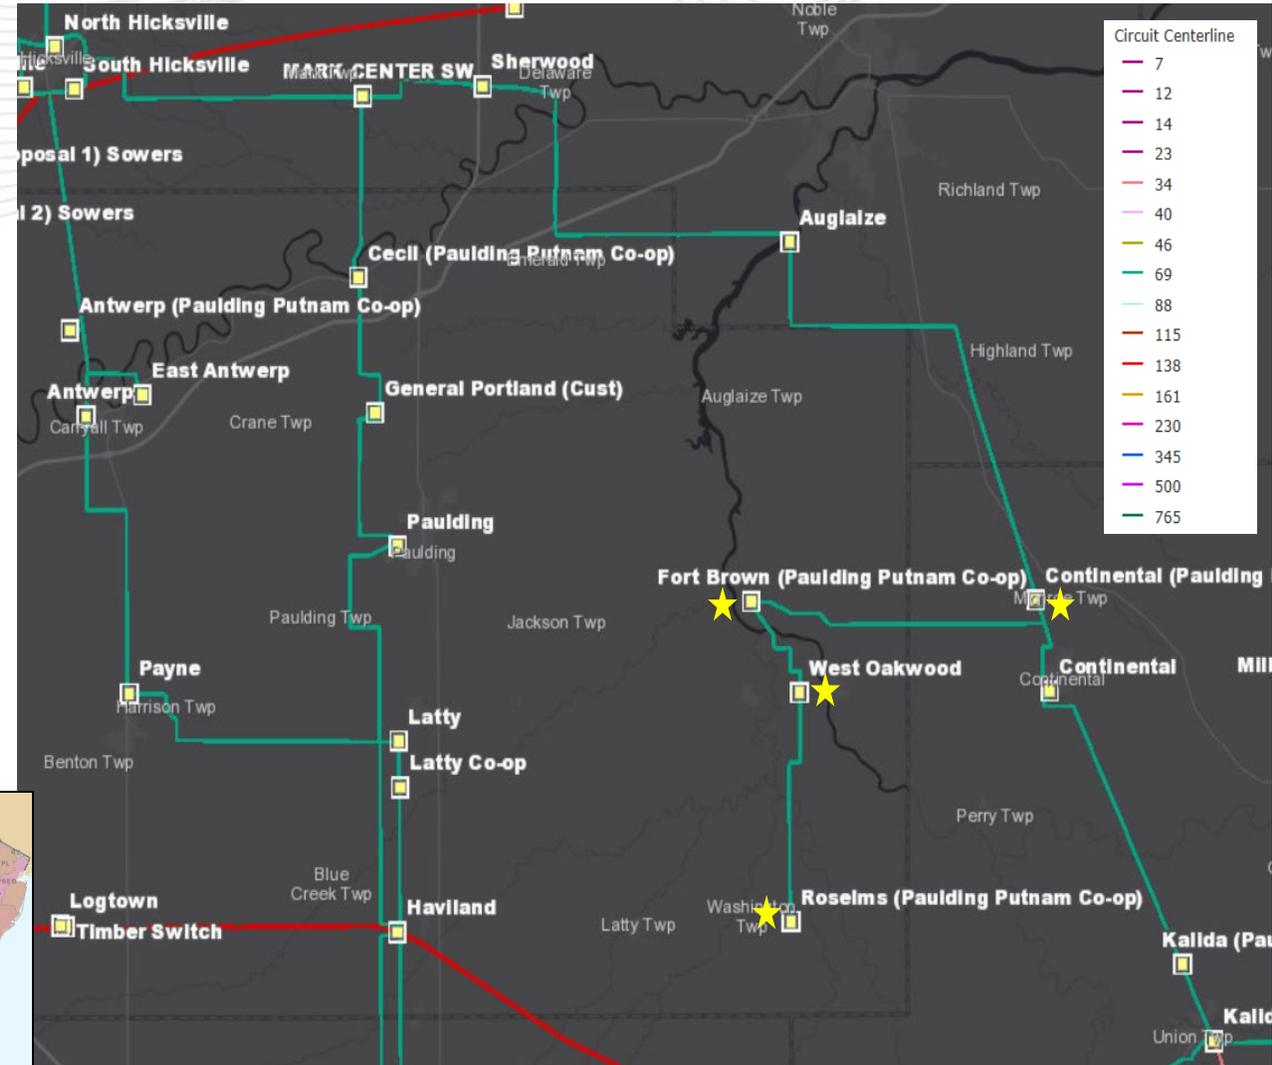
Continental – Roselms 69 kV is a 18 mi radial circuit serving ~10.6 MVA load. The customers served from this radial line have experienced 2.1 million customer minutes of interruptions over last 5 years. These radial loads are not automatically transferable. Any maintenance on this line results in outages to multiple stations.

Majority of the line has 4/0 ACSR conductor with a 2 mi section with 795 ACSR. This circuit has 89 open conditions. Most of the 258 structures on this circuit are 1960s and 1970s wood pole vintage with rotting issues.

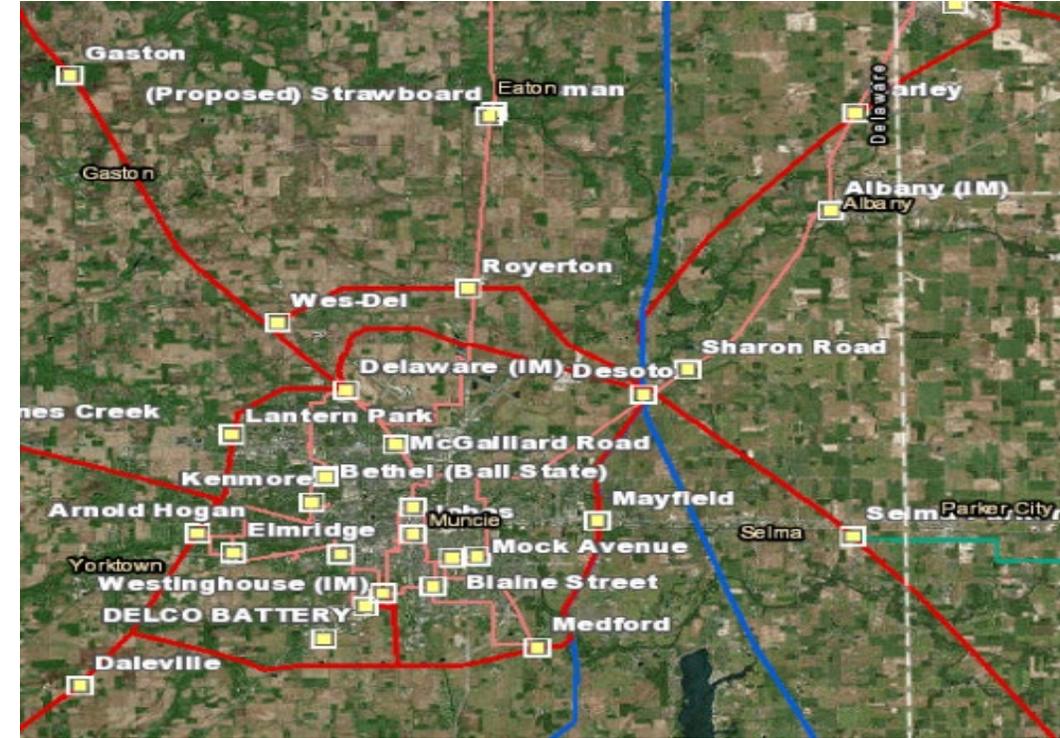
Delaware Station

Delaware – Haymond

Delaware – Jay

- 1920's Vintage wood crossarm construction
- 1/0 Copper conductor
- 100 structures had to undergo active maintenance in the last 10 years and this trend is expected to rise as the line ages.
- 55 open A conditions
- 33 open B conditions
- 556,661 CMI

Barley Station

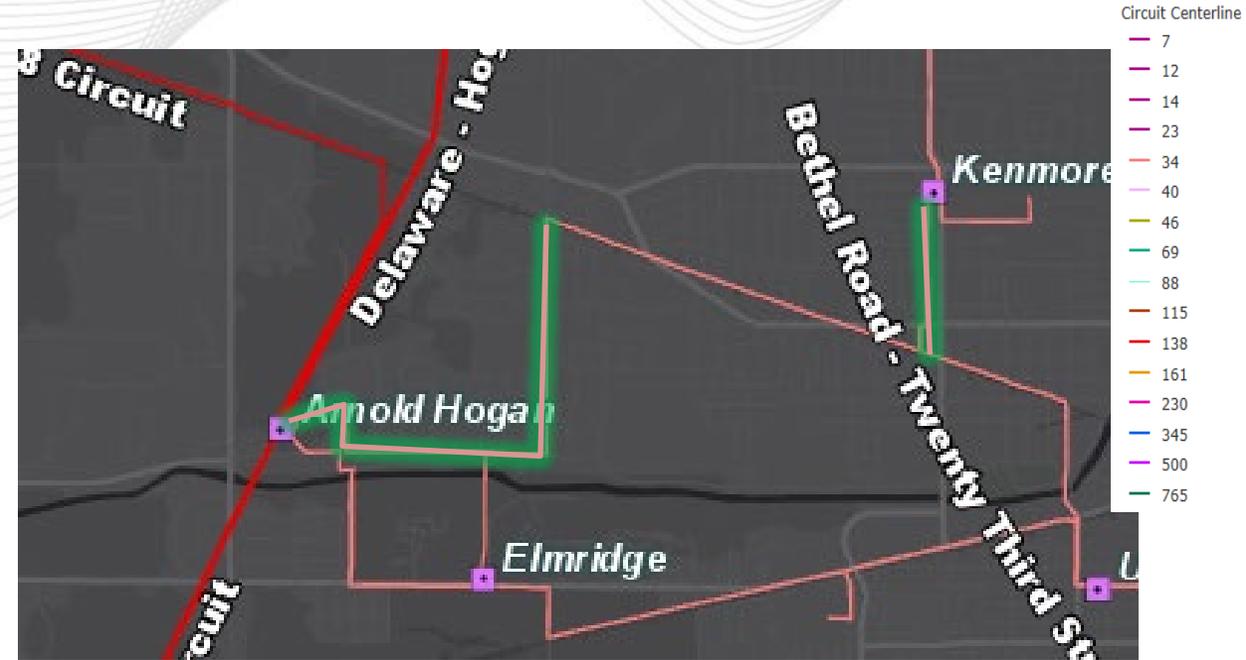
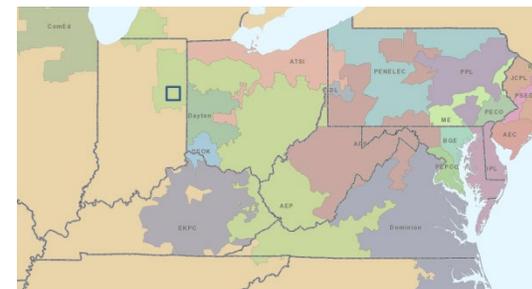
Problem Statement:

Arnold Hogan – Kenmore

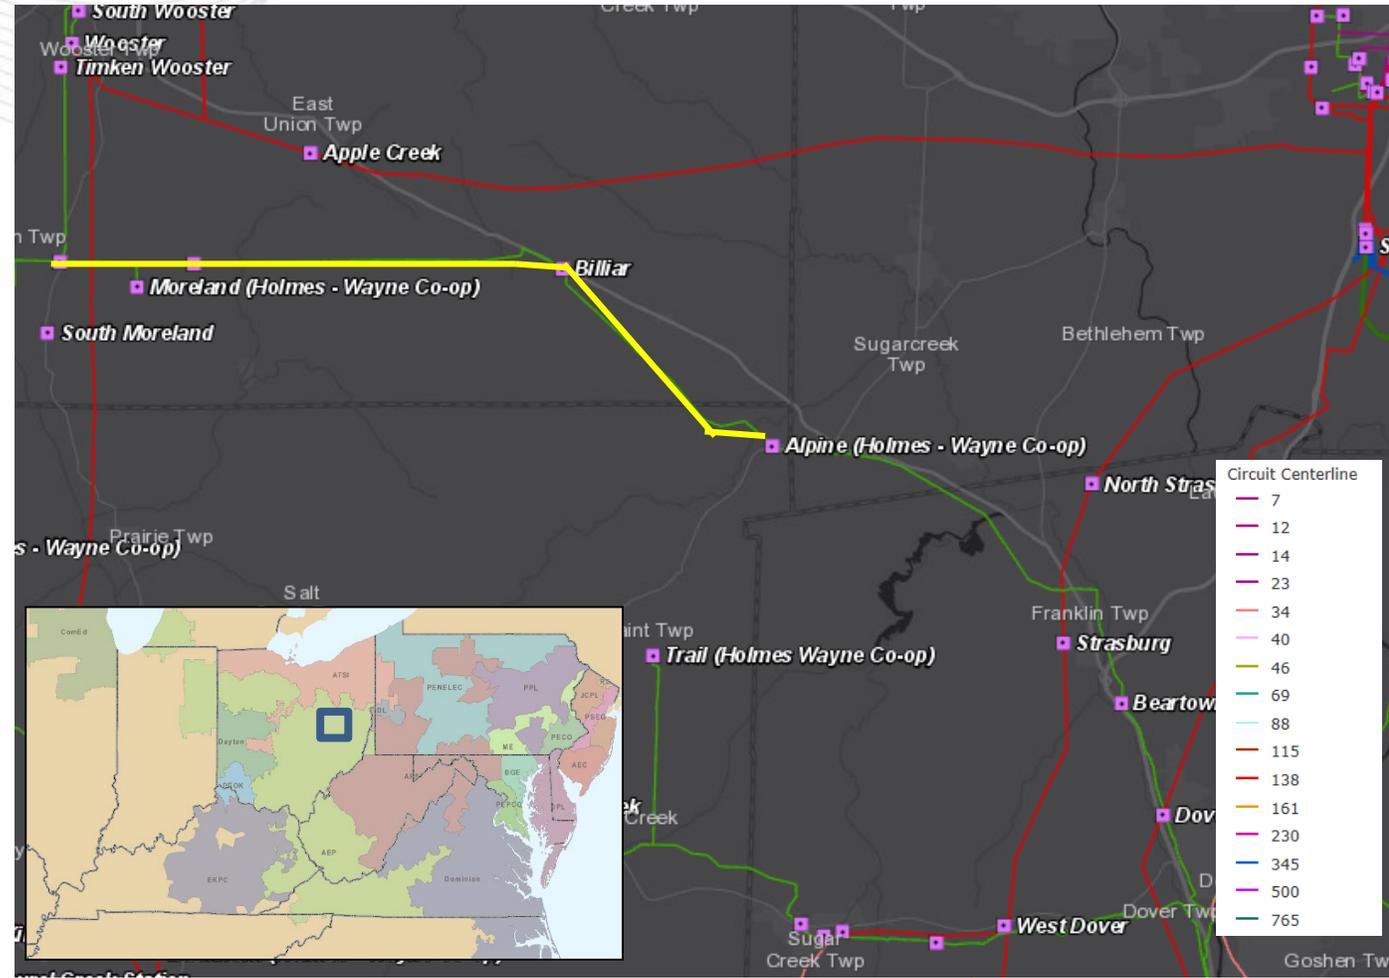
Problem Statement:

The Moreland- West Wilmont 69kV section is 17.7 miles long and serves 1 AEP Ohio distribution station and 1 Holmes-Wayne Co-op station in northeast Ohio. Over the past several years, the circuit has experienced below-average reliability. For the 2017-2018 YTD period, it has experienced 7 sustained outages, an additional 8 momentary interruptions, and 2 emergency repair incidents on the entire circuit. The majority of the outages were due to T-Line structural issues and forestry. The line section consists of primarily 4/0 copper conductor (1940 vintage) and 336 ACSR (1962-64 vintage); it is entirely wood pole construction, with the majority being installed in the 1960's or earlier. The circuit has a reported CMI of 2.0M between 2014 – 2018 and currently has 166 open conditions (152 Category A, 11 Category B). Examples of the conditions include: rotted poles, missing ground-leads, and damaged conductor. During the 2010-2018 period, 112 prior conditions were repaired/addressed on the circuit as a whole.
