Sub Regional RTEP Committee Western Region ComEd

January 11, 2019

Supplemental Project Driver: Customer Service

- New customer has requested transmission interconnection in the DeKalb area
- 18MW
- Customer has large motors

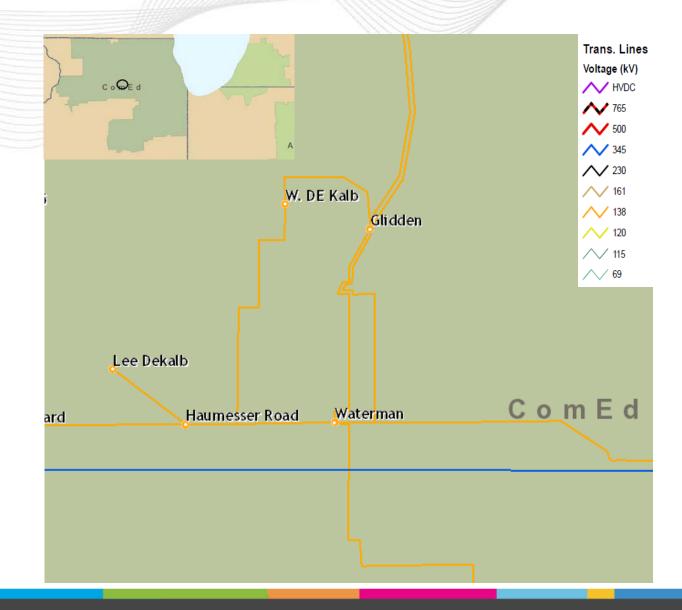
Install new 138kV line from Waterman to customer

- 2.5 miles of new conductor on existing structures
- 1 mile of new conductor and new structures
- Four new 138kV breakers
 Install backup tap on 138kV line 11323
 (Waterman-Haumesser Road-Glidden)
- 138kV breaker will be open in the customer substation

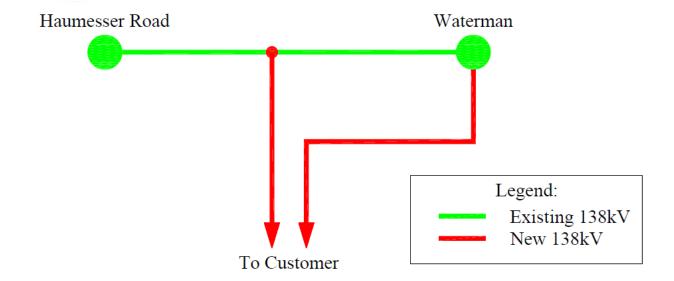
Connect customer as a radial tap off 138kV line 11323

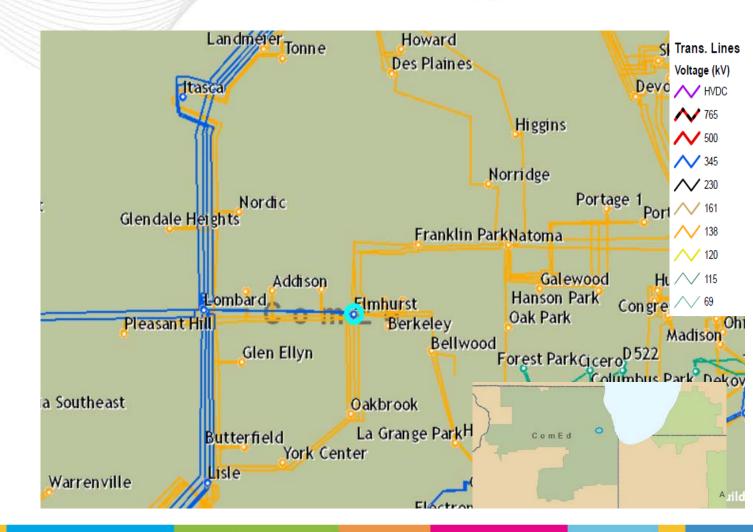
Electromechnical relays on 138kV lines 13505 and 13506 at Elmhurst:

Upgrade relay packages on

138kV line 13505 at Elmhurst

138kV line 13506 at Elmhurst

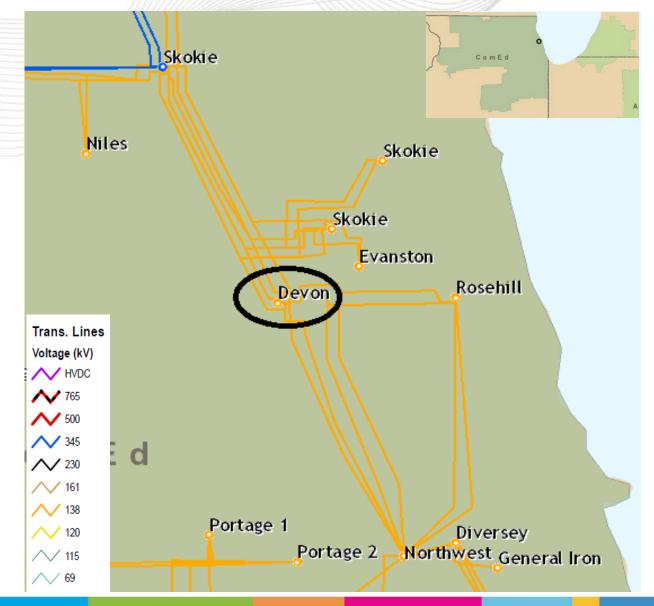
Devon TR72 needs to be replaced due to material condition

The failure of TR72 causes the outage of 138kV line 8809

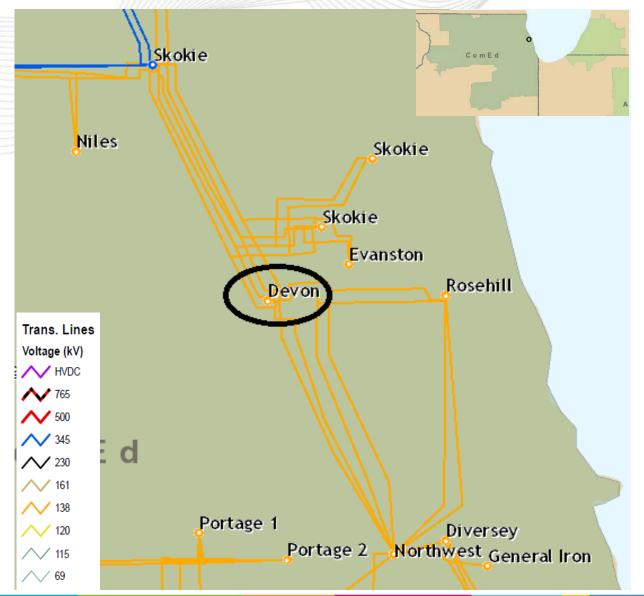
Replace TR72 at Devon Install new 138kV line breaker on 138kV line 8809 at Devon Install new 138kV TR72 high side breaker
