Subregional RTEP Committee – Western FirstEnergy Supplemental Projects

August 14, 2020

Needs

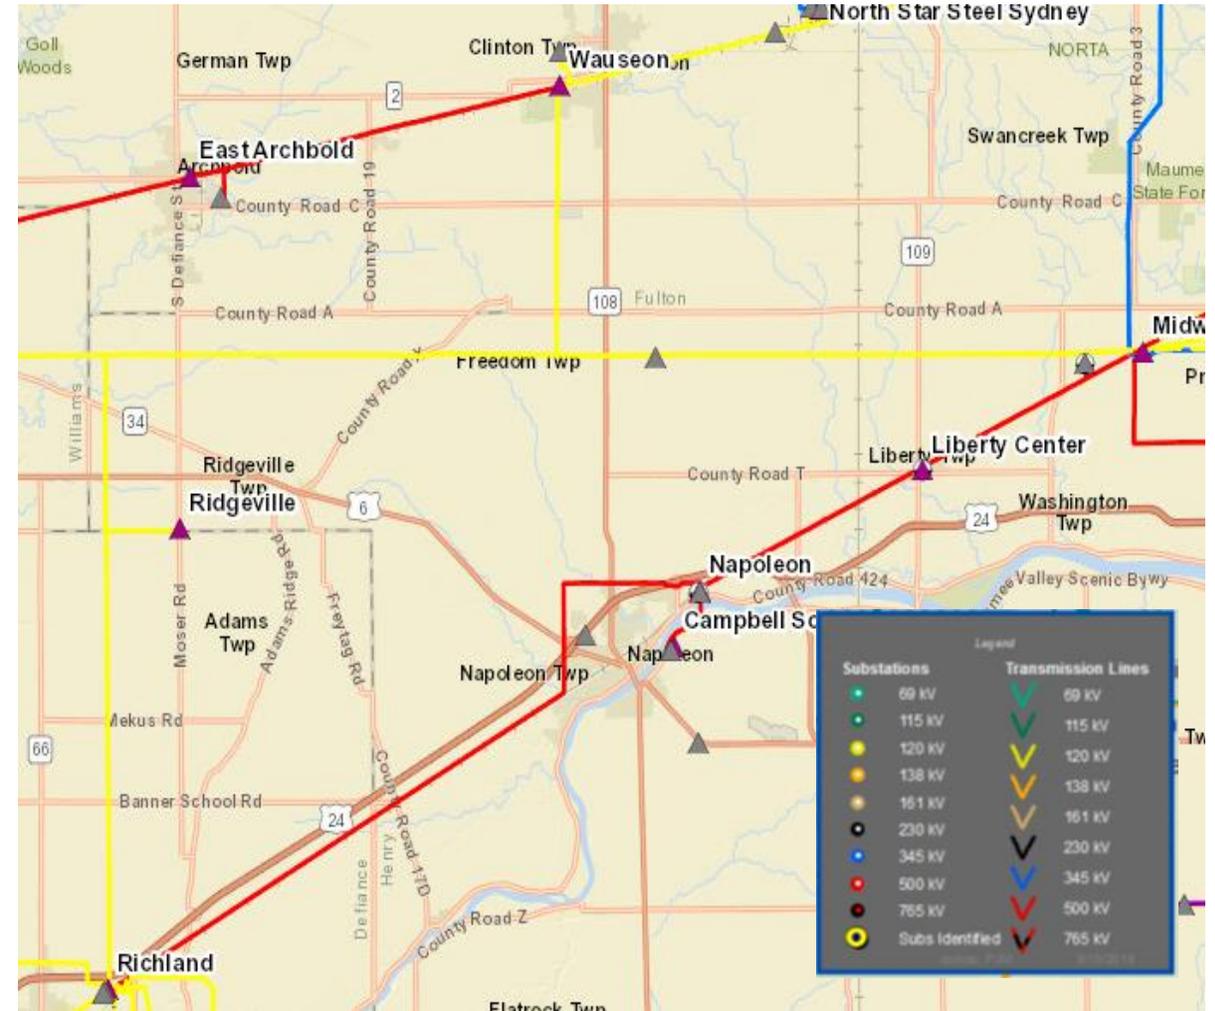
Midway-Richland-Wauseon 138kV (~33.5 miles) Transmission Line:

- Existing 336.4 ACSR has a history of failure due to conductor vibration resulting in thermal overload and corrosion of steel core.
- Original porcelain insulators from 1948 construction are aged and exhibiting wear.
- Comprehensive aerial inspection was completed in 2020 and shows a rising negative trend in required maintenance with 160 structures that presently require repair for structure damage, static wire damage, broken insulators, and broken or overheated conductor.
- Growing trend in unscheduled interruptions on this line with five (5) equipment caused outages in the past 10 years.
- Condition of static wire is deteriorating which may be contributing to rise in lightning caused outages.

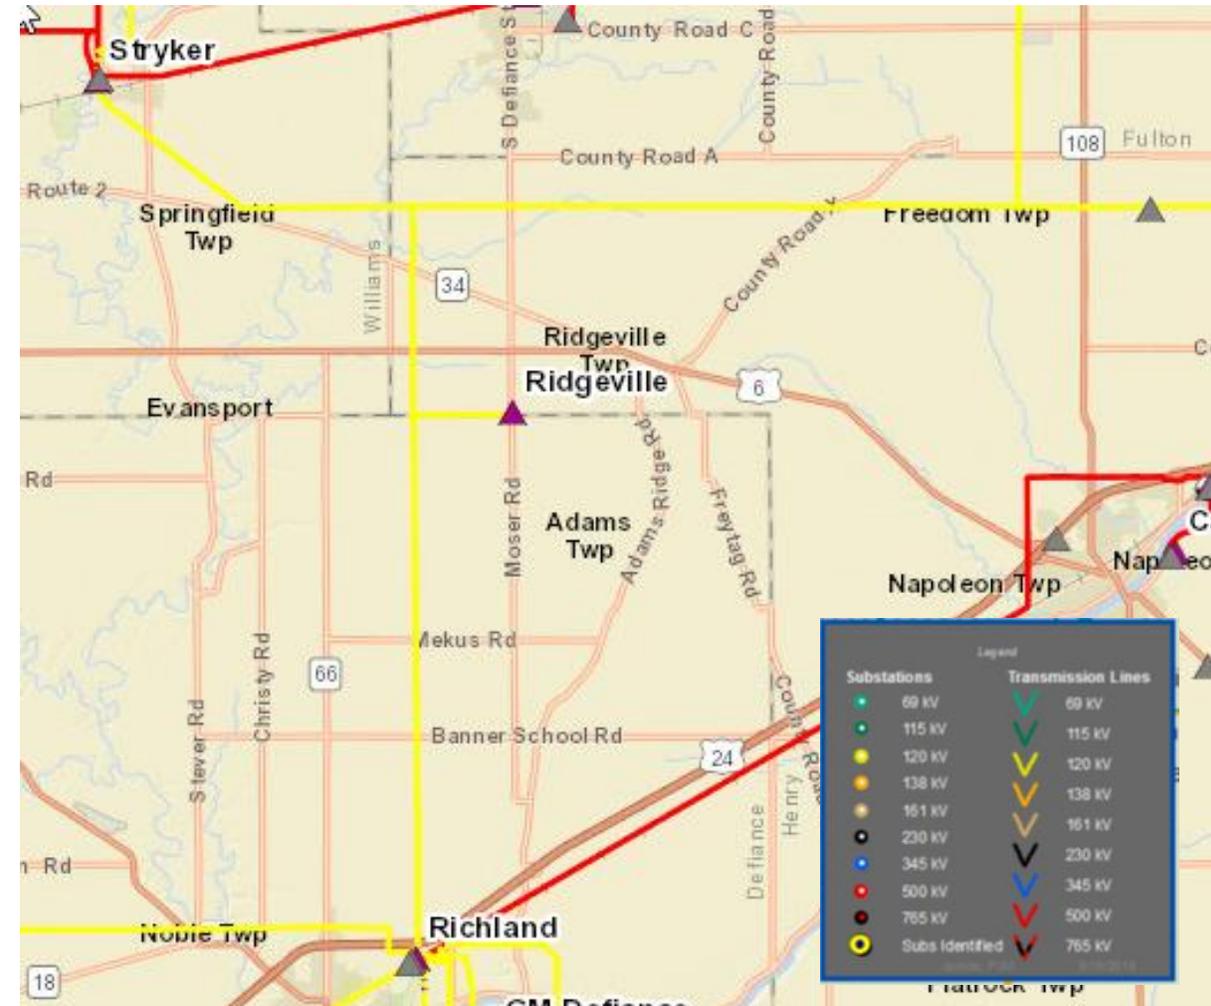
Napoleon-Richland-Stryker 138kV (~32 miles) Transmission Line:

- Existing 336.4 ACSR has a history of failure due to conductor vibration resulting in thermal overload and corrosion of steel core.
- Existing line is constructed on double circuit lattice towers shared with the Midway-Richland-Wauseon 138kV line.
- Comprehensive aerial inspection was completed in 2020 and shows a rising negative trend in required maintenance with 130 structures that presently require repair for worn static wire, damaged attachment hardware, and broken or flashed insulators.
- Growing trend in unscheduled interruptions on this line with six (6) equipment caused outages in the past 10 years.

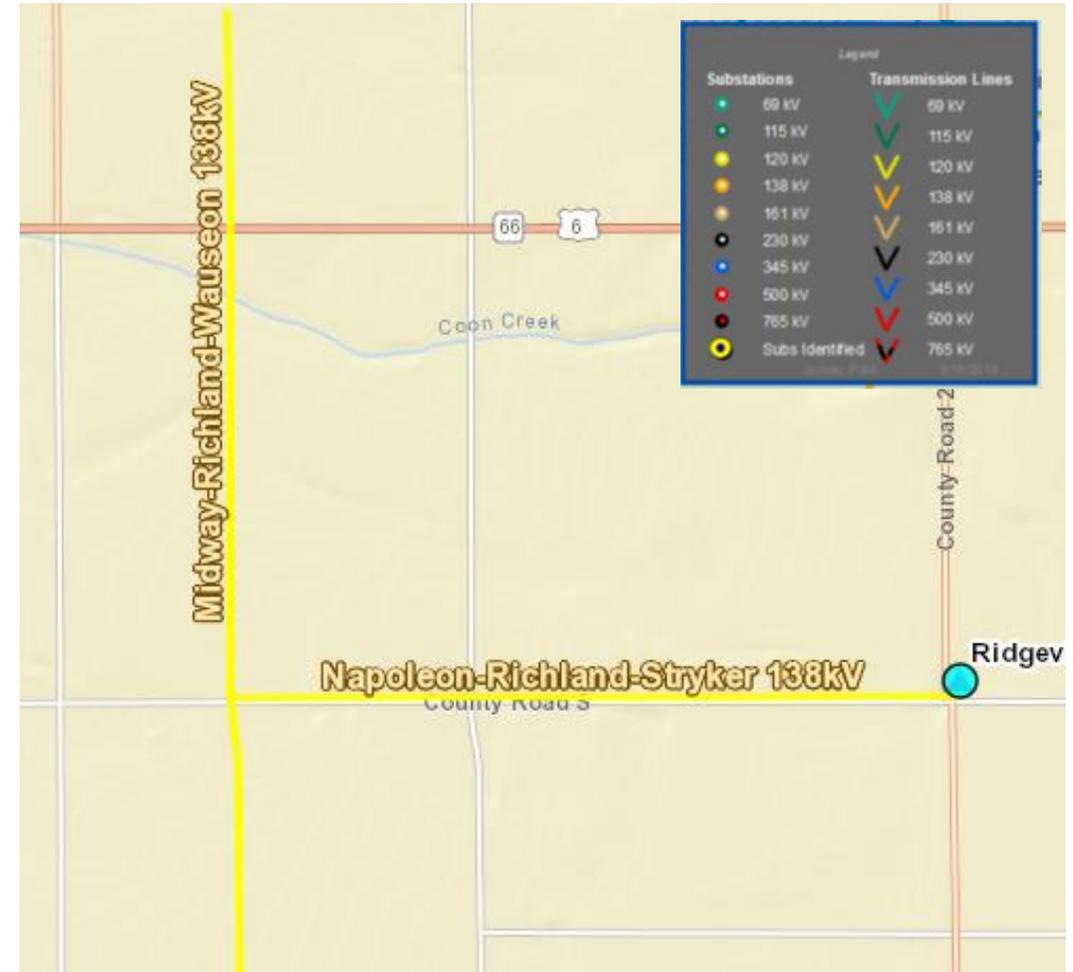
Napoleon-Richland-Stryker 138kV, Tap to Ridgeville (~1.5 miles):

- Tap was originally constructed in the 1970s. The average age of structures on this line are 50 years old. FirstEnergy has historically experienced an average age of reject for wood poles to be 48.7 years.
- 41 of 45 wood pole structures on this tap were bypassed during a previous project on the main line in 2015. Line survey in 2018 determined that all 41 structures failed. The primary reasons for reject were wood pole cracking and decay.
- Both the entrance and exit to Ridgeville substation share the same structures, increasing risk to reliability.

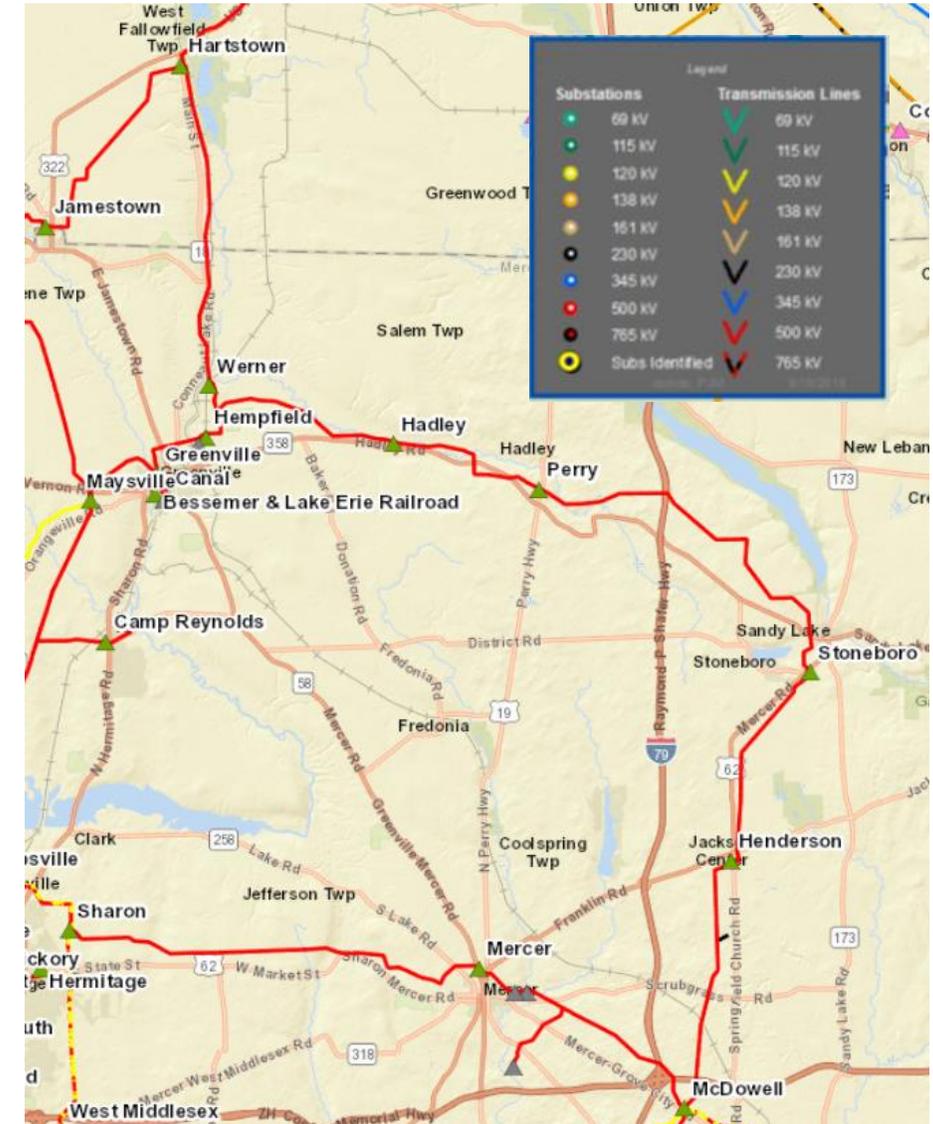
Maysville-McDowell 69kV Line (~33 miles):

- Line was originally constructed in the 1960s. The average age of structures on this line are 54 years old. FirstEnergy has historically experienced an average age of reject for wood poles to be 48.7 years.
- Line survey in 2019 showed a structure reject rate of 86% (528 of 613). The primary reasons for reject were woodpecker holes, wood pole decay, and pole top extensions previously used to mitigate the issue of pole top rot, an indicator that the pole is deteriorating.
- Conductor condition is deteriorating with over 40 conductor splices in a 30 mile line section.
- Obsolete line switches (A-2092, A-2091, A-2143 N.O.) are no longer supported by the manufacturer
- Line has experienced eleven (11) outages in the past five years of which eight (8) are sustained.

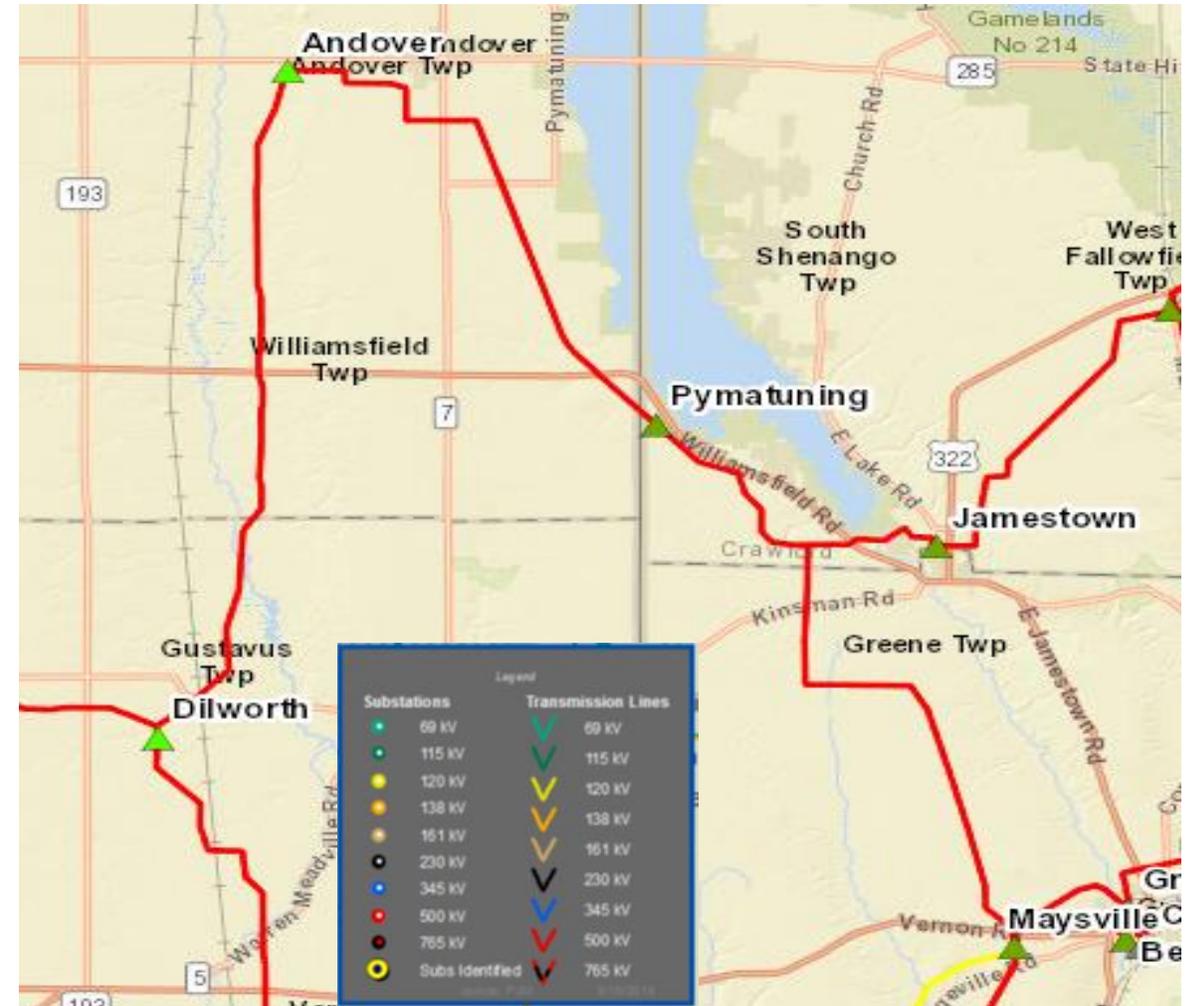
Dilworth-Maysville 69kV (~11.4 miles) Transmission Line:

- Line was originally constructed in 1947. The average age of structures on this line are 58 years old. FirstEnergy has historically experienced an average age of reject for wood poles to be 48.7 years.
- Line survey in 2019 showed a structure reject rate of 57% (166 of 293). The primary reasons for reject were wood pole deterioration, broken static wire, woodpecker holes, broken conductor strands.
- Existing 336.4 ACSR has a history of failure due to conductor vibration resulting in thermal overload and corrosion of steel core.
- Environmental conditions on ROW causes difficulties for routine maintenance, vegetation management, and outage restoration.
- Growing trend in unscheduled interruptions with 10 outages in the past two years with approximately 15,000 customers impacted in the area.
- Obsolete line switch (A-212 N.O.) is no longer supported by the manufacturer.

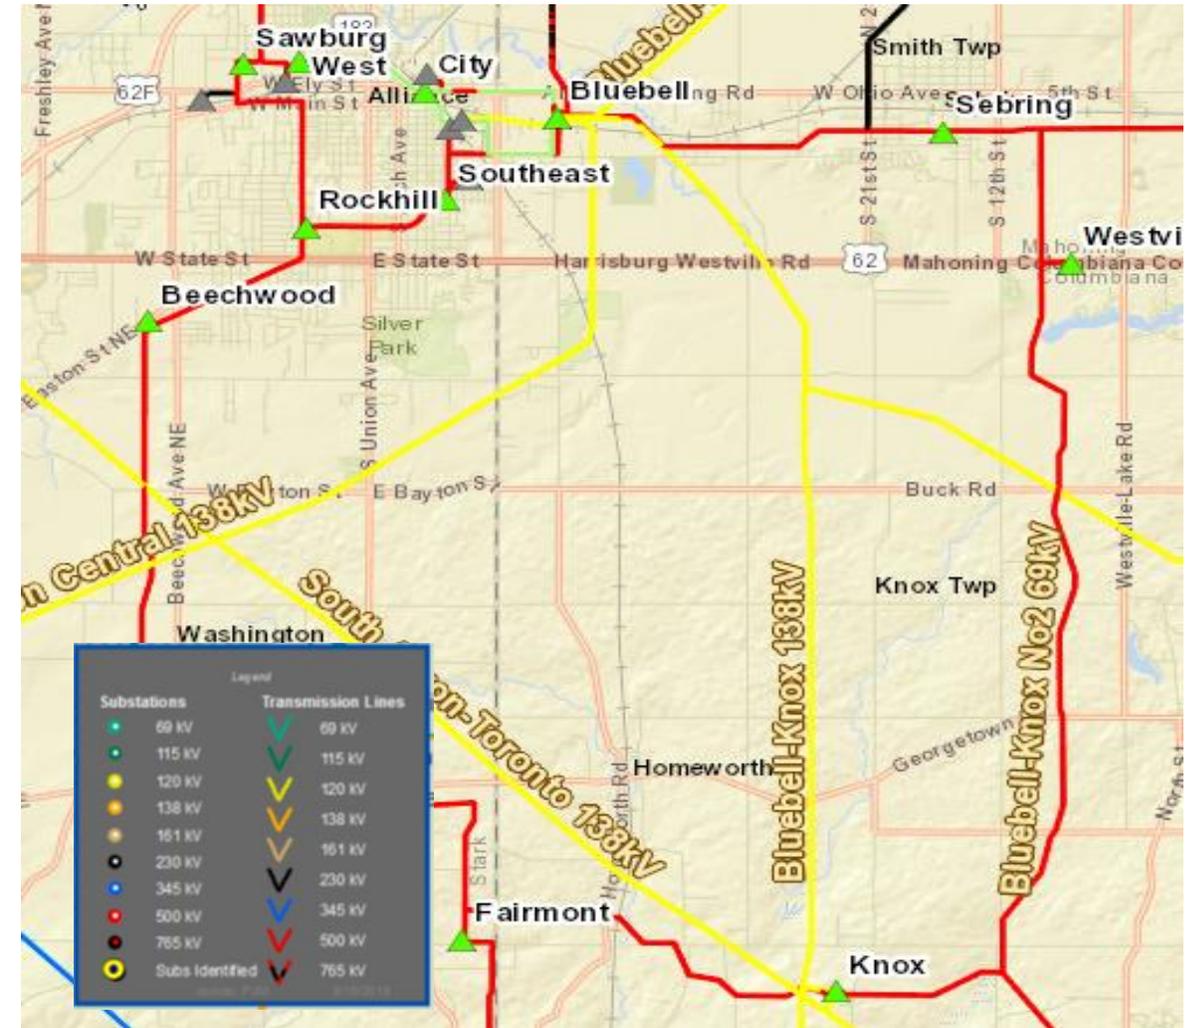
Bluebell-Knox No1 69kV (~16 miles) Transmission Line:

- Original H-frame wood pole construction dating back to 1970s.
- Line survey in 2020 showed a structure reject rate of 92% (242 of 262). The primary reasons for reject were large woodpecker holes, wood pole decay, and pole top extensions previously used to mitigate the issue of pole top rot, an indicator that the pole is deteriorating.
- Obsolete line switches (A-6935 & A-6936) are no longer supported by the manufacturer.
- Growing trend in unscheduled interruptions with six (6) equipment caused outages in the past 5 years for cross-arm failures and pole failures; Outages have historically had a large impact on customers interrupted and customer minutes interrupted.
