# Sub Regional RTEP Committee: Western AEP Supplemental Projects

January 21, 2022

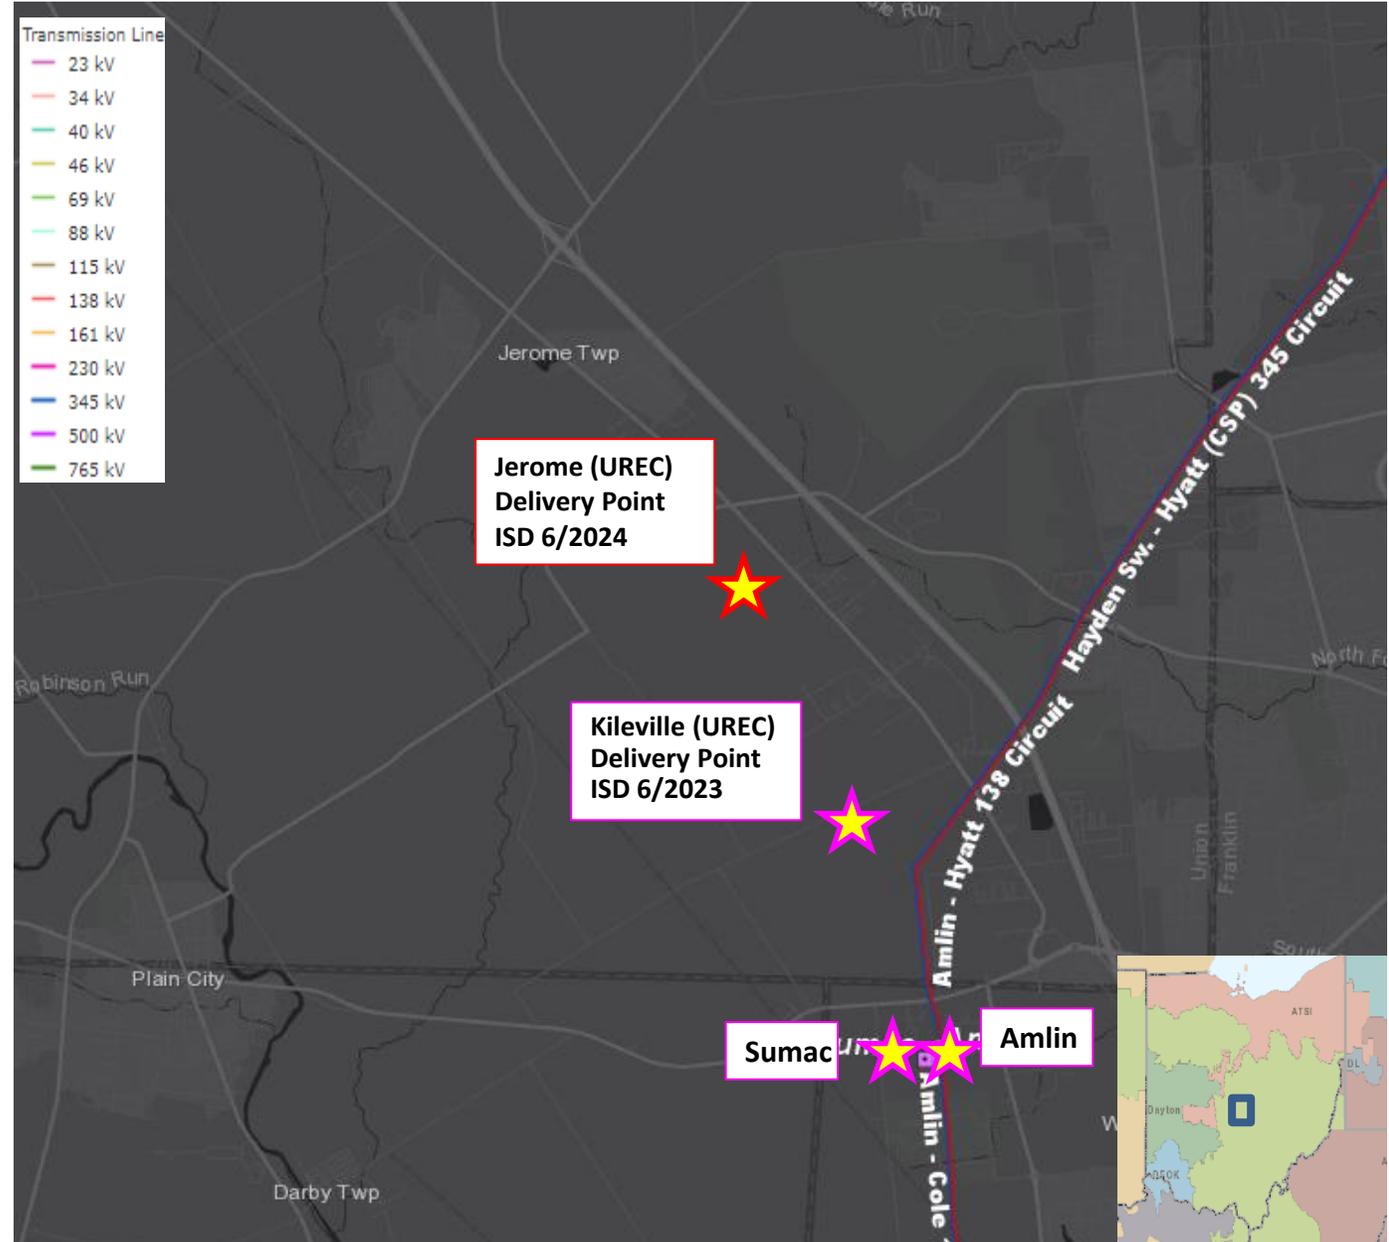
**Need Number:** AEP-2021-OH049

Jerome Delivery Point (UREC) 138 kV:

- Buckeye Power Inc., on behalf of Union Rural Electric Cooperative Inc., has requested new transmission service in Plain City, Ohio.
- The delivery point will be used to serve a customer with high potential for rapid load growth. The initial load will be ~~62.5~~ **106** MW with a potential future peak load demand of ~~250~~ **244** MW.
- Service is requested by ~~January 2025~~ **June 2024**.
- **The customer recently communicated a much more aggressive load ramp/build out schedule that would put their peak load at approximately 160 MW by early 2025 at the site.**

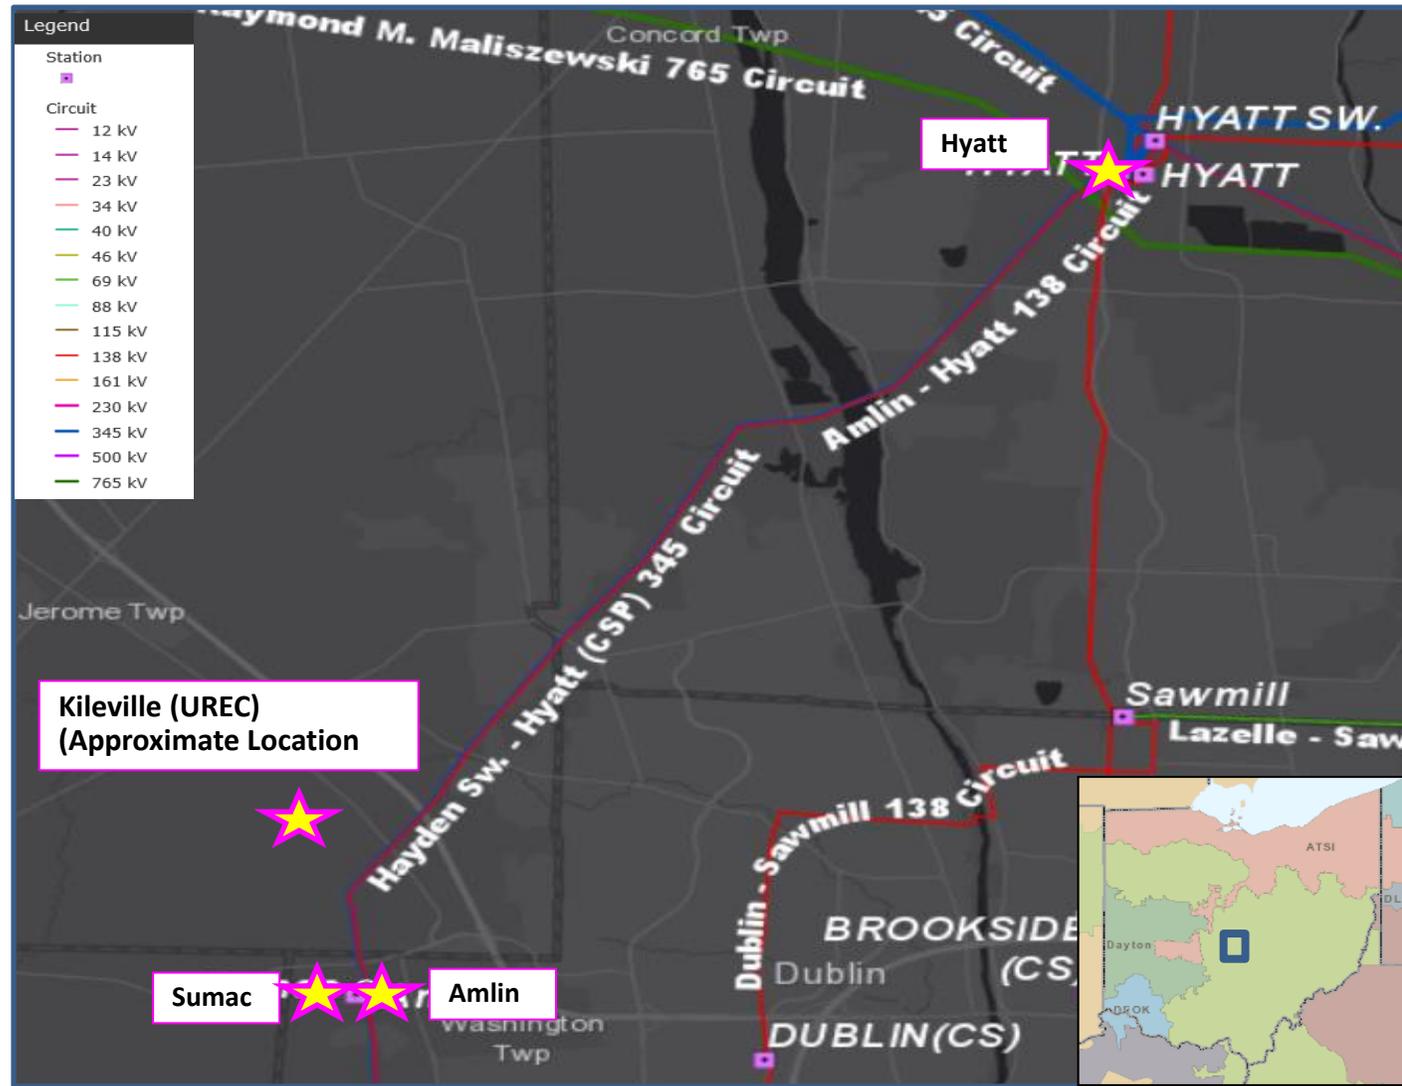
**Need Number:** AEP-2021-OH040

Kileville Delivery Point (UREC) 138 kV:

- Buckeye Power Inc., on behalf of Union Rural Electric Cooperative Inc., has requested new transmission service in Plain City, Ohio.
- The delivery point will primarily be used to serve a large data center customer with high potential for rapid load growth. The Initial load will be 40-106 MW with a potential future peak load demand of 240 MW.
- Service is requested by June 2023.
- **The customer recently communicated a much more aggressive load ramp/build out schedule that would put their peak load at approximately 160 MW by the middle of 2024 at the site.**

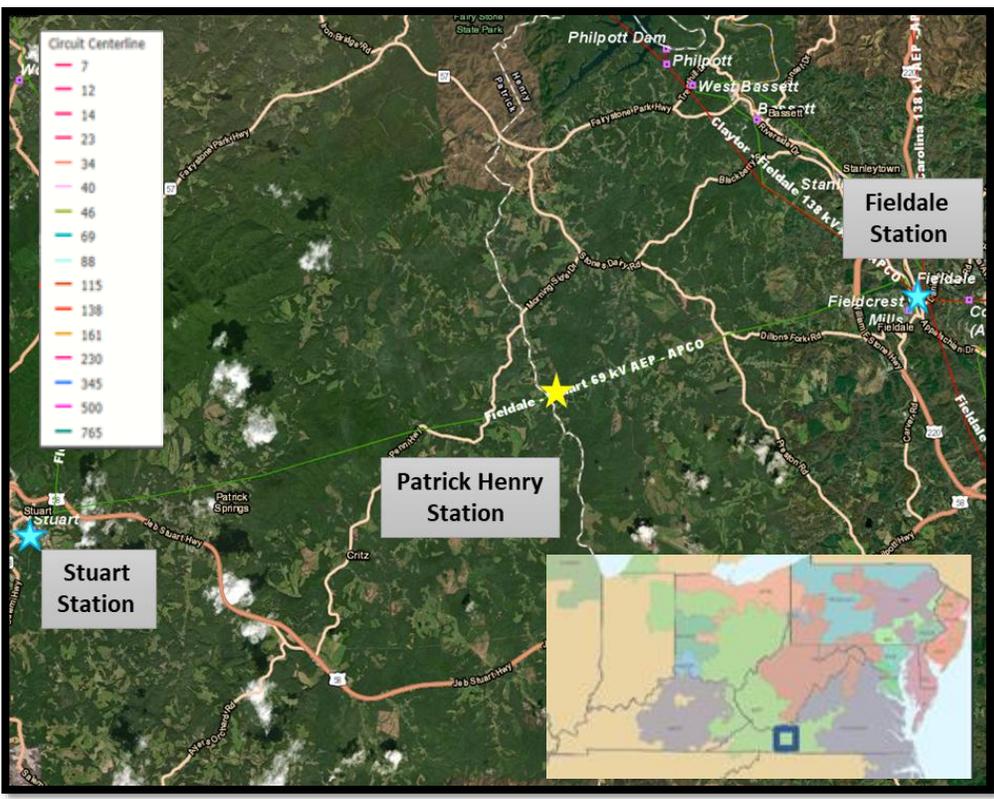
**Need Number:** AEP-2022-AP001

- The Stuart/Critz 34.5 kV circuit averages 945,000 customer minutes of interruption (CMI) per year during the last nine years (considering permanent outages only). There are over 2800 customers served from the Critz circuit over 263 line miles, making it one of the largest 34.5kV distribution circuits in VA. The projected winter peak is 19.1 MVA.

- This new delivery point request will reduce load and exposure on the West Bassett/Blackberry (111 miles), Stuart/Critz (263 miles), and Fieldale/Rangeley (118 miles) 34.5 KV distribution circuits and create a tie to the Fieldale/Carver (75 miles) 34.5kV circuit to improve area transfer capability.

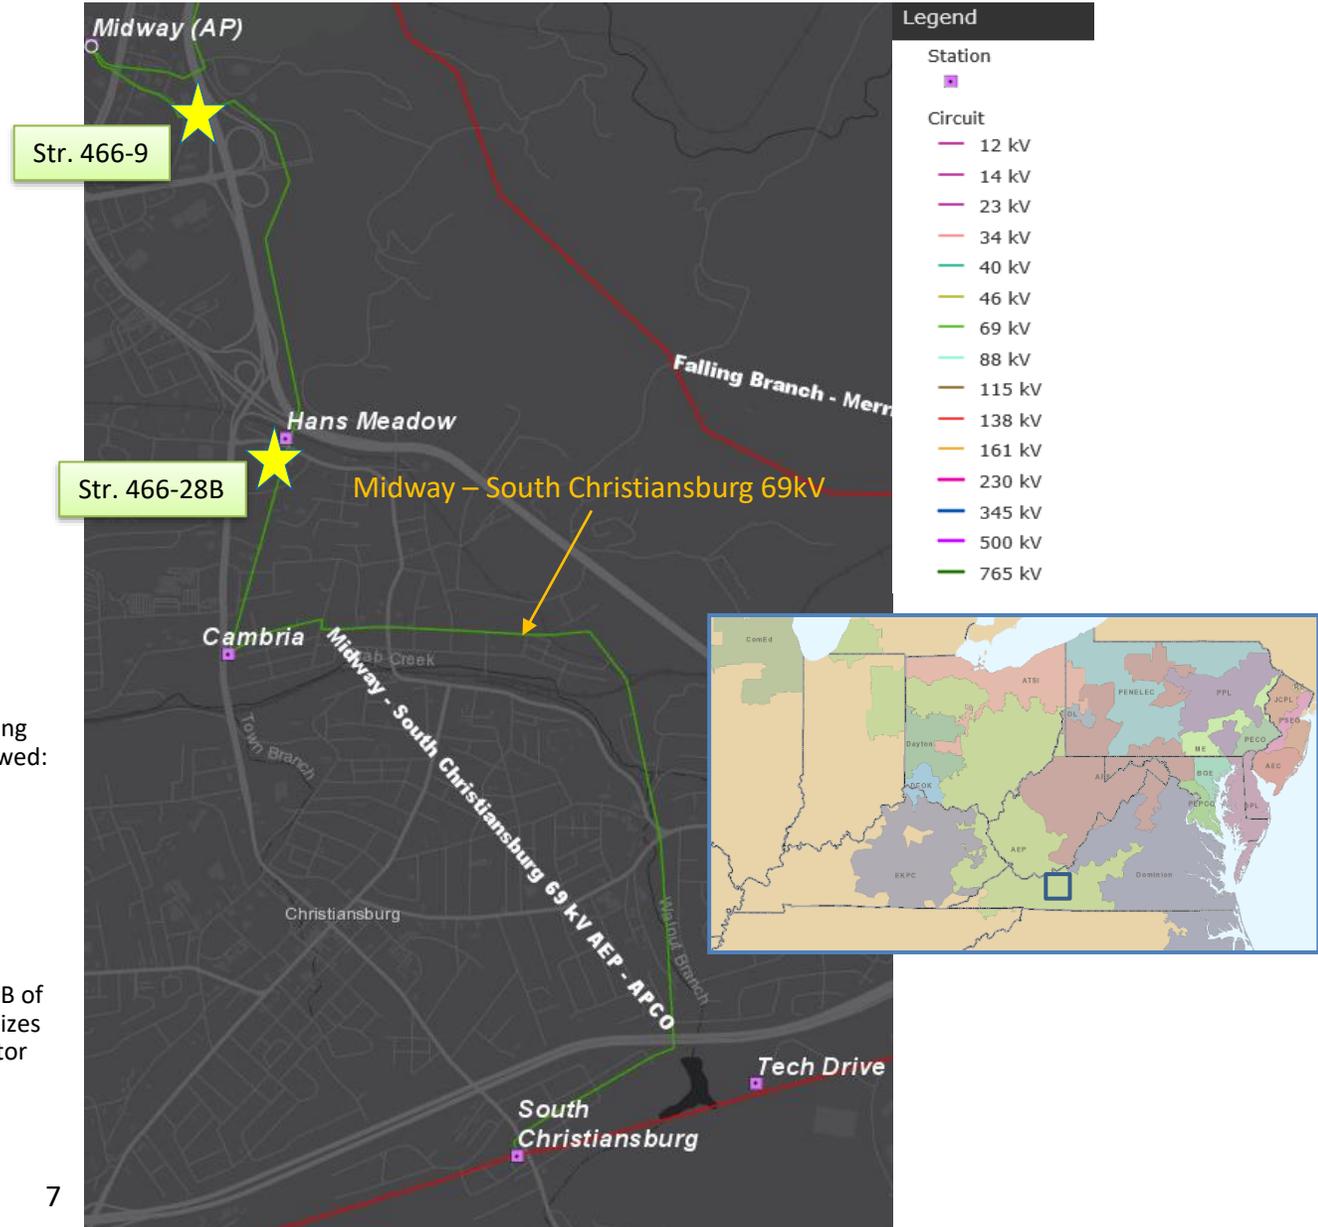
**Need Number:** AEP-2022-AP003

- The line structures fail to meet 2017 NESC Grade B loading criteria, current AEP structural strength requirements, and the current ASCE structural strength requirements.

- The vertical post insulators on the line do not meet current AEP standards for CIFO and minimum leakage distance requirements.
- Additional assessments were taken on a representative sample of the 1960s era structures, indicating numerous conditions that are expected to be present on the remainder of the line. The results showed:

- Pole top weathering on multiple structures
  - Weathered/splitting/cracking crossarms
  - Woodpecker damage
  - Corroded hardware and insulator end fittings

- 19 structure related open conditions affecting the crossarm, knee/ vee brace, or pole including rot, damaged, and insect damage conditions.
- 80 of 111 structures are 1960s vintage. There is a 1.3 mile segment from Structure 466-9 to 466-28B of more recent construction associated with the previous widening of U.S. Route 460. This section utilizes 14 steel poles installed in 2007 and 7 wood poles installed in 1999 or 2007. In addition, the conductor on this section is 2007 vintage 556,500 CM ACSR 26/7 (Dove) and is not a need at this time.

- 16 independent structures with at least one open condition, 18% of the structures on this circuit, excluding the 21 structure segment from Structure 466-9 to 466-28B.

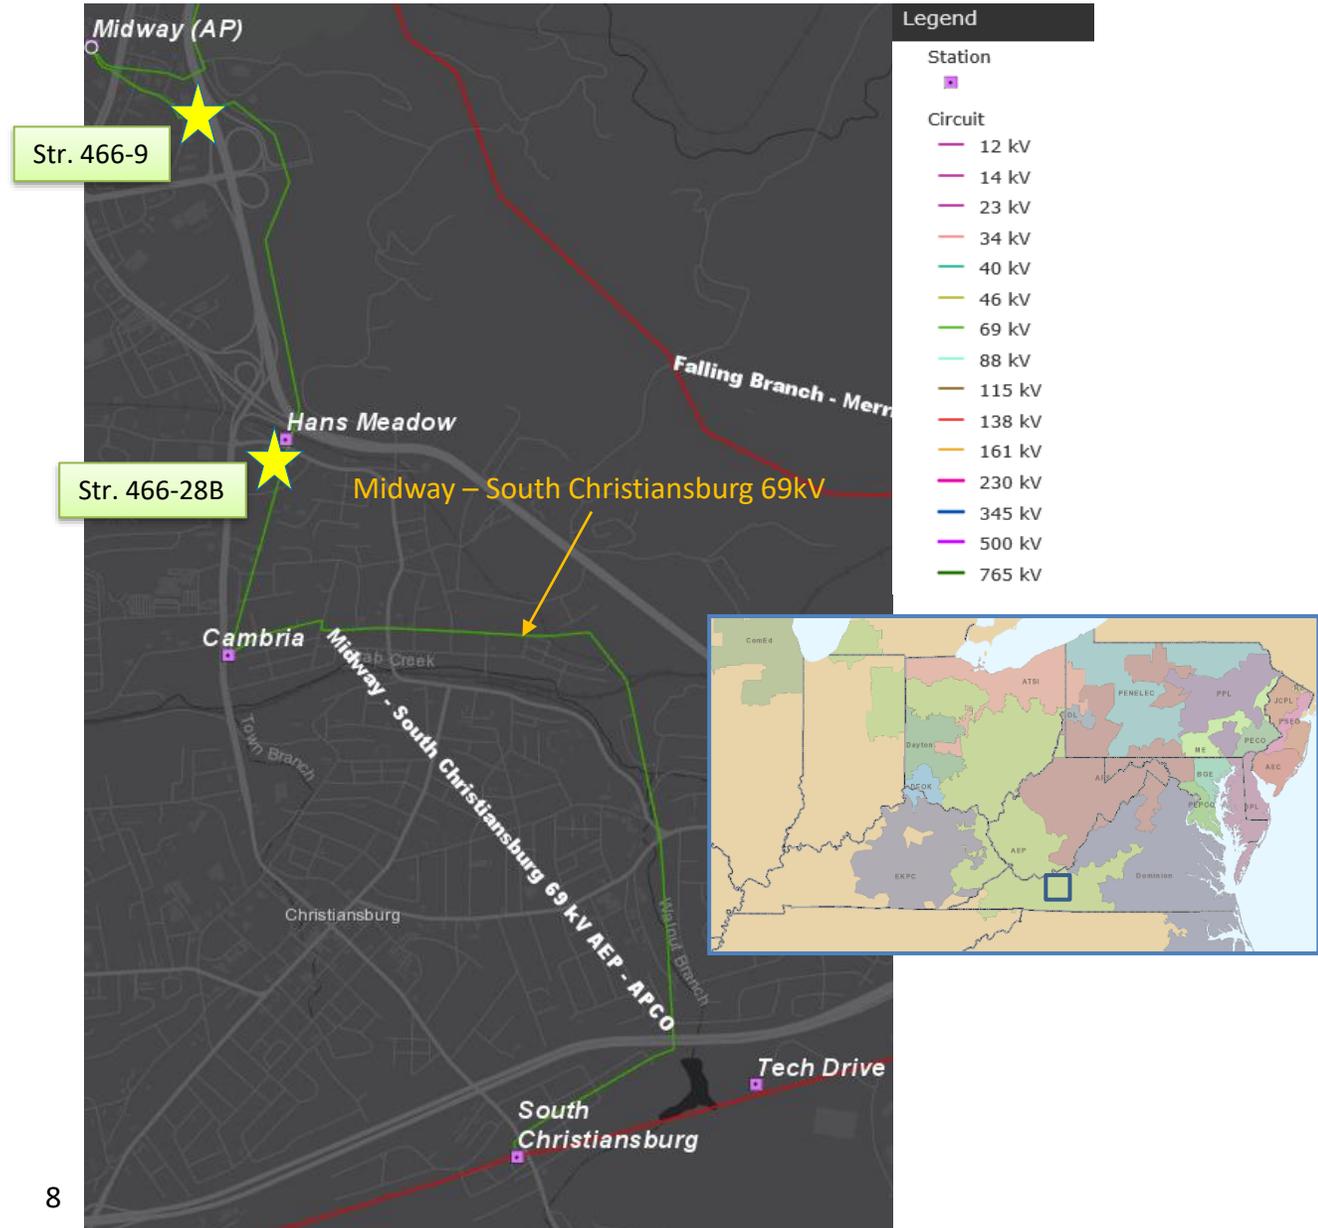
**Need Number:** AEP-2022-AP003

- The butt wrap grounding and typical shield angle is inadequate per current AEP Standards and can cause poor lightning performance. The current grounding system, poor shielding angle, and the electrical strength of the insulators do not meet current AEP and industry accepted criteria, making the line susceptible momentary and permanent outages, affecting customer reliability.
  - The inadequate grounding limits the available path to ground during any type of line fault, increasing the intensity the conductor and related hardware have to withstand during the fault. The reduced electrical strength of the insulators could lead to electrical damage to structures and hardware during a fault if the insulator were to fail from elevated electrical stresses.
  - The line serves a peak load of 43 MVA at Cambria and Hans Meadow Substations.

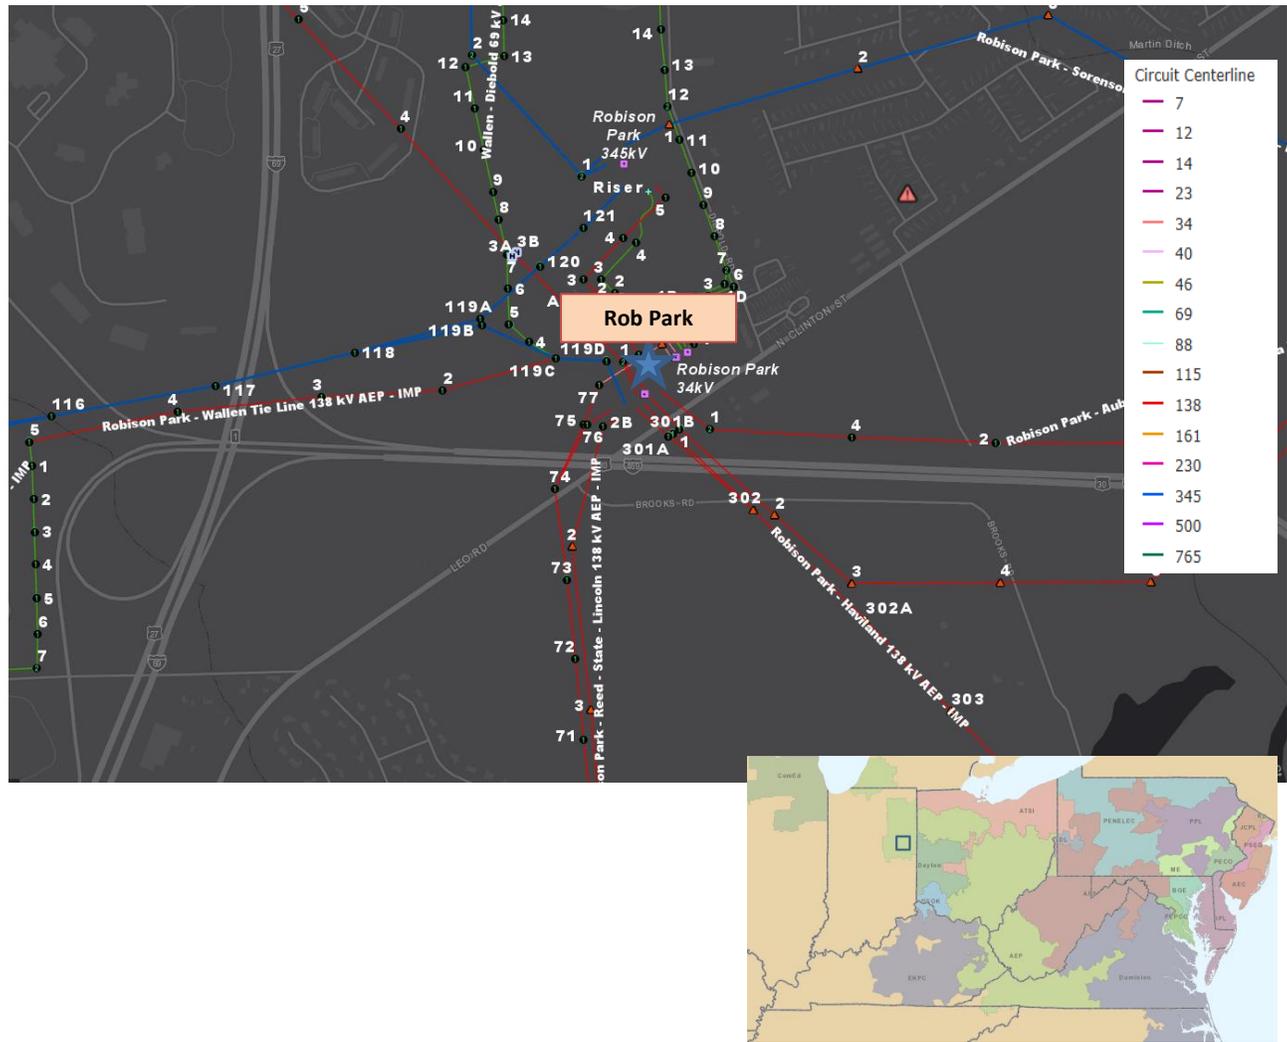
**Robison Park 34.5kV**

- 34.5kV Circuit Breaker S:
- 1956 FK Oil Breaker without oil containment
  - No longer vendor supported and spare parts are not available.
  - This type of breaker has a document history of failures in AEP including compressor failures, valve defects, trip failures caused by latching and motor component failures and contamination from aging gaskets.
- 34.5kV Ground bank:
- 1927 Unit with no oil containment
  - Elevated levels of CO, CO2, Ethylene, and Hydrogen indicating breakdown of the interior components of the unit
  - Extensive visual corrosion

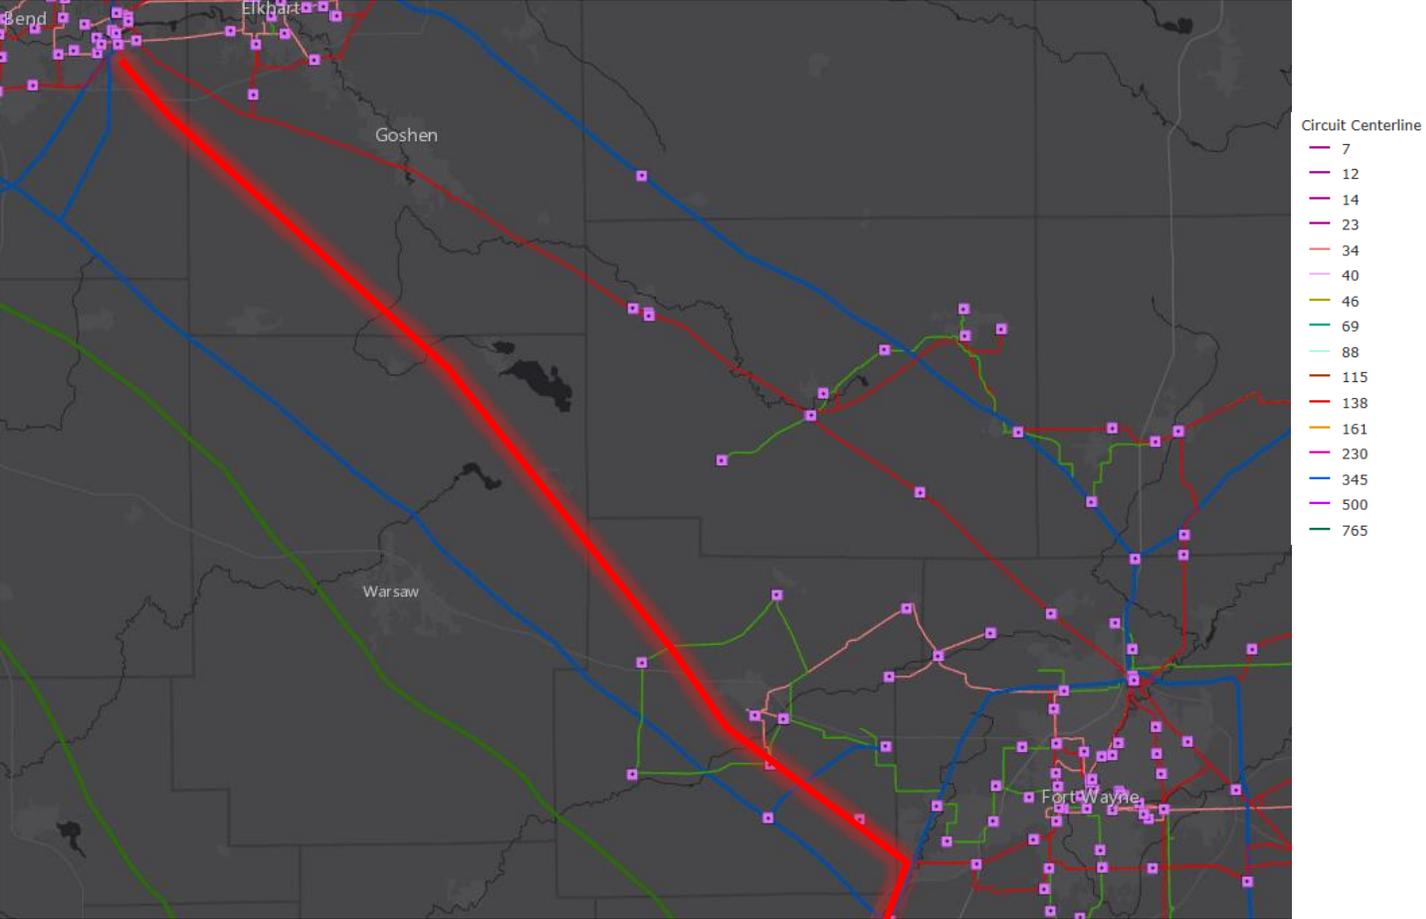
**Twin Branch - Sorenson 138kV line (65.1 miles):**

- Line is 1949 Steel lattice construction
- Since 2014 there have been 6 momentary outages to this line
- Currently there are 172 (47%) structures with at least one open condition.
- Currently there are 222 open conditions including damaged legs, broken strands, damaged conductor, broken shield wire strand, broken/burnt insulators, broken/burnt insulators, or broken and missing shield wire hardware.
- The Shielding Angle is inadequate for AEP standards which can lead to poor performance of the line for lightening strikes.

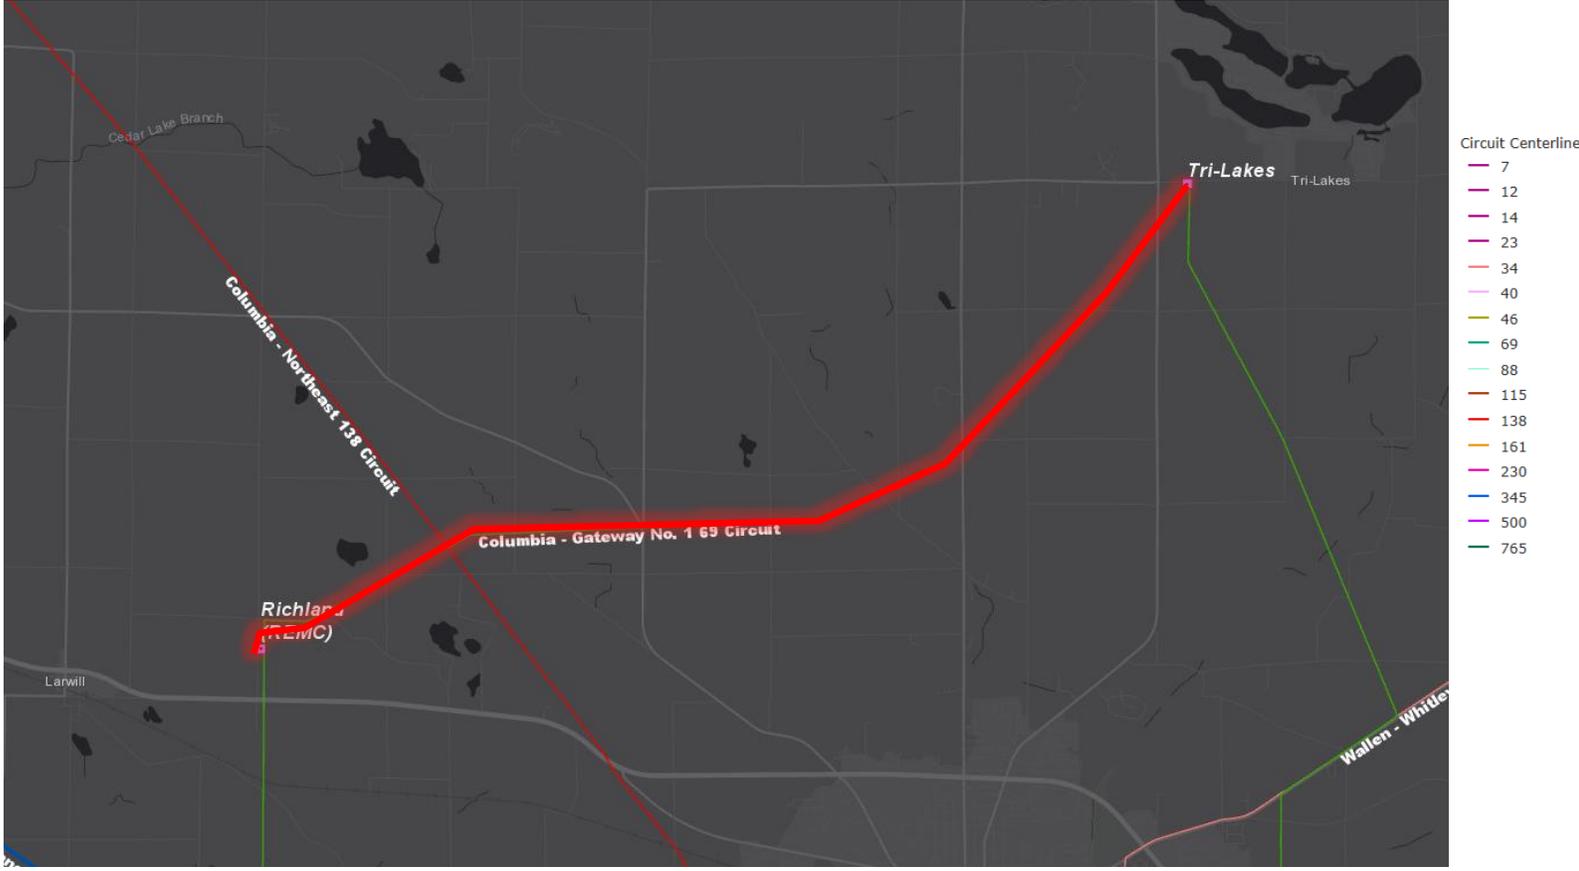
**Need Number:** AEP-2022-IM003  
**Process Stage:** Needs Meeting: 1/21/2022  
**Supplemental Project Driver:** Equipment Condition/Performance/Risk  
**Specific Assumption Reference:** AEP Guidelines for Transmission Owner Identified Needs (AEP Assumptions Slide 13)

**Model:** N/A  
**Problem Statement:**  
 Line Name: Richland – Tri Lakes 69kV

Original Install Date (Age): 1965

- Length of Line: 8.66 Miles
- Total structure count: 122
- Original Line Construction Type: 1960s Wood Pole
- Conductor Type: 4/0 ACSR
- Outage History since 2015
  - Momentary/Permanent Outages and Duration: 20 Momentary and 6 Permanent
  - CMI: 125,904
- Condition Summary
  - 71 structures (58%) have at least one open condition including cracked, rotten, woodpecker damaged and leaning poles; Chipped, Loose, Contaminated and rusted Insulators.
  - 40 representative structures were assessed by drone with 12 assessed by a ground crew. Of these the following was observed
    - Wood decay was moderate to advanced on structures at ground line and poles have rot top.

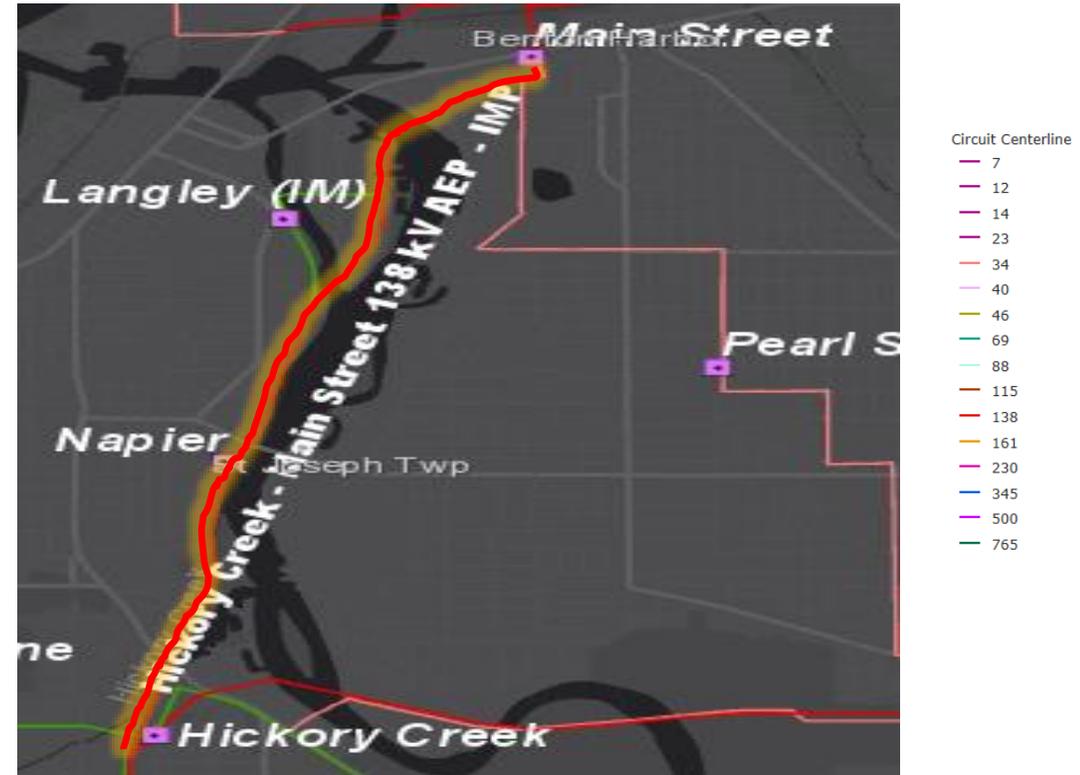
**Need Number:** AEP-2022-IM004

- Structures fail NESC Grade B and AEP Strength requirements. Grounding methods utilize butt wraps on every other structure, which is inadequate for current AEP standards

- 40 representative structures were assessed by ground and drone
  - 50% have ground line heart and/or shell rot
  - High percentage of wood poles have woodpecker damage and moderate to advanced wood decay from insect and bird damage

- There are 11 structures with at least one documented open condition not included in the ground and aerial assessment.

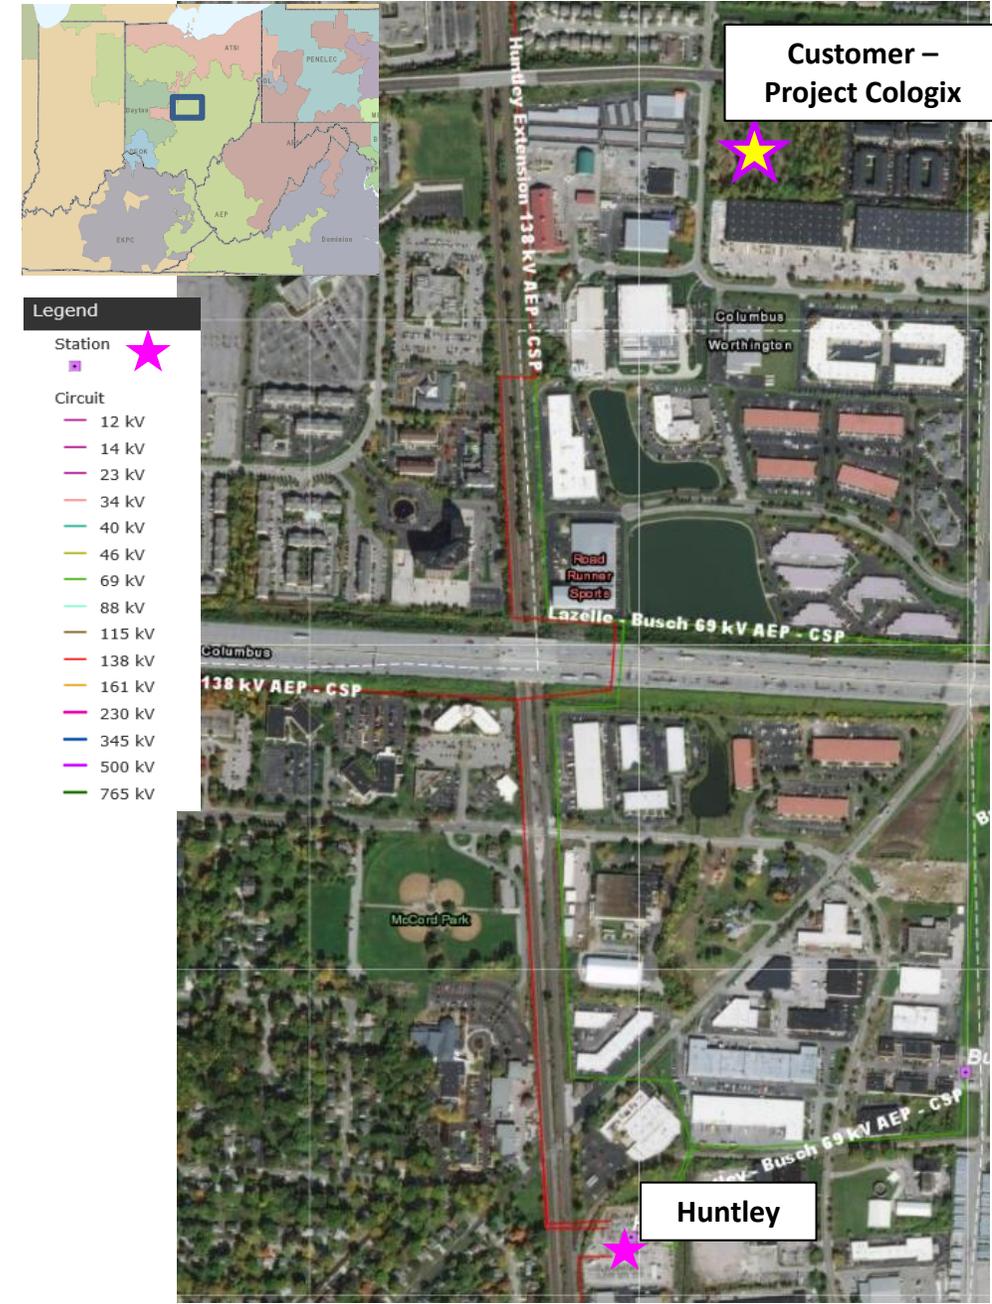
**Need Number:** AEP-2022-OH001

- A customer has requested transmission service at a site North of AEP's existing Huntley station in Worthington, OH.
- The customer has indicated a demand of 40 MW at the site.
- They are seeking an in service date of 4/1/2023 for their permanent transmission service.

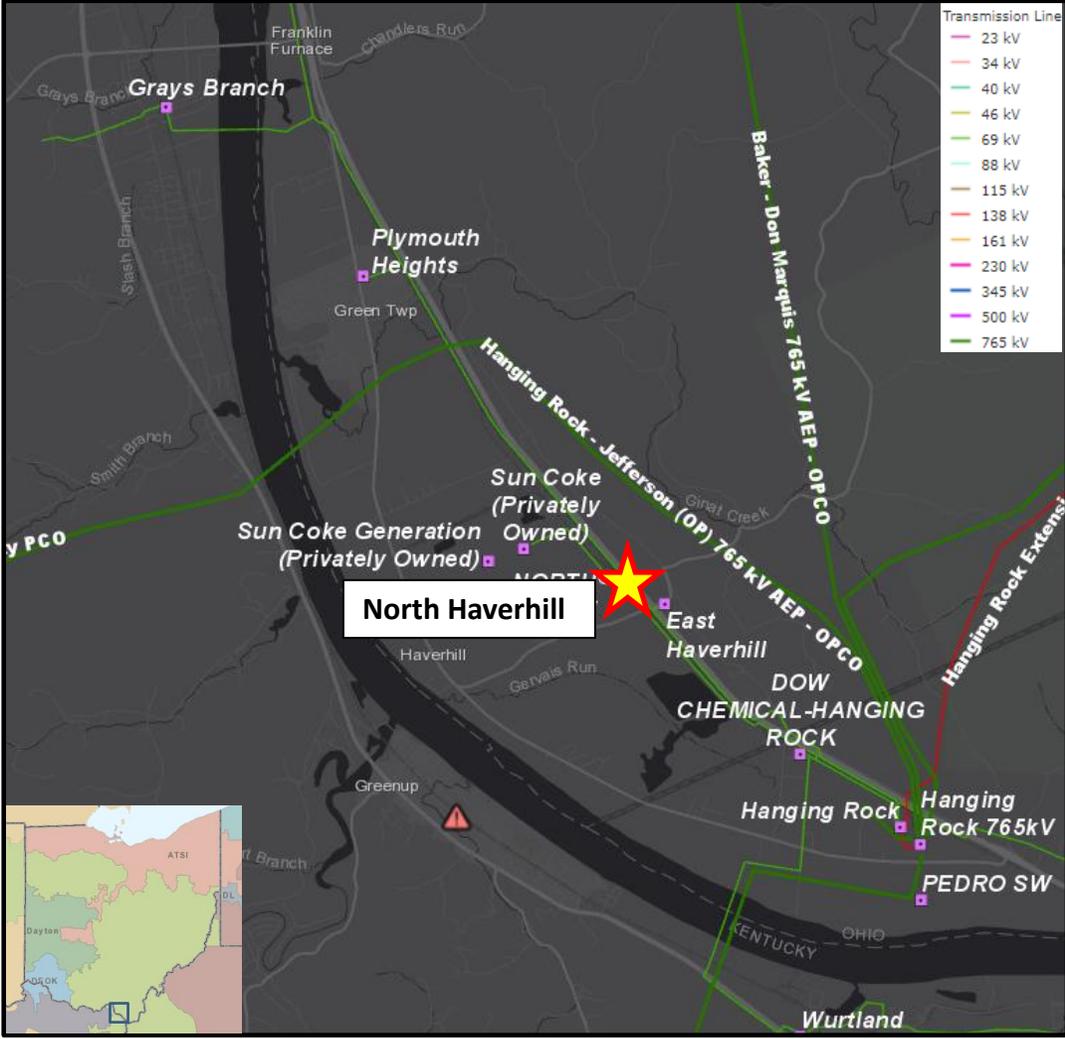
**Need Number:** AEP-2022-OH002

- Breaker Age: 1968 (M), 1977 (P)
- Interrupting Medium: (Oil)
- Fault Operations:
  - Number of Fault Operations: M-13 & P-36
- These breakers are oil filled without oil containment; oil filled breakers have much more maintenance required due to oil handling that their modern, SF6 counterparts do not require. This model family has experienced major malfunctions associated with their hydraulic mechanisms, which includes low-pressure readings, hydraulic leaks, pump lockouts, and failure to shut off. These mechanism malfunctions have led to several failures to close and other types of mis-operations across the AEP fleet.

This family of circuit switchers have no gas monitor and currently in-service units on the AEP System have experienced 80 malfunctions from May 2002 to August 2019. The major malfunction events include gas loss, interrupter failures, operating mechanism failures, and trip or reclose failures. Models manufactured from January 1986 to December 1995 have a high potential for broken spring carriers in the low gas target assembly. This component malfunction presents the possibility of an actual low gas situation going unnoticed due to the indicator not activating. Interrupters can only be replaced, not repaired, as they are hermetically sealed.

- Currently, 65 of the 65 relays (100% of all station relays) are in need of replacement. 38 of these are of the electromechanical type and 2 of the static type which have significant limitations with regards to spare part availability and fault data collection and retention as these relays are no longer supported by the manufacturer. There are also 25 microprocessor based relays commissioned in 2004-2009 that have firmware that is no longer supported.

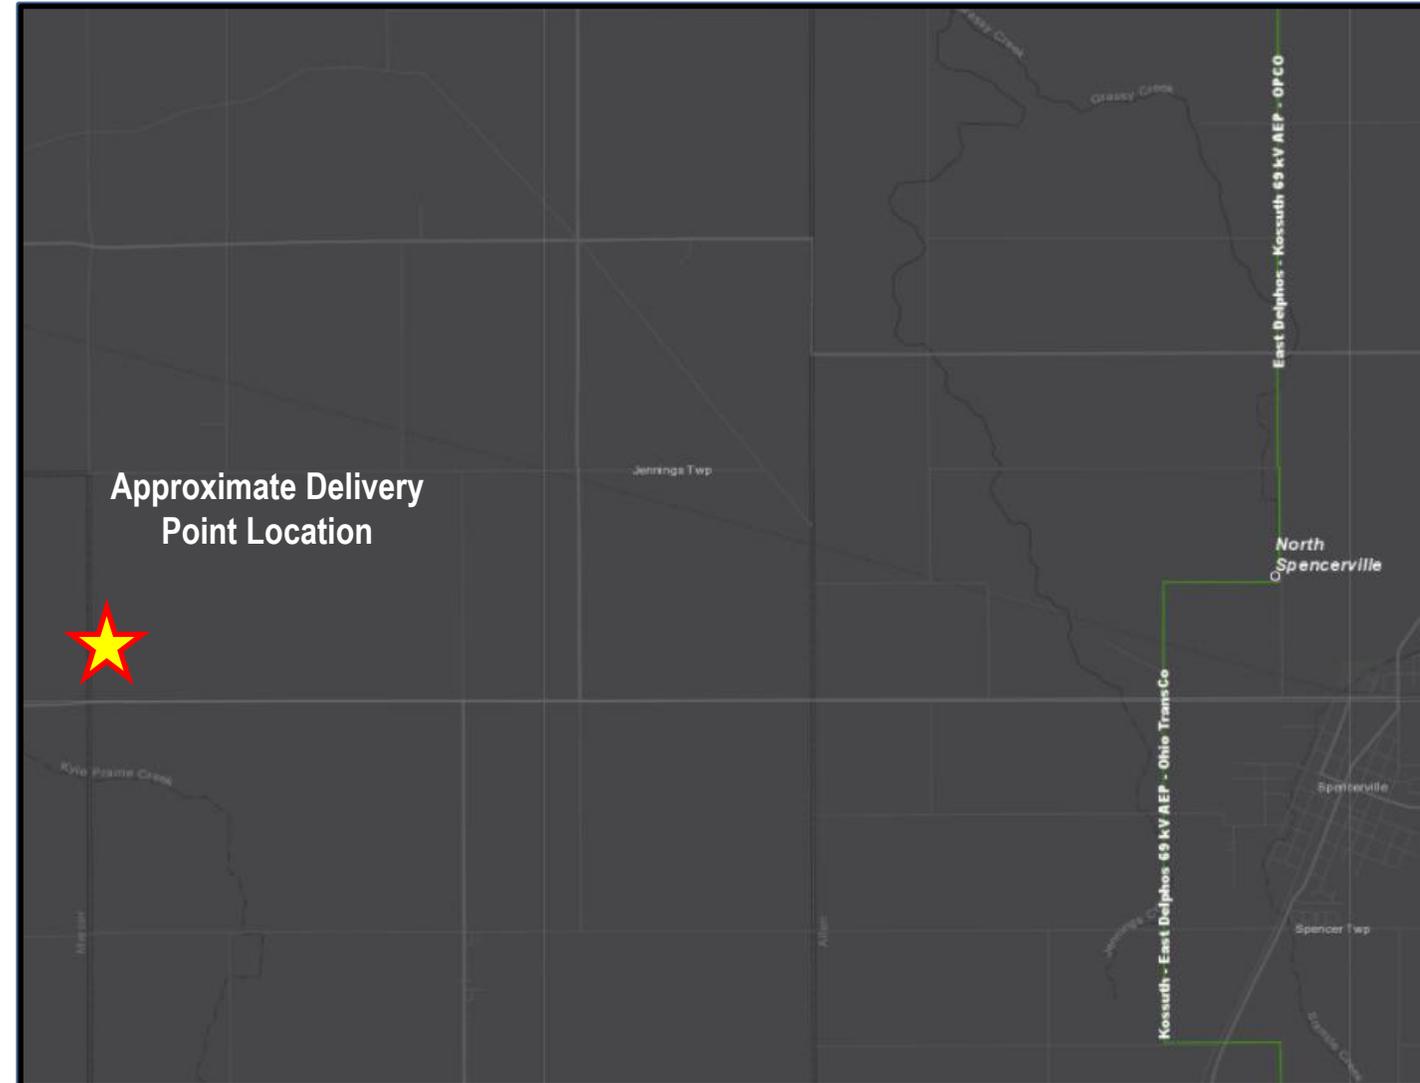
**Need Number:** AEP-2022-OH004

Buckeye Power has requested a new 69kV delivery point in Van Wert County Ohio on behalf of Midwest Electric, Inc. The projected demand at the delivery point is 3.3 MW with an expected annual growth rate of 1.0%. Emergency loading is projected to be 4.9 MW.

They are seeking an in service date of December 2024 for the delivery point.

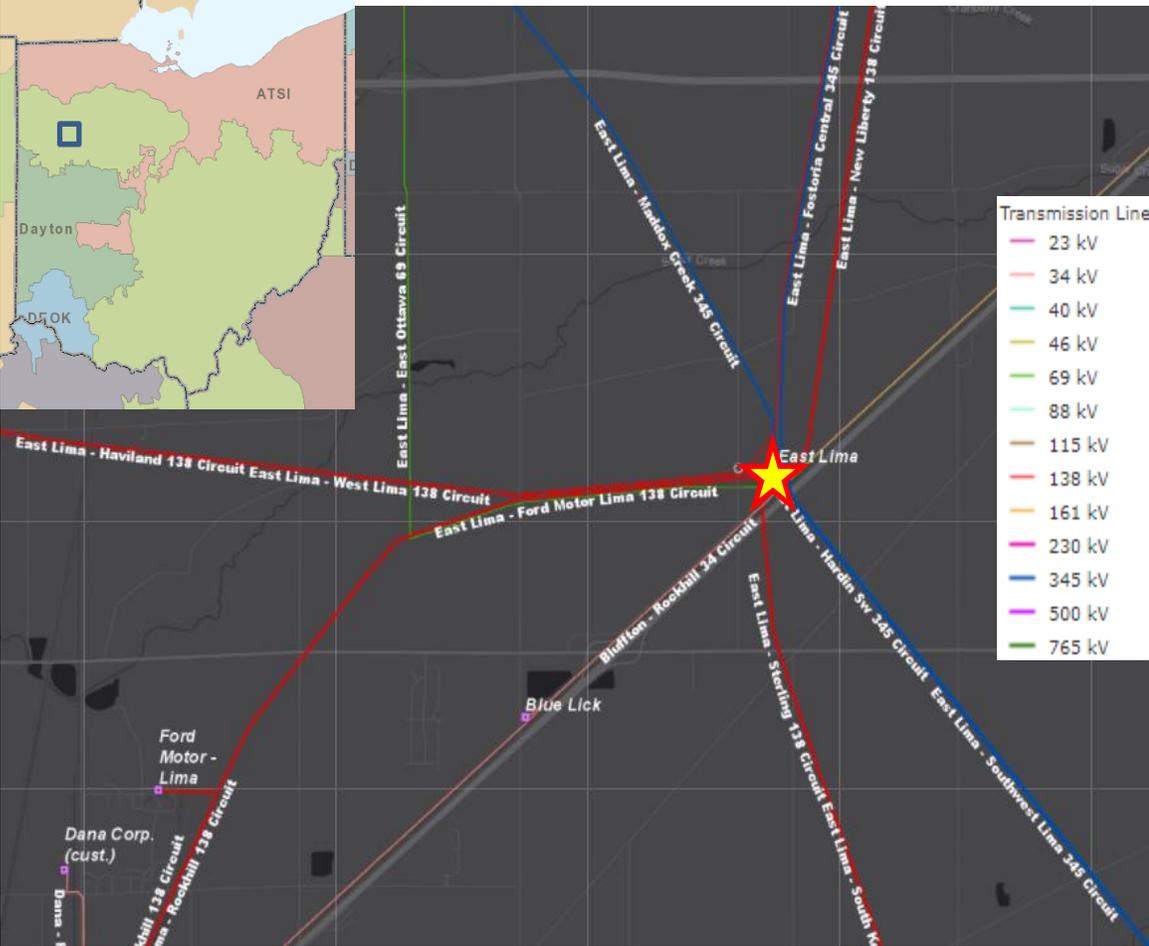
**Need Number:** AEP-2022-OH006

- Breaker Age: U 1967, V 1967
- Interrupting Medium: (oil)
- Fault Operations:
  - Number of Fault Operations: U 107, V 68
  - Manufacturer recommended Number of Operations: 10

- **Additional Breaker Information:** These breakers are CF-48-69-2500 type oil breaker. These breakers are oil filled without oil containment; oil filled breakers have much more maintenance required due to oil handling. Manufacture support and spare parts are not available. This model family uses the OA-3 hydraulic mechanism, which has been associated with several mis-operations across the AEP fleet.

- **Relays:** Currently, 70 of the 129 relays (54% of all station relays) are in need of replacement. 54 of these are of the electromechanical type and 2 of these are of the static type which have significant limitations with regards to spare part availability and fault data collection and retention. 14 relays are microprocessor type outside of their life expectancy

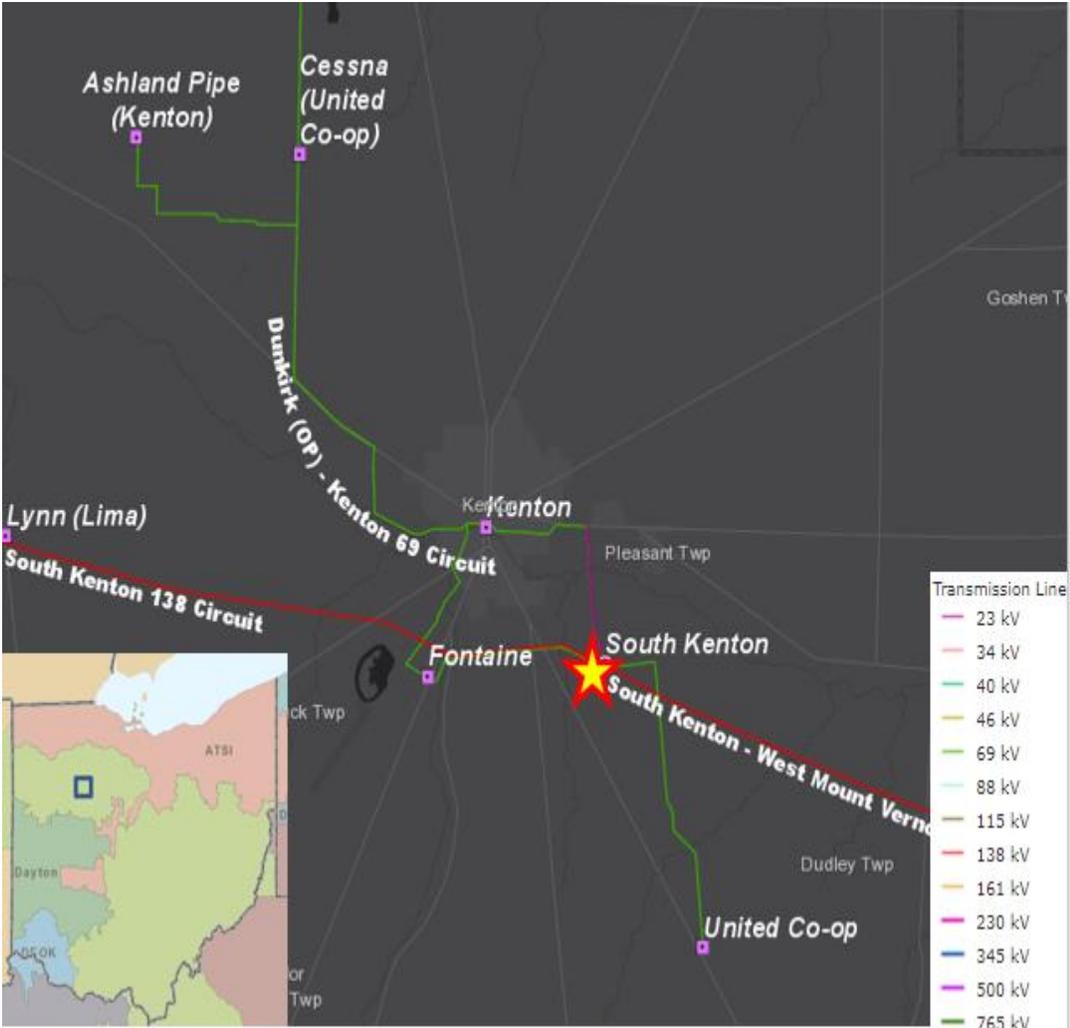
**Need Number:** AEP-2022-OH007

- Breaker Age: A 1953 (138 kV), B 1952 (138 kV), E 1954 (69 kV)
- Interrupting Medium: (Oil)
- Fault Operations:
  - Number of Fault Operations: A 42, B 49, E 26
  - Manufacturer recommended Number of Operations: 10
- Additional Breaker Information: These breakers are FK-439. These breakers are oil filled without oil containment; oil filled breakers have much more maintenance required due to oil handling. Manufacture support and spare parts are not available.

**Relays:** Currently, 56 of the 61 relays (92% of all station relays) are in need of replacement. These relays are the electromechanical type which have significant limitations with regards to spare part availability, fault data collection, and data retention. Station also utilized legacy pilot wire schemes.

**Transformers:** The 138/69kV 15MVA transformer #3 & #2 (both 1962 vintage) are recommended for replacement due to short circuit strength breakdown and dielectric strength breakdown of the oil, reducing the ability of the units to withstand through fault current. These transformers have horizontal bushings which increase the difficulty of routine station maintenance. The transformers are currently operated in parallel with one another.

Transformers #2, #3, and the 138 kV bus are all in the same zone of protection due to lack of sectionalizing on the transformers.
