# Sub Regional RTEP Committee: Western AEP Supplemental Projects

January 21, 2022

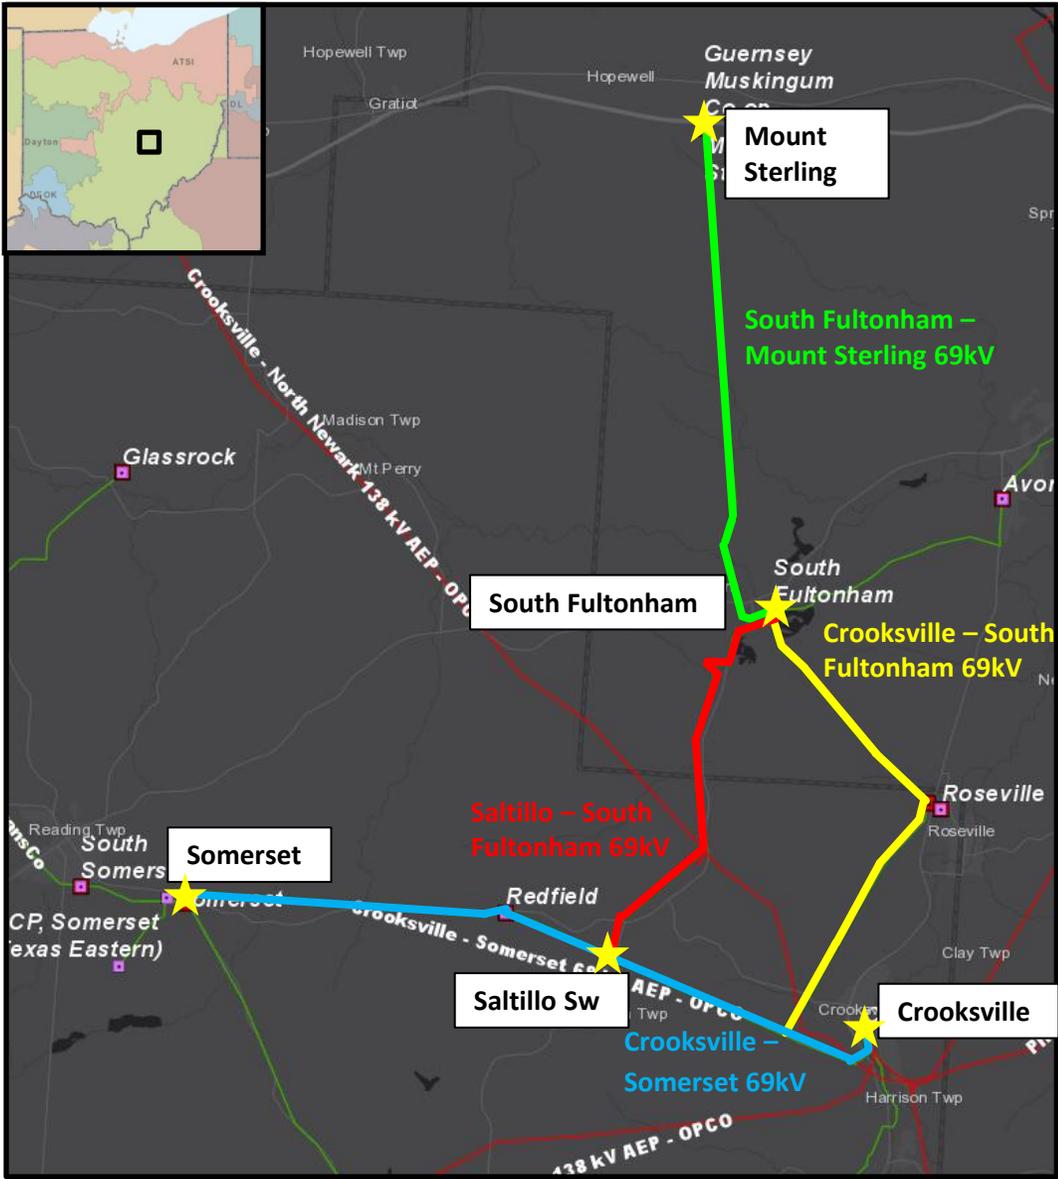
**Need Number:** AEP-2022-OH008

- Line Length: ~10.4 Miles
- Total Structure Count 150
  - Structure Type: Wood / Steel Lattice
- Conductor Type: 3/0 ACSR 6/1 (Pigeon), 2/0 Cu 7 (20COP), & 4/0 ALUM/6201
- Outage History: 12 Momentary and 4 Permanent Outages, total CMI = 25,389 between 11/2016 – 11/2021.
- Open Conditions: 64
  - 13 structure related open conditions including rust, rotted, broken, and burnt conditions, and vines.
  - 1 open condition related to burnt conductor.
  - 32 shielding/grounding conditions including broken and missing wires.
  - 18 hardware based open conditions consisting of burnt, broken, missing, and chipped insulators as well as damaged guy wires

Saltillo - South Fultonham 69 kV (1952):

- Line Length: ~5.91 Miles (Normally open point at Saltillo Switch towards Crooksville)
- Total Structure Count 58
  - Structure Type: Wood
- Conductor Type: 4/0 ACSR 6/1 (Penguin) and 4/0 ALUM ALLOY
- Outage History: 3 Momentary and 1 Permanent Outages between 11/2016 – 11/2021
- Open Conditions: 22
  - 5 open structure related conditions
  - 2 conductor related conditions
  - 3 shielding/grounding conditions and 12 hardware related conditions.

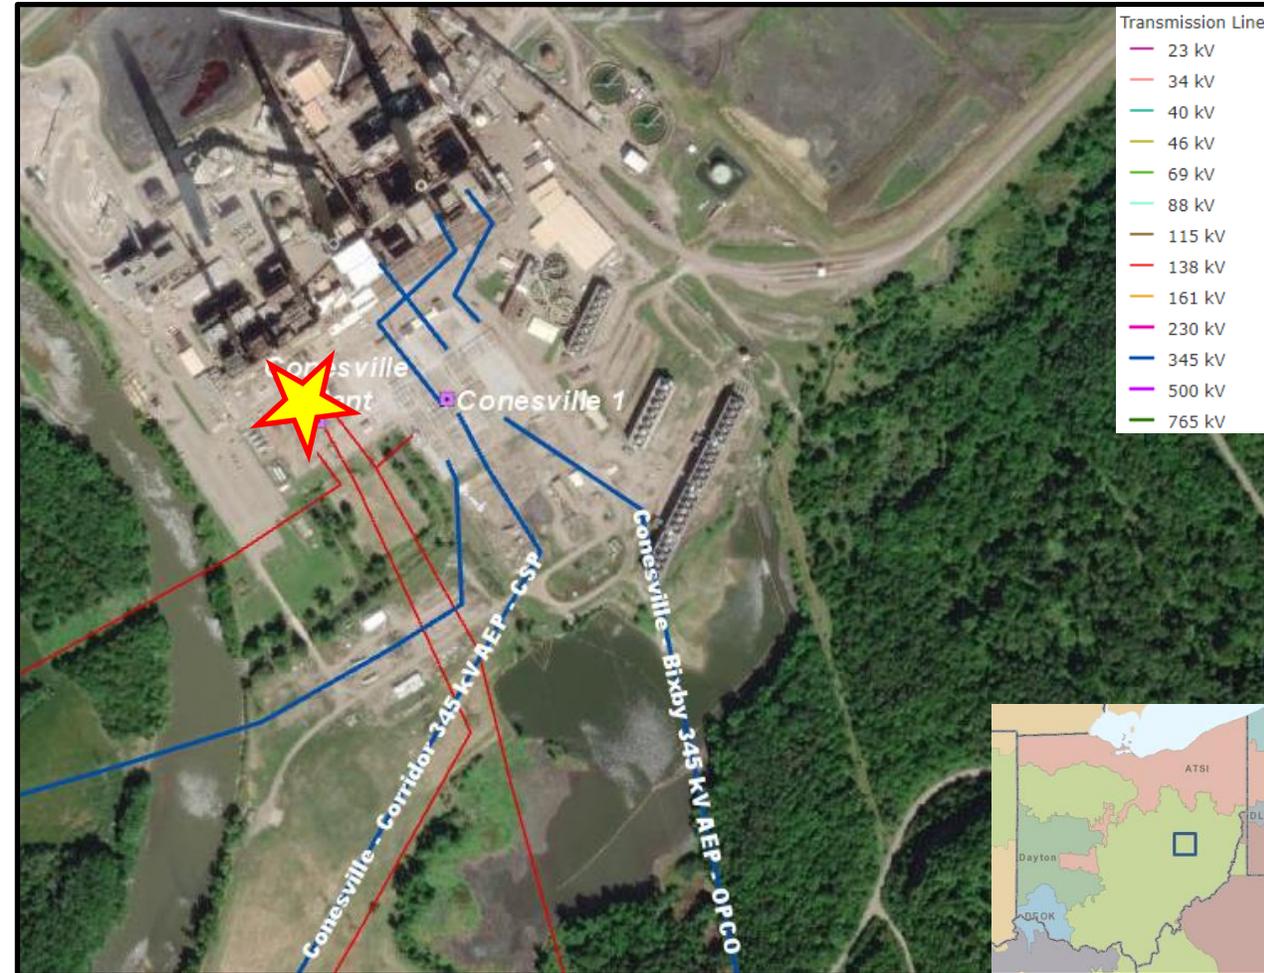
Conesville 138 kV Cap Bank BB (86.4 Mvar):

- This capacitor bank has experienced continuous can failures over the last 4 years.
  - 10/15/2021-10 cans
  - 08/4/2021-10 cans
  - 09/11/2020-2 cans
  - 03/31/2020-10 cans
  - 05/16/2017-4 cans
- After the last can failures in October of 2021 the capacitor was not put back into service until such time a long term solution could be evaluated to address the reoccurring issues. It was detiremented that the bank had seen several overvoltage events that had permanently damaged the capacitor due to it's lack of any voltage margin in it's design.

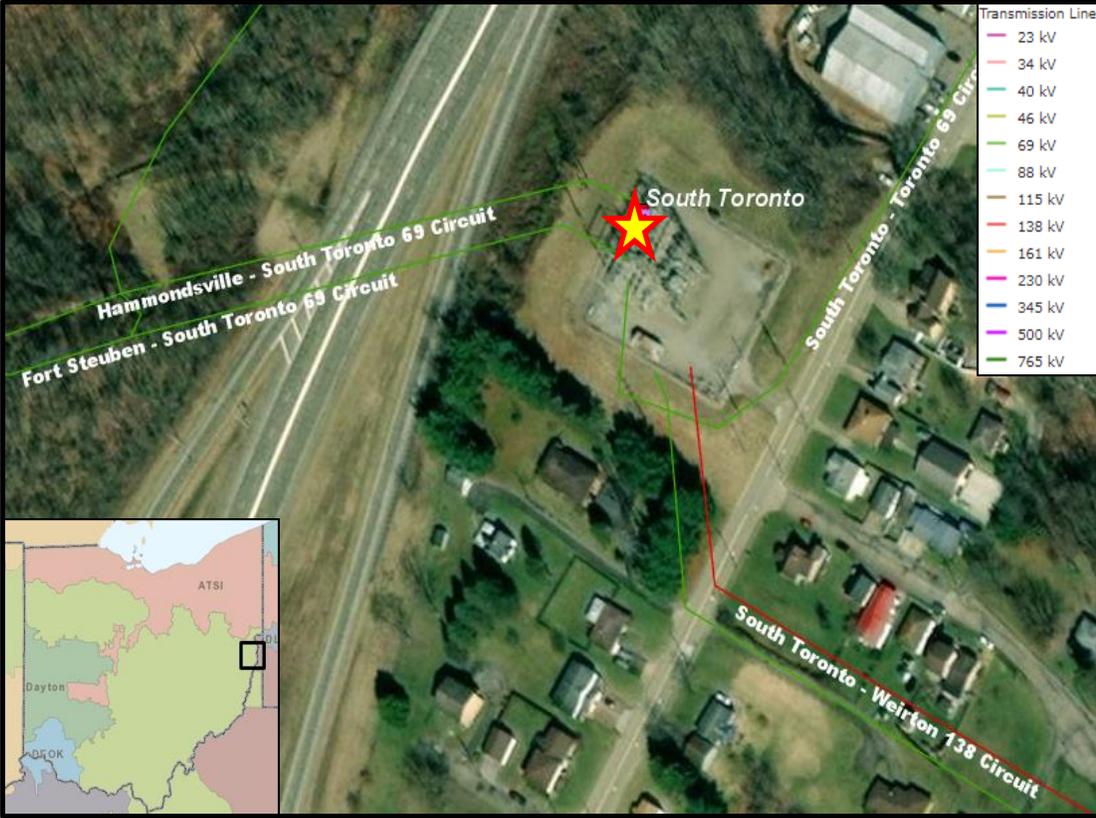
**Need Number:** AEP-2022-OH015

- Breaker Age: 1951
- Fault Operations: 23 (recommended manufacturers limit: 10)
- This breaker is oil filled without oil containment; oil filled breakers have much more maintenance required due to oil handling that their modern, SF6 counterparts do not require.

Relays: 42 of the 47 relays (89% of all station relays) are in need of replacement. 39 of these are of the electromechanical relays and there are 3 static relay types which have significant limitations with regards to spare part availability and fault data collection and retention. In addition, these relays lack of vendor support.

The 138/69kV transformer high-side protection consists of a 138kV ground-switch MOAB system, which requires remote-end fault clearing at FirstEnergy’s Weirton and Wylie Ridge 138kV stations, creating a 3-terminal line.

There are two 69kV T-line hard taps outside the station: one serving the Timet industrial customer, and one on the Ft. Steuben-Hammondsville 69kV circuit.

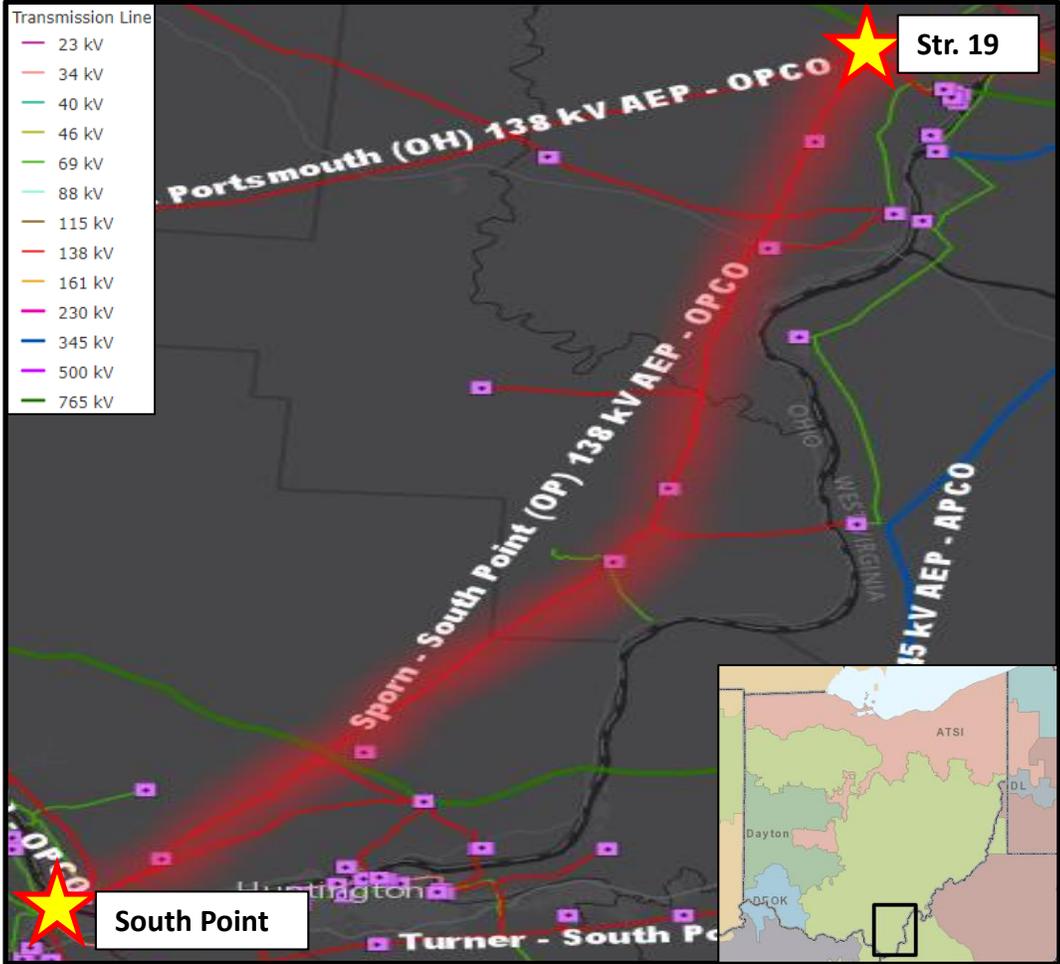
**Need Number:** AEP-2022-OH016

South Point – Sporn 138kV Line (South Point – Str. 19)

- 46 mile long line consisting of double circuit steel lattice towers with vertical and horizontal insulators, originally installed in 1925 with a 397,500 CM ACSR 30/7 (Lark) conductor.
- Outage History:
  - Momentary (22) & Permanent Outages (3)
  - CMI: 20,458 (Past Five Years)
- Total Structure Count: 179
  - Steel Lattice: 171 from 1925
  - Steel: 8 from 2015
- Open Conditions: 67 Total Conditions
  - There are 49 structures with at least one open condition, which relates to 27% of the structures on this line.
  - 3 structure based open conditions consist of bent legs 2 and brush clearance on tower brace 1.
  - 64 hardware based open conditions consists of broken insulators, burnt insulators, damaged body of hardware, damaged insulators, missing corona rings, rusty hardware, heavy rust on hardware, and worn hardware.

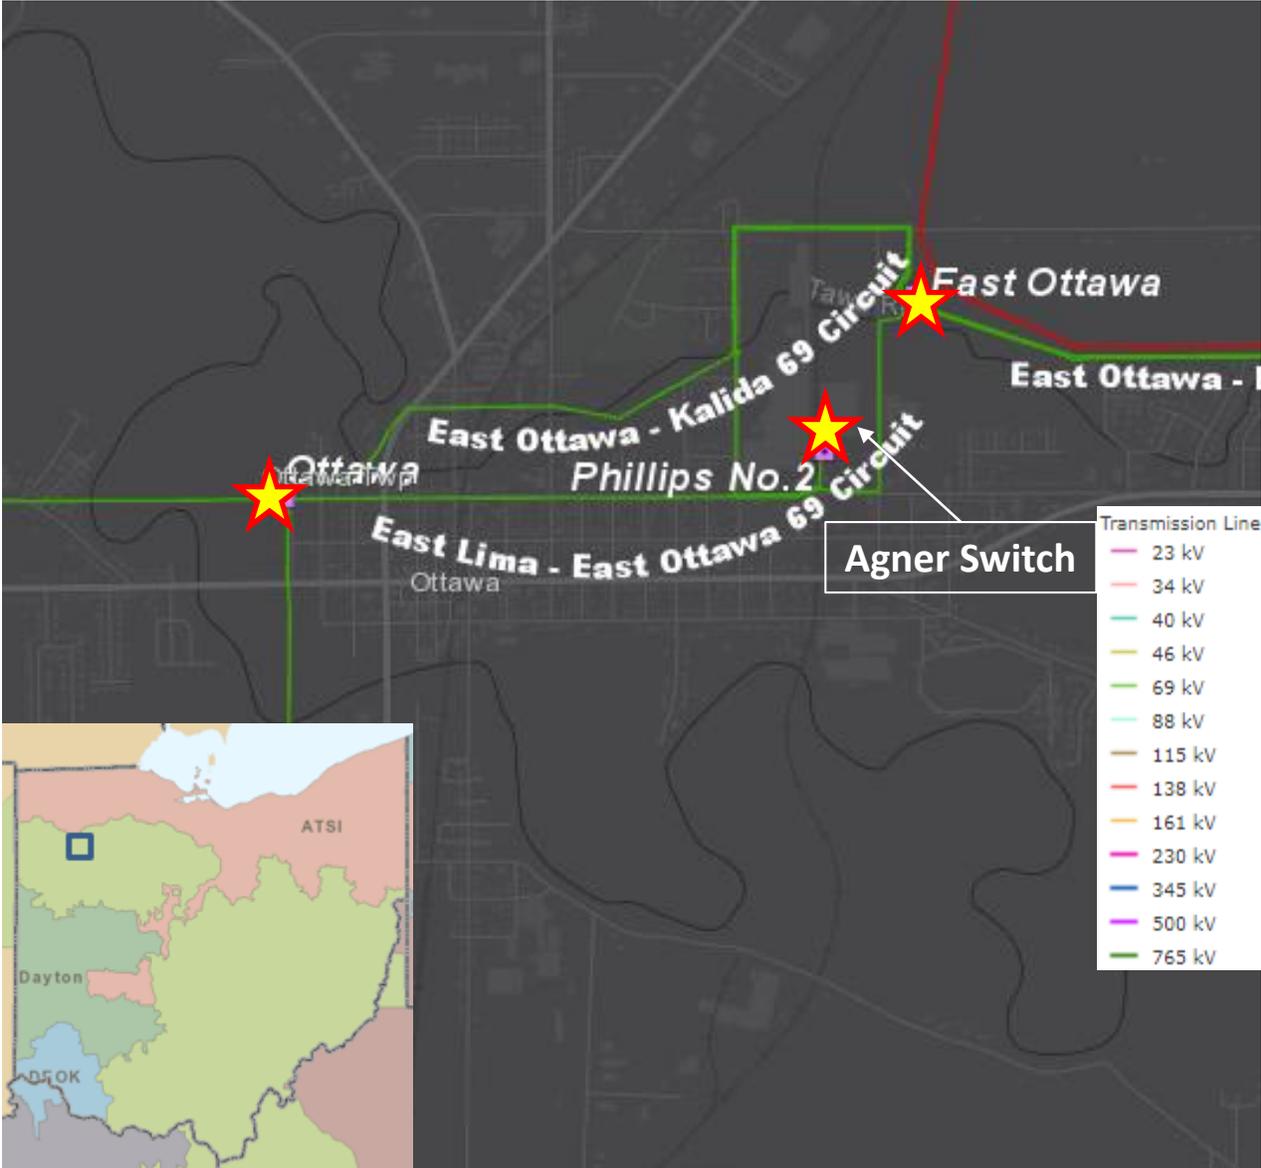
- The structures on the Ottawa – East Ottawa 69 kV line do not meet current AEP structural strength requirements, along with not meeting the current ASCE structural strength requirements. The line is insulated with porcelain insulators which do not meet current AEP standards for CIFO and minimum leakage distance requirements. The line is grounded utilizing the butt wrap method which does not meet current AEP standards. The line shielding angle on the typical tangent structure is measured at 41.12° degrees, which is inadequate for AEP current shielding angle requirements. The shielding angle, butt wrap grounds, and leakage distance requirements all lead to poor lightning performance.

- Open Conditions: 3 (insect damage and missing ground lead)

**Agner Switch:** Switch utilizes a wood pole and was originally installed in 1995. Bowing of the pole and deterioration of the switches has led to switch alignment issues where it does not operate normally.

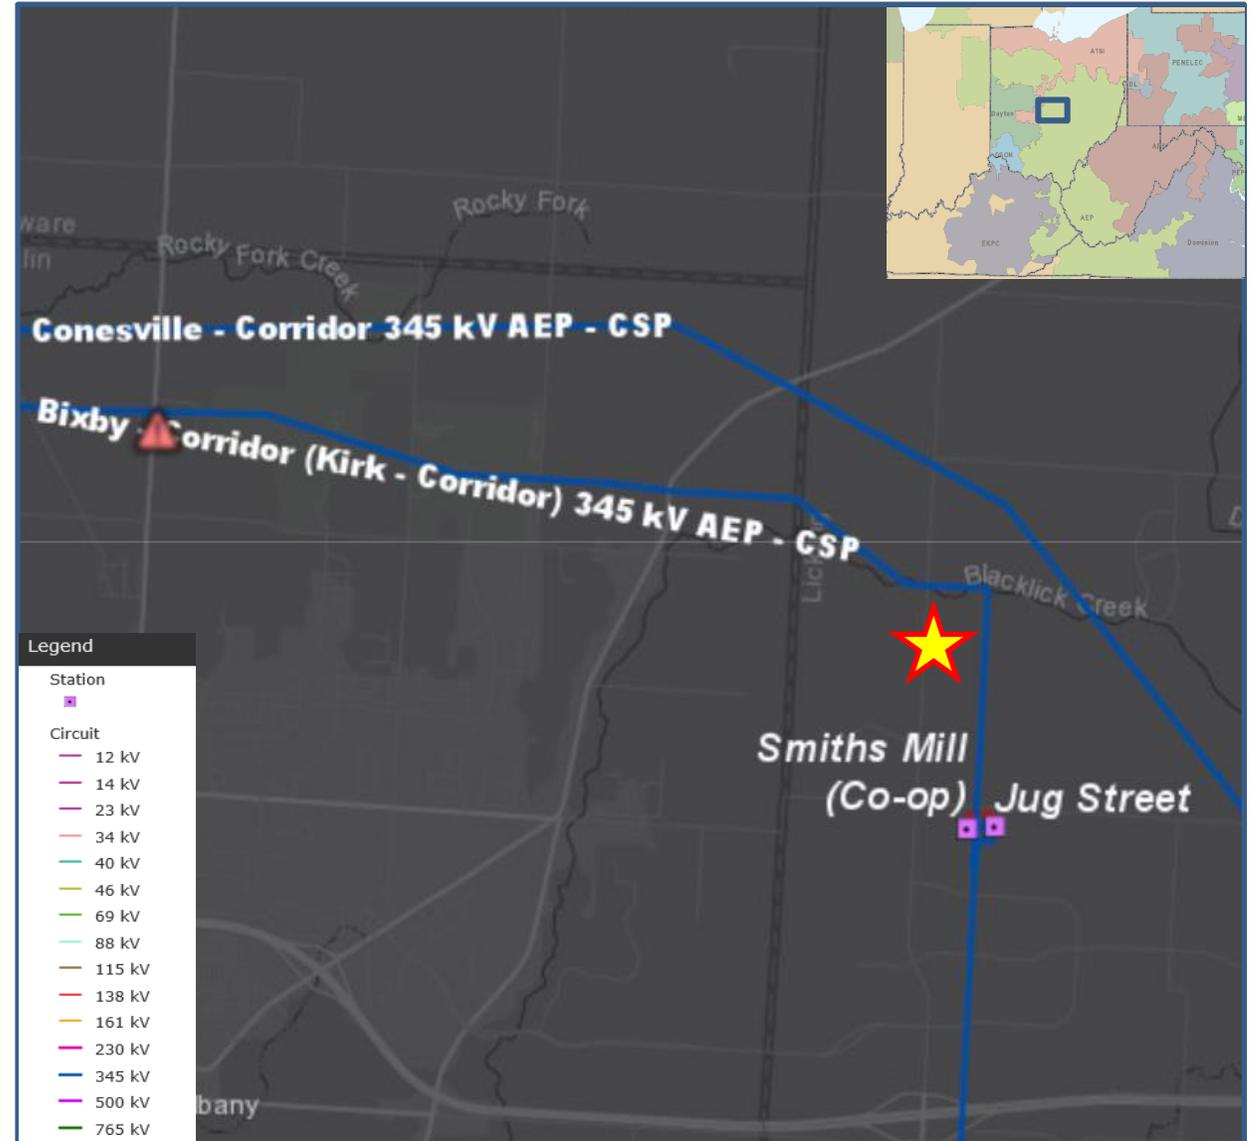
**Need Number:** AEP-2022-OH023

- A customer has requested transmission service at a site North of AEP's existing Jug Street station in Columbus, OH.
- The customer has indicated an initial peak demand of 90 MW with an ultimate capacity of up to 360 MW at the site.
- Initial customer requested in-service date of June 1, 2024.

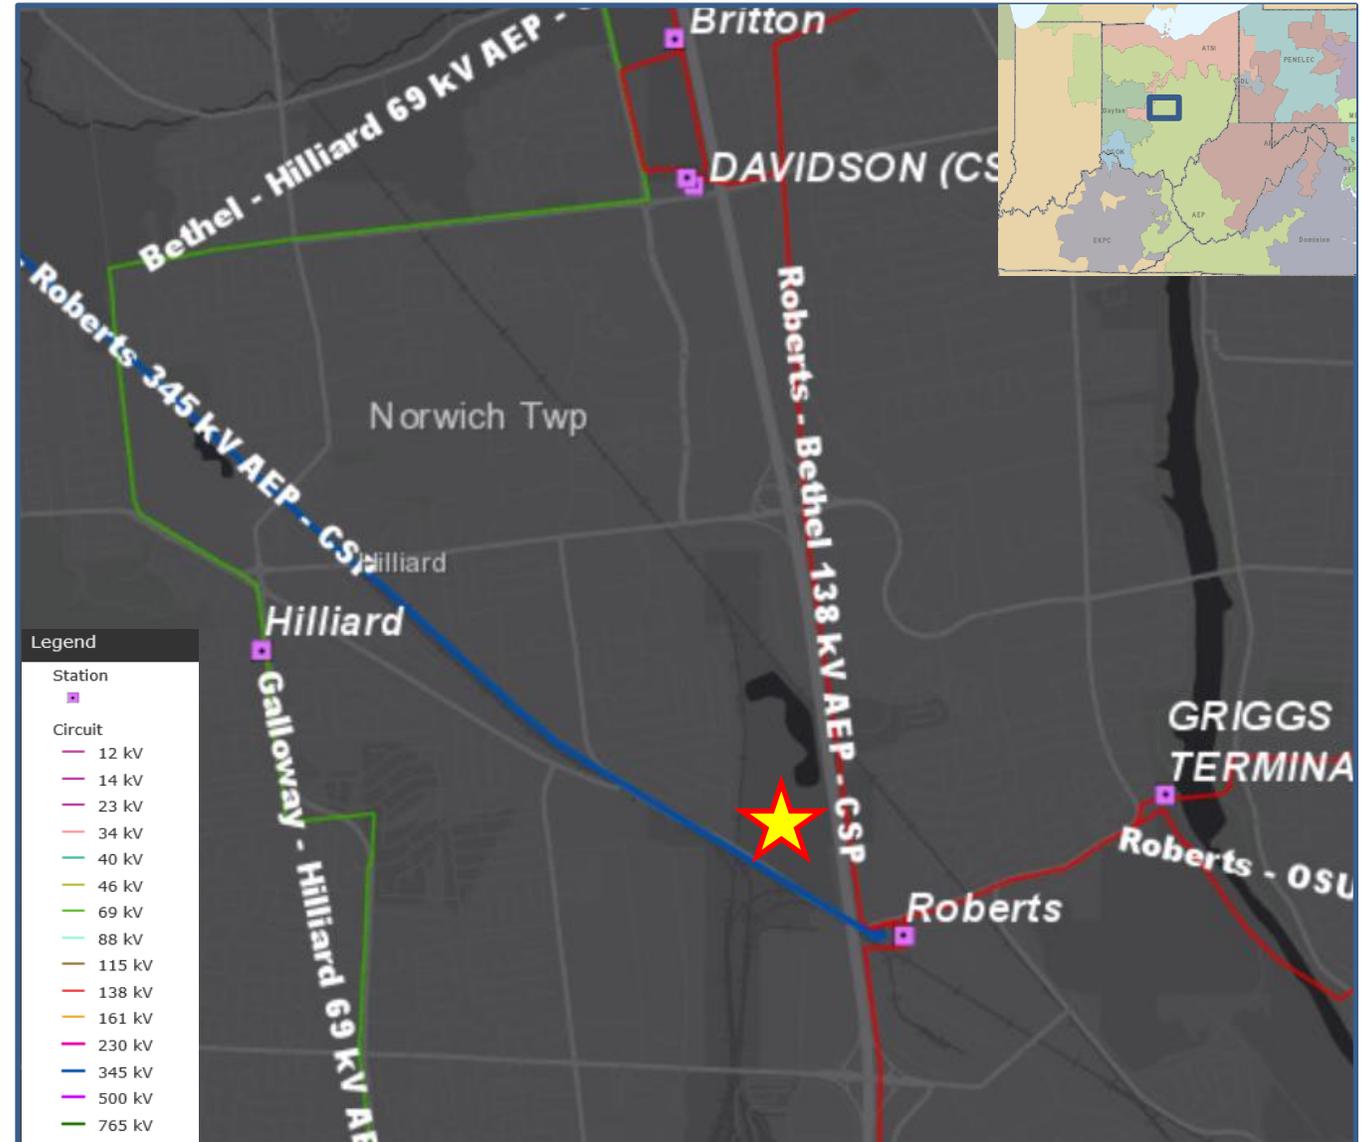
**Need Number:** AEP-2022-OH024

- A customer has requested transmission service at a site North of AEP's existing Roberts station in Columbus, OH.
- The customer has indicated an initial peak demand of 90 MW with an ultimate capacity of up to 360 MW at the site.
- Initial customer requested in-service date of June 1, 2024.

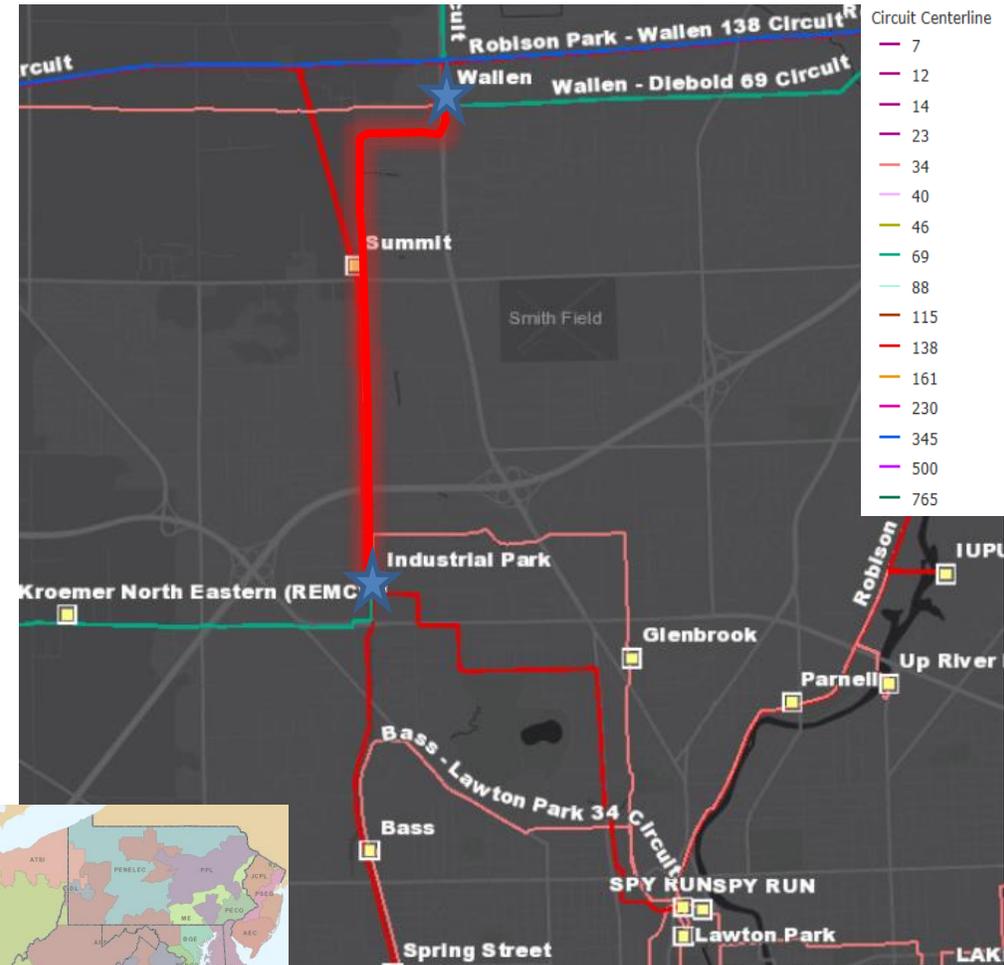
- 1925 vintage steel lattice construction
- There are currently 5 open conditions on this line with majority being structure issues. The O&M cost of the line is expected to increase as the age of the line increases.
- Six wired Copper conductor with copper weld shield wire. Copper conductors become brittle with age and Copper weld conductor has long been obsolete

Industrial Park 138kV

- Breakers F, D & E 34kV
  - 1967 vintage Oil breakers
  - Fault Operations: F(18), D(0) & E(14) – Recommended(10)
- Breakers G 69kV
  - 1967 vintage Oil breakers
  - Fault Operations: G(50) – Recommended(10)
- Oil filled breakers have much more maintenance required due to oil handling that their modern, vacuum counterparts do not require. Finding spare parts for these units is difficult or impossible, and these models are no longer vendor supported.
- Multiple wood pole 138kV transformer lead support structures inside Industrial Park Station

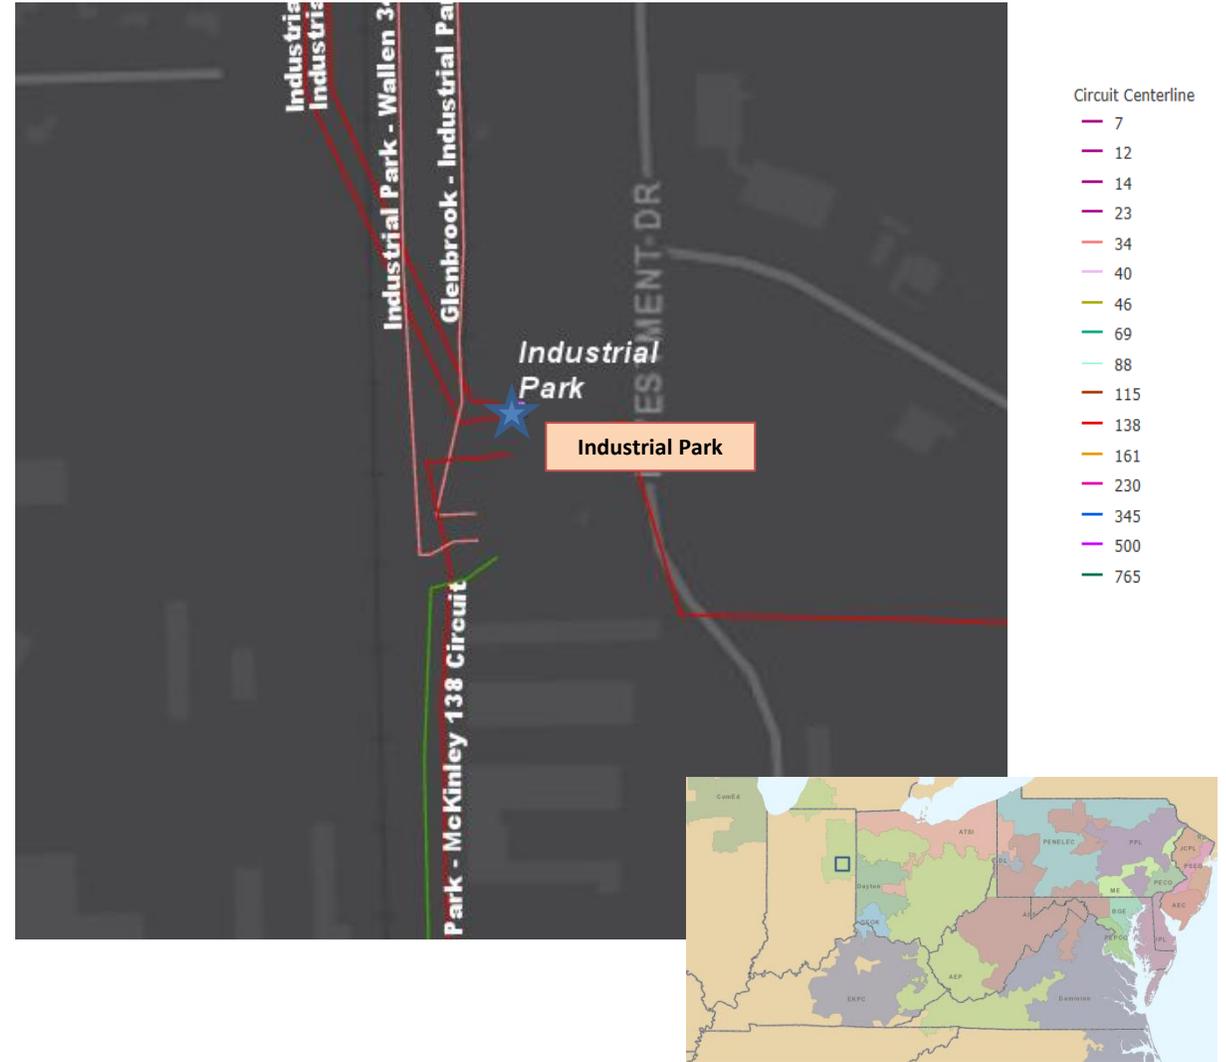
138/69/34.5kV Transformer 1

- Manufactured in 1967
- Transformer has increased levels of CO2 indicated in the dissolved gas analysis.
- Level of CO2 indicates decomposition of the paper insulating materials which impairs units ability to withstand faults.
- The downward Interfacial Tension trend paired with upward power factor trend indicate that there are increased particles within the oil, which decreases the dielectric strength of the transformer.
- Doble tests on the bushings indicate changes in the bushing power factor and capacitance. This change indicates these bushings are at a greater risk of failure.

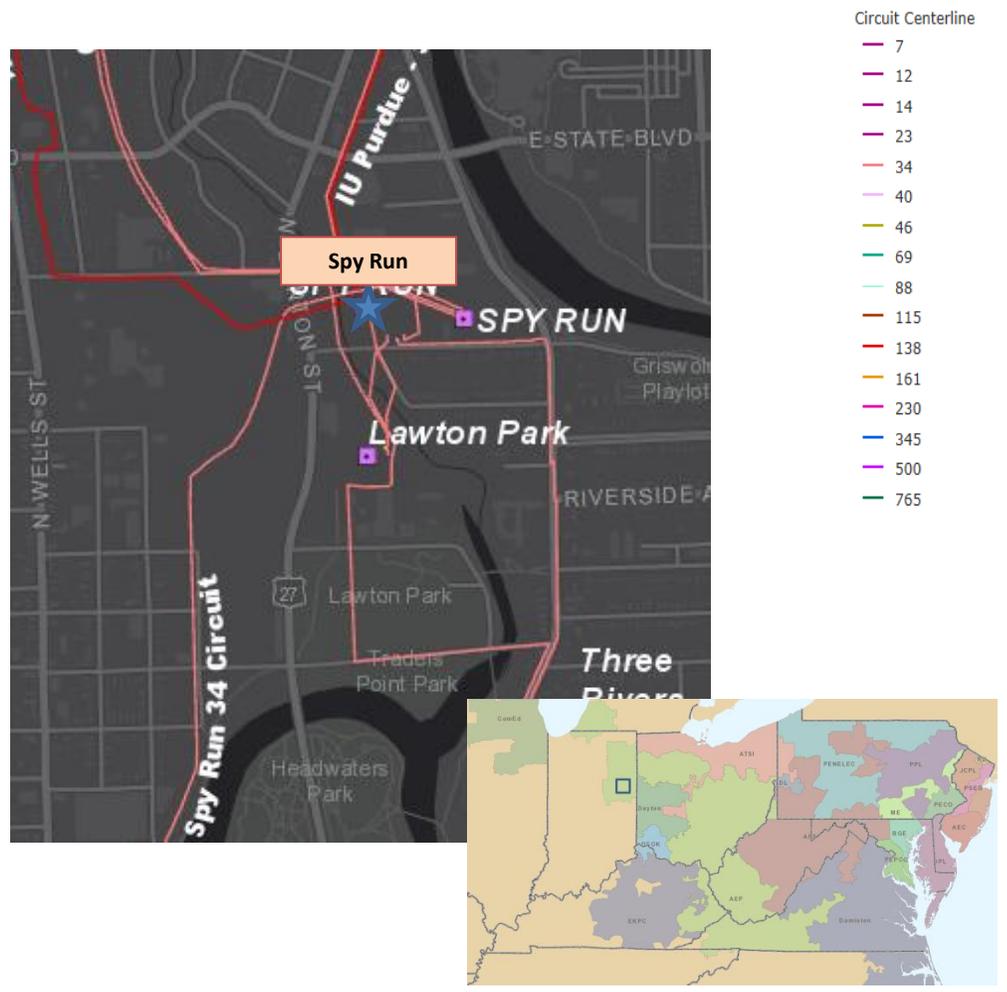
138/34.5kV Transformer 3

- Manufactured in 1975
- Per DGA analysis, this transformer has increased levels of gassing of Ethylene, Ethane, and CO2
- The low level of dielectric strength indicates acid coating insulation with sludge ready to deposit in the transformer, increasing the risk of failure.
- The levels of moisture and dielectric strength indicate the insulation system is in poor condition, reducing the ability of the unit to withstand through faults.

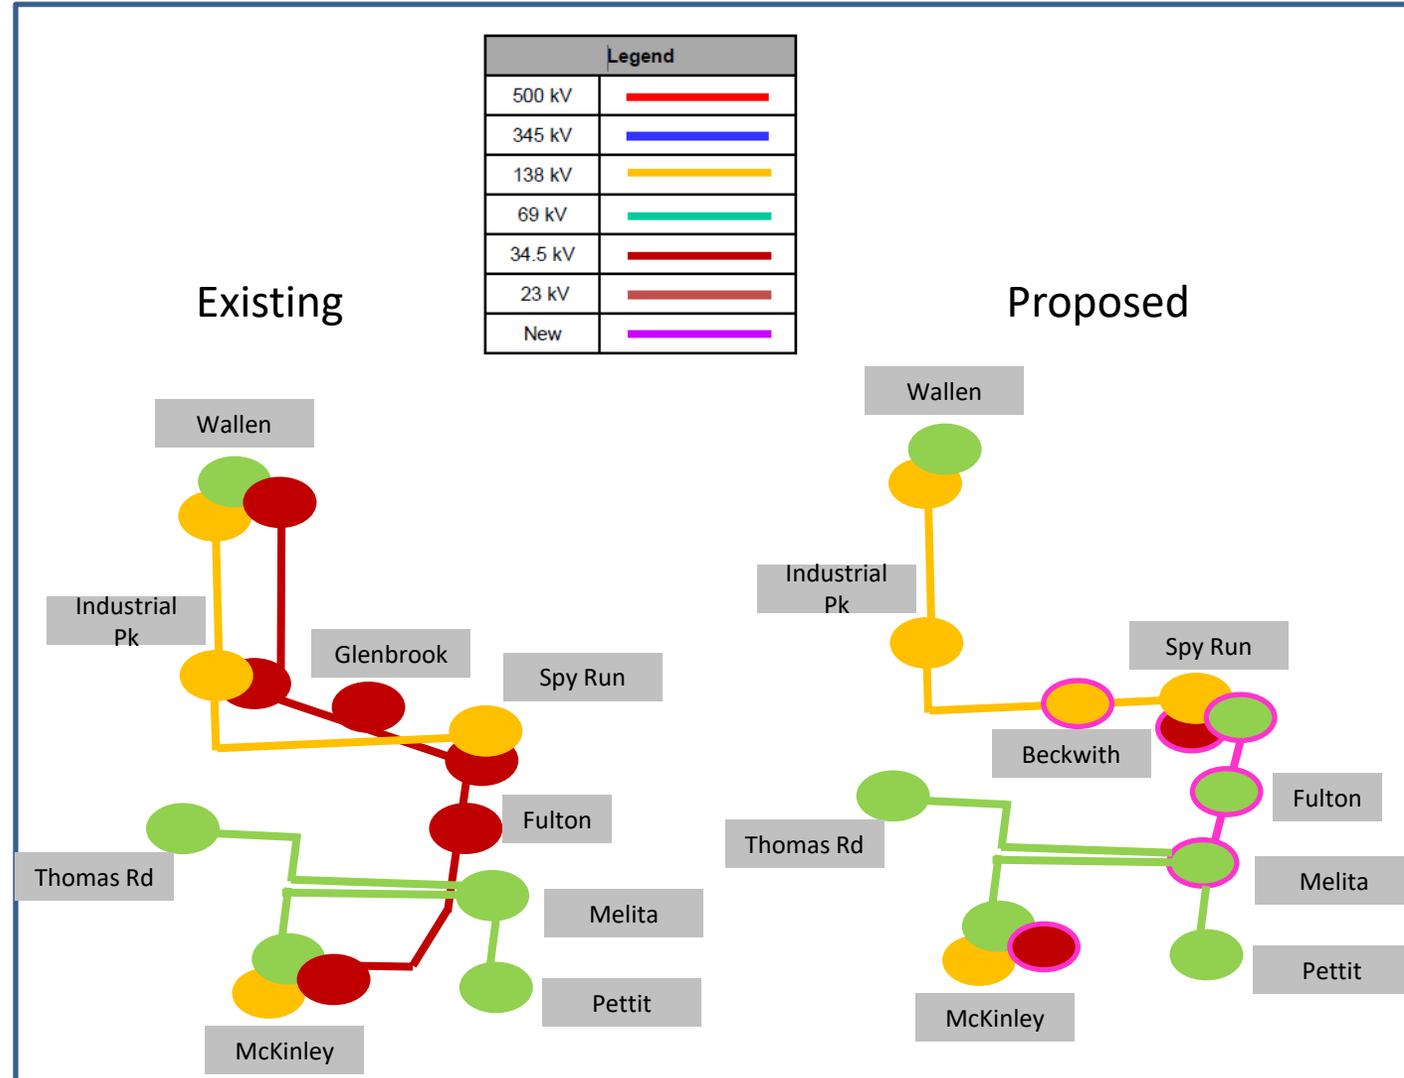
The Northern Ft Wayne 34.5kV network is comprised of 1920's steel and 1960's wood that have been identified as needs on the previous slides. By constructing a new distribution station to replace Glenbrook and transformer replacements at Industrial Park, Spy Run and Fulton, AEP is reducing the amount of urban line rebuild to less than 20% of the original mileage and retiring the rest. Not only will this save ratepayer investment, but will also reduce the impact to the urban city center and will remove the 34.5kV drop-and-pick operating procedures from this segment of Fort Wayne.

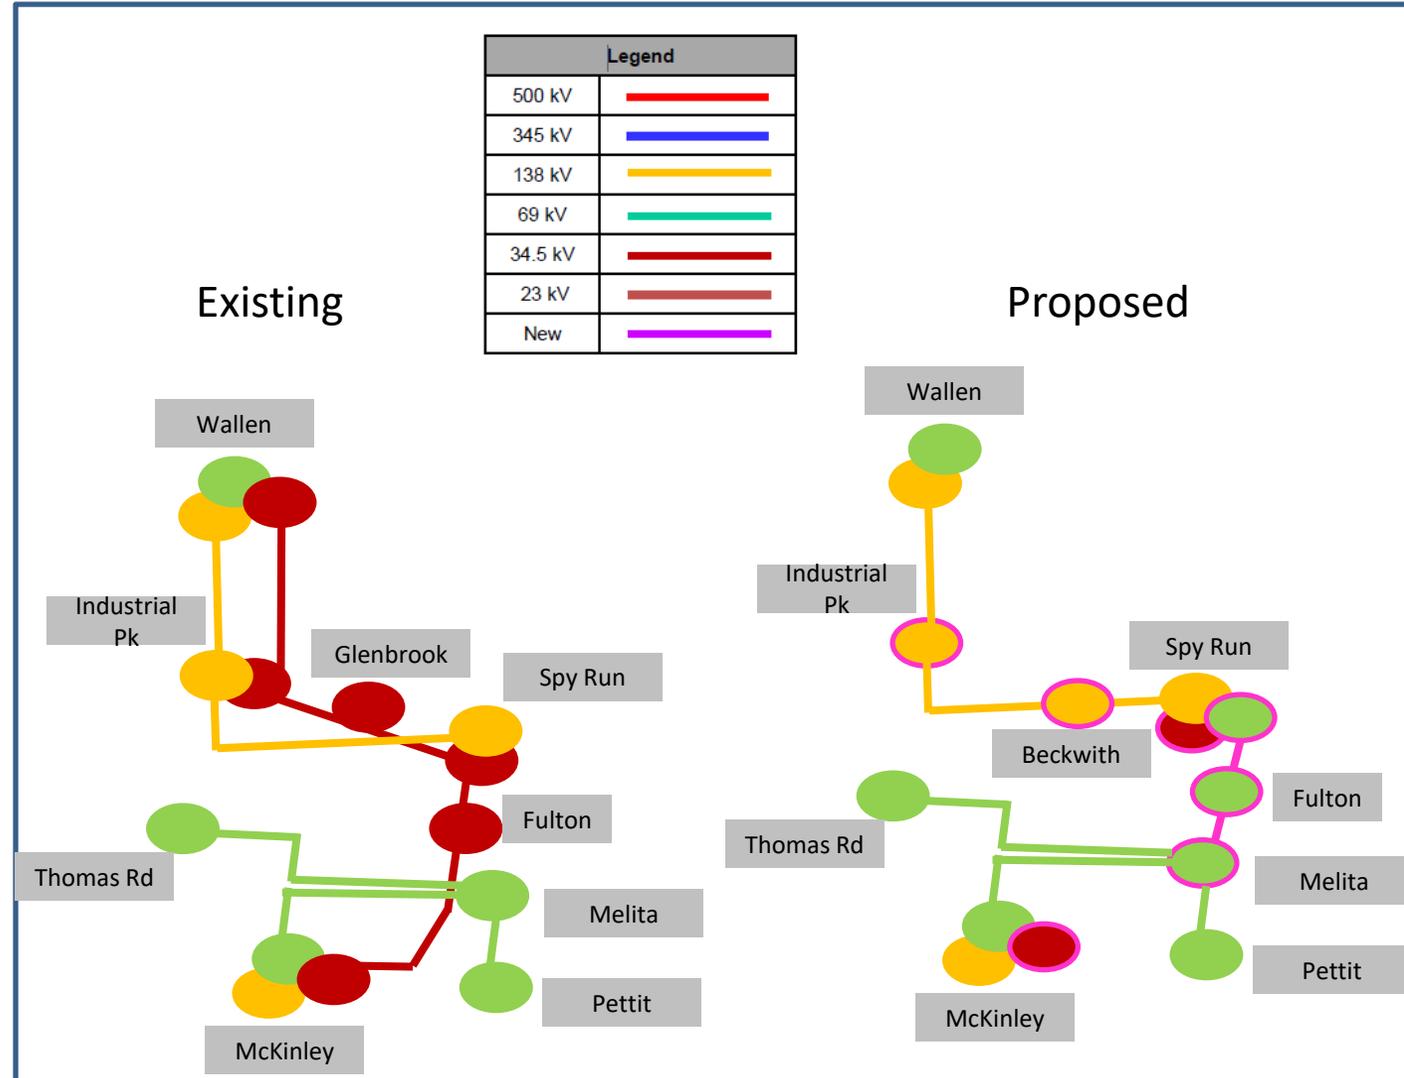
- Rebuild the through-path of Fulton 34.5/12kV station at 69kV and replace the transformer with a 69/12kV unit.

- At Spy Run station, replace transformer #3 with a 138/69/34.5kV unit. Move the Fulton exit from 34.5kV to 69kV.

- At Industrial Park station, retire the entire 34.5kV voltage class, install a new 138/12kV load delivery to replace the 34.5/12kV delivery. Replace 69kV CB "G", Replace the 138/69kV XFR 1 and add a high side switcher to XFR 1.

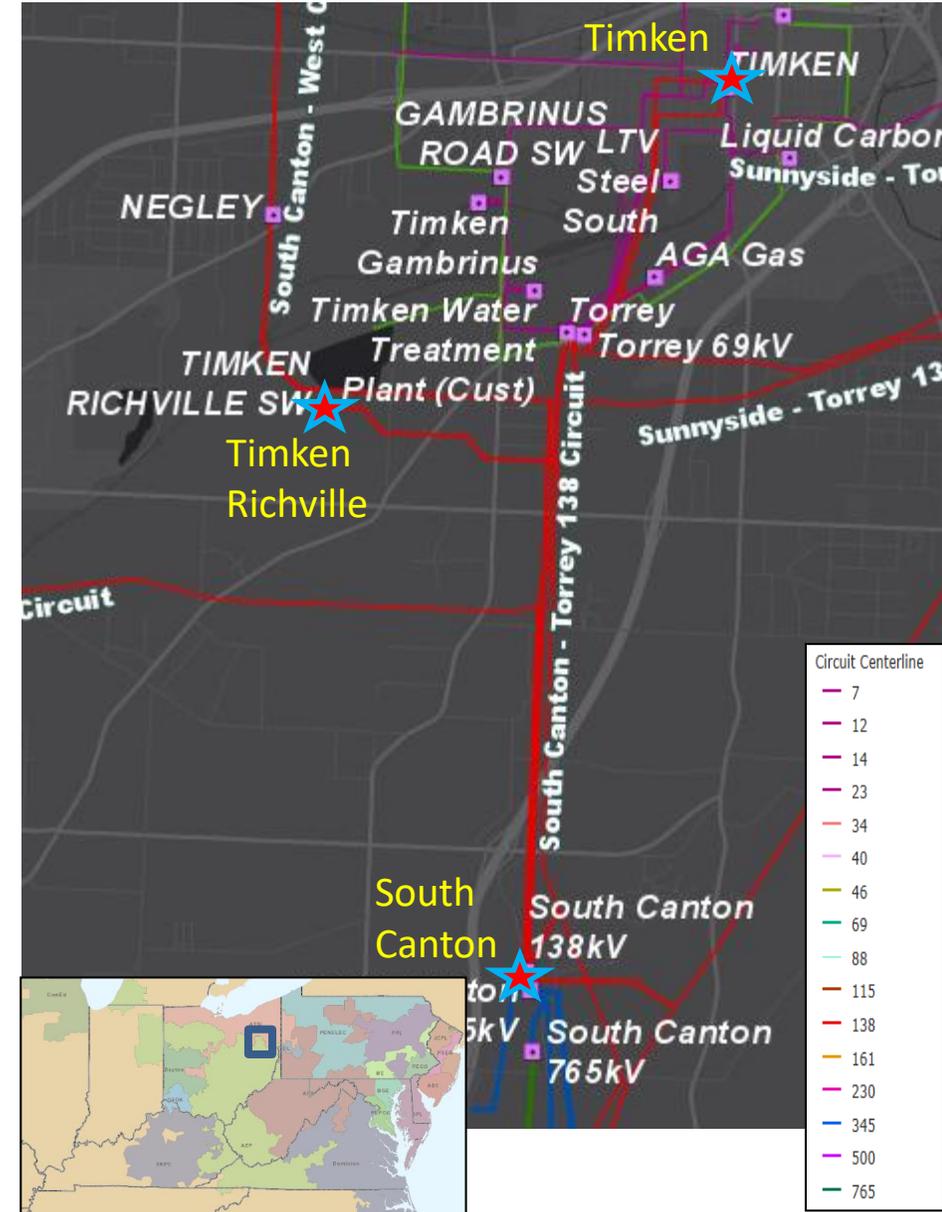
- **Timken Richville 138kV Station**

- The station contains 2- 138kV lines and 2- 138kV customer feeds with only a single 138kV bus-tie breaker. A fault on either of the 138kV lines or bus will take out up to 75 MW of load for a single event (1/2 of peak load).
- A fault on either 138kV circuit requires tripping one of the customer's 138kV breakers to clear the fault. If the customer's equipment were to fail to clear a line fault, a single 138kV circuit fault would expand to take out both 138kV circuits connected to Timken Richville, dropping the customer entirely and requiring additional remote-end clearing (at South Canton or Timken station).

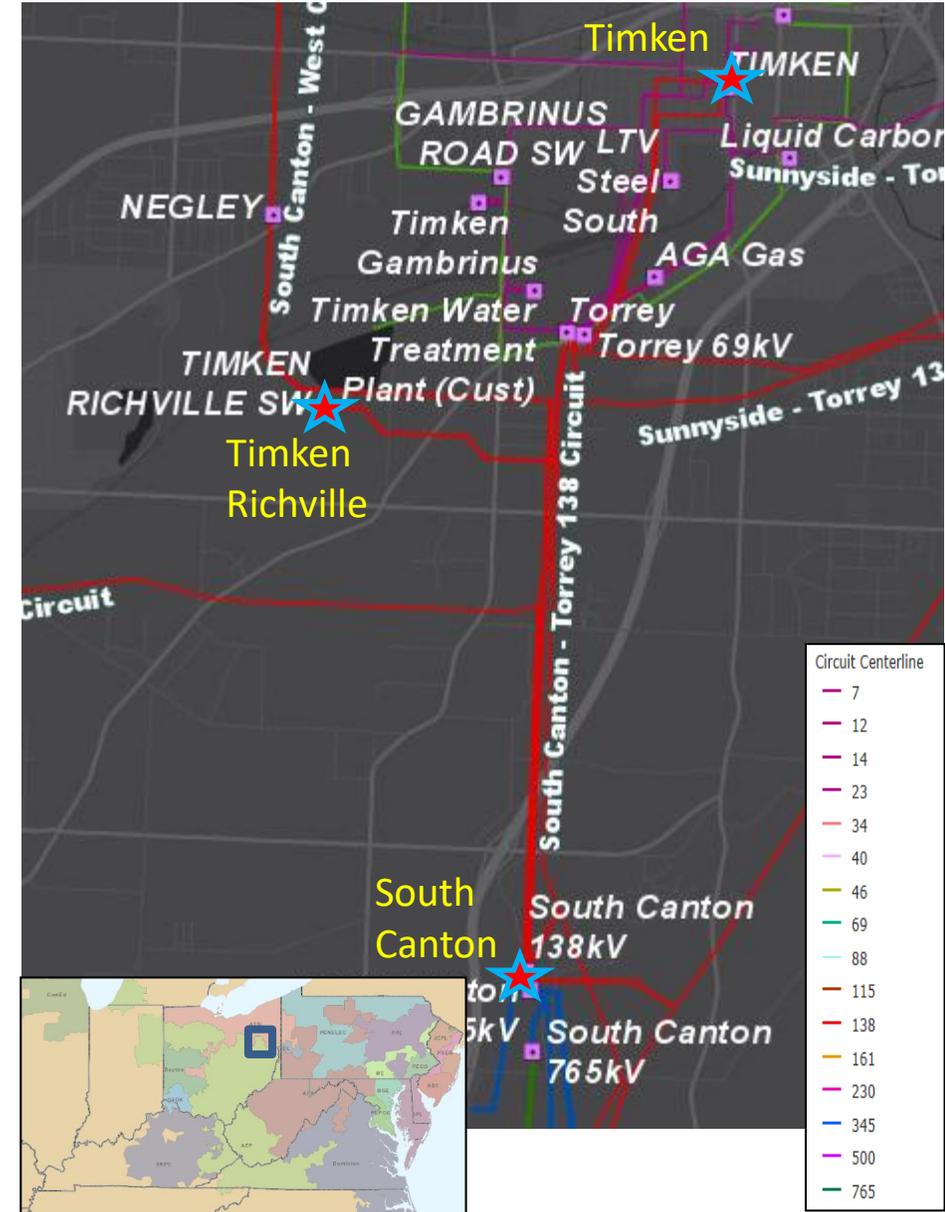
- Timken Richville 138kV Station**

- The station was constructed in 1985 and 32 of the 34 protective relays in the station are electromechanical (with 2 static relays). Electromechanical relays lack vendor support, don't have SCADA, and lack fault data collection.
- The line protection to Timken and to South Canton consists of an outdated pilot wire scheme that is increasingly prone to failure.
- The RTU is a legacy model that is no longer supported by the manufacturer.
- AC station service comes from the customer's substation, which is a reliability concern.
- The control house ceiling is made of an asbestos-cement product (transite).
- There is no fence separating AEP's substation from the customer's substation, which is a physical security risk.
- The metering PT's and CT's show signs of heavy rusting.

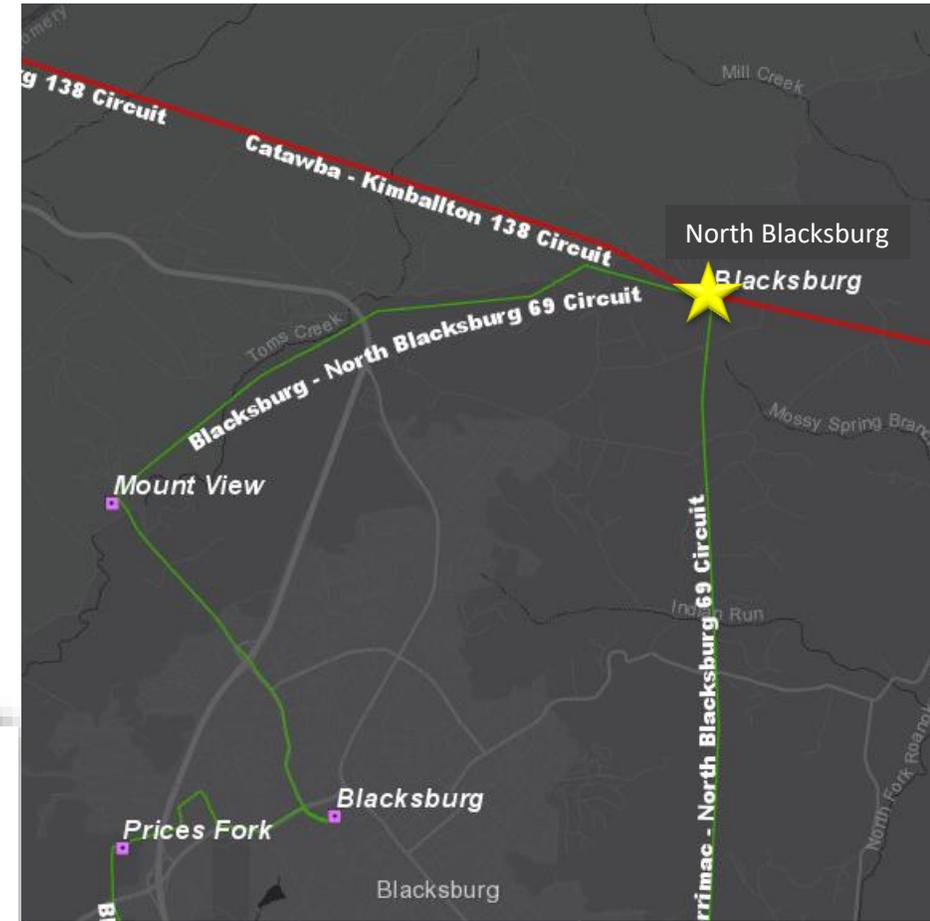
- 138/69-12 kV Transformer #1
  - 1972 Vintage Transformer
  - The presence of Ethane, along with the indication of overheating faults, indicates decomposition of the paper insulation that impairs the unit’s ability to withstand future short circuit or through fault events.
  - The dielectric is driven by the upward trend in insulation power factor, which indicates an increase in particles within the oil.
  - The transformer has had issues with proper oil flow.

- 138/12 kV Transformer #2
  - 1967 Vintage Transformer
  - The presence of Acetylene, confirms the insulation system (oil and paper) is in poor condition and also indicates electrical discharge faults of low energy have occurred within the main tank causing electrical breakdown of the unit.
  - The transformer has significant rust spots and weld leaks.
  - This is allowing voltage phase imbalances, specifically high voltage, to pass through to distribution customers served from North Blacksburg station.

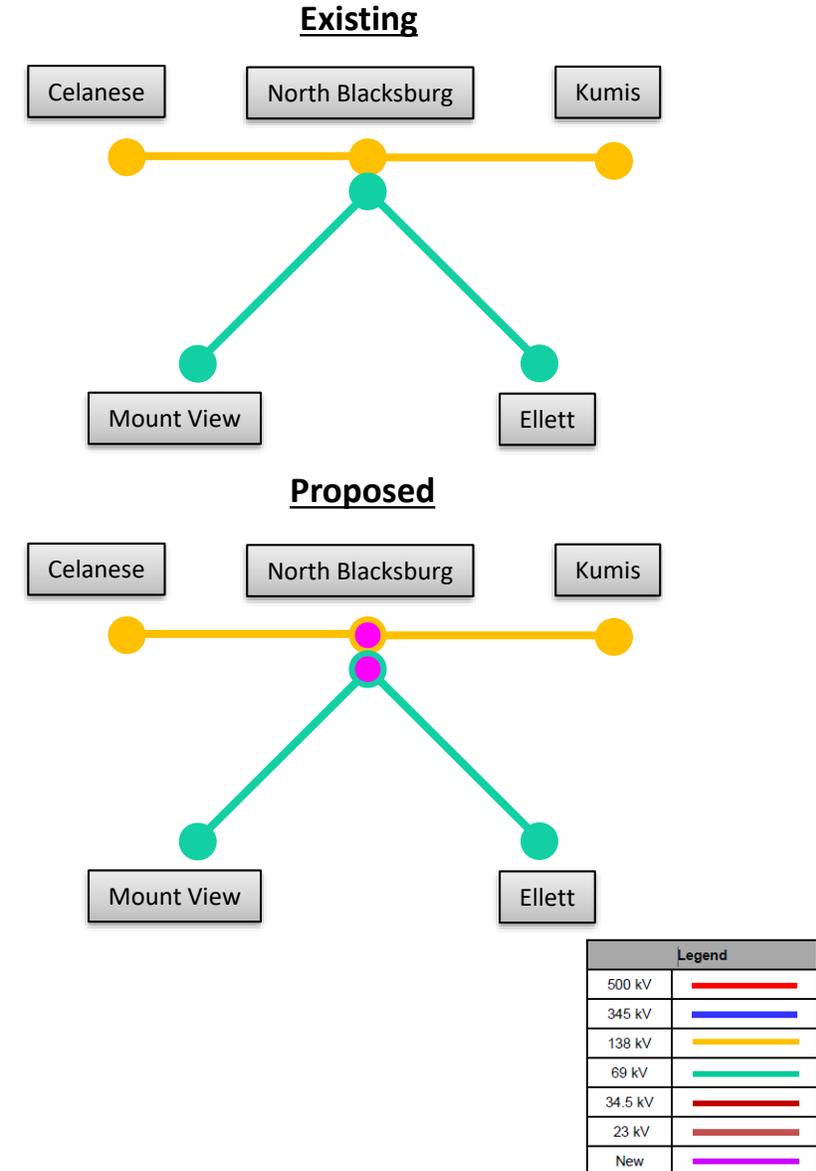
- Replace existing Transformer #1 with a 130 MVA 138/69-12 kV transformer.
- Replace existing Transformer #2 with a 25 MVA 138/12 kV transformer and add bus regulators.
- Add a 69kV circuit breaker on the low side of Transformer #1
