# Sub Regional RTEP Committee: Western AEP Supplemental Projects

January 21, 2022

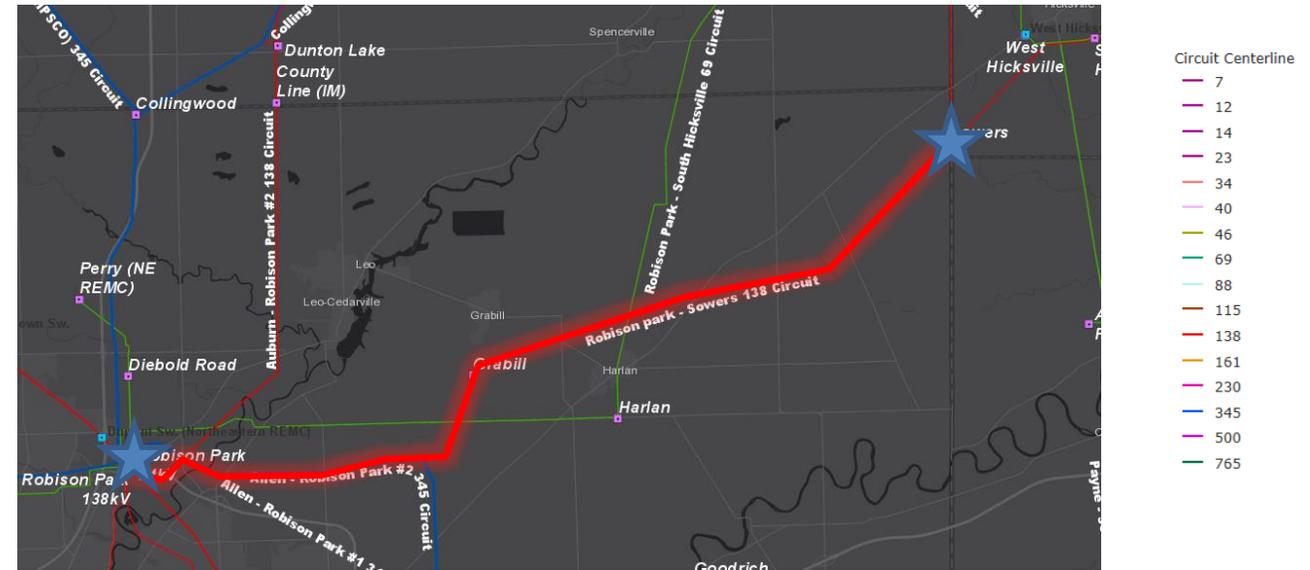
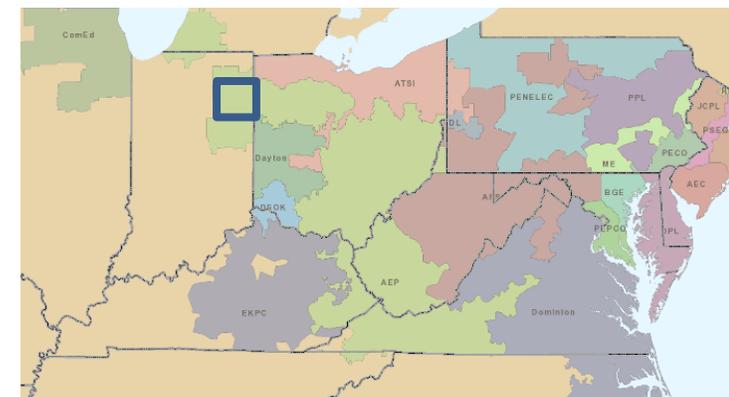
### Robison Park – Sowers 138kV line:

- 13.6 miles of this 18 mile line is 1966 wood H Frame construction
- 4.3 miles of this 18 mile line is 1966 Steel lattice and isn't identified as a need at this time.
- 17.9 miles of this 18 mile line is 1966 636 Grosbeak ACSR conductor
- The wood structures fail AEP Strength requirements and ASCE structural strength standards and AEP Shielding requirements
- The 2015-2020 time period has seen 4 momentary and 3 permanent outages
- Line has been subject to 464,404 CMI to customers served out of Grabill station.
- 15 structures were inspected by drone with 16 assessed by ground crew
  - Moderate shell decay on most wood poles
  - Most Cross Arms have moderate decay on top side of arms
  - 40% of structures had broken/missing grounds.
- 11 structures with open conditions are on this line currently including disconnected X Braces/Crossarms, Rot Top and broken ground leads.

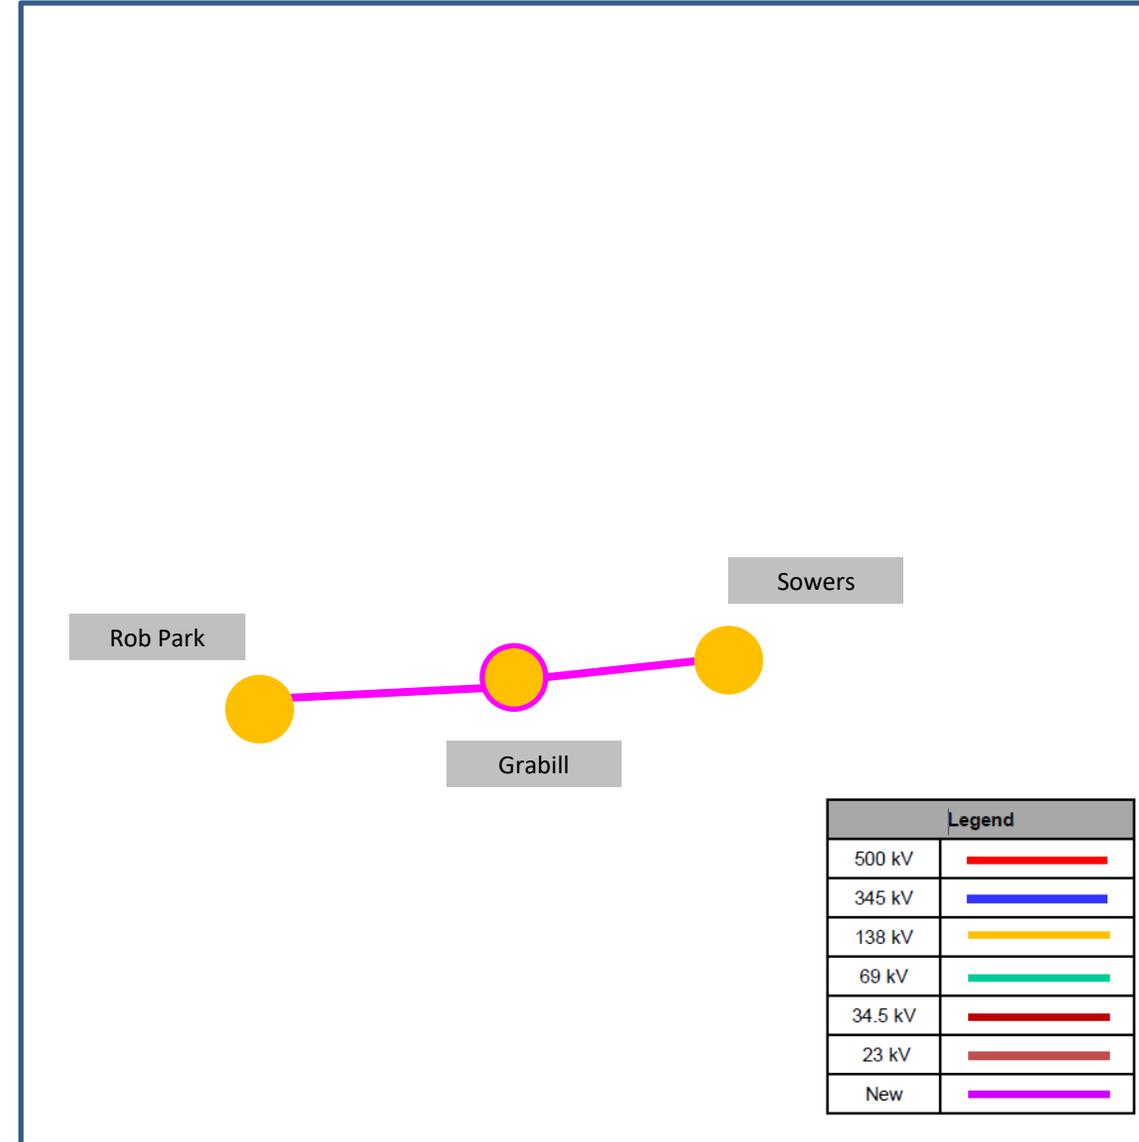
Replace switches and risers at Grabill switch to accommodate the line rebuild.

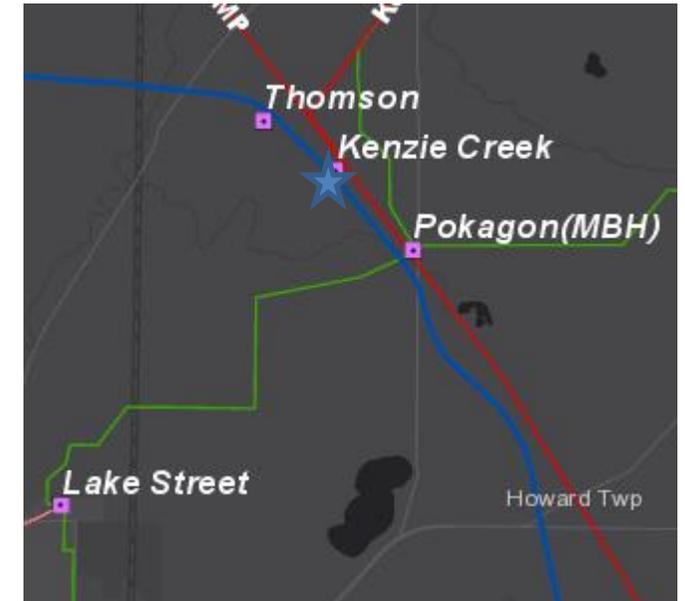
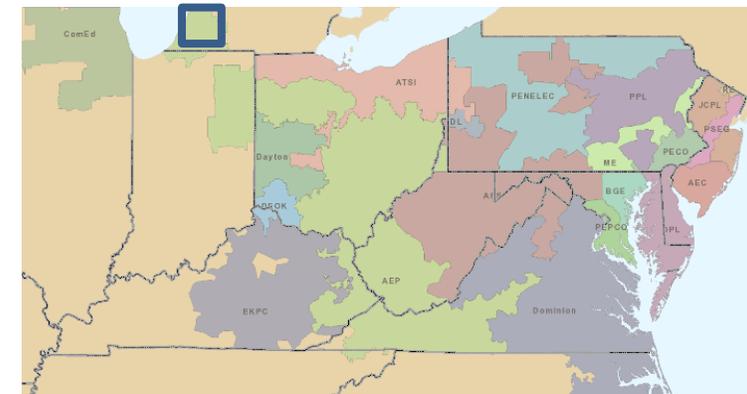
- **Kenzie Creek 345/138/69kV**
- CB “F”, “F1”, “F2”, “G” and “G1” are 1990’s vintage 145-PA type breakers
  - The 145-PA Type Breakers are experiencing marked increases in malfunctions. There have been 437 recorded malfunctions on 132 total units of this model type on the AEP System. The most common issues are related to loss of SF6 gas and mis-operations. The expected life of the bushing gaskets and door inspection port seals is 25 years. Seals that are no longer adequate can cause SF6 leaks to become more frequent. Low SF6 pressure in the breaker reduces the ability of the breaker to correctly interrupt a fault. Additionally, low pressure alarms and SF6 leaks lead to increased maintenance costs. The manufacturer provides no support or parts for this model of circuit breakers. Finally, SF6 leaks impact the environment.

- The CB’s have experience the following faults and are above the manufacturers recommended rating of 10
    - Breaker G: 39
    - Breaker G1: 24
    - Breaker F1: 12

- Breaker F: 29
    - Breaker F2: 34

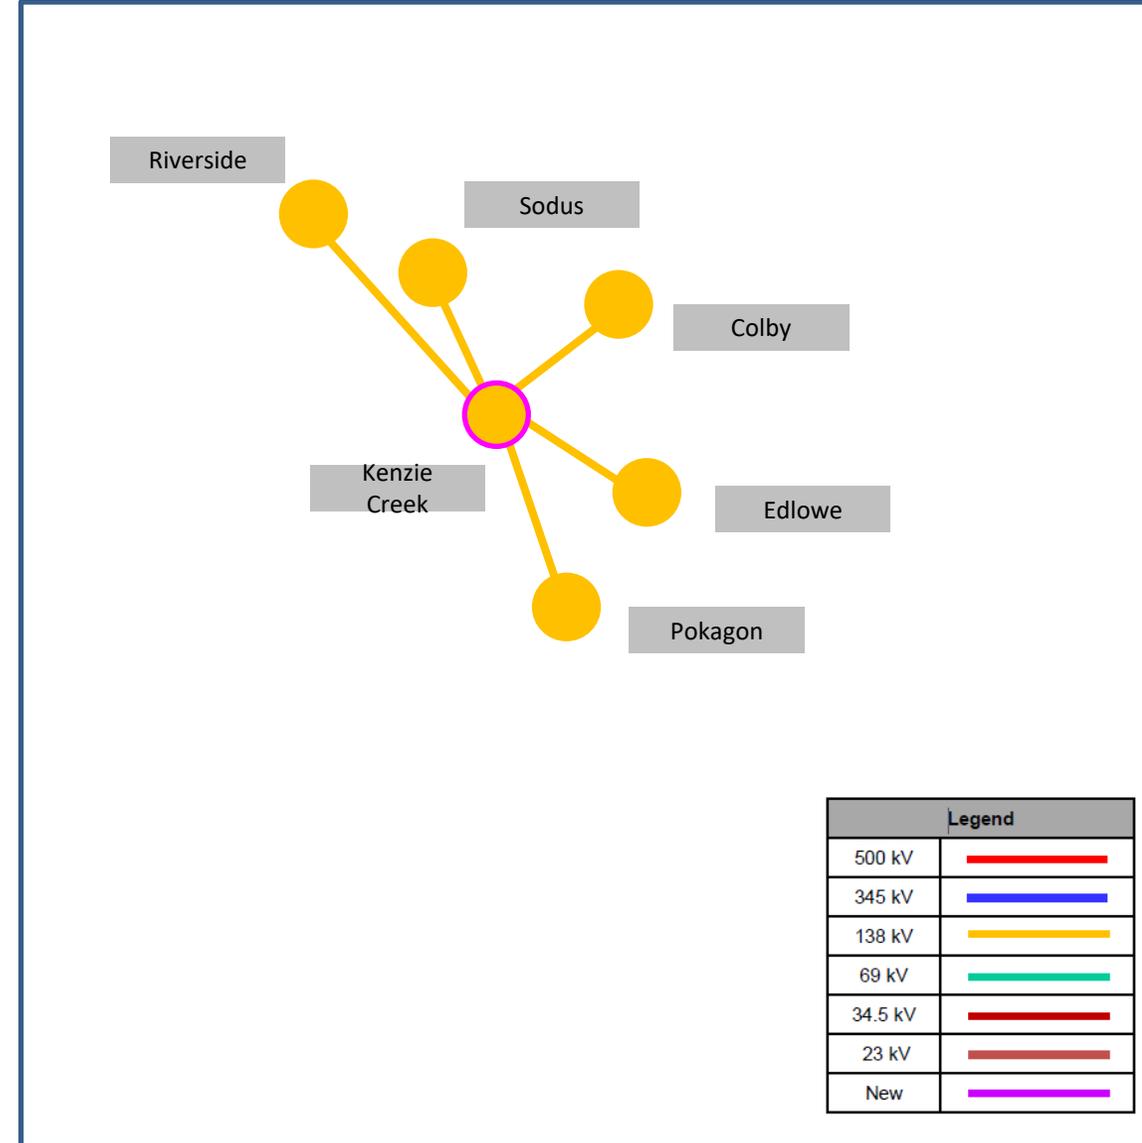
Kenzie Creek 345/138/69kV station:  
Replace 138kV CB's "F", "F1", "F2", "G" and "G1" with 40 kA circuit breakers.

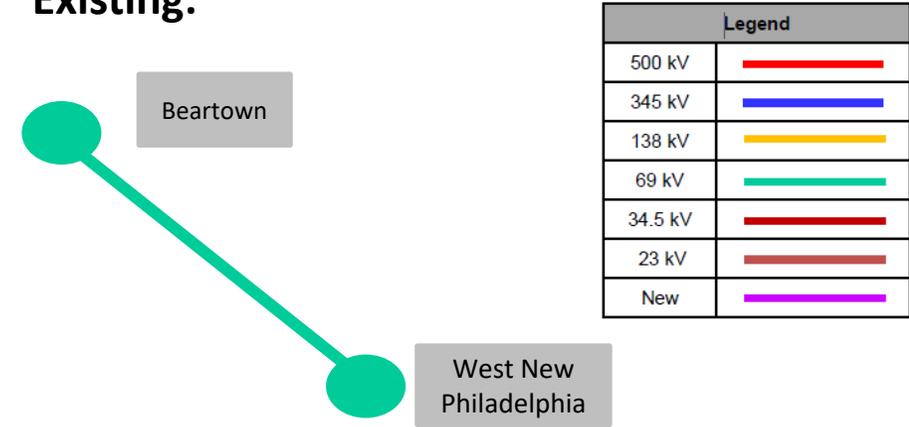
**Existing:**

## AEP Transmission Zone M-3 Process Dover Customer Service

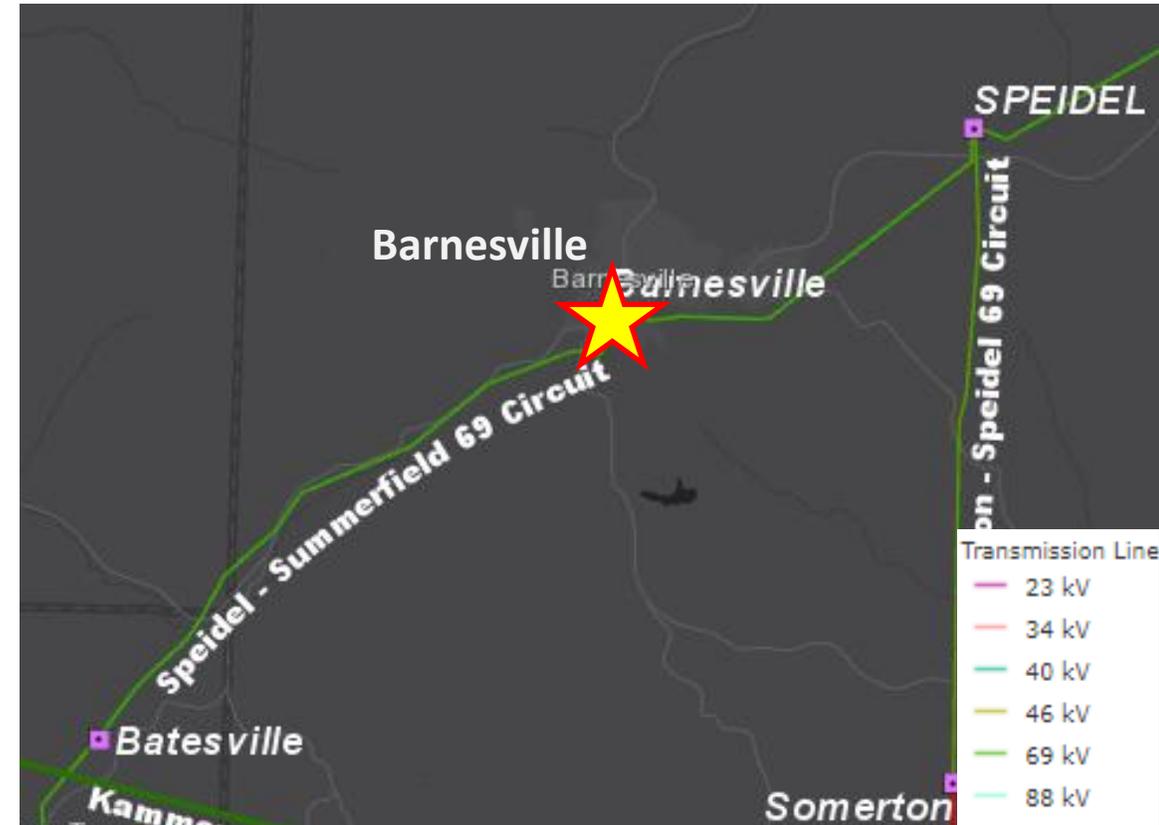
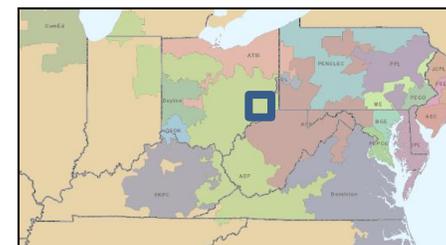
The station is served radially via a 0.4-mile 69kV tap. This T-line tap dates back to 1942, with original #1 copper conductor, and currently has 2 open conditions. Other projects in the area have proposed to rebuild the remainder of the 69 kV line in the area.

Barnesville has an obsolete MOAB/ground-switch for the transformer protection system. This requires remote-end breaker clearing many miles away, and drops another tapped AEP Ohio distribution station in the process (Batesville).
