Western Sub Regional RTEP: AEP Supplemental Projects

April 21, 2023

AEP Transmission Zone M-3 Process Huntington, WV

Need Number: AEP-2023-AP009

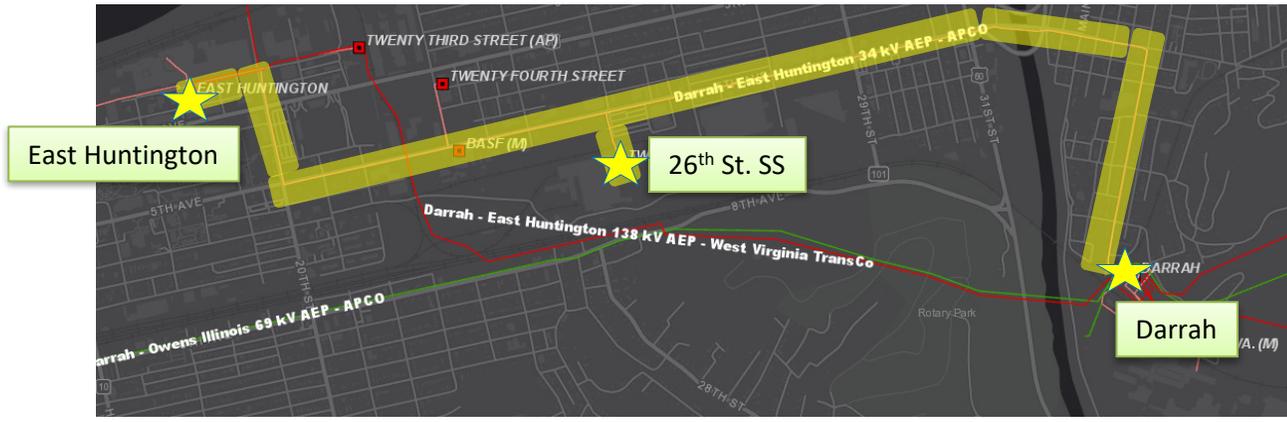
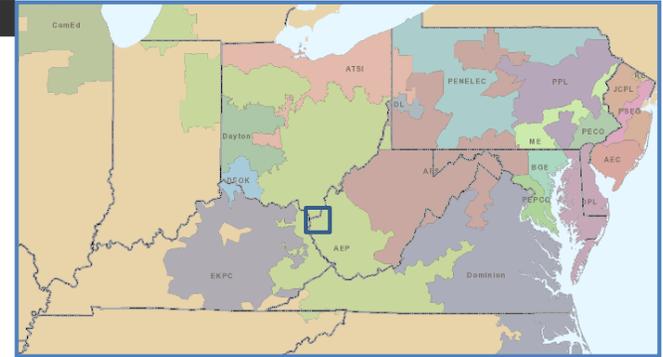
Circuits: Darrah – East Huntington 34.5 kV

Length of Line: 3.2 miles

Total Structure Count: 82, 87% is 1939 vintage

Original Line Construction Type: Wood, Lattice Steel

Conductor Type: 636,000 CM ACSR 26/7 (Grosbeak), 1,033,500 CM ACSR 54/7 (Curlew), 4/0 ACSR 6/1 (Penguin)

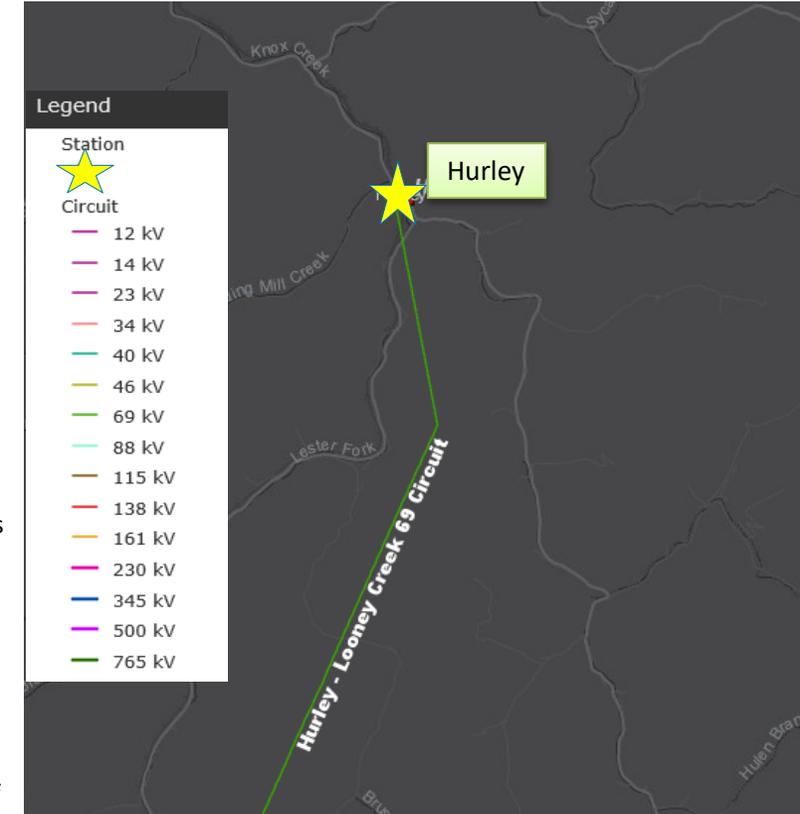
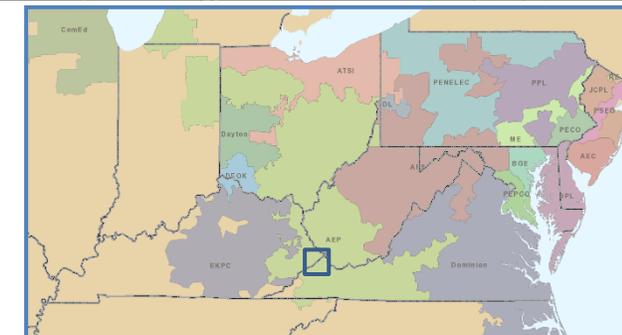
Problem Statement Hurley Station:

- 1977 Vintage Transformer
- The elevated and rising levels of acetylene indicate high decomposition of the paper insulating materials.
- The transformer has elevated moisture level which can be the result of gasket leaks or breakdown in the oil or paper/pressboard insulation. The decreasing and low level of dielectric strength, indicates an increase in particles within the oil, which in turn decreases the dielectric strength of the oil to withstand fault events. This can ultimately damage the paper insulation. The values of moisture and oil dielectric strength indicate the dielectric strength of the insulation system (oil and paper) is in poor condition.
- The condition of the transformer's wood tie foundation is unknown because it lies under the legacy asphalt oil containment.

- One 69kV line outage on the Hurley – Looney Creek 69kV circuit from 2017 to 2022 caused 863,000 CMI for distribution customers at Hurley due to being on a radial 69kV service and Distribution not having any transferable capability. The radial 69kV line is 10.1 miles long and the Distribution load is 12.5 MVA.

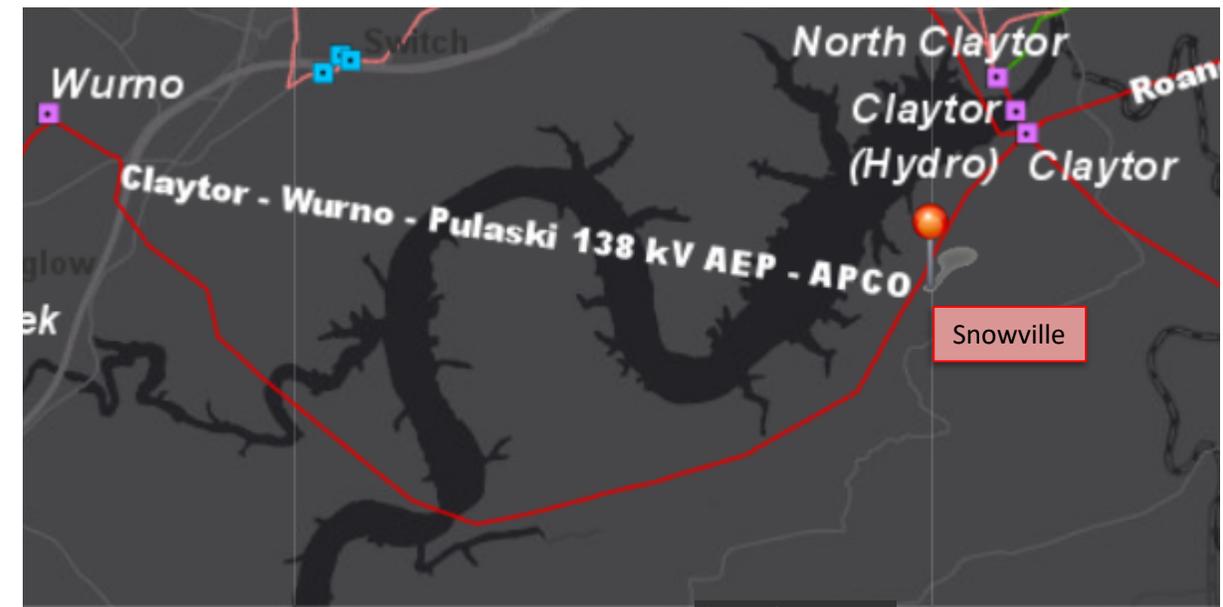
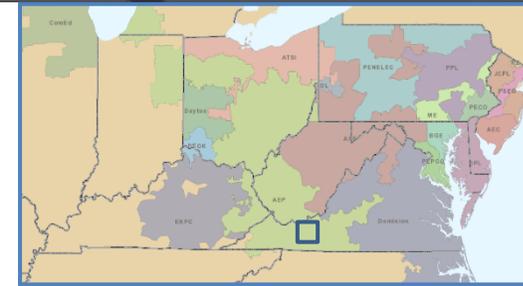
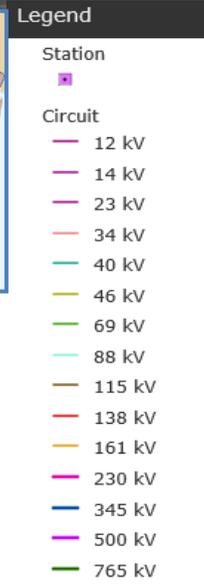
- AEP Distribution has requested a new delivery point (Snowville).
- The Distribution customers south of Claytor Lake are fed by one 34.5kV distribution circuit out of Wurno station and the circuit has one lake crossing. This circuit is currently 187-line miles long and has no other 34.5kV distribution circuit ties. Over the past five years, there were 223 distribution outages resulting in 5.9 million CMI.
- The greenfield Snowville station will pick up 6.5 MVA from Wurno station.

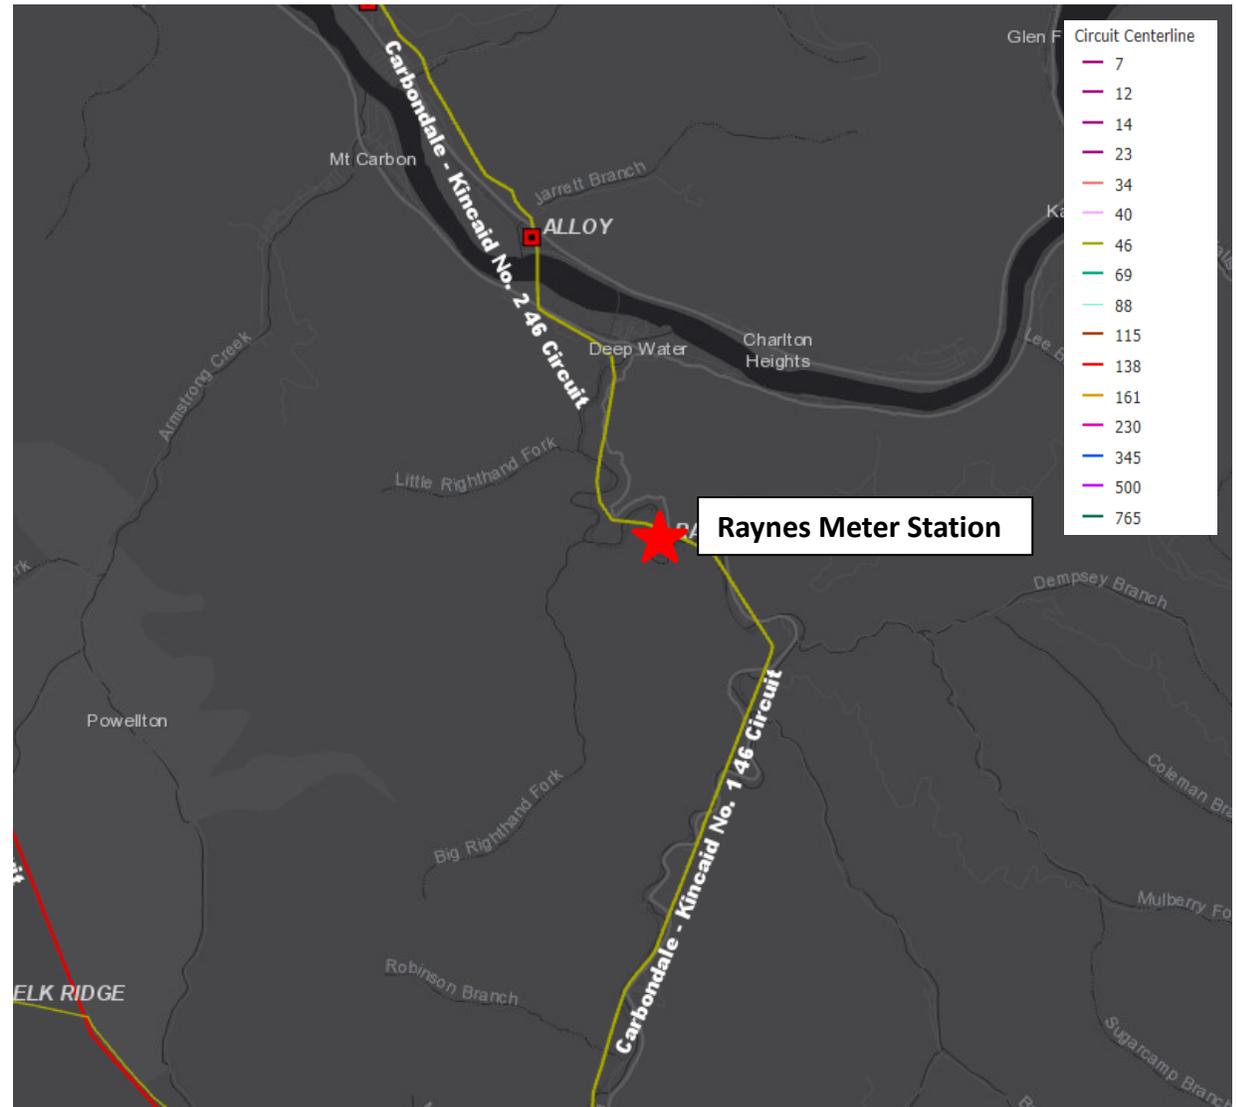
Resilient Mining has requested service at the existing Raynes Meter Station to serve a new delivery point, approximately 1.5 MW of load. The requested in service date is 10/2023.

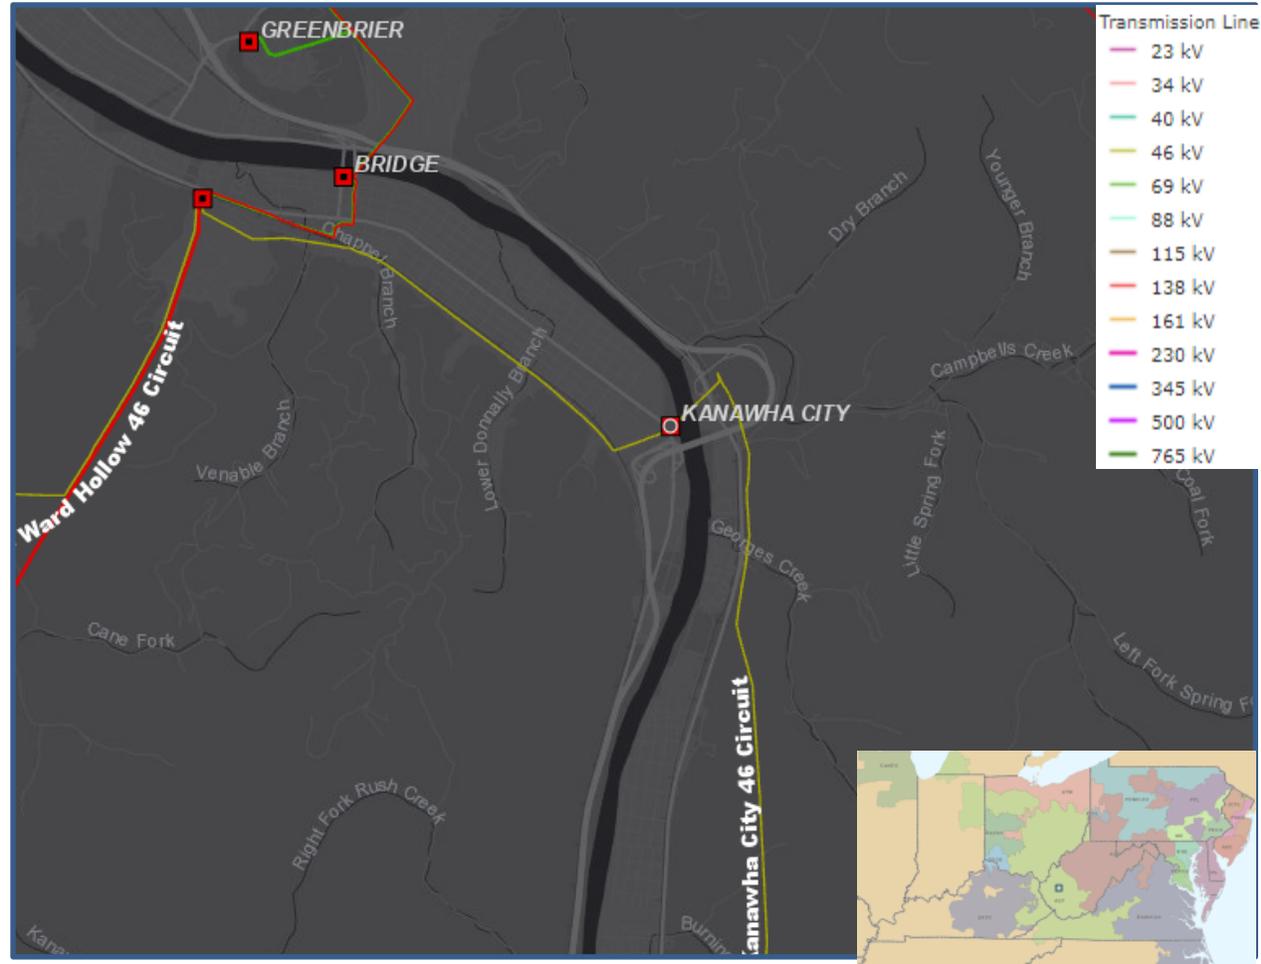
- 46kV circuit breaker A is 72PM31-20 type, SF6 filled breaker.
 - 1994 vintage
 - Circuit breakers of this type across the AEP system have had reports of moisture ingress into the breaker tank. This moisture ingress leads to increased maintenance and a higher risk of failure. These breakers have documented issues with failures to close due to burned up coils. There have been five catastrophic failures involving this specific model type on the AEP system.

- 46 kV circuit switcher AA is a VBM-69 type, vacuum filled switcher
 - 1997 Vintage
 - This model family has experienced malfunctions including failing to trip due to pole malfunction, worn out stops on the control yoke or solenoid nylon pin binding not allowing it to trip due to corrosion, loose bolts, or broken poles. In addition, these switchers perform poorly in cold weather, leading to more malfunctions.

- This unit has experienced two malfunctions related to a failure to close.
- 32 of the 38 relays at the station are in need of replacement/upgrades
 - 30 relays are electromechanical type which have significant limitations with regards to fault data collection and retention.

- 2 MP relays have firmware that is unsupported
- 46 kV capacitor bank AA has failed

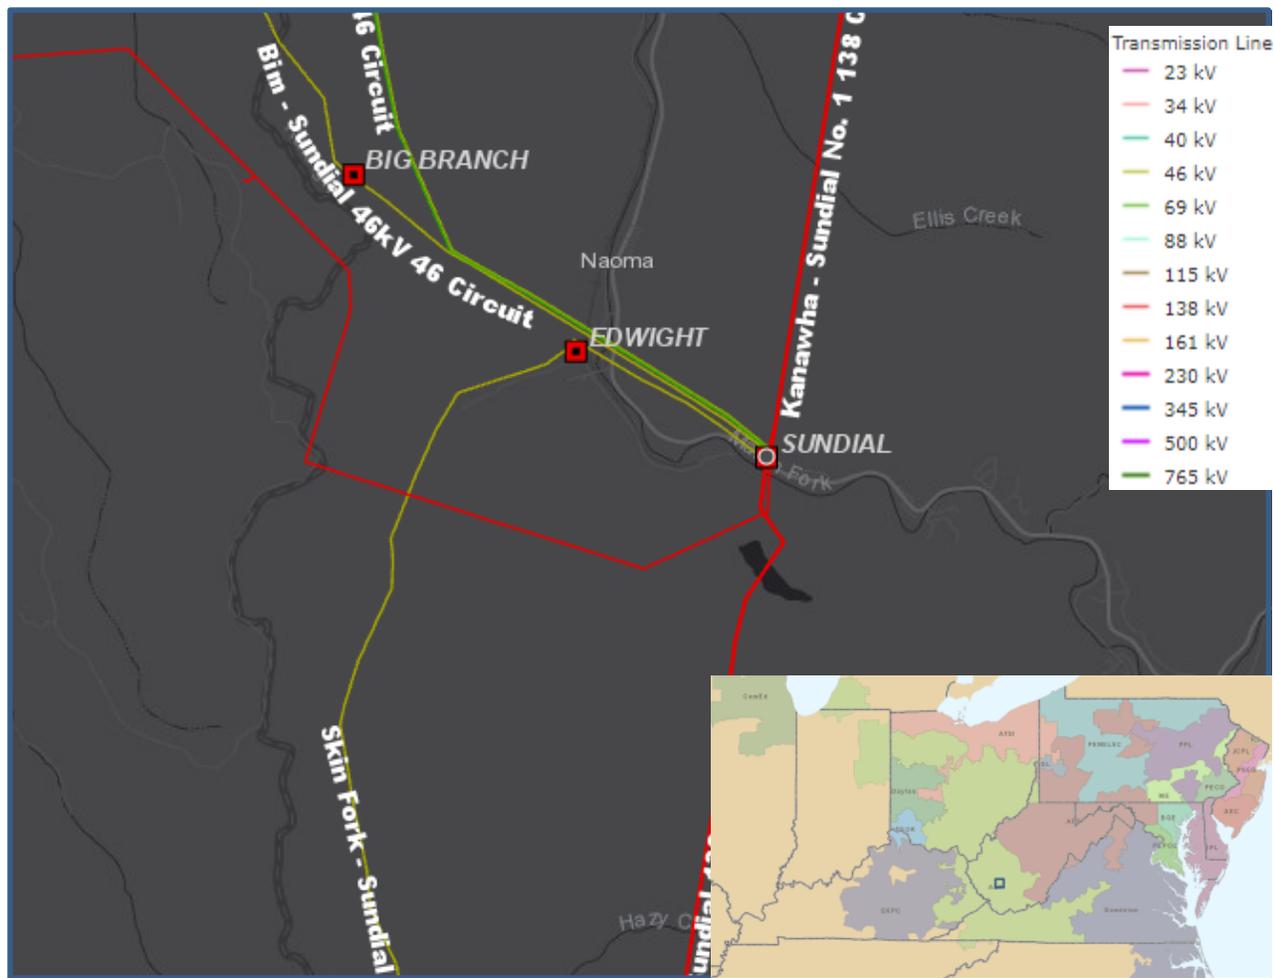
- 46kV circuit breaker A is 72PM31-20 type, SF6 filled breaker.
 - 1996 vintage
 - Circuit breakers of this type across the AEP system have had reports of moisture ingress into the breaker tank. This moisture ingress leads to increased maintenance and a higher risk of failure. These breakers have documented issues with failures to close due to burned up coils. There have been five catastrophic failures involving this specific model type on the AEP system.

- 1978 Vintage
 - This model family has experienced malfunctions including failing to trip due to pole malfunction, worn out stops on the control yoke or solenoid nylon pin binding not allowing it to trip due to corrosion, loose bolts, or broken poles. In addition, these switchers perform poorly in cold weather, leading to more malfunctions.

- Older VBM types have been very problematic over the years especially on higher voltages where there are two vacuum interrupters in series per phase
- 60 of the 75 relays at the station are in need of replacement/upgrades

- 51 relays are electromechanical type which have significant limitations with regards to fault data collection and retention.
 - 3 static relays which have significant limitations with regards to spare part availability and fault data collection and retention.

- 6 MP relays have firmware that utilize obsolete firmware

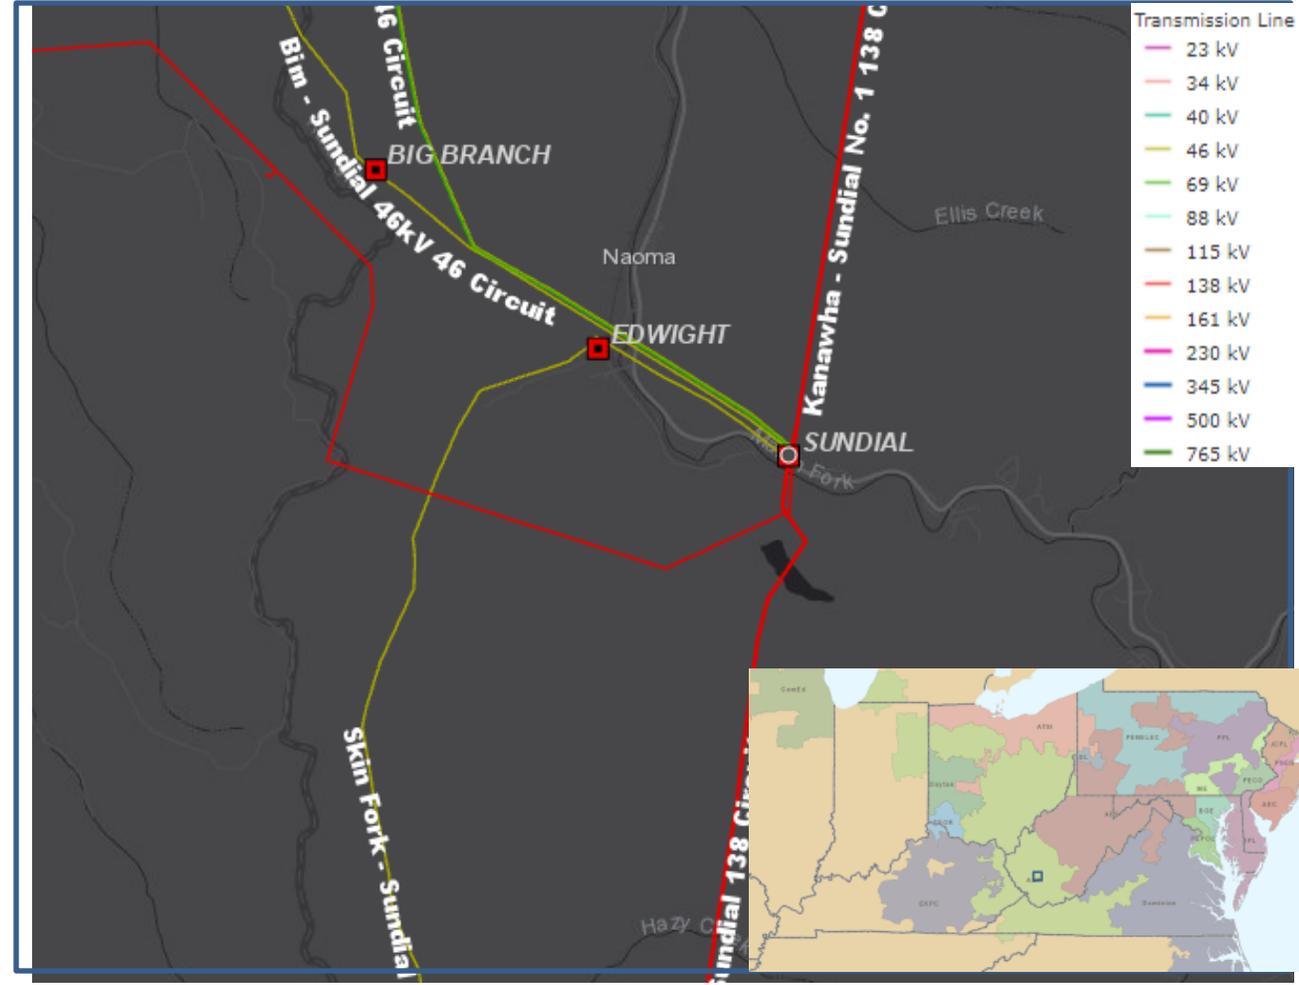
Sundial Station

- Ground Bank #2 has experienced elevated levels of Ethane and Carbon Dioxide. The presence of Ethane and Carbon Dioxide, along with the indication of overheating faults, indicated decomposition of the non-thermally upgraded and increasingly brittle paper insulation that impairs the unit’s ability to withstand future short circuit or through fault events.
- Sundial 138/69/46 kV Transformer #1 lacks high side sectionalizing.
- Currently Sundial Station has two 138 kV buses that are electrically separated. Both of these buses are part of a significant 138 kV path between Kanawha River Station and Baileysville Station. Due to the buses being electrically separate, it limits operational flexibility on the system to utilize both paths to better serve load in the area when necessary during outages.

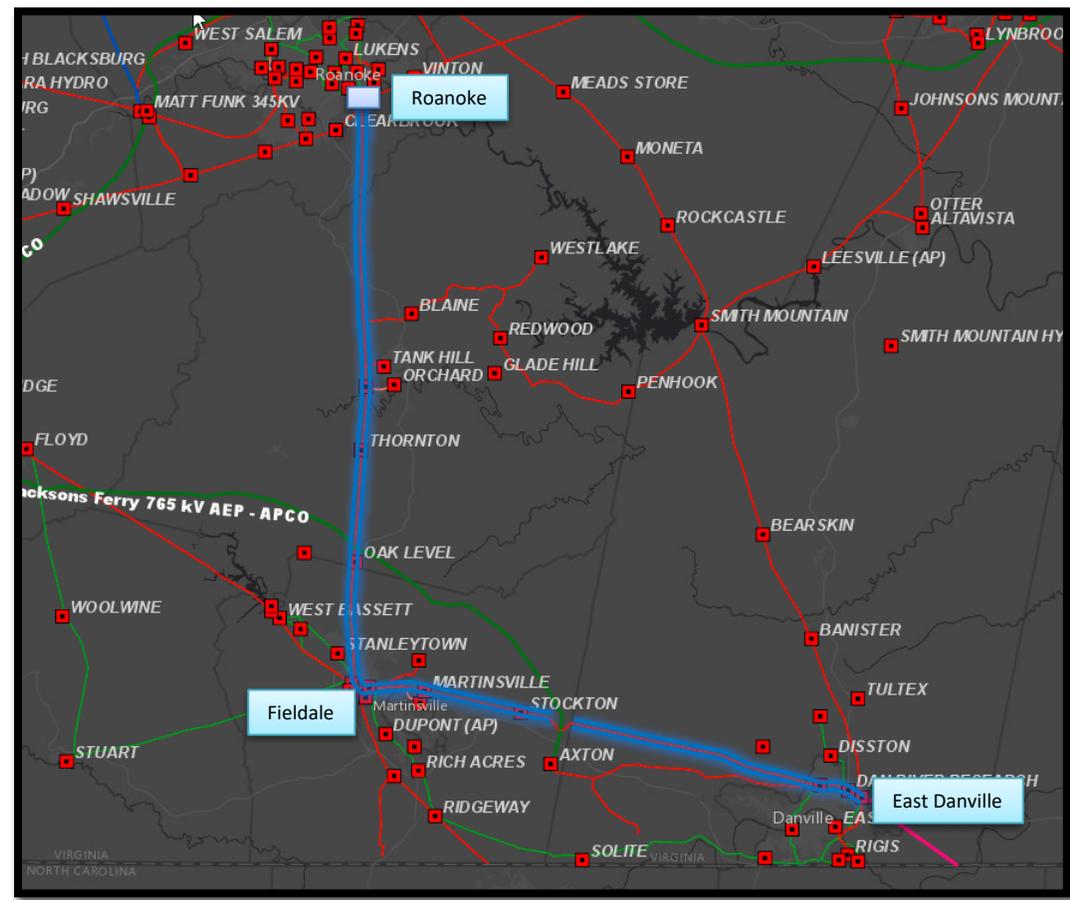
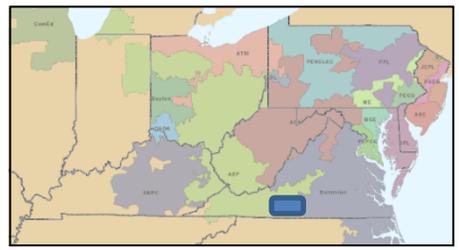
- The representative structure on the Roanoke – Carolina 138 kV Line fails to meet 2017 NESC Grade B loading criteria, fails to meet current AEP structural strength requirements, and fails to meet the current ASCE structural strength requirements.

- The porcelain insulators on the line do not meet current AEP standards for CIFO and minimum leakage distance requirements.
 - The shield angle on a typical tangent structure is measured at 50° and is inadequate for current AEP shield angle requirements. This could be contributing to the poor lightning performance of some of the associated circuits.

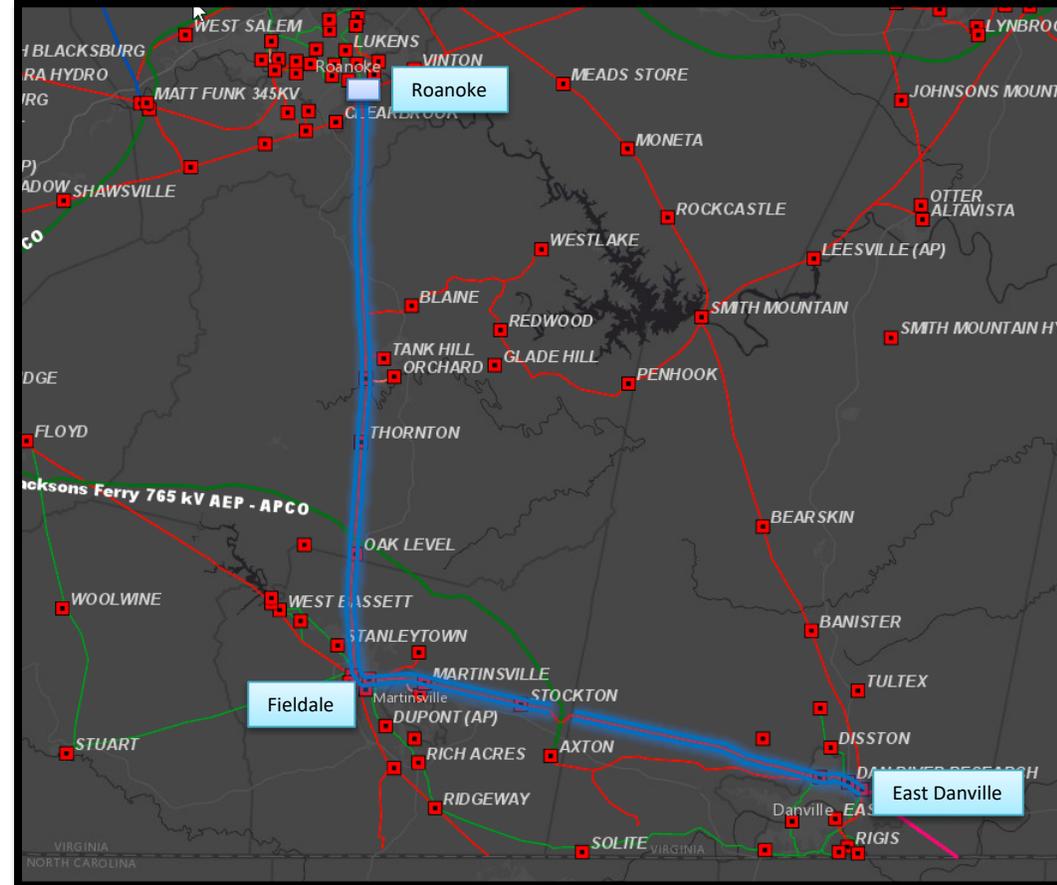
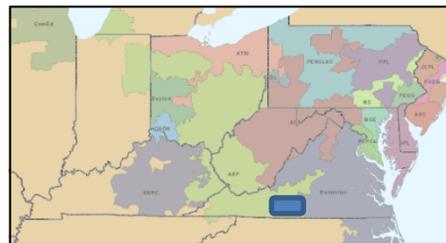
- 11 structures were assessed by a ground crew and 161 structures were assessed by an unmanned aerial vehicle (UAV). About 30% of those structures had reported conditions; however, this statistic doesn't properly capture the prevalence of rust and hardware attachment point ovalization in structures along the line. Of the 11 structures assessed by ground crews, all of them showed signs of moderate to severe rust across the structure and hardware.

- The other most common conditions found are as follows:
 - 39 structures displayed flashing damage on insulator porcelain and glass.
 - 9 of the structures assessed by ground crews had rusty hardware including bolts, connections, and insulator hardware.

- 9 of the structures suffered from moderate ground line corrosion.
 - At least 5 structures exhibited ovalization of bolt holes at attachment points.
 - 5 structures had arresters that were disconnected.

- 3 structures showed severe rust on their conductor dampeners.
 - 2 structures showed severe rust on the insulator end fittings and hardware.
 - 2 structures displayed bowing on their cross braces.

- There are currently 2 open structural conditions for bent lacing. There are currently 109 open hardware conditions related to broken arresters (105), disconnected arresters (2), a burnt arrester (1), and an insulator with electrical interference (1). This significant amount of arrester damage could be contributing to the poor lightning performance of some of the associated circuits.
- There are currently 6 open conductor conditions, related to broken strands.
- There are currently 2 open shielding conditions related to broken shield wire strands. This could be contributing to the poor lightning performance of some of the associated circuits.

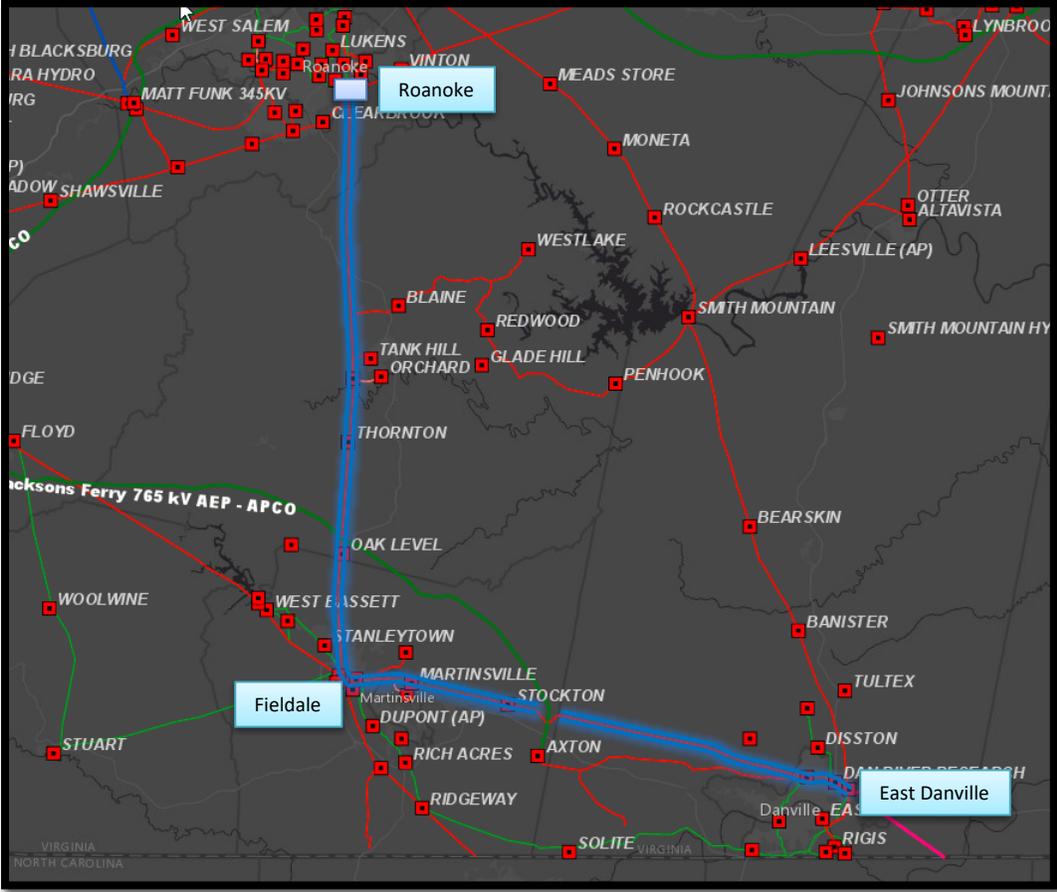
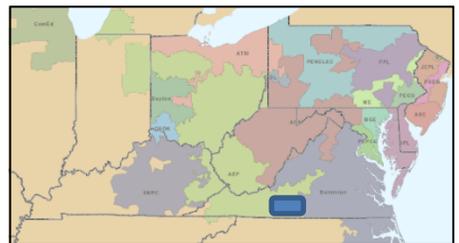
- **Axton-Danville No. 1 138 kV Circuit**
 - Since 2018, there have been 9 momentary and 4 permanent outages on the Axton – Danville No. 1 138kV Circuit. The 9 momentary outages were due to lightning (7) and unknown (2) causes. The 4 permanent outages and 1 of the lightning caused momentary outages caused about 148 hours of transmission circuit interruption. The permanent outages were due to vegetation fall-ins from outside the AEP ROW (2), ice/snow (1), and station insulator (1) causes.

- **Blaine-Roanoke 138 kV Circuit**
 - Since 2018, there have been 2 momentary and 2 permanent outages on the Blaine – Roanoke 138kV Circuit. The 2 momentary outages were due to vegetation fall-in from outside the AEP ROW (1) and unknown (1) causes. The 2 permanent outages caused just over 63 hours of transmission circuit interruption. The permanent outages were due to wind (1) and vegetation fall-in from outside the AEP ROW (1) causes.

- **Axton-Fieldale 138 kV Circuit**
 - Since 2018, there have been 2 momentary and 2 permanent outages on the Axton – Fieldale 138kV Circuit. The 2 momentary outages were due to lightning (1) and field error (1) causes. The 2 permanent outages caused just over 12 hours of transmission circuit interruption. The permanent outages were due to other (1) and field error (1) causes. The outage coded as other was the result of several factors occurring at the same time. The Axton – Danville No. 1 138kV Circuit locked out as a result of a failed station insulator during a scheduled outage of the new Axton – Berry Hill 138kV Circuit, ultimately causing an outage on the Axton – Fieldale 138kV Circuit.

- **Axton-Martinsville 138 kV Circuit**
 - Since 2018, there have been 5 momentary outages on the Axton – Martinsville 138kV Circuit. These 5 momentary outages were due to distribution (2), wind (1), field error (1), and unknown (1) causes. The outage coded as unknown was most likely related to a relay mis-operation associated with the circuit latching of the 138kV CB C at Martinsville Substation. The outage notes indicated this has been a recurring issue.

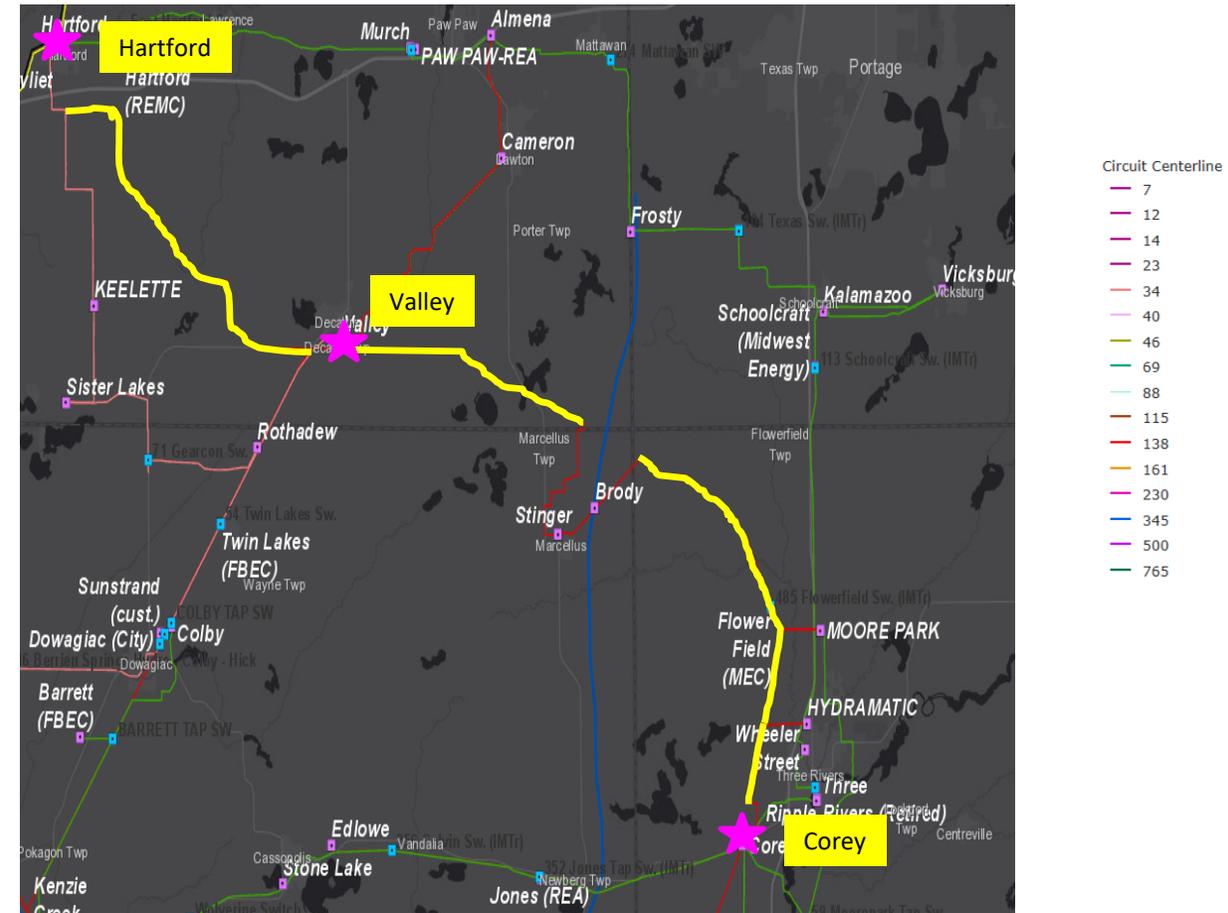
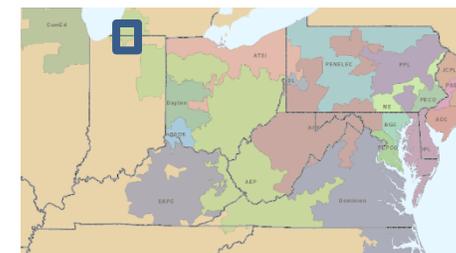
- Hartford – Valley – Corey 138kV line is 36.49 miles long that was originally installed in 1973 and mostly consists of single wood poles
- Since 2018, the Hartford – Valley 138kV circuit has experienced 2 momentary and 3 permanent outages caused by weather and vegetation. The permanent outages resulted in about 213 hours of interruption to the circuit

- Structures fail to meet 2017 NESC Grade B and AEP structural strength requirements
- The insulators on the line do not meet current AEP standards for CIFO and minimum leakage distance requirements.

- The grounding does not meet current AEP standards
- There are 210 structures with that have at least one (1) open condition (44% of line). These conditions specifically affecting the pole include woodpecker damage, rot top, insect damage, split, rot shell, general damage, rot heart, rot pocket, sitting in water, cracked, and leaning traverse conditions

- Out of 60 structures assessed (30 by aerial drone and 30 by ground crew), the following conditions were found:
 - The vast majority of wood poles assessed have some level of decay or top rot, woodpecker holes, insect damage, and/or shell rot

- There is a significant number of structures with flashed, burnt, or broken insulators due to the application of aluminum grounding

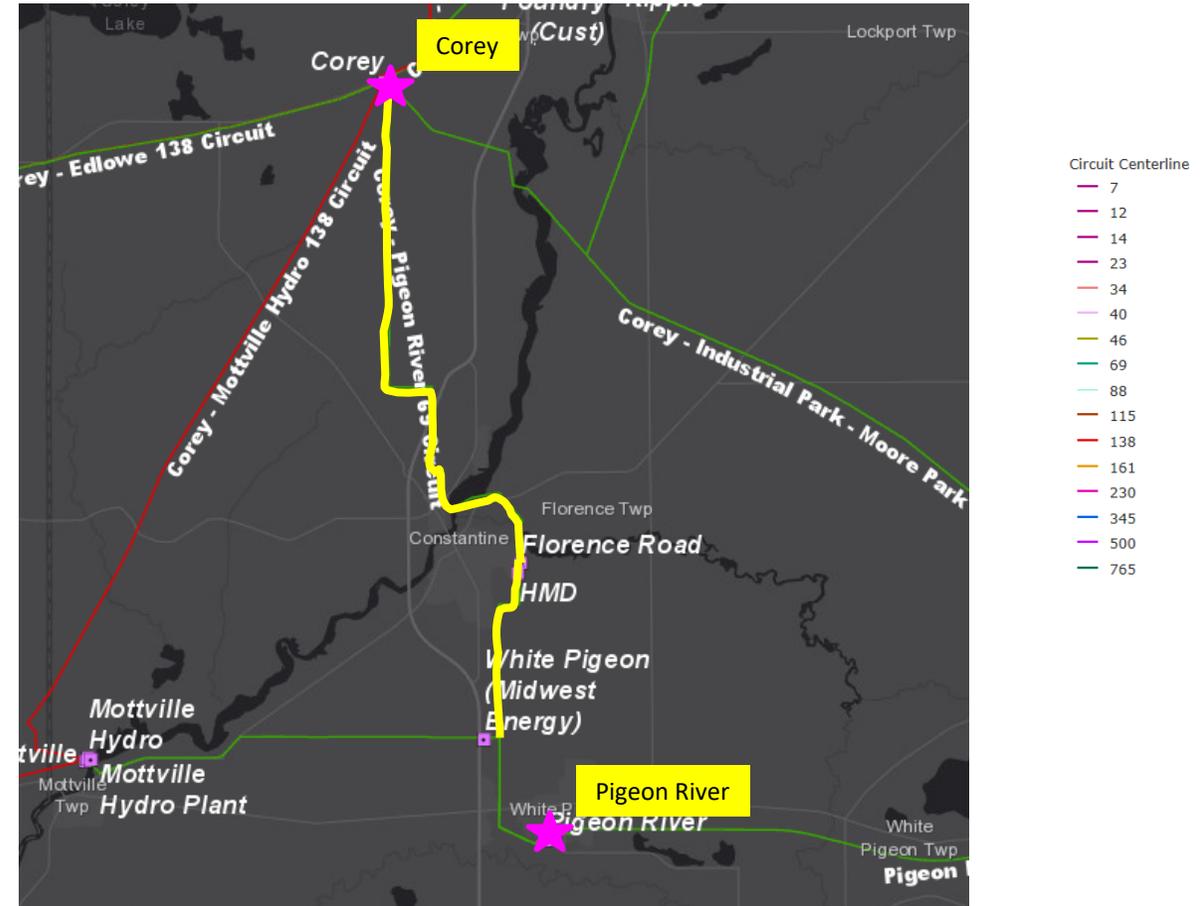
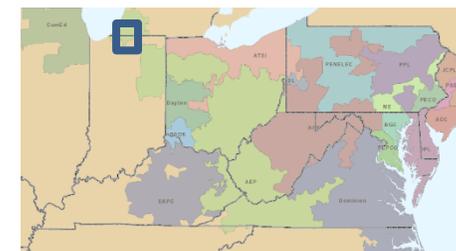
- Structures fail to meet 2017 NESC Grade B loading criteria
- The insulators on the line do not meet current AEP standards for CIFO and minimum leakage distance requirements.

- The grounding does not meet current AEP standards. The grounding method utilizes butt wraps on every other pole, which is inadequate for AEP standards

- There are 33 structures that have at least one (1) open condition (59% of line). These conditions specifically affecting the pole include woodpecker, rot top, rot heart, rot shell, burnt, and split conditions

- Out of the 39 structures assessed, approximately 23% have pole cavities or woodpecker damage

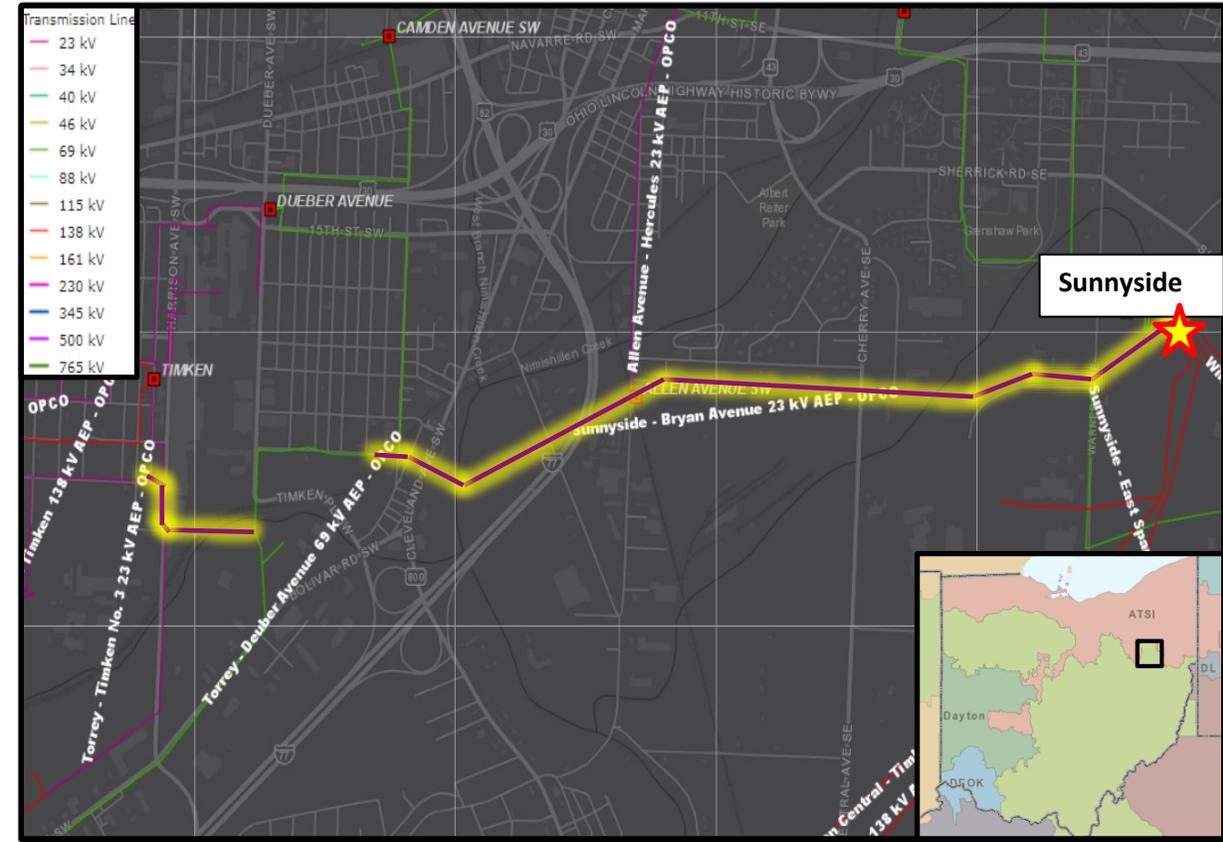
- 0.11 Miles of 336,400 CM ACSR 30/7 (Oriole) from 1962
 - 0.02 Miles of 556,500 CM ACSR 18/1 (Osprey) from 1972
- 5 structures were assessed by a ground crew. 80% of those structures had reported conditions, which includes the following: one structure had rot heart conditions, one structure had moderate deterioration to the distribution arm, one structure had a faded aerial number sign, two structures had moderate deterioration to arms/braces, one structure had surface rust present on the guys/anchors, one structure had rusted and corroded guys, one structure had wooden guy strain insulators that are moderately deteriorated, one structure had 3 reported shield wire splices, three structures had rusty steel clamps, one structure had a weathered pole topper, one structure had a weathered bayonet and two structures had porcelain insulators that are deteriorated.

- The representative structure on the Sunnyside – Bryan 23kV line fails to meet 2017 NESC Grade B loading criteria and fails to meet current AEP structural strength requirements.

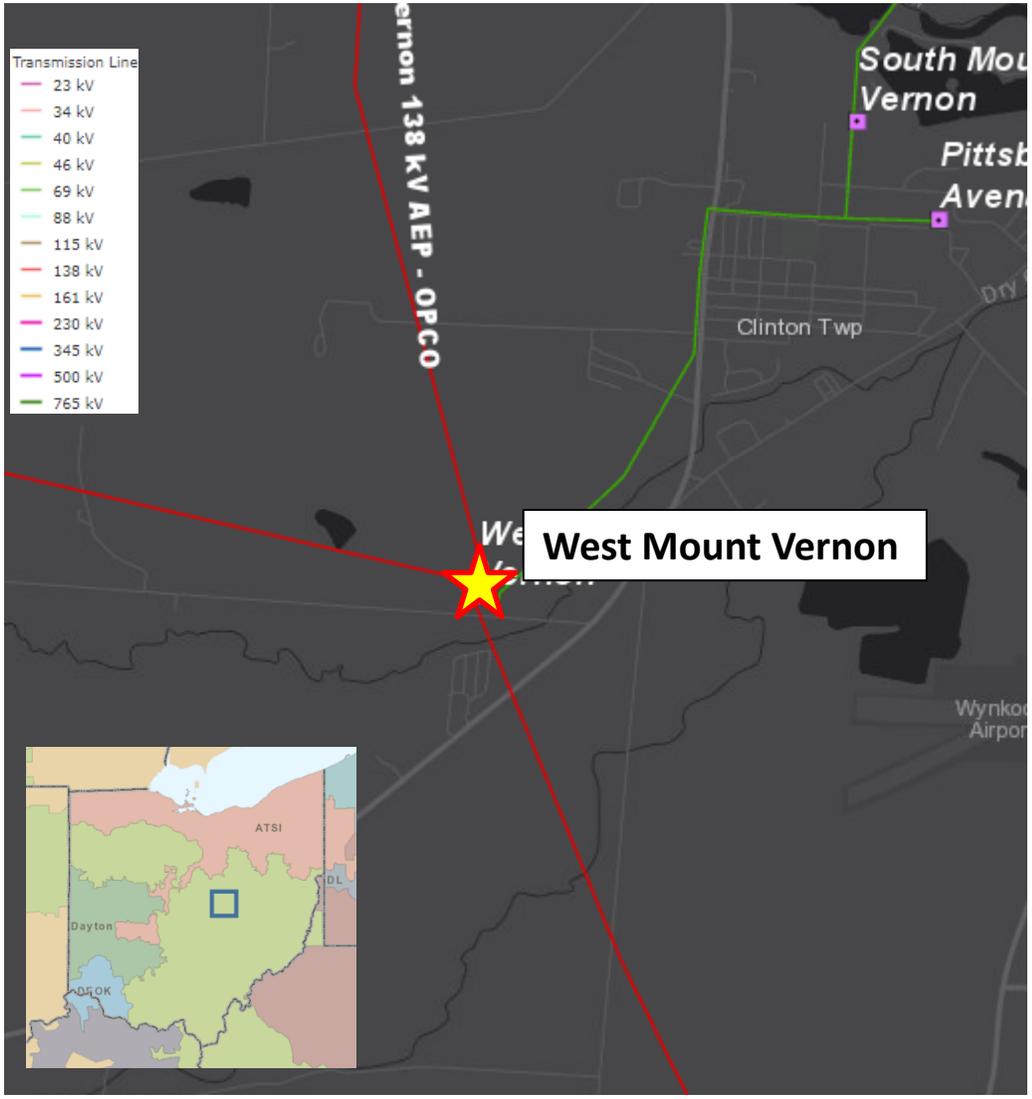
- From the time period of July 2020- January 2023, there have been 82 recorded malfunctions of this 145-PA model family on the AEP System. The most common issues documented are related to loss of SF6 gas and mis-operations. The expected life of the bushing gaskets and door inspection port seals is 25 years; Both of these units have reached this age. Seals that are no longer adequate can cause SF6 leaks to become more frequent. The manufacturer provides no support for this 145-PA family of circuit breakers, and spare parts are no longer available.

- CB-A has experienced 60 malfunctions and CB-B has experienced 30 malfunctions. These malfunctions include low gas alarms which required additional SF6 gas to be added, malfunctions due to a leak in the valve packing and malfunctions due to low temperature readings in the breaker.

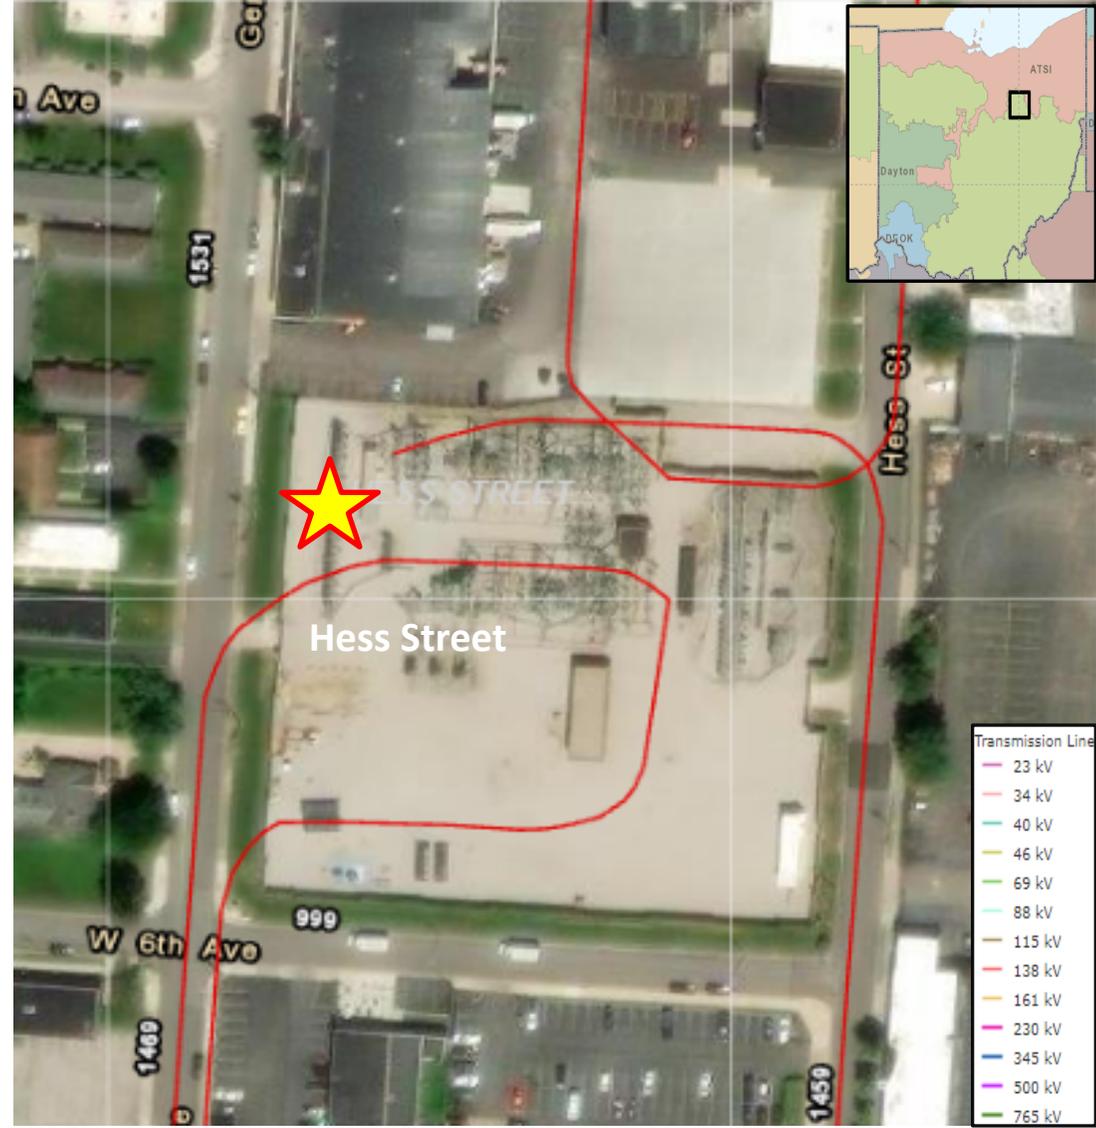
138 kV Circuit Breakers CB- 1, 2, 3, 4:

- Breaker age: CB- 1= 1980, 2&3 =1966, 4=1969
- Interrupting Medium: (Oil)
- Additional Information:
 - These breakers are all oil filled without oil containment; oil filled breakers have much more maintenance required due to oil handling that their modern, SF6 counterparts do not require. These breakers are of 1960s and 1980s vintage. The breakers are no longer supported by vendors with spare parts no longer being available.

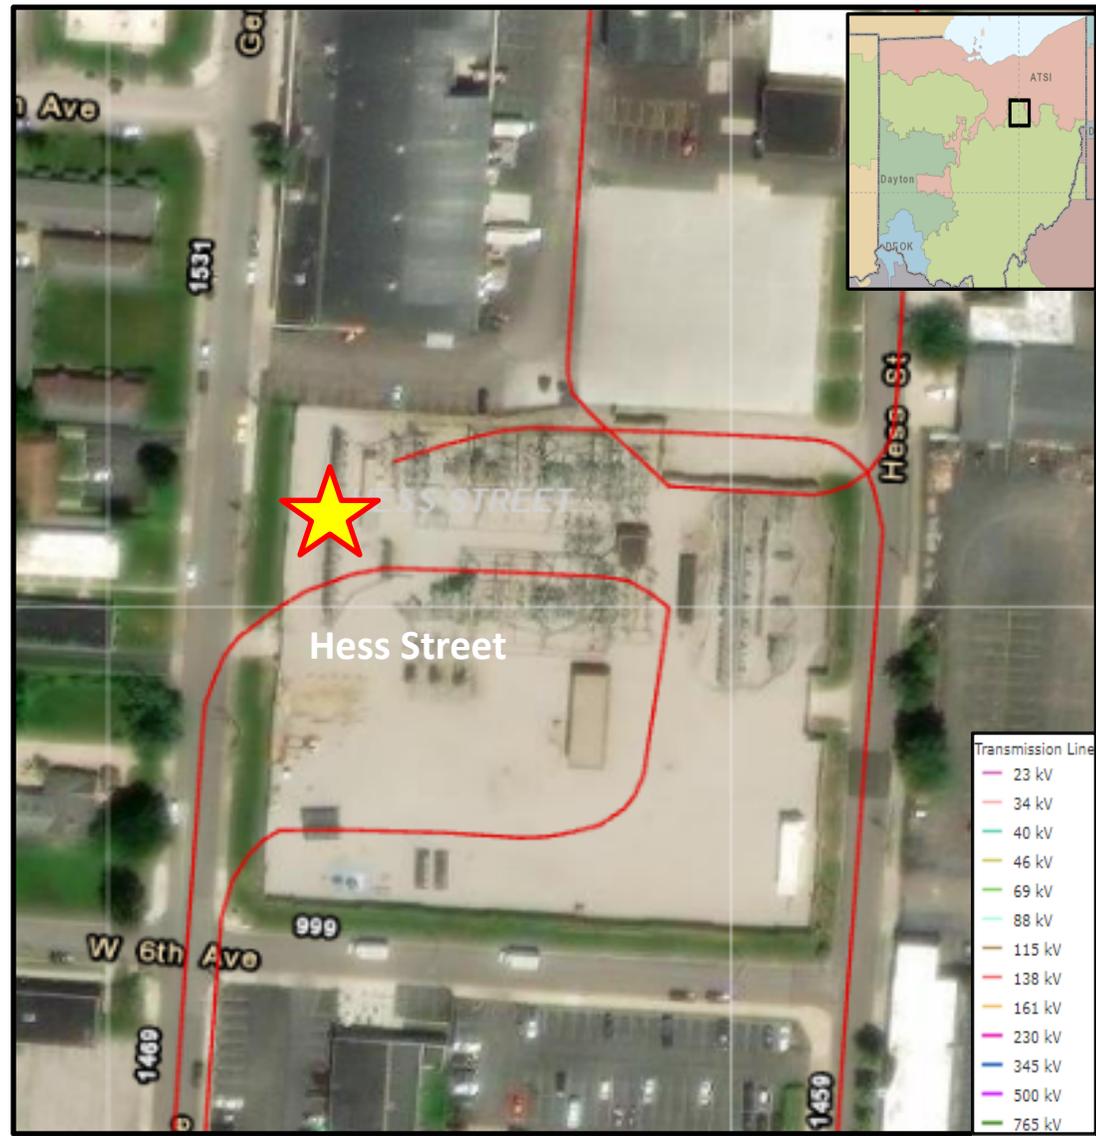
- Circuit Switcher age: 1995
- Interrupting Medium: SF6
 - The 138 kV circuit switcher CS-AA is an SF6 type switcher. It's 1993 vintage switcher type and has no gas monitor. From May 2000 to December 2022, this model of switcher has experienced 88 malfunctions with in-service units on the AEP system. Failed operational components, including high contact resistance, gas loss, and interrupter failure, represent half of these malfunctions. Two malfunctions catastrophic equipment failures involving failures to trip.

- Currently, 133 of the 147 relays (90% of all station relays) are in need of replacement or upgrades. There are 111 of the electromechanical type and 8 of the static type which have significant limitations with regards to fault data collection and retention. These relays lack vendor support and have little to no access to spare parts. In addition, there are 14 microprocessor relays that were installed/commissioned between 2002 and 2010.
- AEP Ohio Distribution has indicated that there is a significant amount of distribution equipment at the station in poor condition that needs addressed.
