Western Sub Regional RTEP: AEP Supplemental Projects

April 21, 2023

AEP Transmission Zone M-3 Process Huntington, WV

Need Number: AEP-2023-AP009

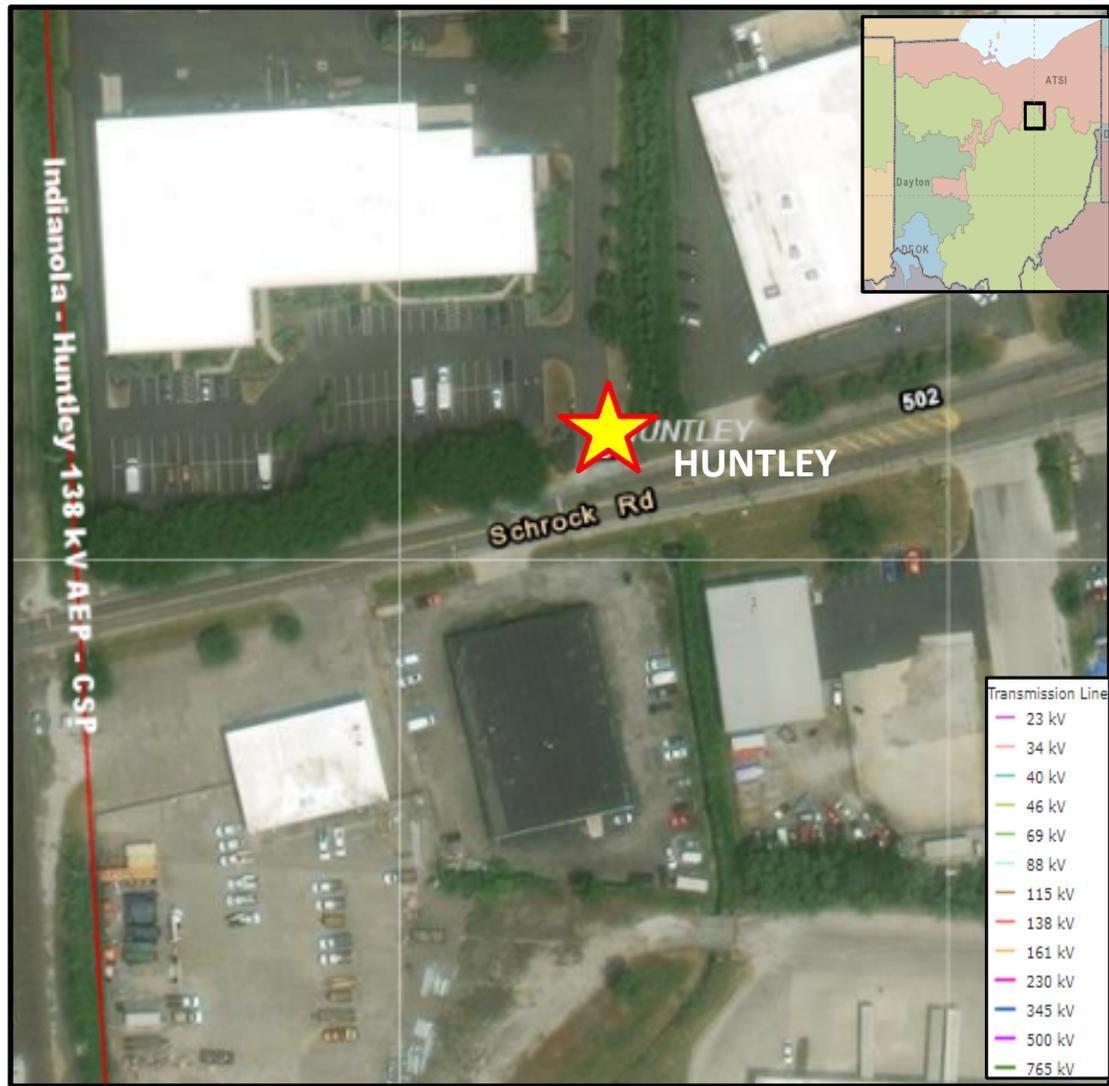
138 kV Circuit Switcher CS - AA:

- Circuit Switcher age: 1995
- Interrupting Medium: SF6
- Additional Information:
 - The 138 kV transmission owned circuit switcher CS-AA is a SF6 type switcher. It's 1993 vintage switcher type and has no gas monitor. From May 2000 to December 2022, this model of switcher has experienced 88 malfunctions with in-service units on the AEP system. Failed operational components, including high contact resistance, gas loss, and interrupter failure, represent half of these malfunctions. Two malfunctions of note were catastrophic equipment failures involving failures to trip.

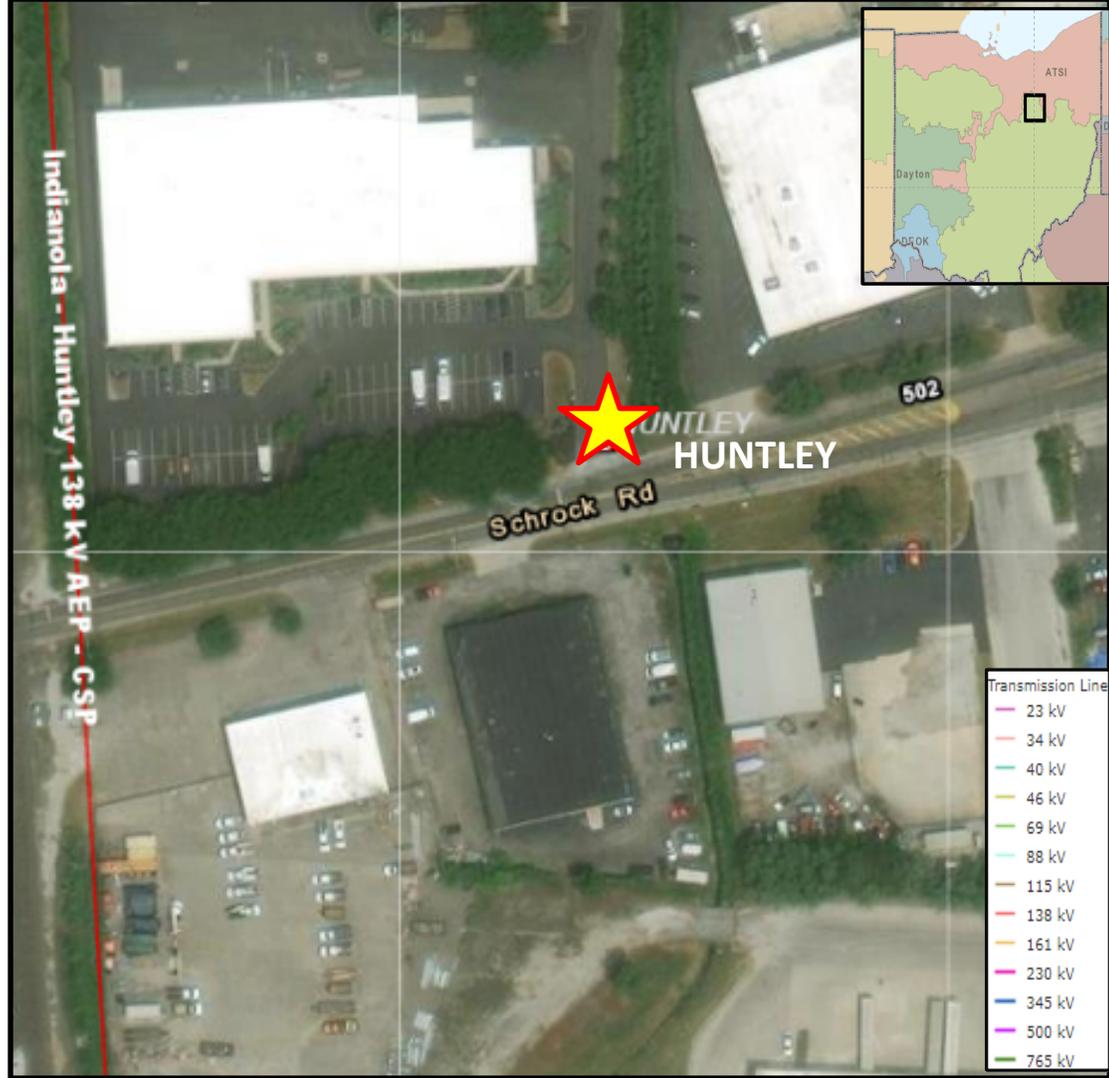
- Breaker age: CB- 63, 64, 65, 66, 69 = 1971, CB- 60 = 1976
- Interrupting Medium: (Oil)
- Additional Information:
 - These breakers are oil filled without oil containment; oil filled breakers have much more maintenance required due to oil handling that their modern, SF6 counterparts do not require. These breakers are of 1970s vintage. The manufacturing company does not provide any support for these circuit breakers and spare parts are not available. This kind of breakers have several malfunctions within the AEP system such as; low-pressure readings, hydraulic leaks, pump lockouts, and failure to shut off. These mechanism malfunctions have led to several failures to close and other types of mis-operations across the AEP fleet.

- Currently, 146 of the 176 relays (83% of all station relays) are in need of replacement or firmware upgrades. Of the 146 relays, 142 are of the electromechanical and static type which have significant limitations with regards to spare part availability and fault data collection and retention. These types of relays have a history of causing problems with the protection and operation of the substation. This specific type of relay has a high failure/malfunction rate. Fault monitoring and capability checking is not accessible, and information cannot be sent to the RTU through SCADA. This relay does not have DME capability meaning fault data cannot be recorded which hurts the determination of proper operation and fault location. Electromechanical relays do not meet current AEP P&C standards. There are 4 microprocessor relays that were installed/commissioned in 2007.

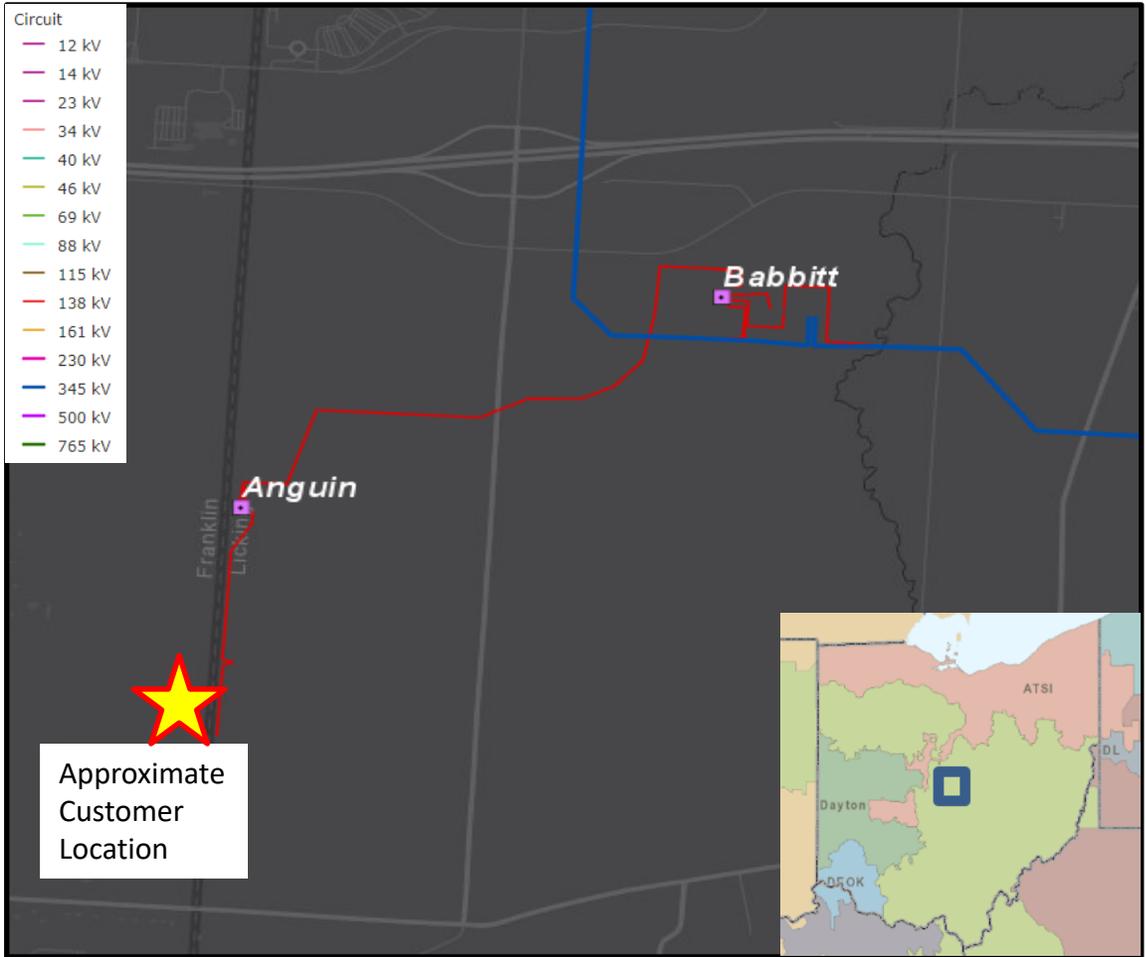
- An existing customer served out of AEP’s Anguin Station in New Albany, OH, has requested an additional service for a new bulk load addition of 100 MW. This will bring the total load for the customers site to 450 MW with an ultimate capacity of up to 720 MW.
- Customer requested in-service date of 3/31/2024.

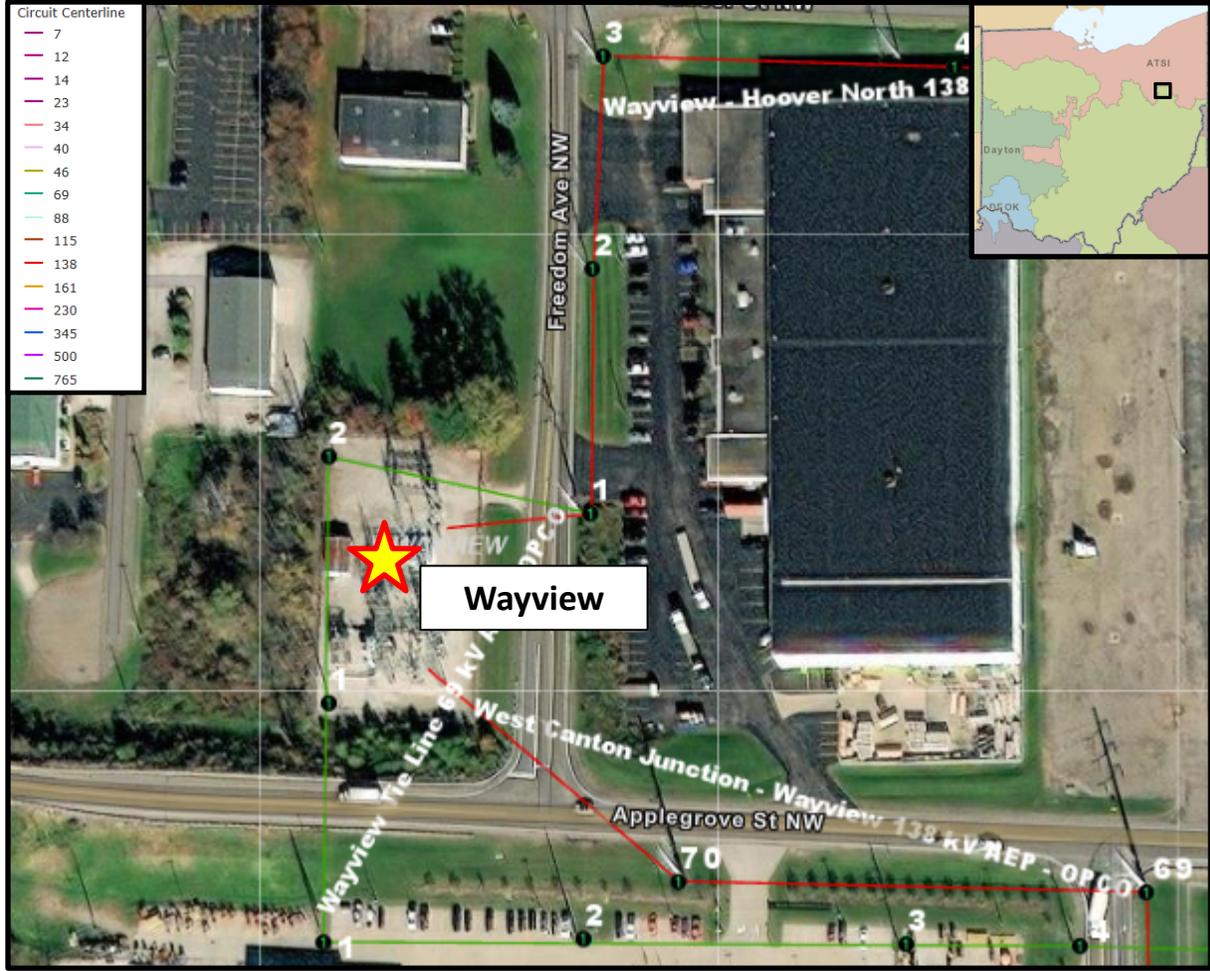
AEP Ohio has requested to add capacity at Wayview station, due to continuous load growth in the North Canton area near the Akron-Canton Airport. The station has limited transferability to surrounding distribution stations. The anticipated total peak distribution load is 24 MVA. The requested in-service date is 12/31/2025.

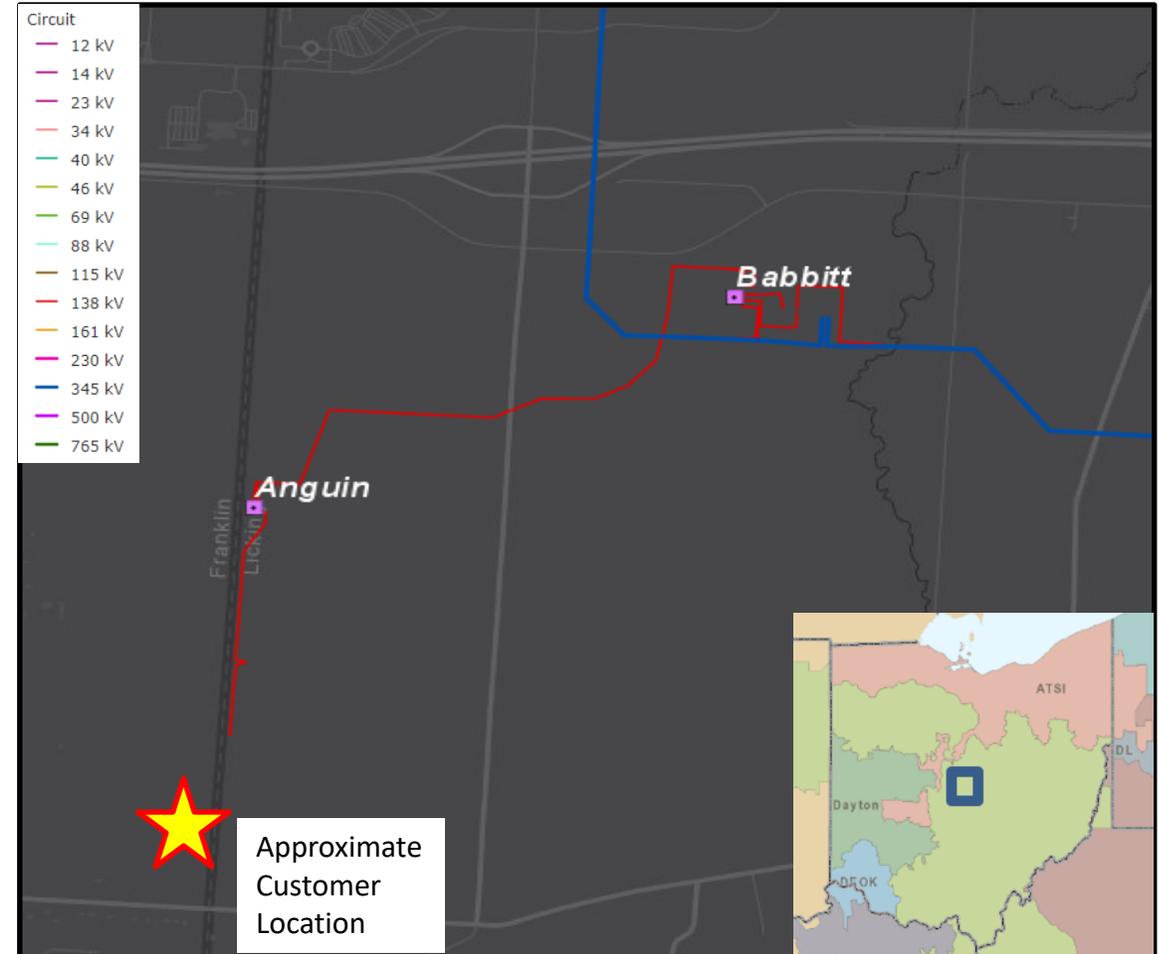
- An existing customer served out of AEP’s Anguin Station in New Albany, OH, has requested an additional service for a new bulk load addition of 100 MW. This will bring the total load for the customer’s site to 550 MW with an ultimate capacity of up to 720 MW.
- Customer requested in-service date of 07/31/2024.

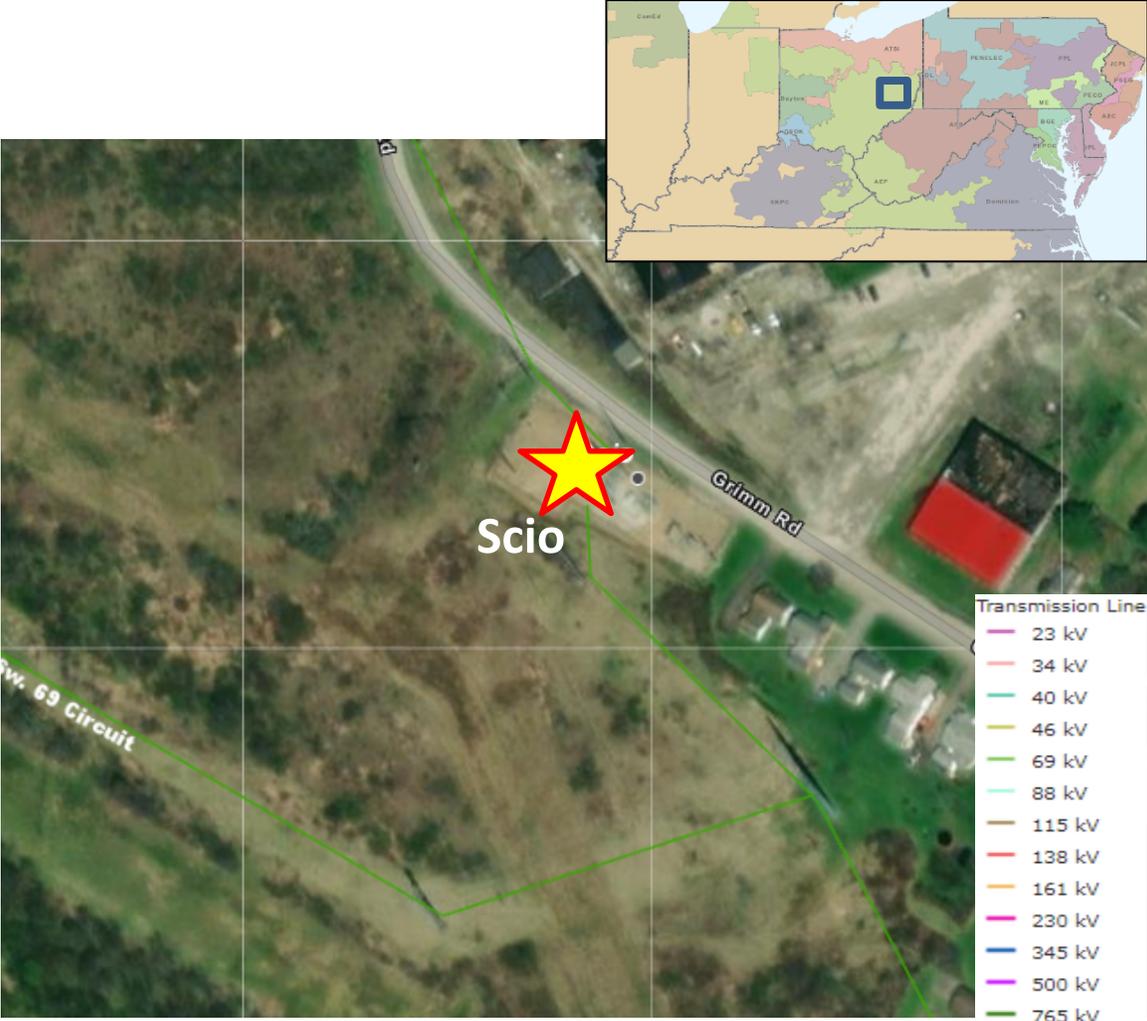
AEP Ohio’s Scio distribution station does not have any SCADA functionality, limiting the ability of T & D operations personnel to properly monitor real-time conditions at the station. It can also lead to lengthier outage times for customers.

In addition, it has an outdated ungrounded 69 kV capacitor bank (9.6 MVAR) that has been prone to malfunction. The capacitor was manufactured in 1989. This cap bank is a manually switched bank with no SCADA control of the switcher.

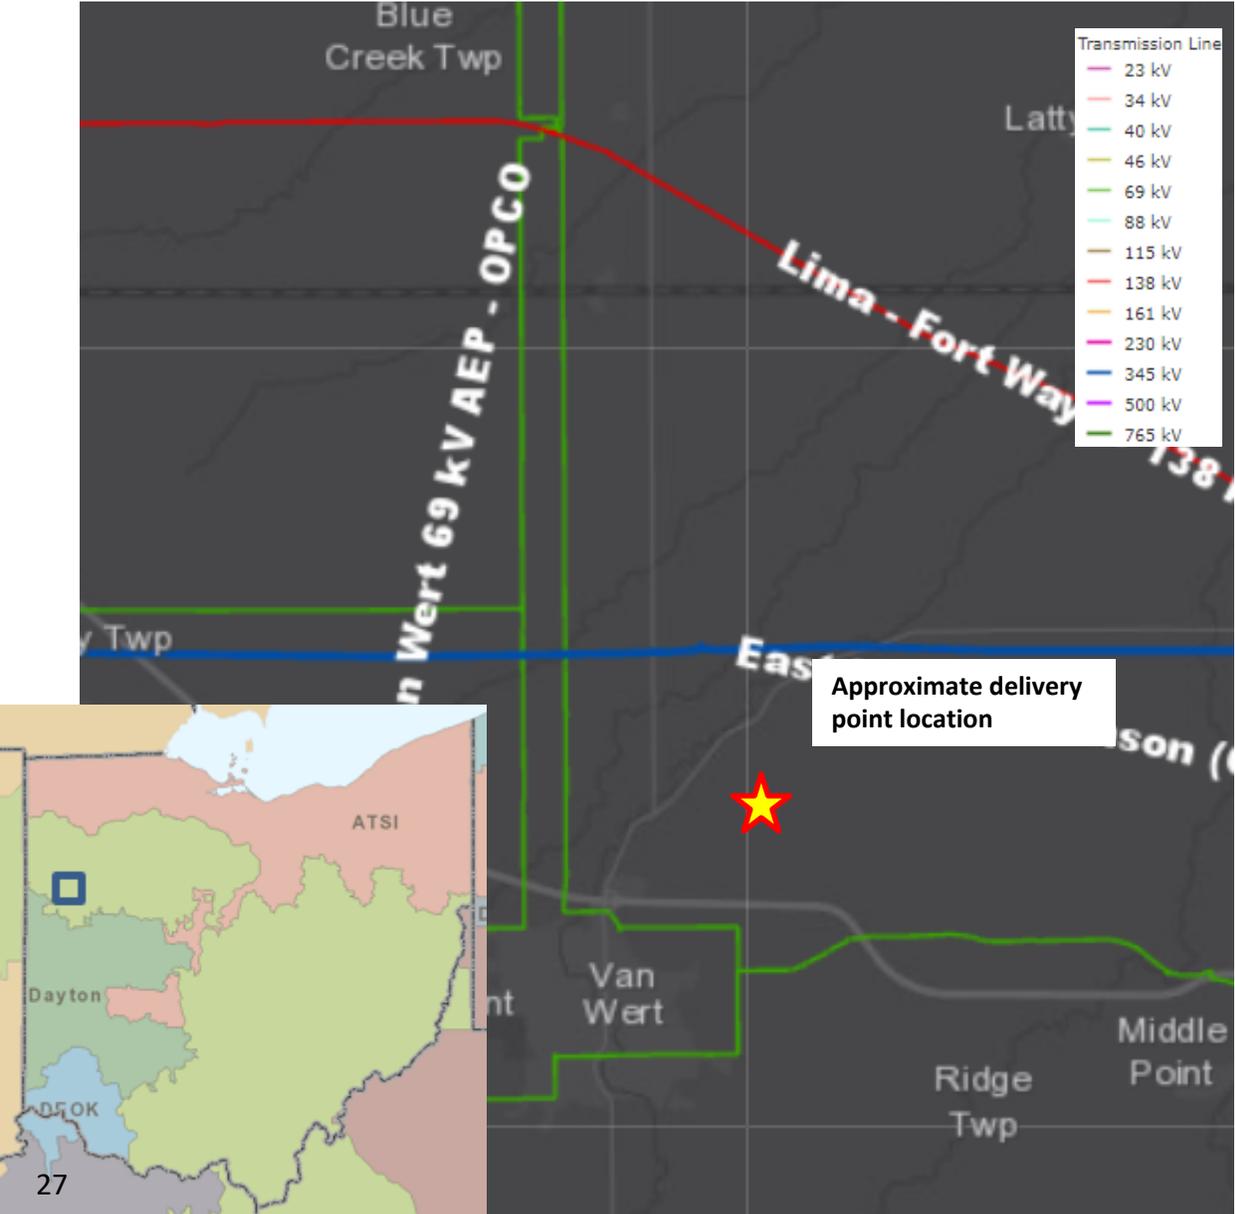
The Van Wert Mega industrial site is located north of Van Wert in Van Wert County Ohio. The site is approximately one mile east of AEP's Van Wert - Haviland 69kV circuit. The site has been heavily targeted by regional and state economic development efforts and will continue to be. The site is highlighted by JobsOhio and its partner Regional Growth Partnership as its top available property for EV manufacturing. From January 2022 to March 2023 AEP Economic Development has had 32 requests for electric service plans at the site. The prospective customer's electric demand ranged from 5MW to 760MW. Around the industrial site, significant investment has been performed to prepare the site for manufacturing industry development, including installation of a rail spur.

Many of these prospective customers cannot be connected to the existing Van Wert area 69kV network without significant upgrades.

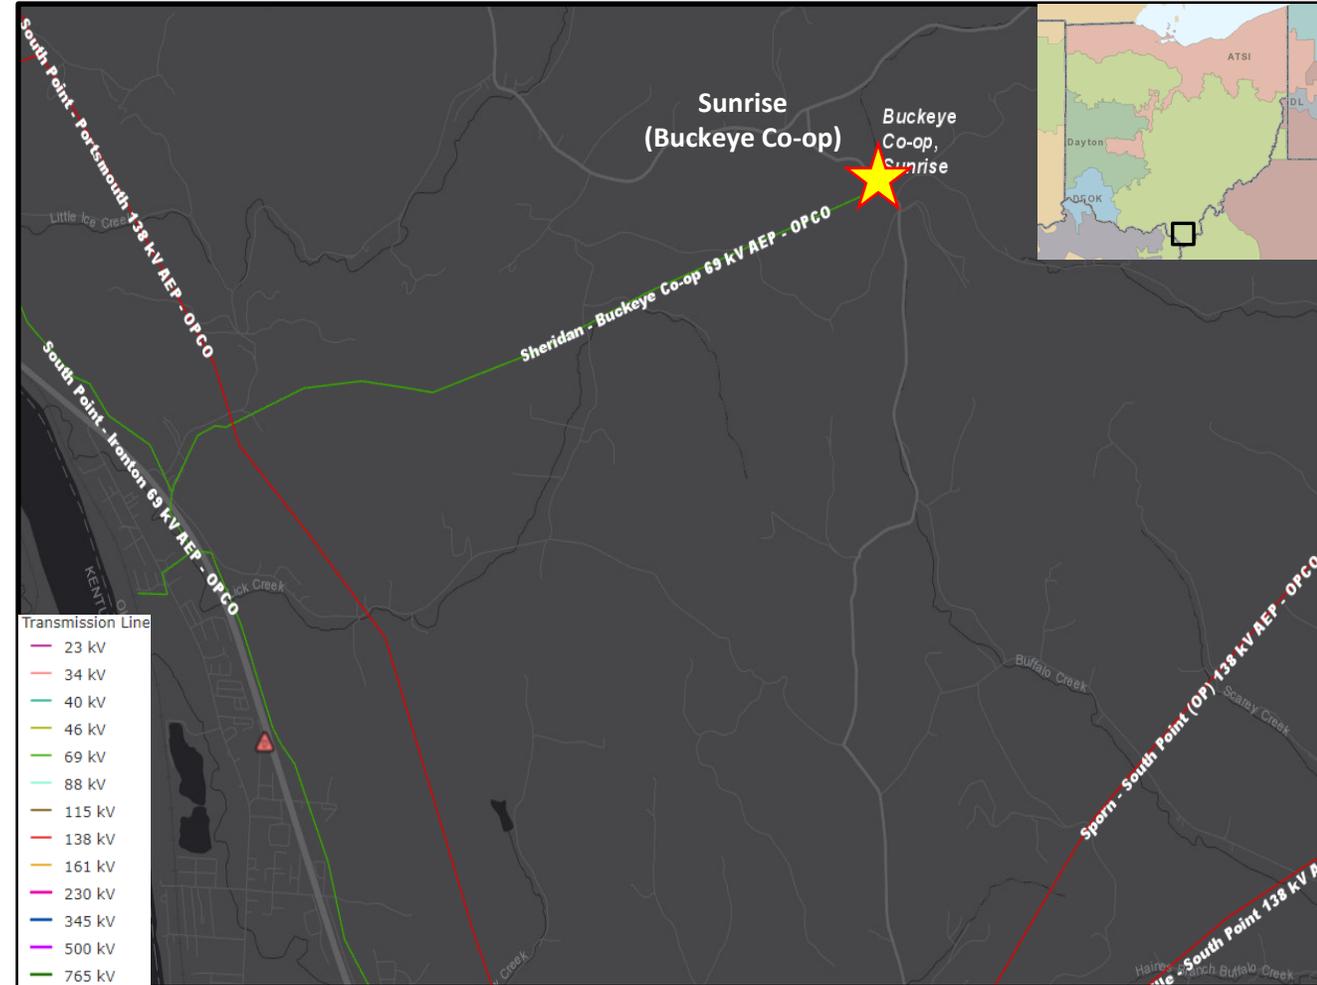
Additional Info: Radial service severely restricts the ability to perform routine maintenance and restoration activities. The maintenance of radial transmission lines often requires costly temporary facilities or other labor-intensive measures involving energized work because a maintenance outage to such radial loads is generally not feasible.

The South Point-Ironton 69 kV line feeds the Sunrise radial line. The South Point-Ironton line is a 1950s vintage line. 96 of the 158 structures on the line are 1970s vintage or older, accounting for 60% of structures.

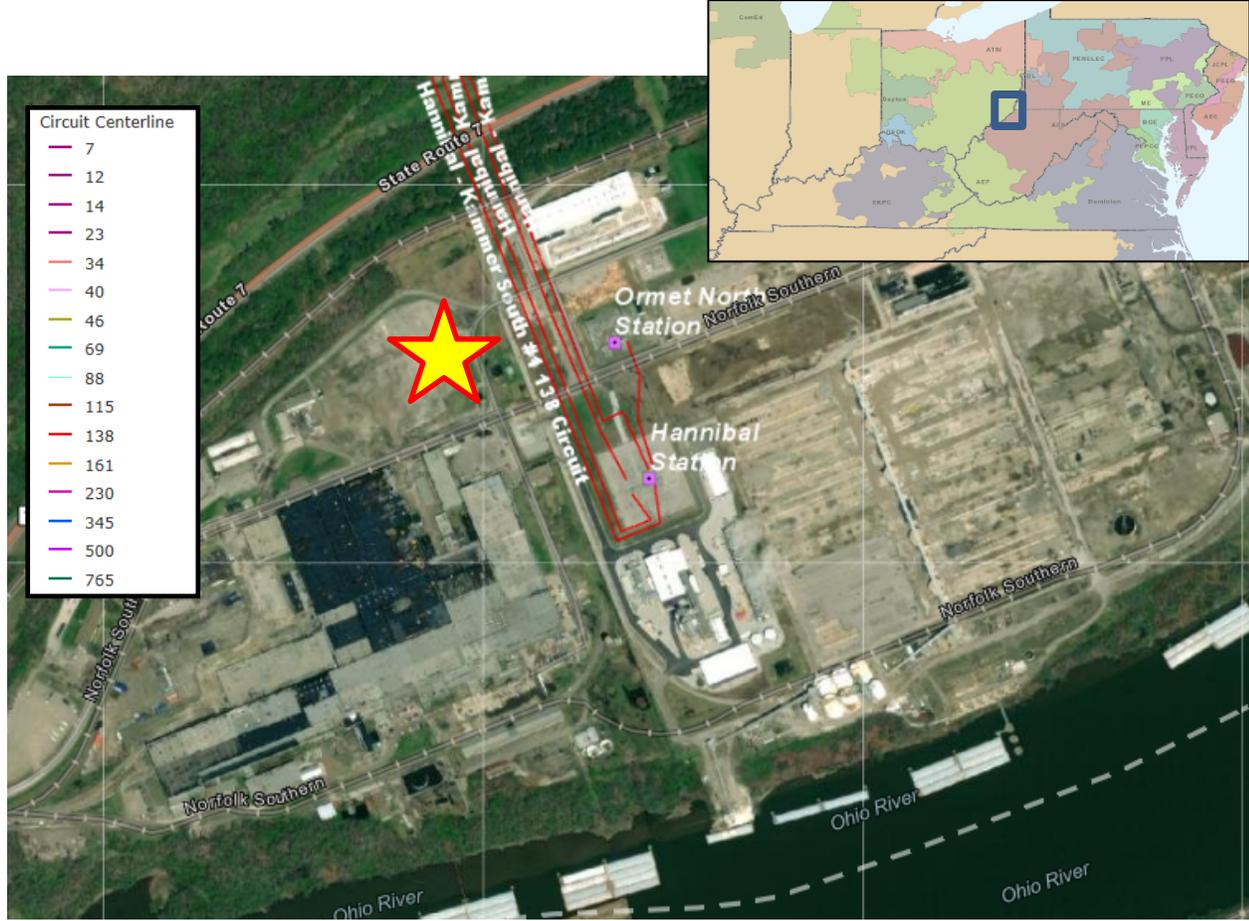
Lastly, there is an island of local Ohio distribution customers served via distribution circuits sourced across the Ohio River in West Virginia, which pose various risks to the customers.

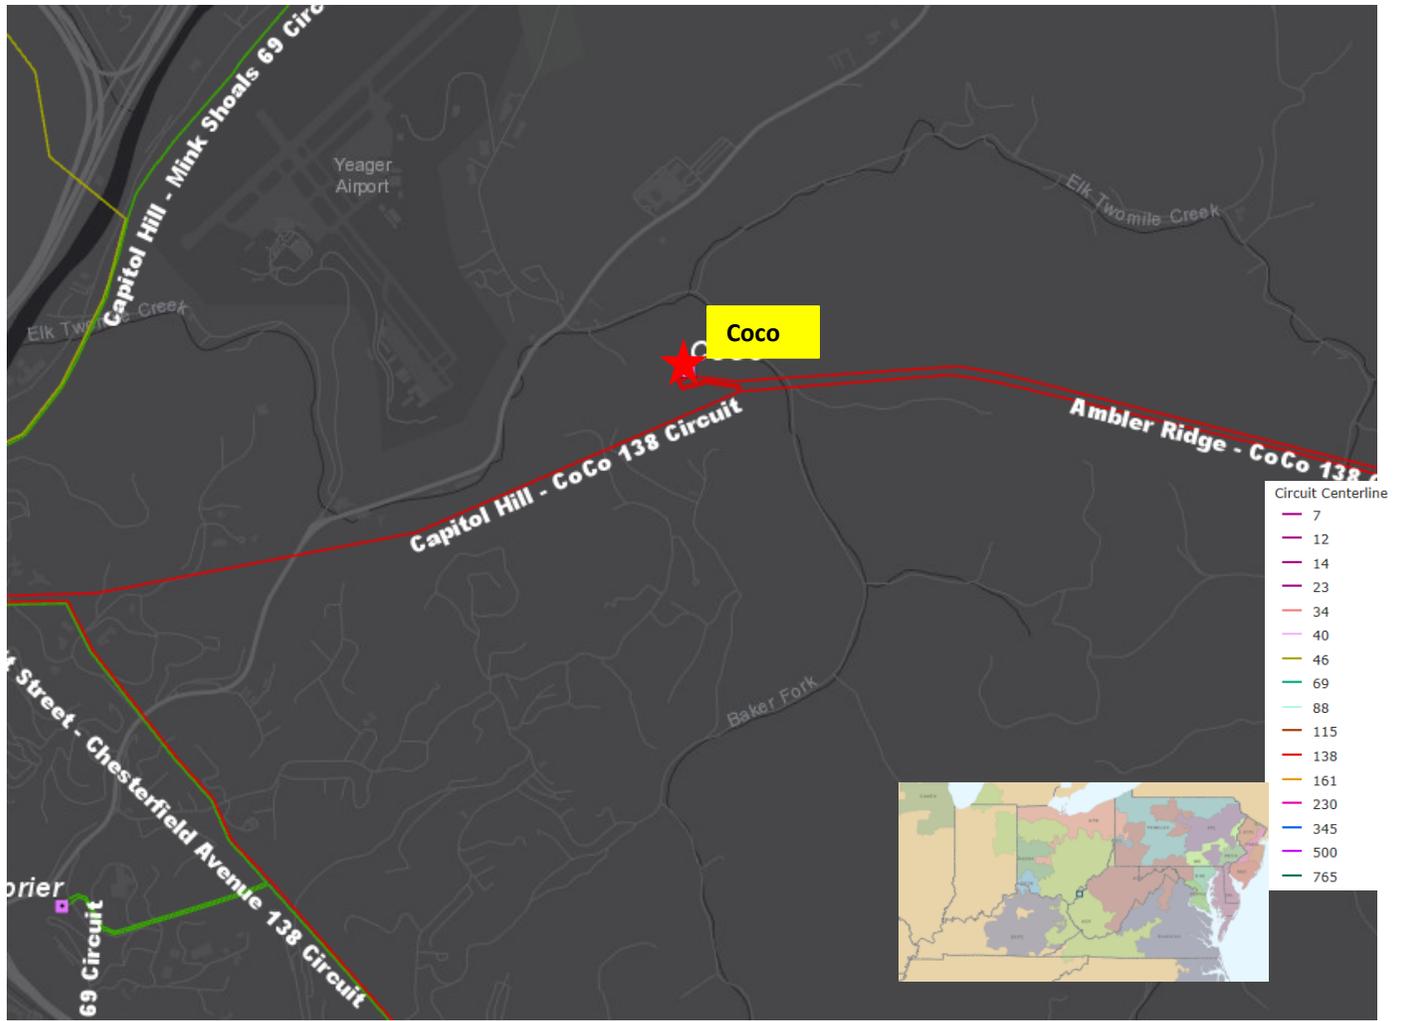
APCO Distribution has requested to install new distribution transformer at the existing Coco 138 kV Transmission Station to support load growth in the Meadowbrook, WV Area. The projected load at the new Coco transformer is 6.9 MVA and this is being transferred from Mink Shoals and Greenbriar stations.

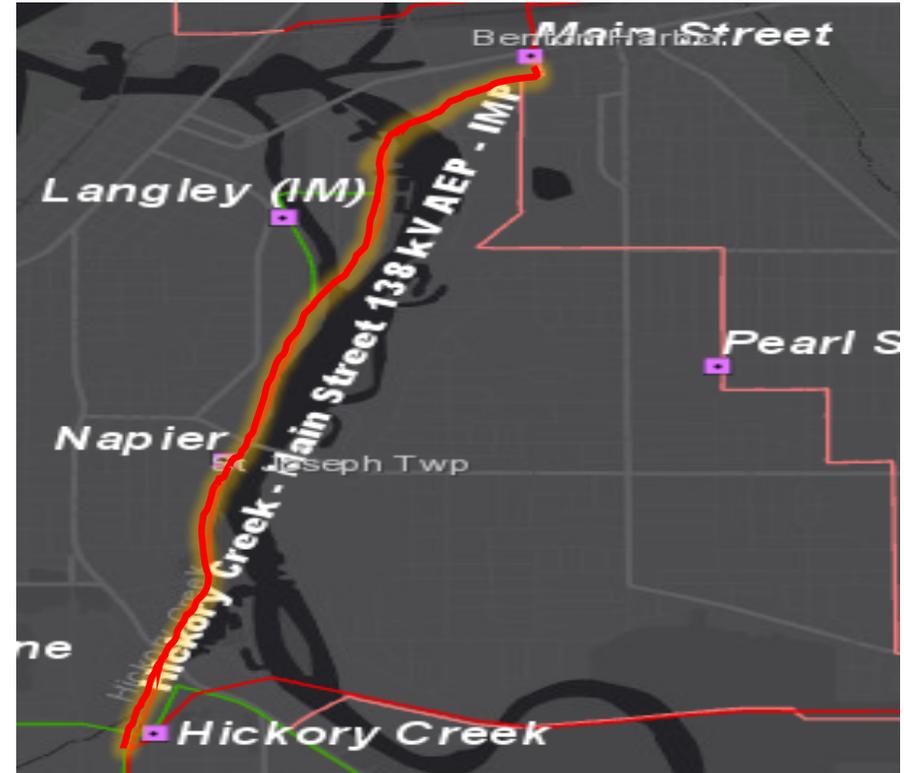
- Structures fail NESC Grade B and AEP Strength requirements. Grounding methods utilize butt wraps on every other structure, which is inadequate for current AEP standards

- 40 representative structures were assessed by ground and drone
 - 50% have ground line heart and/or shell rot
 - High percentage of wood poles have woodpecker damage and moderate to advanced wood decay from insect and bird damage

- There are 11 structures with at least one documented open condition not included in the ground and aerial assessment.

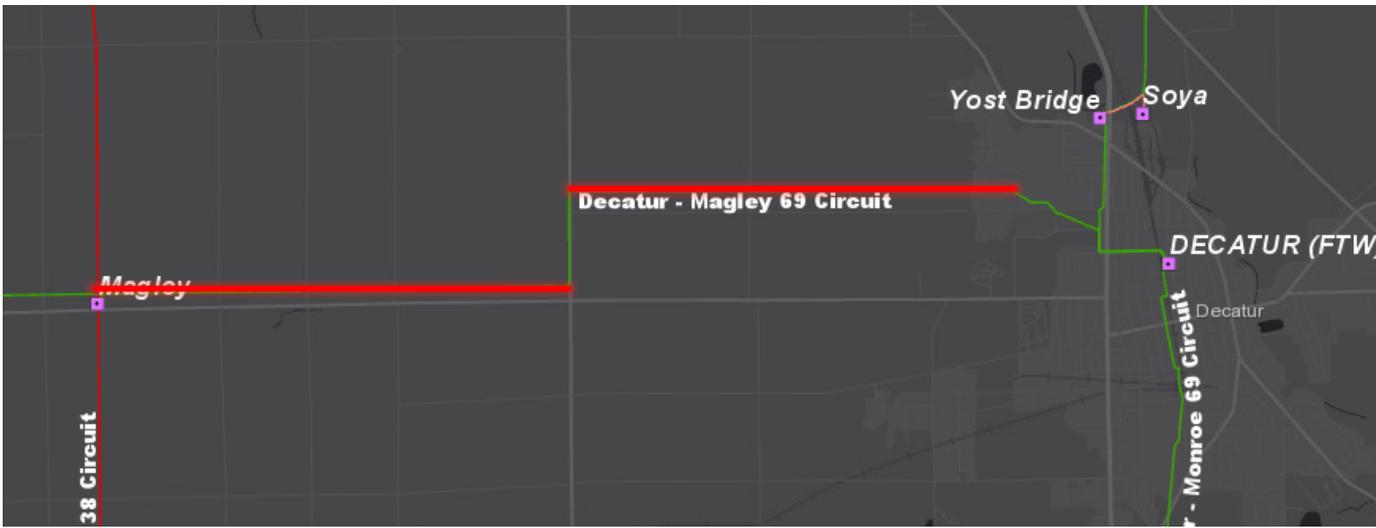
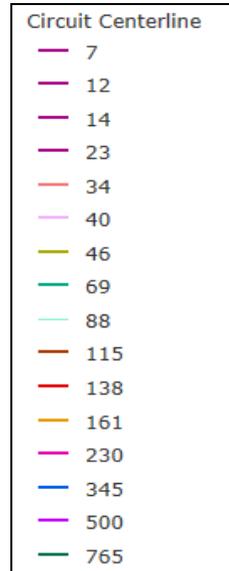
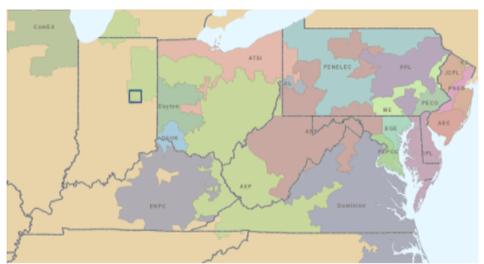
- 5/16" steel shield wire which has history of failure
- Conductor Type:
 - 6 wired, 4/0 ACSR 6/1 Penguin (1957): 3.16 miles
 - 336,400 CM ACSR 30/7 Oriole (1966): 2.72 miles

- Momentary/Permanent Outages: 7 Momentary and 1 Permanent
- Condition Summary:
 - Number of open conditions: 6 structures have at least one open condition. 43 structures were assessed by drone and 10 assessed by a ground crew and the following were identified

- H Frame structures had moderate shell damage with some heavy checking.
 - Wood structures on this line are subject to high number of woodpecker and insect damage.

- Multiple instances of decay, pole split, rot top, crossarm split, pole cavity, brace splitting and flashed/split insulator.
 - Structures fail NESC Grade B, ASCE structural strength requirements, AEP grounding standards, AEP structural strength requirements and the H Frame portions fail AEP shielding angle standards.

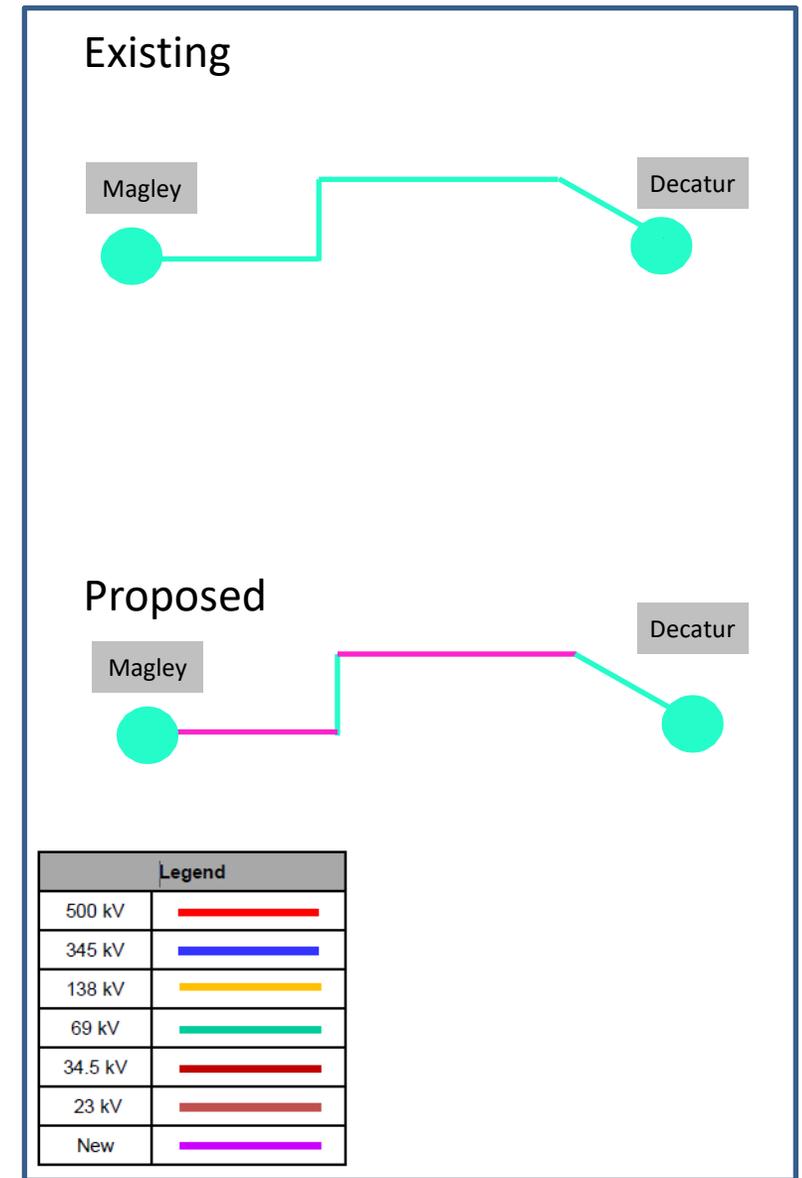
Rebuild 5.88 miles of the 6.36 mile circuit from Magley-Decatur with 795 ACSR. The rebuild will consist of all 1957 and 1966 vintage poles, towers with failed strength requirements, as well as the 4/0 and 336 ACSR conductor.

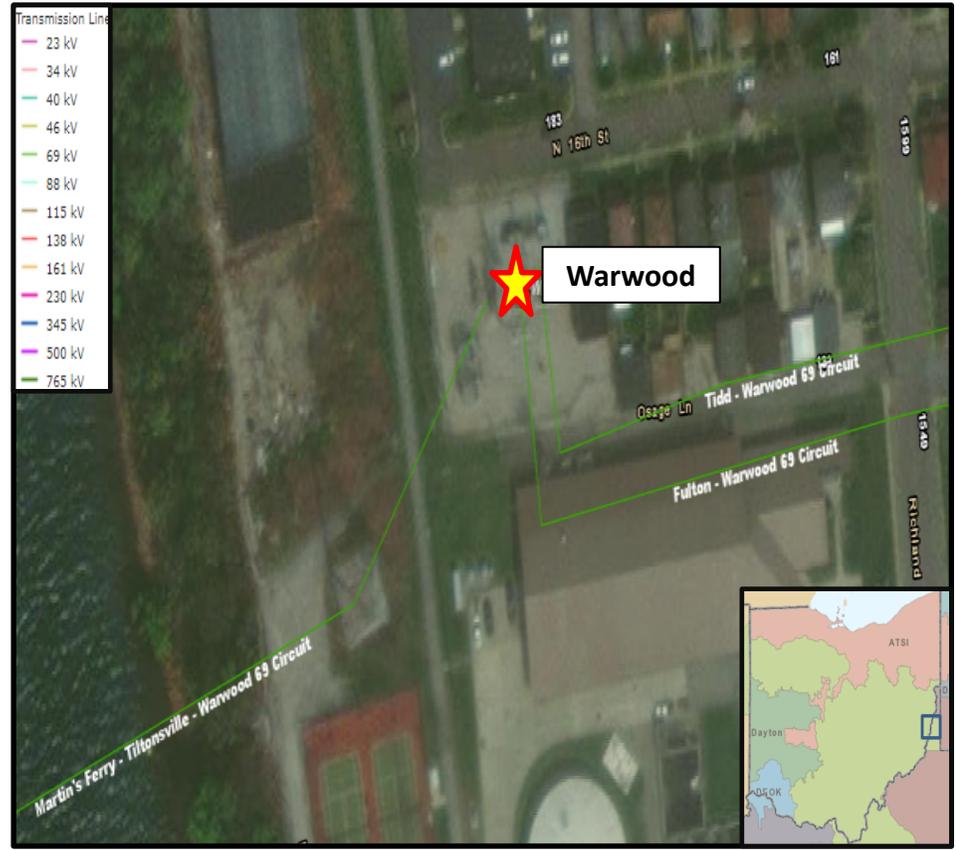
- Circuit Breakers A & B are part of the CF family. The manufacturer provides no support for the CF/CG/CGH/CH family of circuit breakers and spare parts are increasingly more difficult to obtain. This model family has experienced major malfunctions associated with their OA-3 hydraulic mechanism, which includes low-pressure readings, hydraulic leaks, pump lockouts, and failure to shut off. These mechanism malfunctions have led to several failures to close and other types of mis-operations across the AEP fleet.

- Circuit Breaker K is part of the FK family. The manufacturer provides no support for this fleet of circuit breakers and spare parts are increasingly more difficult to obtain; components are often taken from out of service units with remaining usable parts. A common failure mode documented in AEP malfunction records are compressor failures and valve defects, which cause low pressure and oil leaks. Another failure mode includes trip or reclose failures, caused primarily by spring latching and charging motor component failures. In addition, the vacuum oil and oil breakers have a lot of oil contamination from aging gaskets allowing moisture and other particle ingress.

Currently, 23 of the 27 relays (85% of all station relays) need replacement. 21 of these are of the electromechanical type which have significant limitations with regards to spare part availability and fault data collection and retention. In addition, these relays lack vendor support. There are also 2 DPU type units. Out of the 366 relays of this family in the AEP system, 97 of them have had at least one malfunction record documented. This relates to 27% of the DPU fleet. The DPU relays pose a potential safety risk to persons performing breaker operation because the DPUs are mounted directly on the circuit breaker without a delay for opening and closing the breaker.

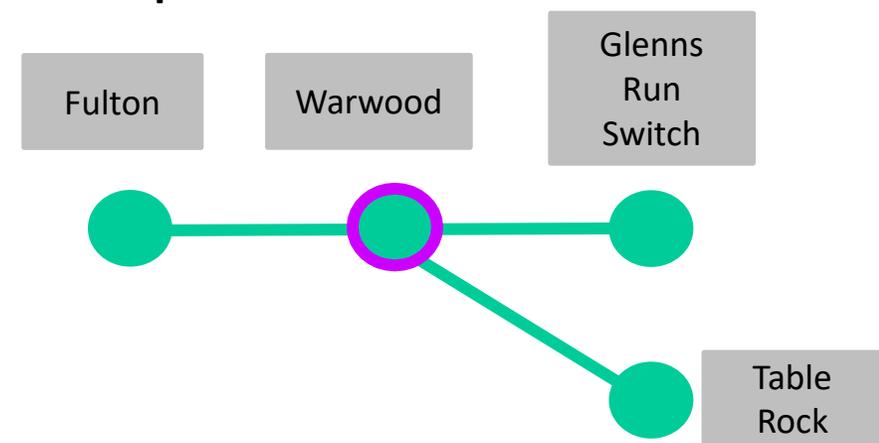
Proposed:

Replace the 3- 69kV oil circuit breakers with new SF6 gas breakers. Replace the electromechanical 69kV line relays and bus differential relays with microprocessor-based relays.
