Western Sub Regional RTEP: AEP Supplemental Projects

August 18, 2023

Changes to the Existing Supplemental Projects

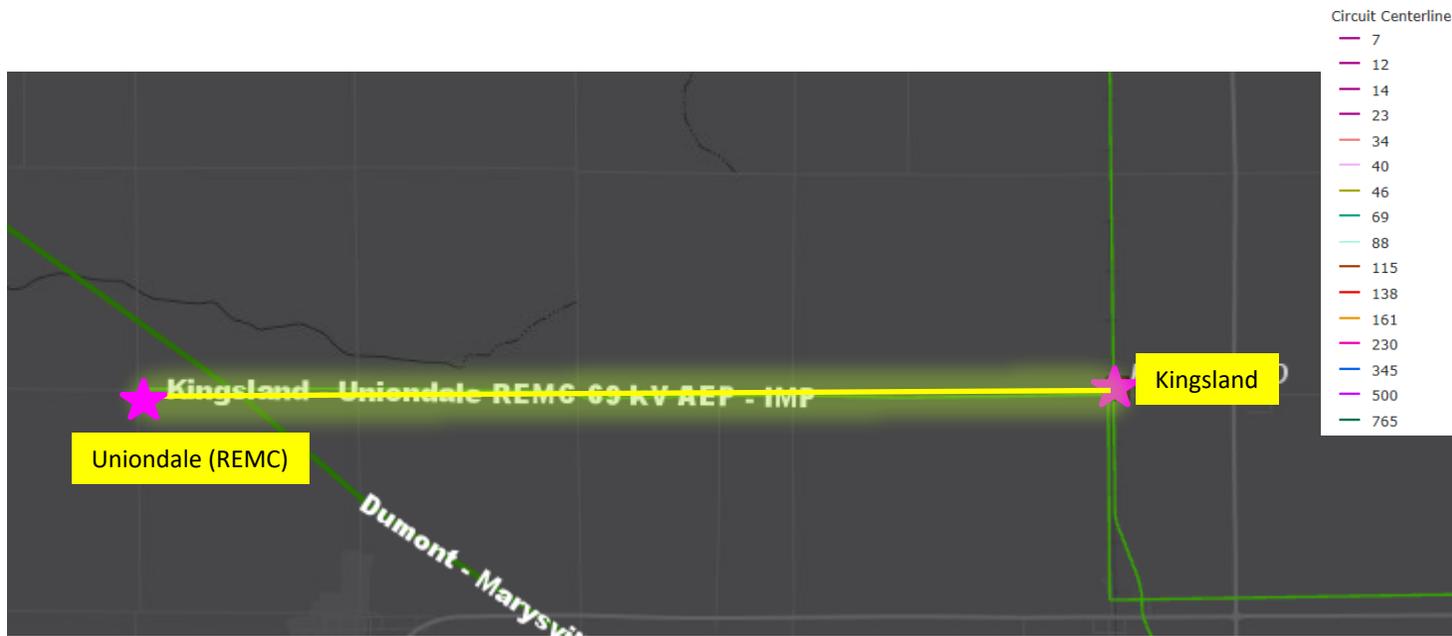
- The Kingsland-Uniondale is 4.43 mile long radial line originally installed in 1969 mostly consisting of wood poles that feeds Uniondale station.
- Structures fail to meet NESC Grade B and AEP structural strength requirements

- The insulators on the line do not meet current AEP standards
- The grounding method utilizes butt wraps on 1/3 of the structures which is inadequate for current AEP Standards.

- 38 structures were further assessed (24 by aerial drone and 14 by ground crew) 50% of the poles were found with deficiencies such as:
 - Decay beyond normal weather conditions

- Many wood poles had moderate wood decay that includes shell decay, insect damage and woodpecker holes. Several poles have heavy checking and rotted pole tops

- Brown porcelain horizontal post insulators with flashed insulators
 - Three structures have had steel enforcer systems added as temporary means to extend pole life until the structure can be replaced

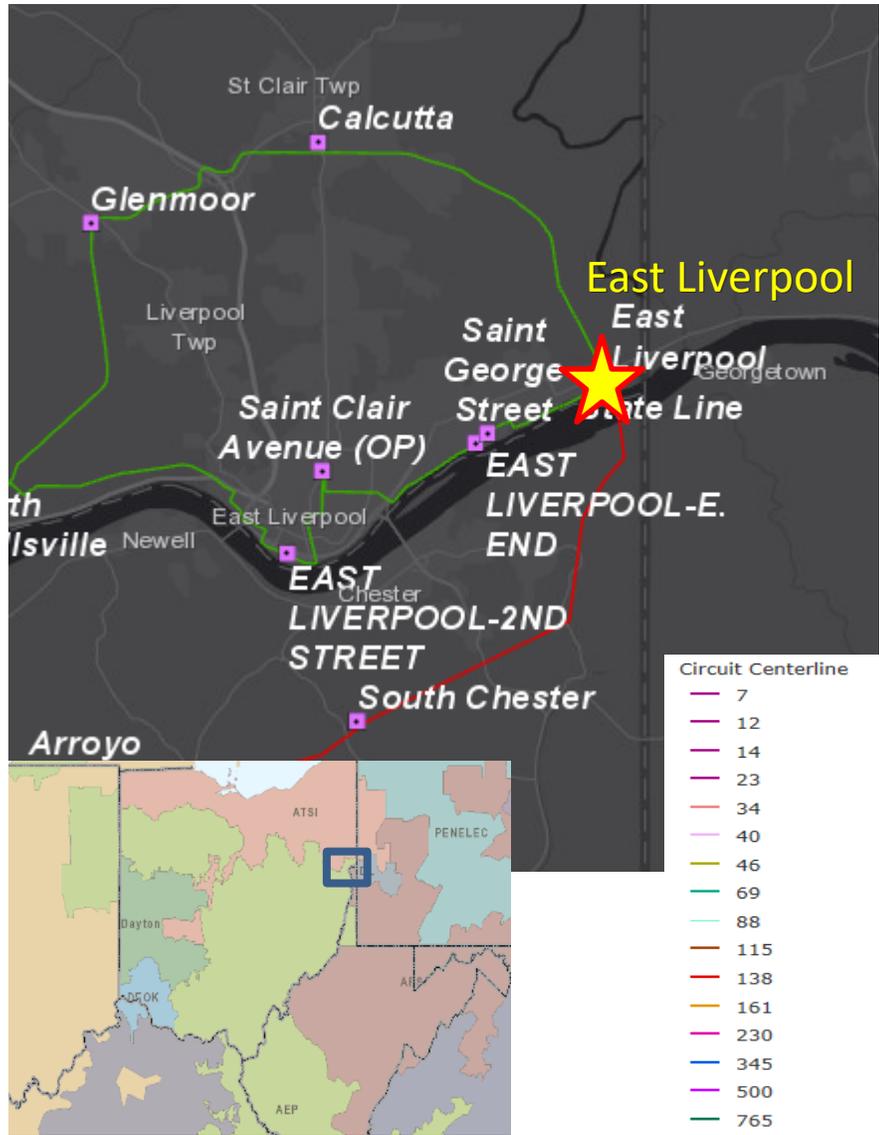
- The East Liverpool – Second Street 69kV circuit protection uses electromechanical relays and a legacy pilot wire communications channel. These relays have significant limitations with regard to spare part availability, SCADA functionality, and fault data collection and retention. In addition, these relays lack vendor support. Pilot wire cables are showing increased rates of failure and signal degradation across the AEP system.

- The 138kV tie-line to FirstEnergy uses electromechanical relays. The power-line-carrier equipment at East Liverpool was installed in 1962, presenting a failure risk. FE has indicated a future project is planned to upgrade relays on their side.

- The 138-69kV transformer protection system also utilizes outdated electromechanical relays.
- The 1962-vintage control house has various issues of concern: lead-based paints, asbestos, no air conditioning or exhaust fans, and small roof leaks.

- The station PT's are original to the station (1962) and are in poor condition with rusting. The AC station service system is in poor condition and uses a corner-ground connection which is a safety concern.

- There is a broken 69kV hook-stick disconnect switch needing replaced.

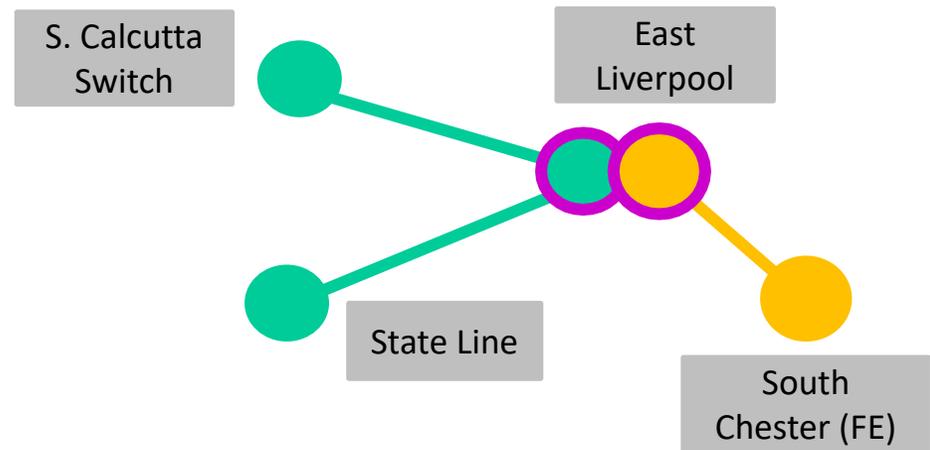
Proposed:

- At East Liverpool station, replace the 138kV MOAB/ground switch system with a circuit breaker and new relays. Install a 69kV breaker on the low side of the 138-69kV transformer. Upgrade tie-line metering, relays, and expand SCADA functionality at the station. Replace the control house with a new prefabricated control building. \$3.0 Million
- At the 69kV remote end station of Second Street, replace the electromechanical relays and pilot wire communications with microprocessor-based relays, to coordinate with East Liverpool. Install new 69kV CCVT's. \$0.3 Million

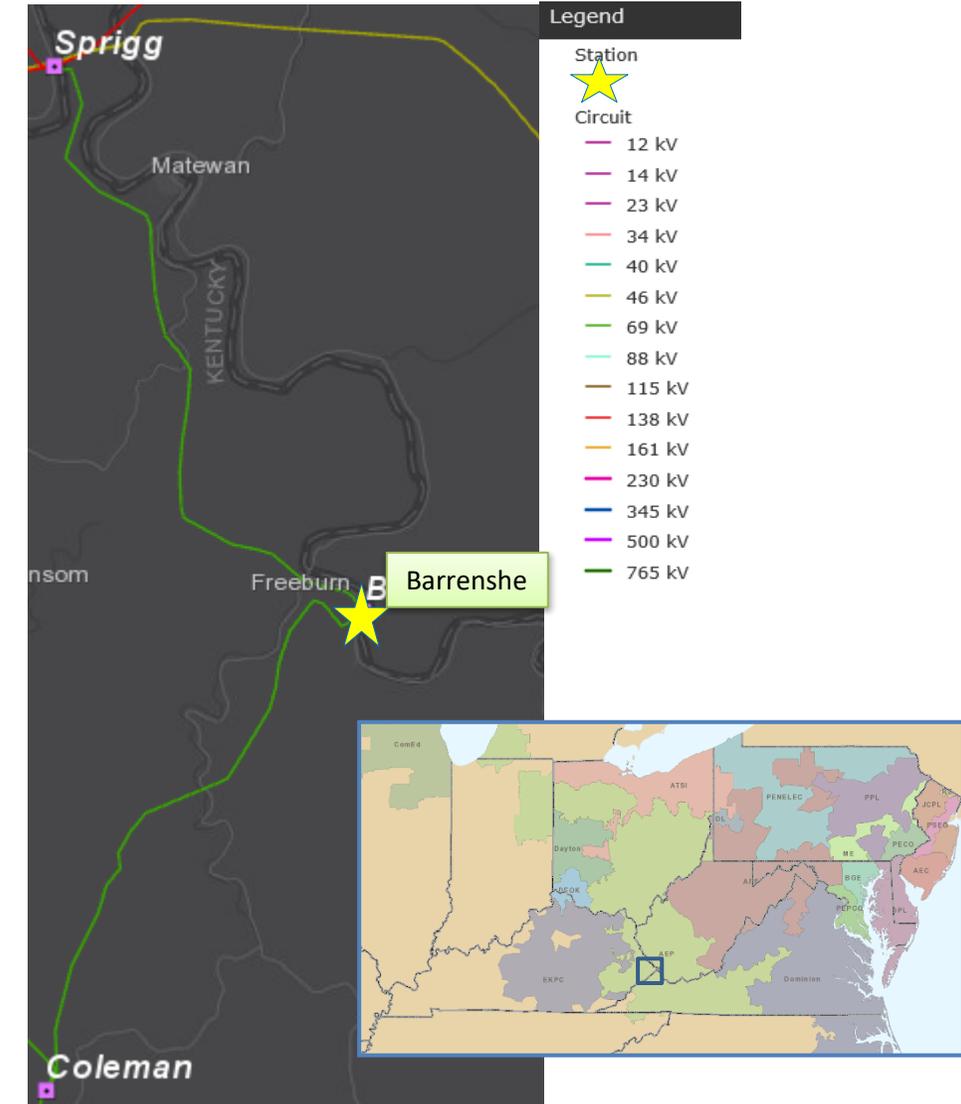
- All 15 relays at Barrenshe station are in need of replacement. There are 11 electromechanical relays which have significant limitations with regards to fault data collection and retention. These relays lack vendor support and have little to no access to spare parts. Also, the remaining 4 microprocessor relays were commissioned from 2006-2007 and are at the end of their useful life.

- The station bay was constructed using wood poles that were installed in 1953. The poles are very rotten and there is concern that any type of stress on the poles could cause the station to fail completely. The poles closest to the transformer are leaning and have twisted the bus.

- In 1977, flood waters were over 3/4 up the control cabinet. There has been repeated wash out in the rear of the station causing the fence post foundations to wash away. The station lies in the 100 year flood plain between mountainous terrain and highway 194 making expansion at the existing site extremely difficult.

- 69 kV MOAB W is 1973 vintage and needs replaced due to wear and lack of available parts.

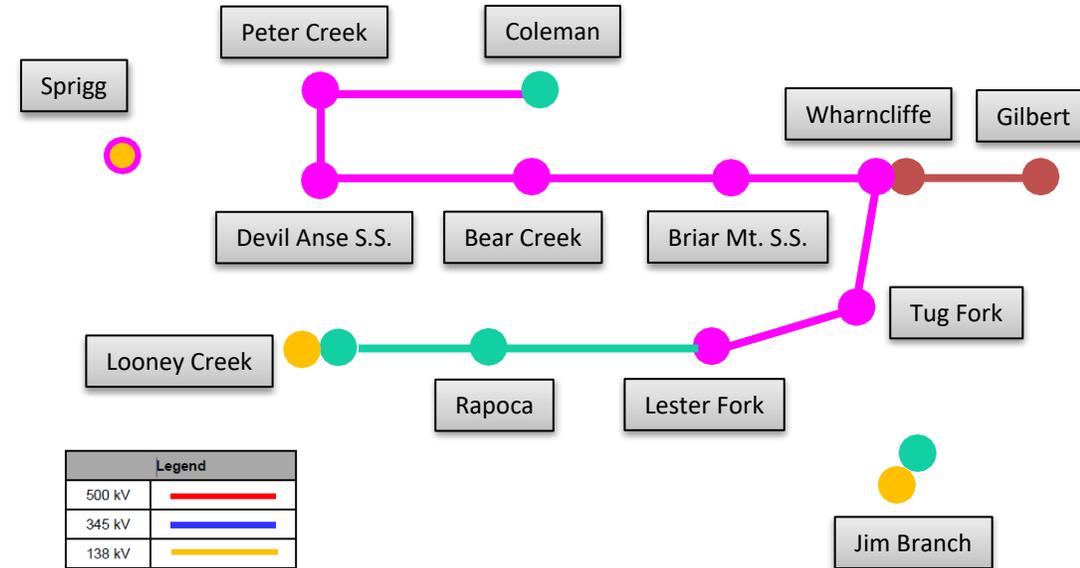
Proposed

- Rapoca 69kV Customer - Replace the Rapoca Station hard tap from the Hurley - Looney Creek 69kV circuit with a Phase over Phase switch. **Estimated Cost: \$0.7 M**

- Bear Creek Station - Two 69kV MOABs that are automatic, and SCADA controlled for the Bear Creek 69kV work. **Estimated Cost: \$0.9 M**

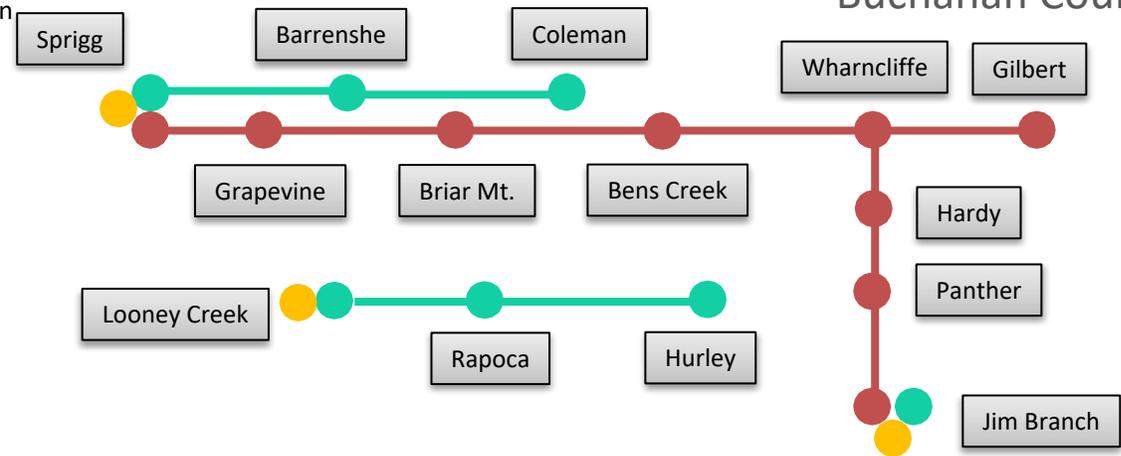
Existing

- Sprigg Station ~~Removal~~ - Remove all the 46kV bus and attached equipment. Remove the 138/69 – 46kV transformer and the 46/7.2KV GND Bank. Remove the 69kV bus and attached equipment. **Remove the 138kV equipment. Rebuild the station as a four 138kV circuit breaker ring bus station. Estimated Cost: \$1.1M-\$5M**

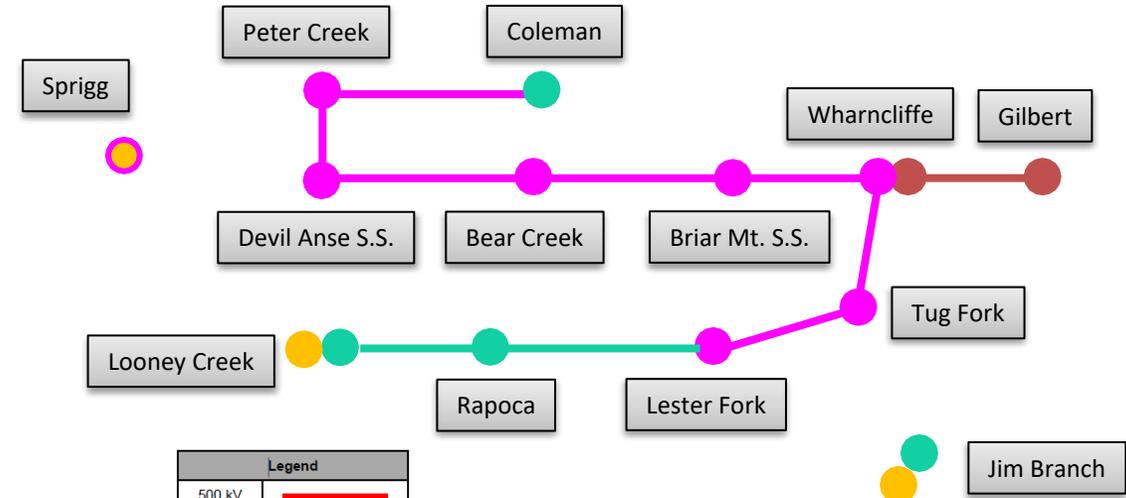
Proposed

AEP Transmission Zone M-3 Process
 Pike County, KY
 Mingo & McDowell Counties, WV
 Buchanan County, VA

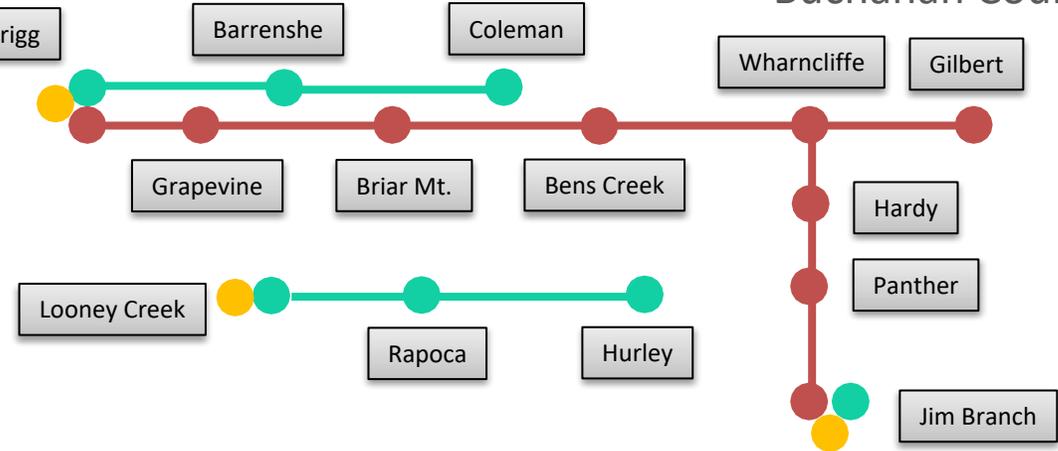
Existing

AEP Transmission Zone M-3 Process Pike County, KY Mingo & McDowell Counties, WV Buchanan County, VA
