Western Sub Regional RTEP: AEP Supplemental Projects

May 17, 2024

AEP Transmission Zone M-3 Process Illinois Road, IN/Gateway, IN

Need Number: AEP-2024-IM012

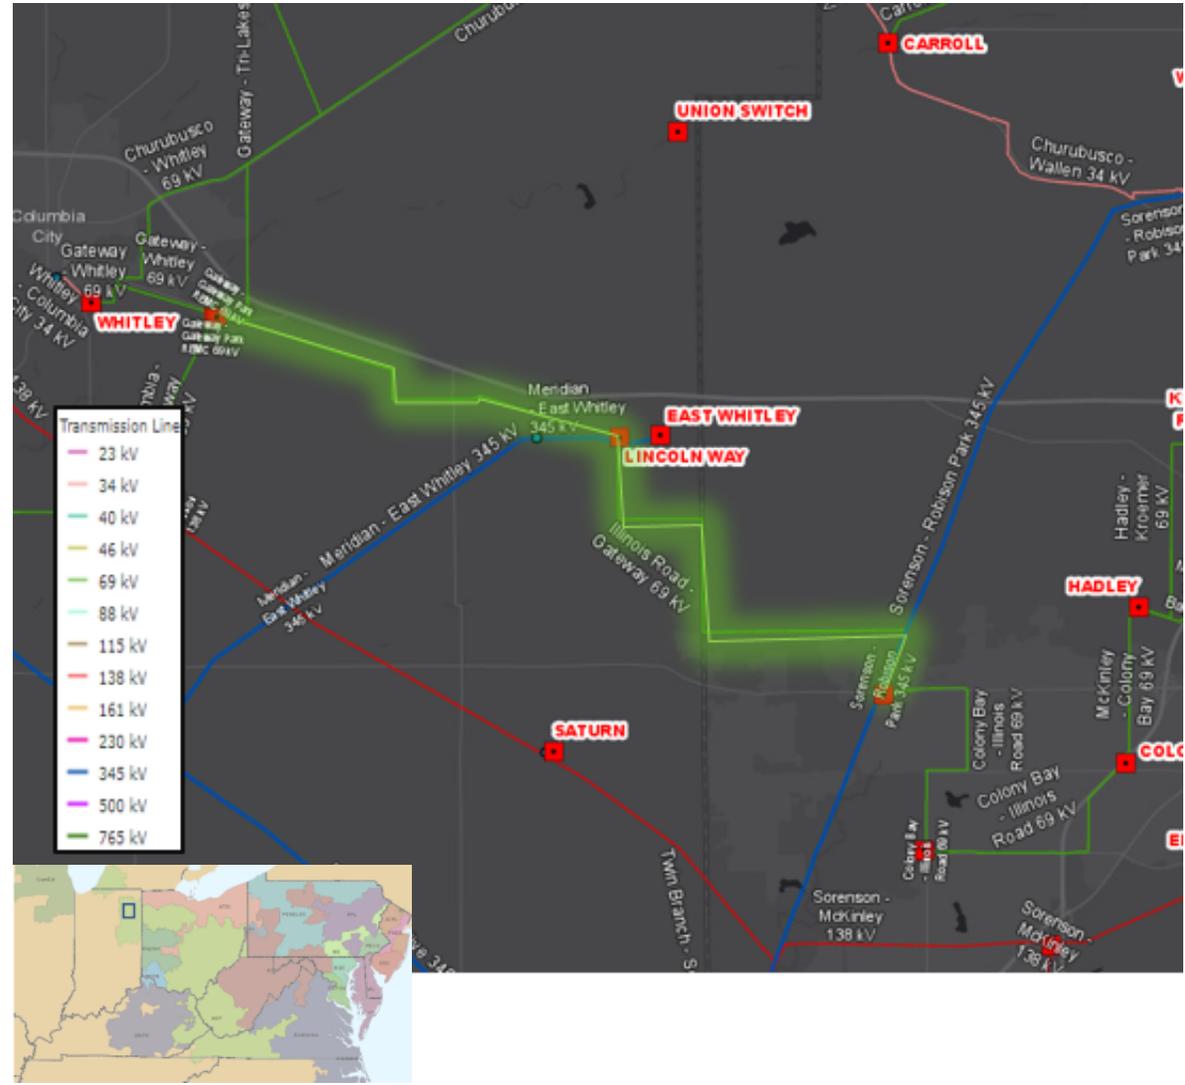
Illinois Road – Gateway 69kV

The Illinois – Gateway 69kV line is 12.39 miles long constructed in 1973. The line consists primarily of original single circuit wood pole structures with legacy porcelain horizontal post insulators. Some pole replacements have taken place in 2015, 2018, 2021.

From January 1, 2019 to December 31, 2023, there have been 6 momentary and 4 permanent outages on the Gateway – Illinois Road 69kV Circuit. The momentary outages were due to lightning, foreign interference related to other utility or distributor equipment, and a circuit switcher failure. The direct permanent outages were due to multiple broken poles during a windstorm, a relay malfunction, and a circuit switcher failure.

As of January 4, 2024, there are 59 structures with at least one open structural condition, which relates to 22% of the structures on the line. Structure conditions causes: woodpecker, broken , insect damage, rot heart, rot shell, split, leaning transverse, burnt, damaged, rot top, sitting in water, strength deficiency, and unauthorized attachment, knee/vee braces broken and loose, and 1 is related to a damaged push pole. There is currently 1 open conductor condition with broken strands. There is currently 1 open shielding/grounding condition related to a disconnected ground rod. There are currently 11 open hardware conditions such as horizontal post insulators with burnt/corroded, flashed, broken, and twisted causes, and guys with an exposed guy anchor, loose guy wire, and a missing guy guard. Twenty-six structures were assessed by an aerial drone and by a ground crew. Of those structures assessed, 100% had reported conditions, and the following were the most common conditions found: The majority of wood poles have moderate wood decay that includes shell decay, insect damage, and woodpecker holes. Several poles also have heavy checking and rotted pole tops. Several structures assessed are in potential wetland areas and in most cases are very difficult and expensive to access with vehicles and equipment. Insulators are gray porcelain HP design. A few flashed insulators were found. In some locations, insulators are pulling away from the pole. Structure down-leads are aluminum on stand-off brackets and pole butt wrap.

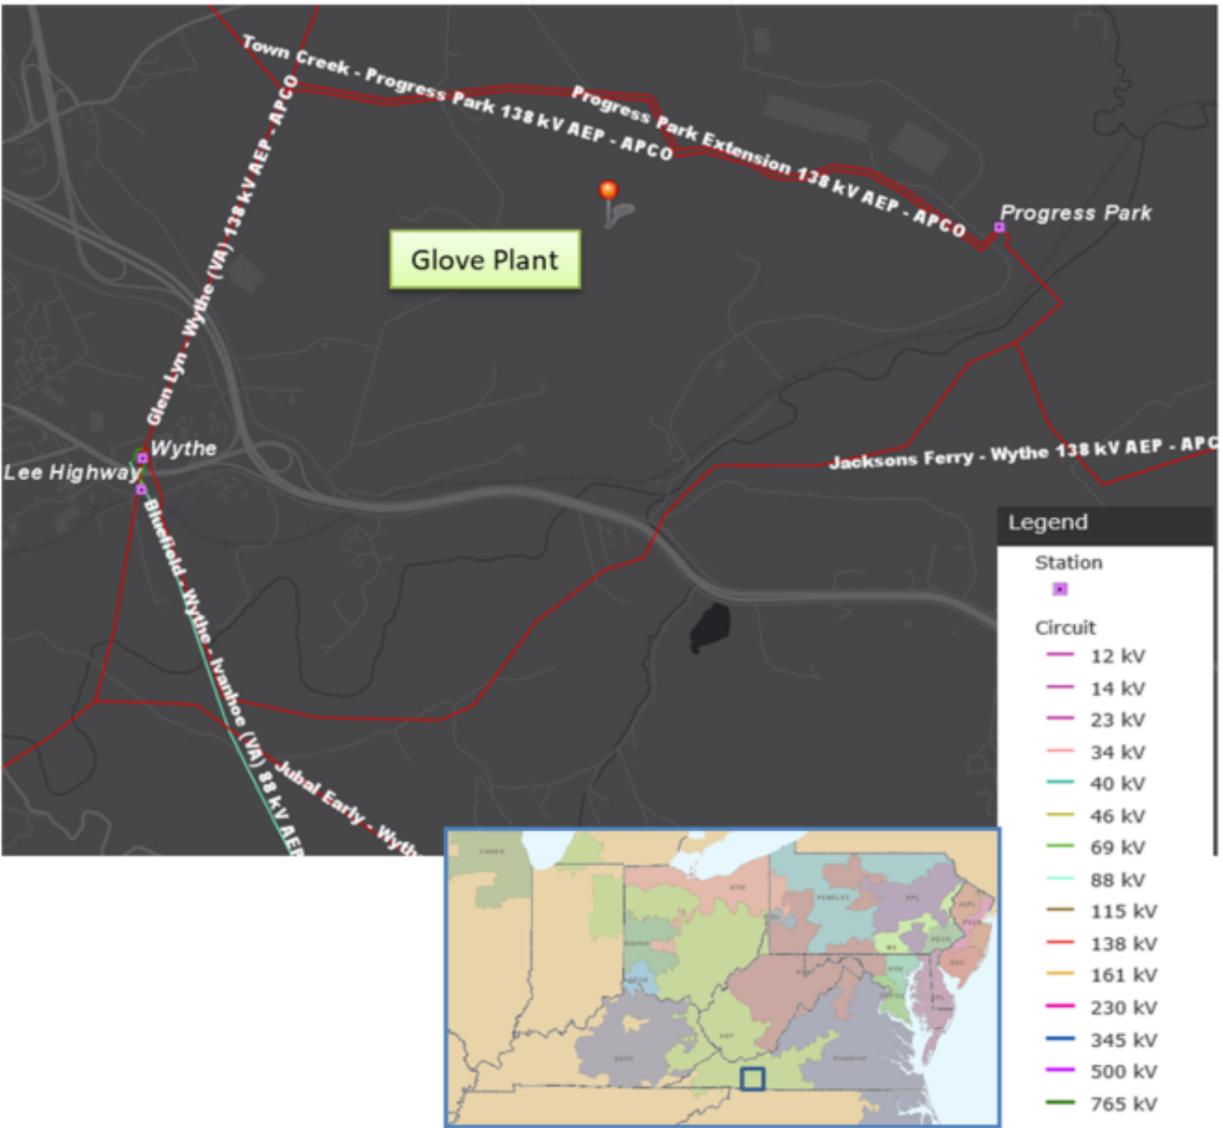
AEP Distribution has requested a new delivery point (Glove Plant).

A customer is constructing a manufacturing facility which will bring on a load that is projected to grow to 59.5MW by May 2026.

Reason for the Cancellation: The customer has withdrawn the request for a new delivery point. This need can be cancelled.

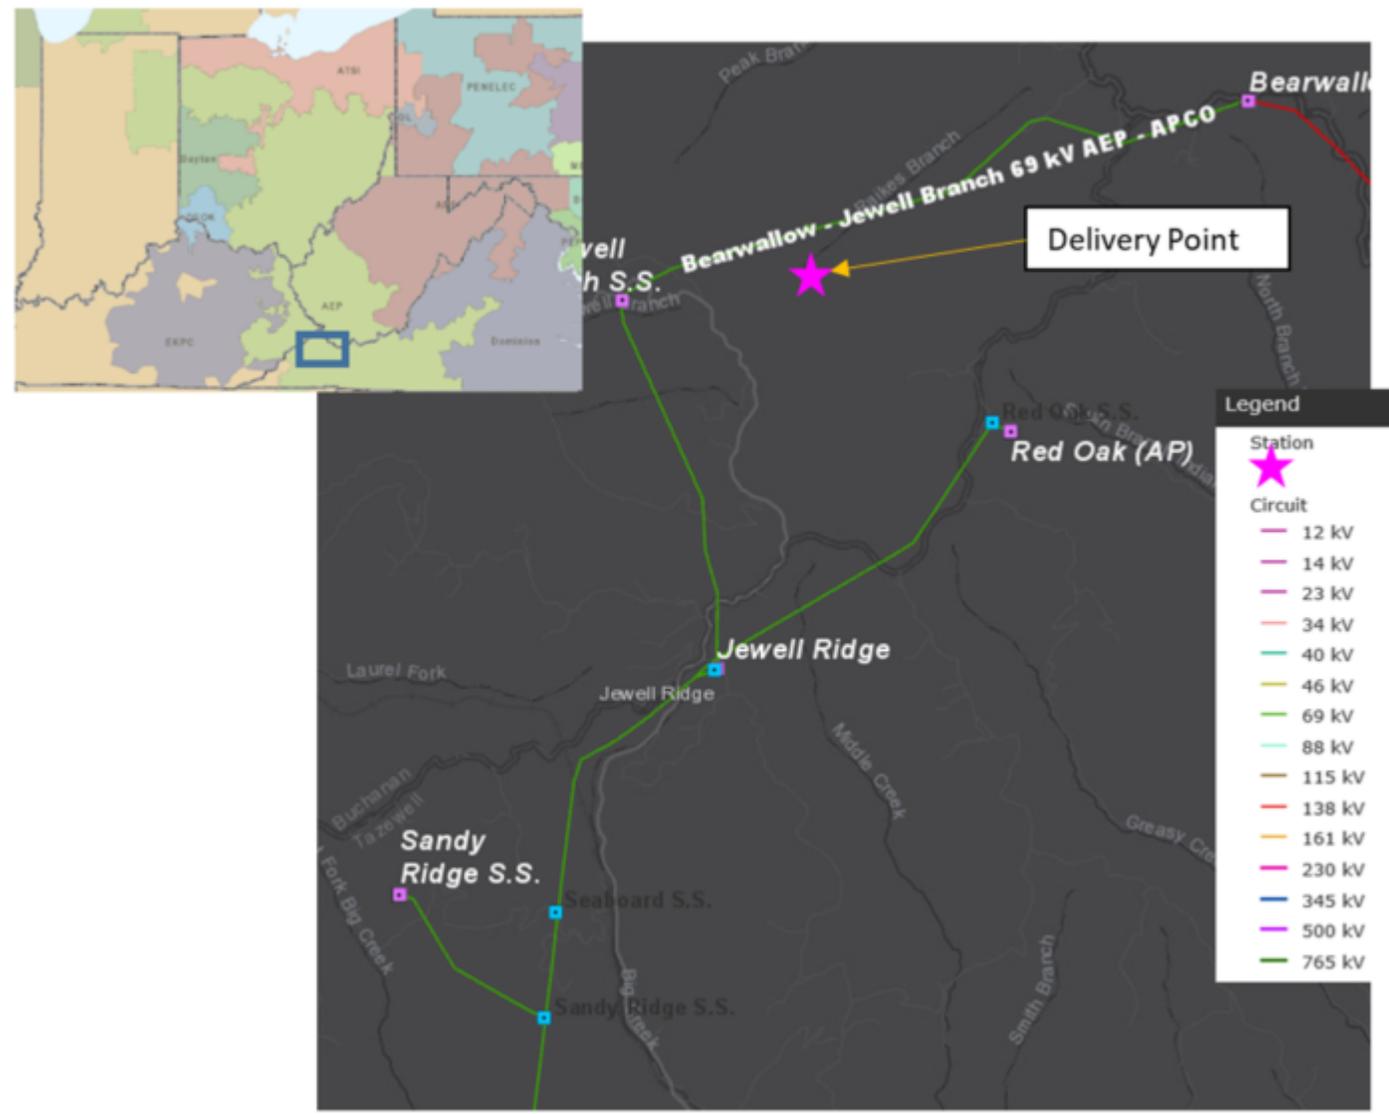
- Coronado Global Resources Inc. has requested new delivery point for their facility at Jones Fork Rd, Buchanan County, VA.
- The anticipated Peak load for this facility is 2 MW (future possible load ramp of up to 5MW).
- The customer has requested an ISD of 06/01/2024.

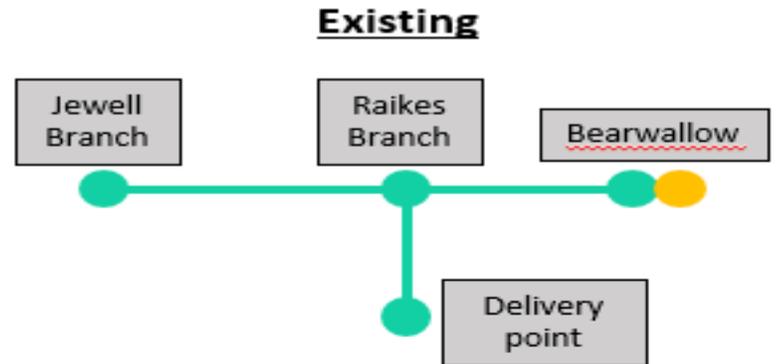
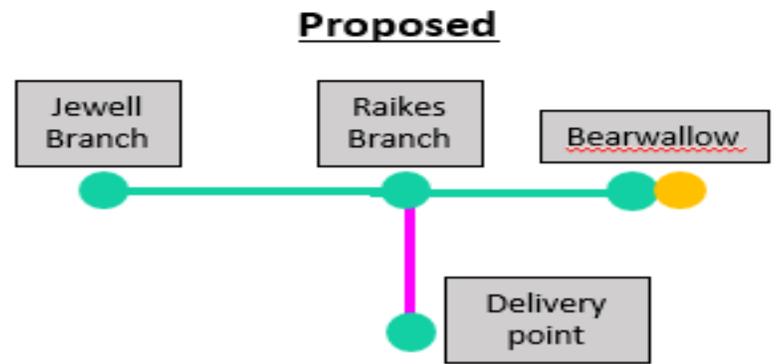
AEP Transmission Zone M-3 Process Raikes Branch Delivery Point

Raikes Branch Metering Install: Remove an existing wood pole structure on the Raikes Branch customer delivery line and install a new pole that will have the new metering equipment. This cost is reimbursable from the customer; the previous delivery point switches are still in good condition and do not need replaced.

Ancillary Benefit: This solution is able to reuse an existing phase over phase switch to connect the 2 MW load request. The Raikes Branch delivery point is currently unused after a previous customer discontinued operation.

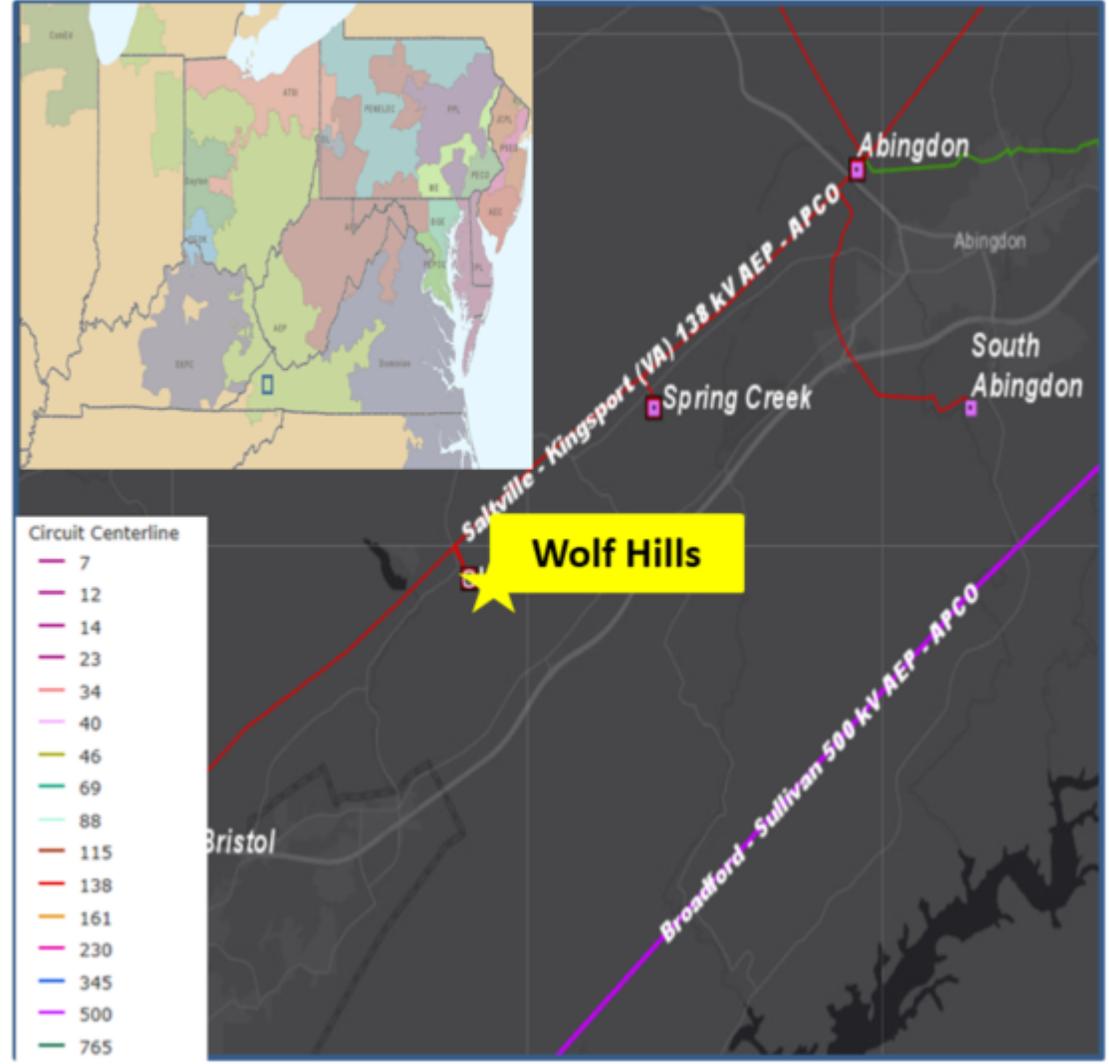
Station Name: Wolf Hills

Circuit Breakers A, B, C & D (138 KV) Concerns:

- All of these breakers are HVB145-40000 type, SF6 filled. These breakers are 2000 (CBs B, C, & D) and 2001 (CB A) vintage and manufactured by GE-Hitachi.

- This type of CB requires maintenance beyond the typical SF6 model type because of air trip mechanisms. The entire air system must be rebuilt whenever maintenance is performed resulting in significant costs.

- The HVB145 model family has the propensity to mechanically pump closed instead of locking open as it awaits an electrical close command from the relaying. This presents a high mis-operation risk on the system.

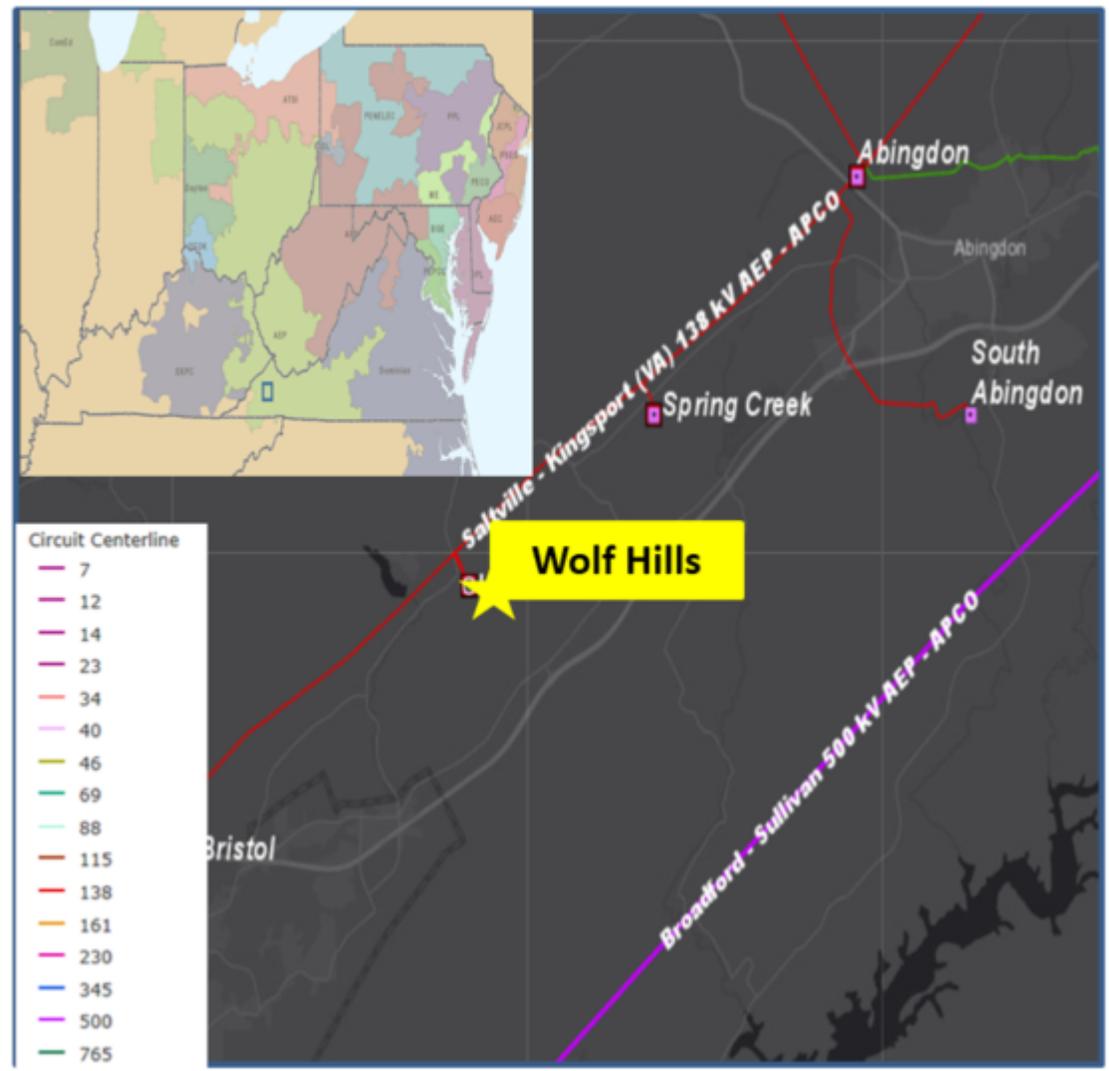
AEP Transmission Zone M-3 Process Wolf Hills Breaker Replacement

Wolf Hills Breaker Replacements: Replace existing 138 kV circuit breakers A, B, C, and D with four new 138 kV 3000 A 40 kA circuit breakers and install a new a new 138 kV 3000 A 40 kA circuit breaker between Wolf Hills 138 kV Bus #1 and Wolf Hills 138 kV Bus #2. Upgrade control house and install primary and backup station service.

Alternatives Considered: Rebuild Wolf Hills Station and reconfigure the 138 kV yard into an 8 breaker ring bus configuration. This would require station expansion which is not feasible in the current location and rebuilding completely in the clear would be cost prohibitive.
