Submission of Supplemental Projects for Inclusion in the Local Plan

AMPT Projects in ATSI/AEP Transmission Zone M3 Process Brewster, OH

Need Number: AMPT-2021-006

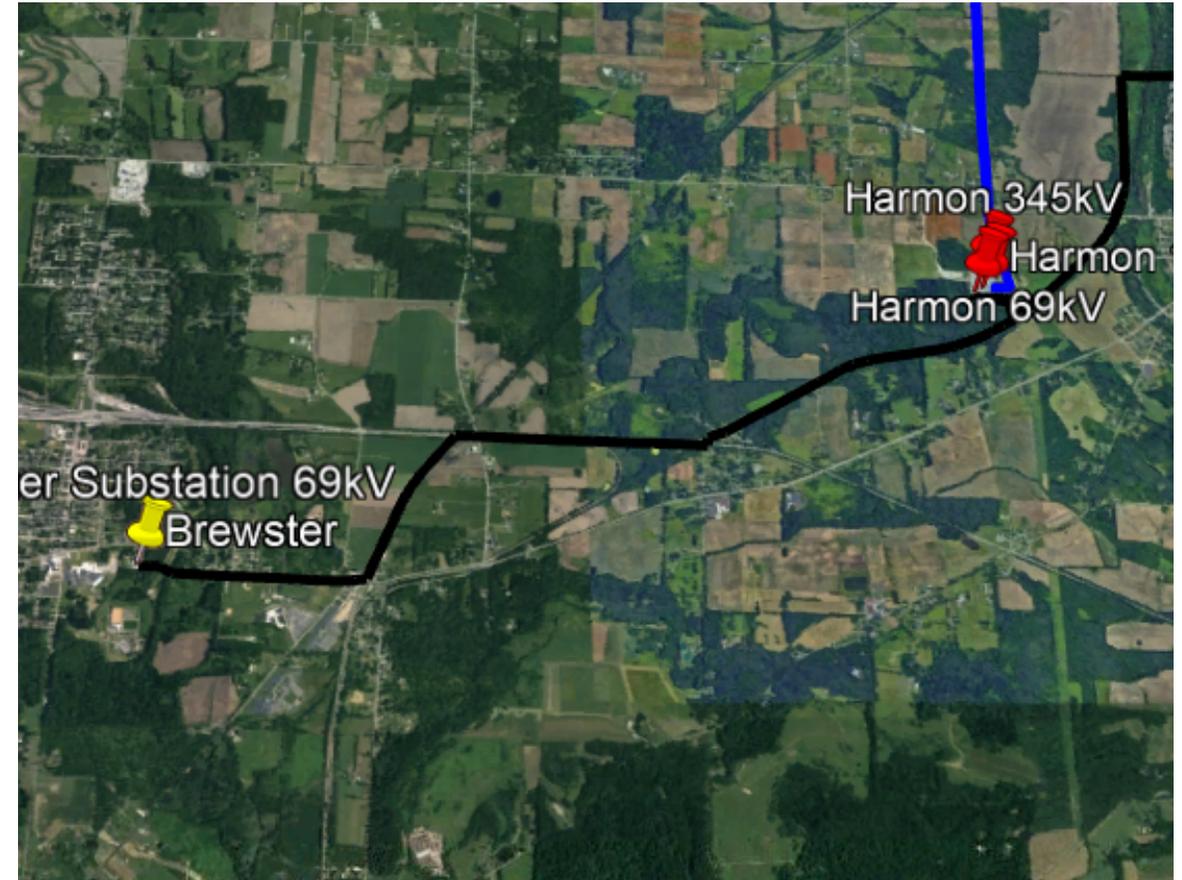
The existing interconnection is an approximately 3.5 mile radial 69 kV line from ATSI's Harmon substation. Current peak load at Brewster is 9 MW.

The village of Brewster has requested a 2nd supply to support the load. The radial supply presents a single point of failure that could jeopardize reliability for the village. AMPT Interconnection requirements specify a need for a second source for loads 5 MW and above.

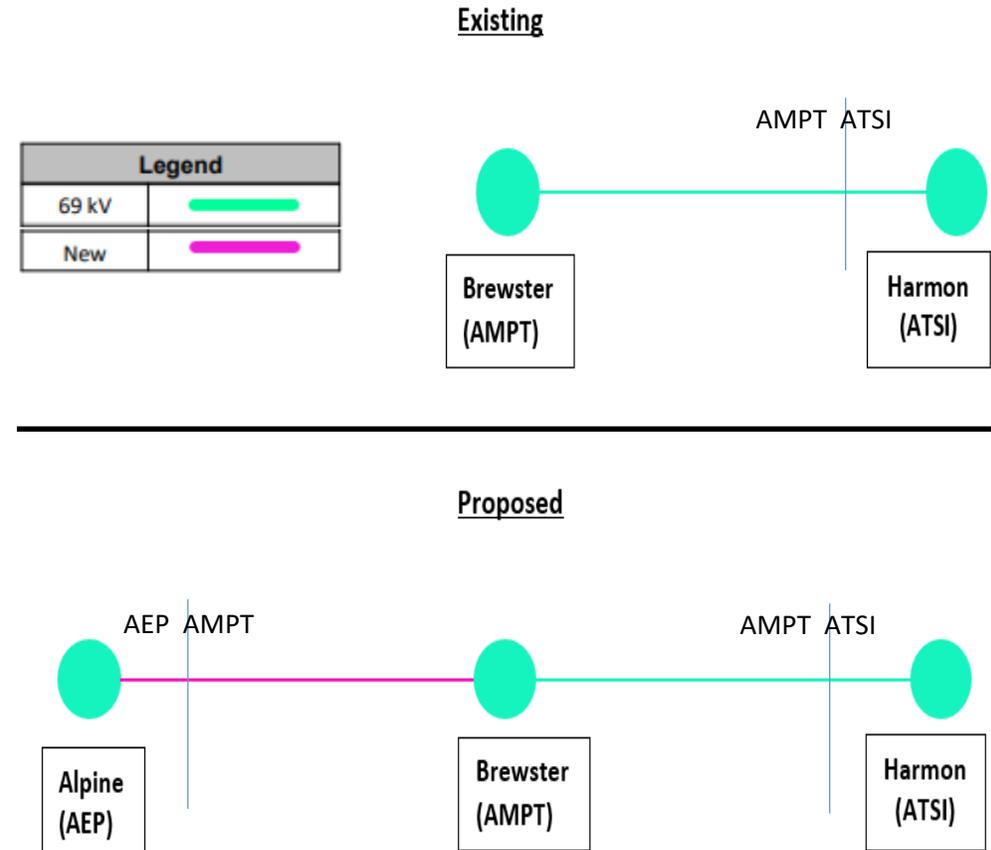
- Construct a greenfield 69 kV single circuit transmission line for approximately 5.5 miles using 795 26/7 ACSR conductor from AMPT’s Brewster 69 kV substation to a structure outside of AEP’s Alpine 69 kV ring bus station. **(\$9.8 M)**
- Build a four (4) CB 69kV ring station at the existing Brewster Substation location. The new ring bus will be used to re-terminate the existing 69 kV Brewster-Harmon (FE) line, terminate the new 69 kV Alpine-Brewster (AEP) line, and tie with two (2) existing terminals feeding the existing Brewster 69/12 kV transformation. **(\$8.2 M)**

- Modify AEP’s proposed Alpine 69 kV ring bus station (s2534.8) by adding an additional 69 kV circuit position to Brewster. Install one (1) 69 kV circuit breaker, protective relaying, and tie-line metering. **(\$1.03 M)**
- Construct a 0.1 mile segment of 69 kV transmission line using 795 ACSR 26/7 conductor leaving Alpine station to connect to AMPT’s transmission line toward Brewster. **(\$0.78 M)**

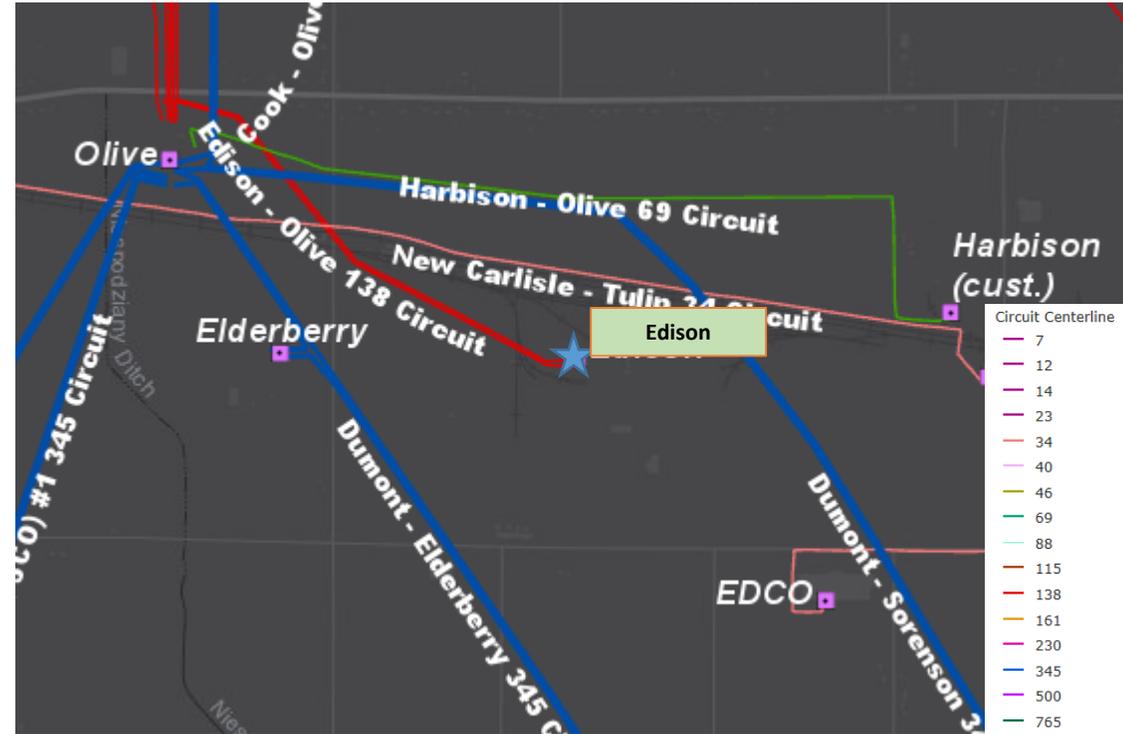
Edison 138kV

- Circuit breakers A, B, and C are 1988 138kV 145-PA type breakers.
 - The 145-PA Type breakers are experiencing marked increases in malfunctions. There have been 437 recorded malfunctions of this model type on the AEP system. The most common issues are related to loss of SF6 gas and mis-operations. The expected life of the bushing gaskets and door inspection port seals is 25 years. Seals that are no longer adequate can cause SF6 leaks to become more frequent. Low SF6 pressure in the breaker reduces the ability of the breaker to correctly interrupt a fault. Additionally, low pressure alarms and SF6 leaks lead to increased maintenance costs. The manufacturer provides no support or parts for this model of circuit breakers. Finally, SF6 leaks impact the environment.
 - Circuit breaker C has experienced 12 fault operations, which is over the manufacturer's recommendation of 10.

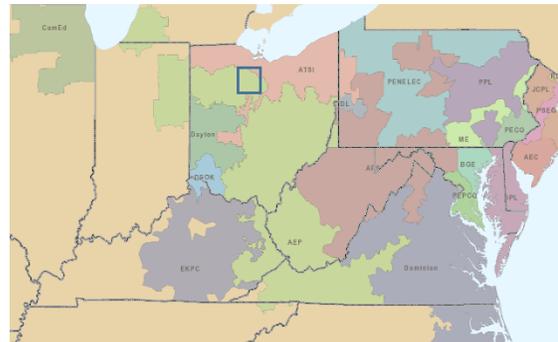
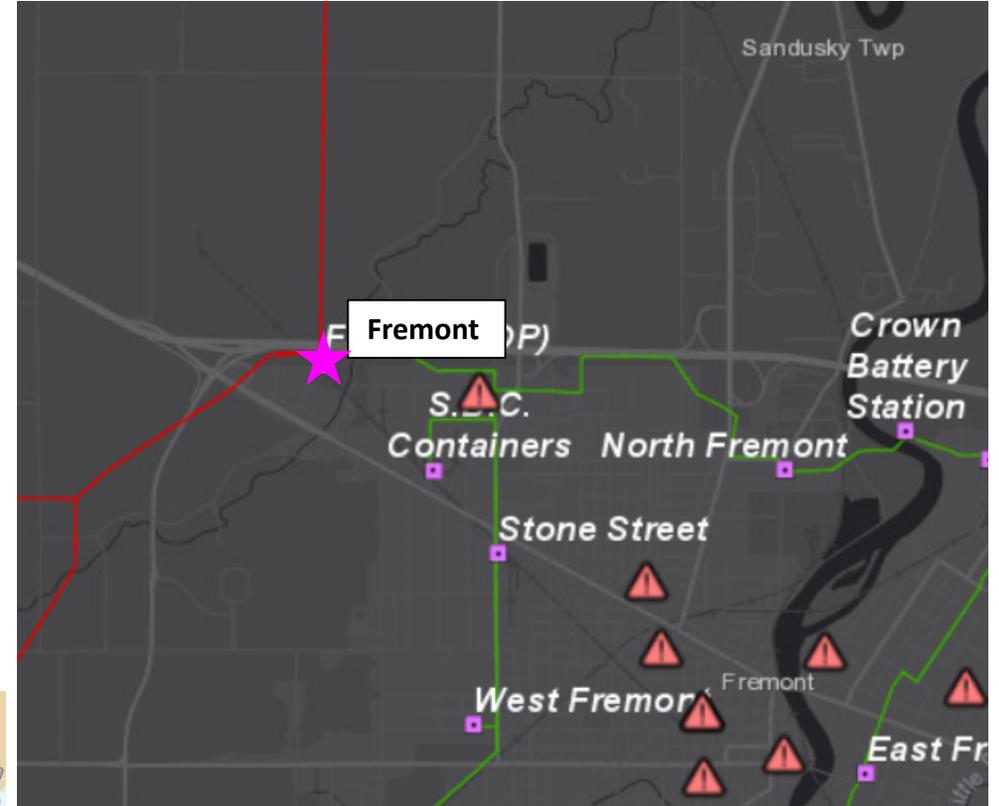
- Breaker Age:
 - 1988
- Interrupting Medium: (Oil)
- Fault Operations:
 - Number of Fault Operations: 43
 - Manufacturer recommended Number of Operations: 10

- The manufacturer provides no support for this family of circuit breakers and spare parts are increasingly more difficult to obtain. This model family has experienced major malfunctions associated with their hydraulic mechanism, including low-pressure readings, hydraulic leaks, pump lockouts, and failure to shut off. These mechanism malfunctions have led to several failures to close and other types of mis-operations across the AEP system.

- The 138kV line MOAB "W" toward West Fremont is in need of replacement due to obsolete contacts and a broken insulator.

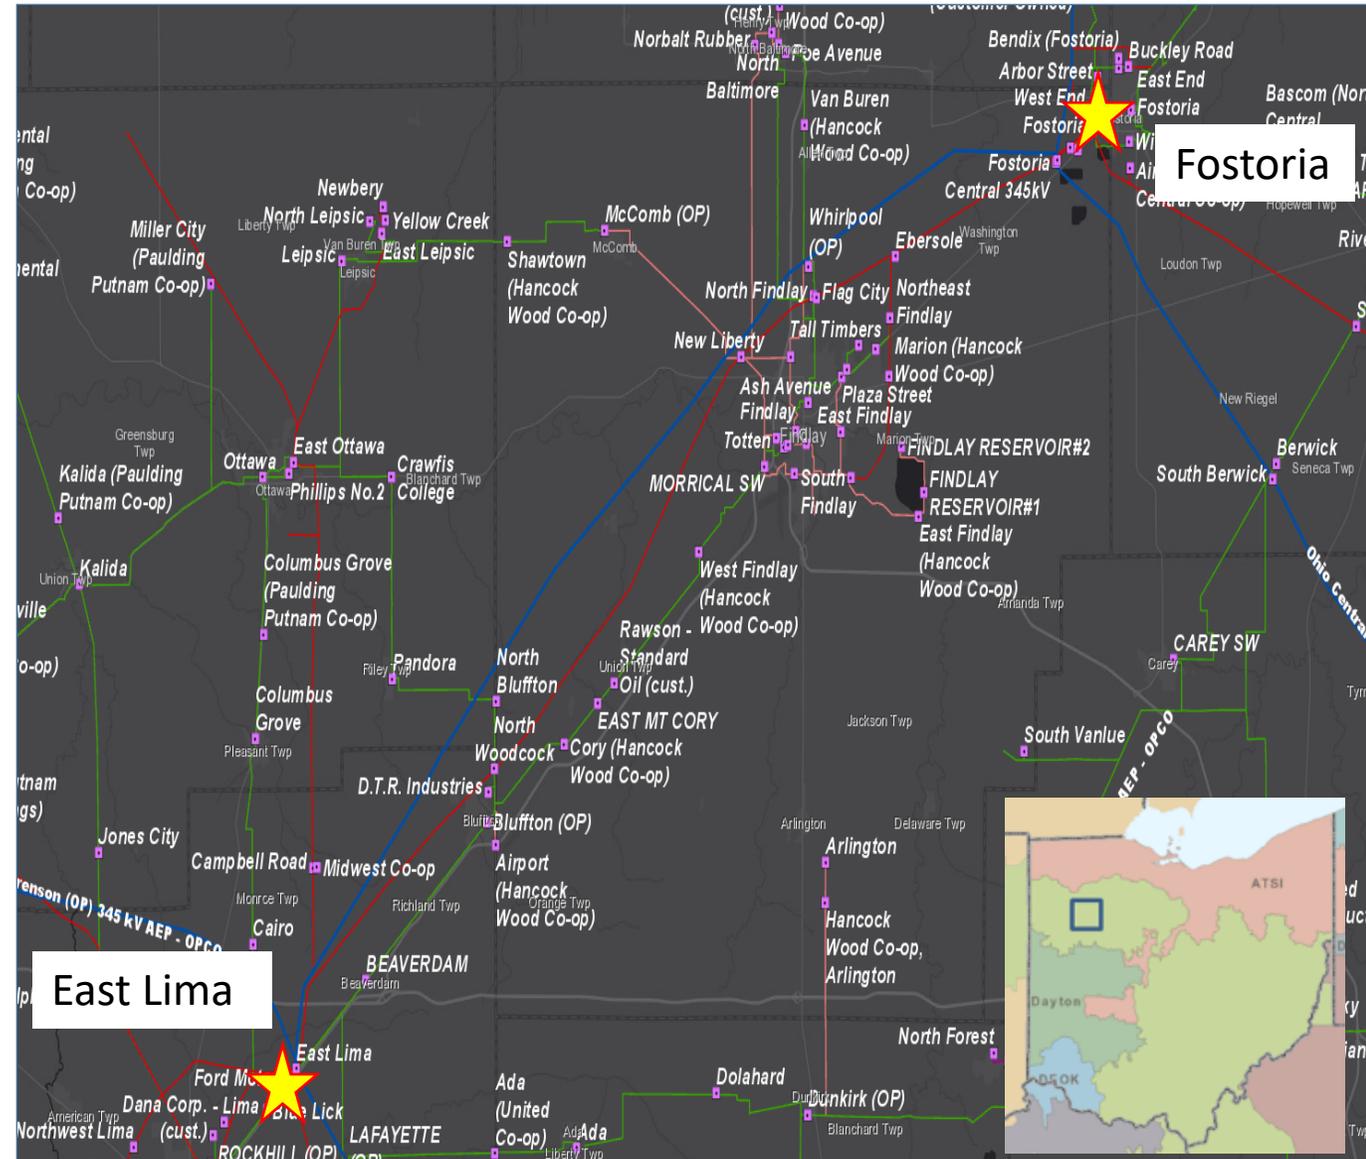
Fostoria – East Lima 138kV

- **Original Construction Date:** 1924
- **Length:** 41.26 miles
- **Total structure count:** 205
- **Original Line Construction Type:** Double circuit steel lattice towers with vertical insulators
- **Conductor Types:** 397,500 CM ACSR 30/7 (Lark) & 336,400 CM ACSR 30/7 (Oriole)
- **Outage History:** Since 2015, there have been 2 permanent outages and 6 momentary outages. The Ebersole – New Liberty Circuit has accounted for 19,640 customer minutes of interruption for 326 distribution customers at the Flag City Substation.
- **Condition Summary:** Currently, there are 44 structures with at least one open condition, which relates to 22% of the structures on this line.

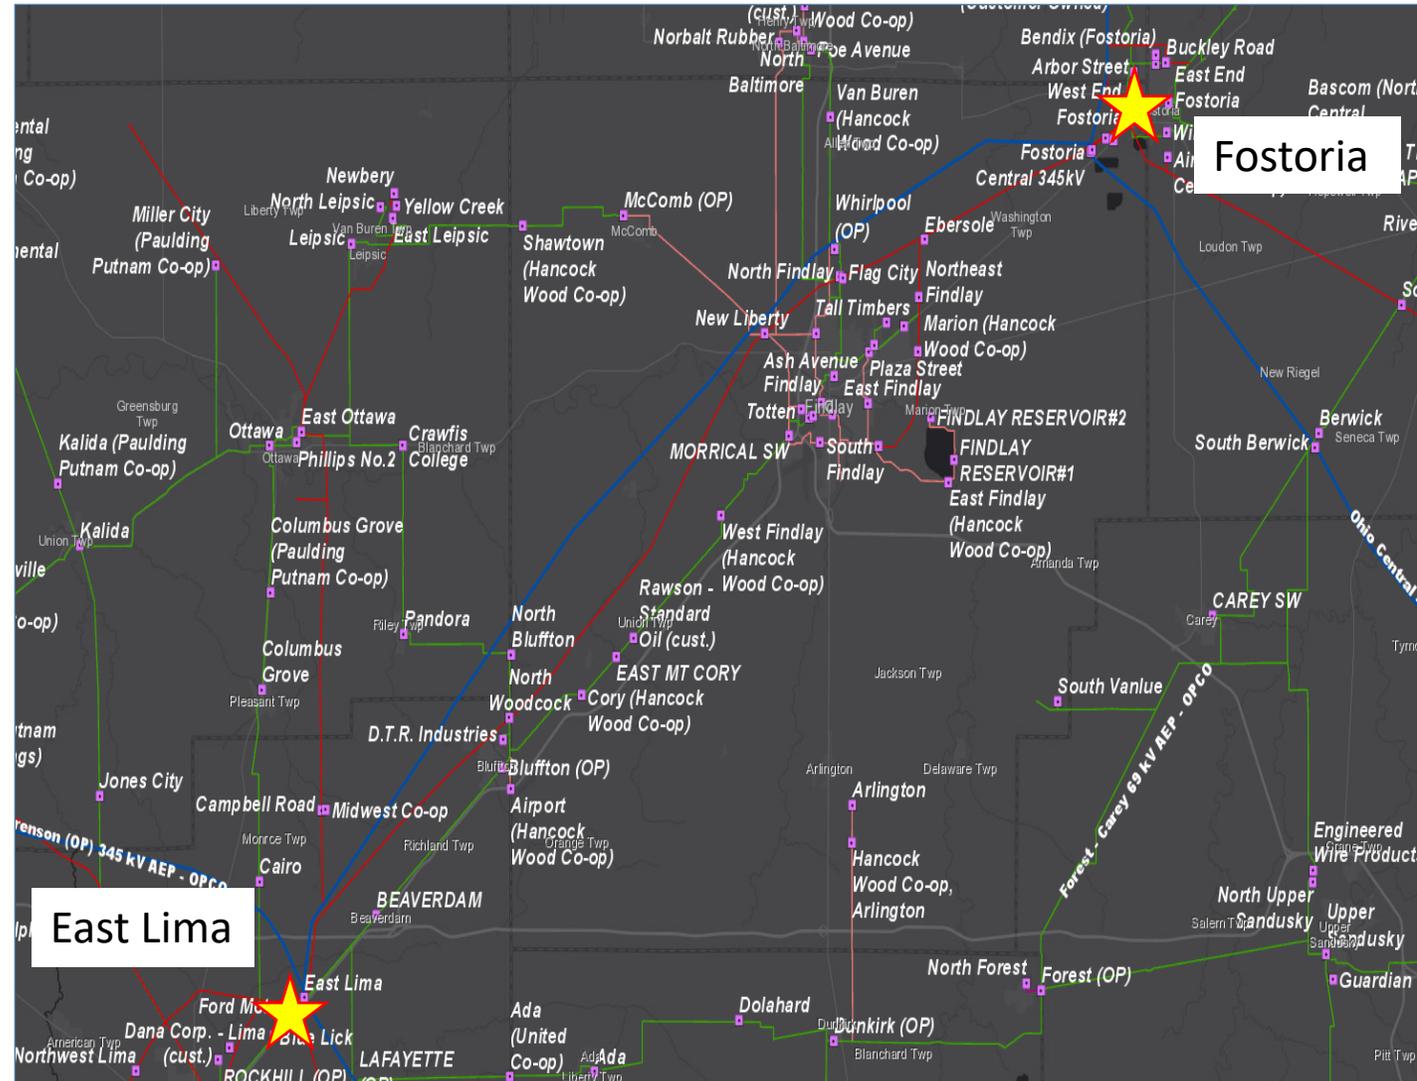
Additional Information: Multiple issues are starting to emerge on this line indicating accelerated deterioration phase of its life. Structures inspected either aerially or by ground crews showed heavy visible corrosion on conductors and shield wire, surface rust on towers, insulator end fittings and dampers.

- **Section Loss:** The connecting elements including the tower attachment hole and the insulator hook have experienced serious cross-section loss due to corrosion and wear. This loss of metal cross-section significantly reduces the capacity of the connection

- **Corrosion:** The insulator caps and connecting hardware have experienced heavy to complete loss of galvanizing. When the protective galvanized coating is gone or significantly compromised, the bare steel corrodes at an accelerated rate

- **Tower members with corrosion and damage.** Lattice tower structures have little structural redundancy. A failure of one member of the structure will impact the integrity of the structure and may cause the entire tower to collapse.

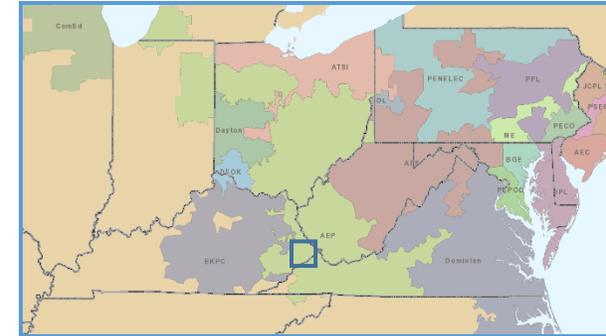
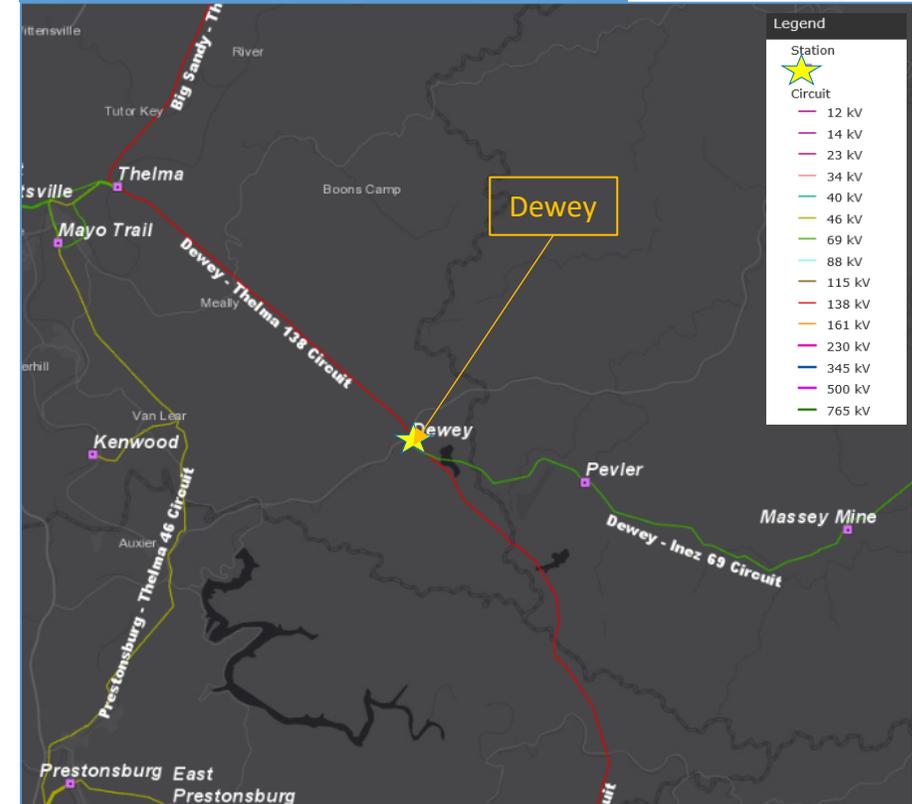
- 138kV Circuit Breaker B:
 - 1992 Vintage, number of fault ops: 55
 - The 138kV transmission owned circuit breaker, CB-B, is a 145-PA-40-20B type, SF6 filled breaker. As of May 11, 2020, there have been 437 recorded malfunctions of this 145-PA model family on the AEP System. The most common issues are related to loss of SF6 gas and mis-operations. The expected life of the bushing gaskets and door inspection port seals is 25 years; this unit has reached this age. Seals that are no longer adequate cause SF6 leaks to become more frequent. SF6 leaks impact the environment. The manufacturer provides no support for this family of circuit breakers and spare parts are not available.

- Relaying
 - Currently, 21 of the 34 relays (62% of all station relays) are in need of replacement. 21 of these are of the electromechanical type which have significant limitations with regards to spare part availability and fault data collection and retention.

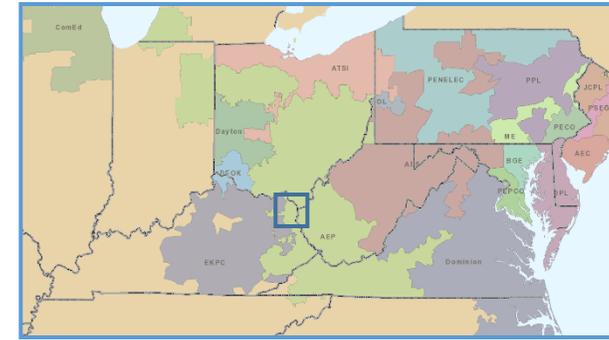
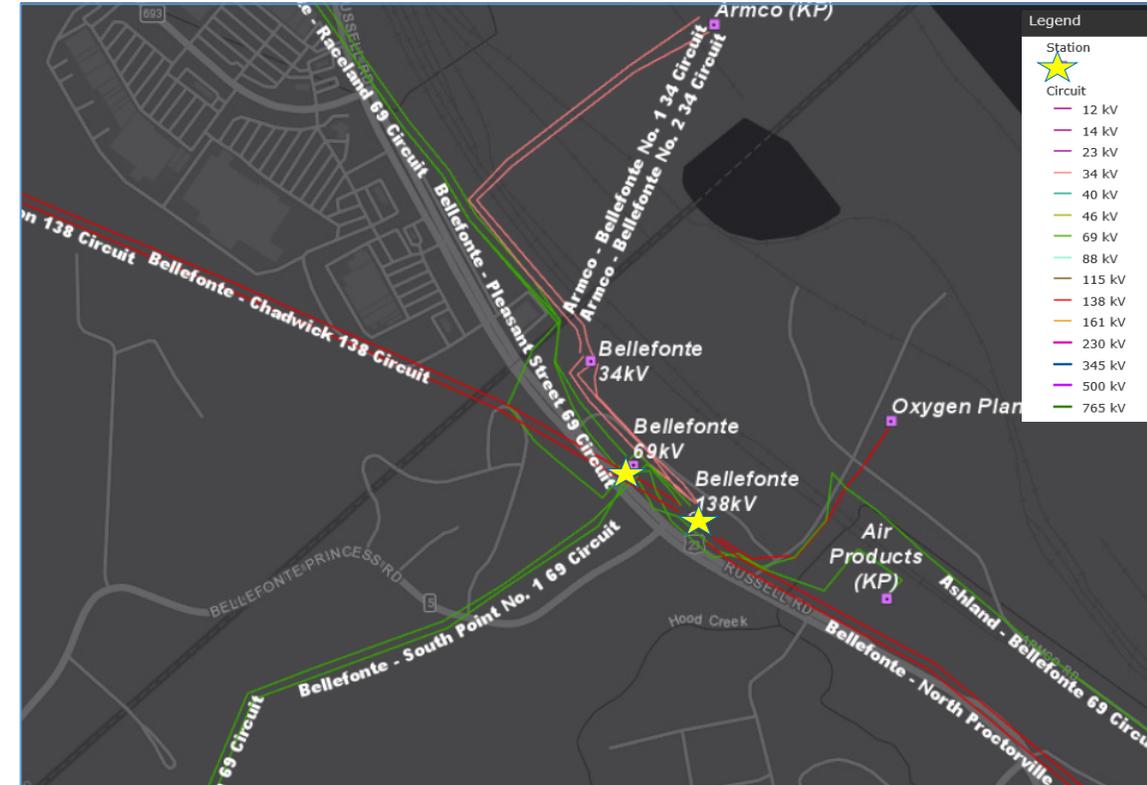
- 138/34kV 45MVA Bank #1:
 - 1950s Vintage, originally manufactured in 1951,
 - The dielectric strength of the overall insulation system (oil and paper) is in poor condition, which impairs the unit's ability to withstand electrical faults.

- The high side bushings have seen increased capacitance, indicative of capacitive layer deterioration. The low side bushings lack sufficient dielectric testing data and were commissioned in 1996. The low side bushings are on the recommended replacement list due to the population being advanced in age and degradation, leading to high risk of violent failures from arcing through the ground sleeve.

- The majority of this family of bushings were manufactured pre-1952. As a bushing ages, O-rings, gaskets, and seals may become more brittle, which may result in moisture ingress. The change in high side bushing dielectric data, the low side bushing type, and the age of all the bushings indicates these bushings are at a greater risk of failure. Failure of a bushing may cause a failure or loss of service of the transformer.

- Active Oil leaks.
- 138/69-34kV 196 MVA Bank #2:
 - 1970s Vintage, originally manufactured in 1970,
 - Low side bushings have Capacitive layer deterioration.

- This unit has severe nitrogen leaks. There are racks installed with manifolds in order to keep the nitrogen pressure on this transformer. This unit also has active oil leaks. One third of the fans on this unit have failed.

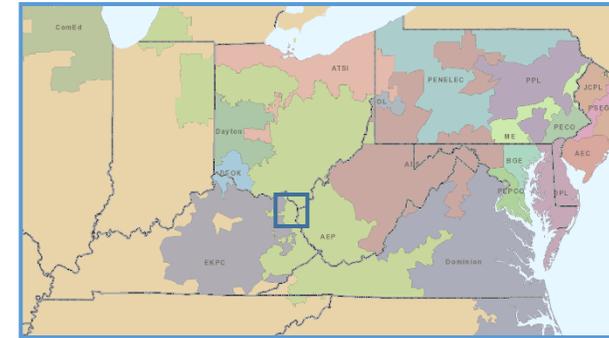
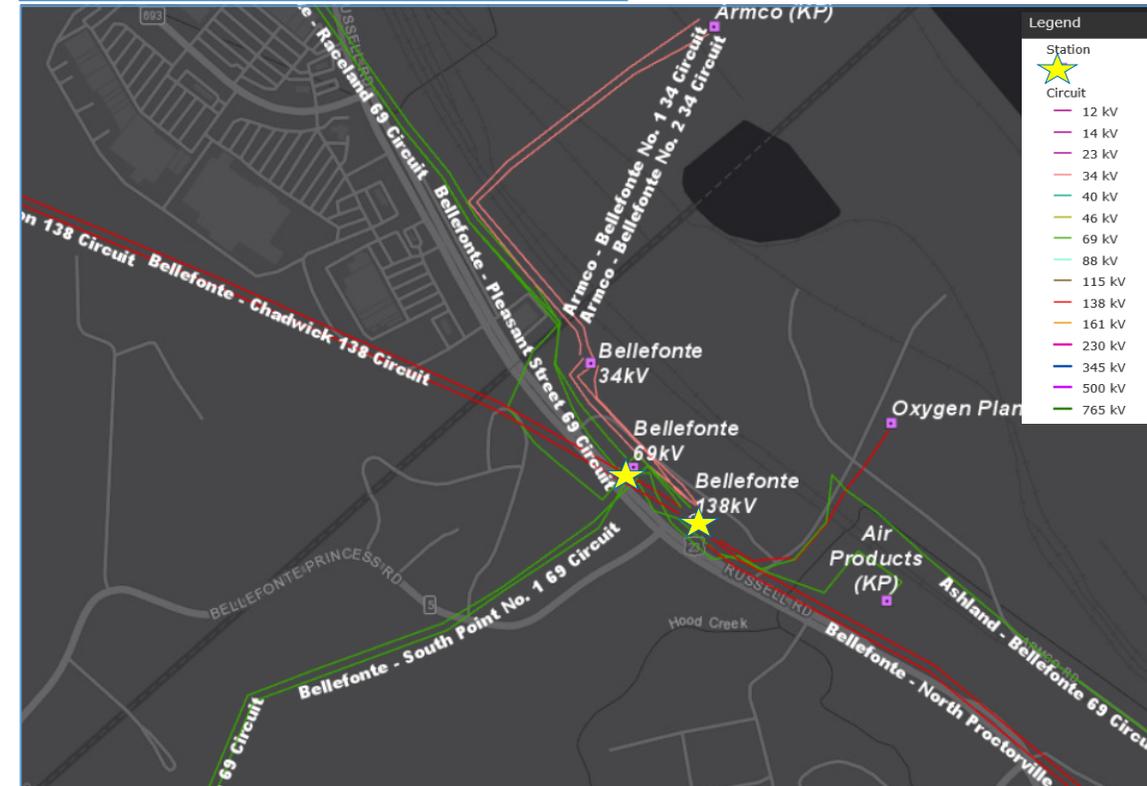
- This unit has severe nitrogen leaks. There are racks installed with manifolds in order to keep the nitrogen pressure on this transformer. This unit also has active oil leaks.

- This unit has active oil leaks. One quarter of the fans on this unit have failed.
- Relaying 138 kV Yard:
 - 97 of the 110 (88%) relays at the 138kV yard station are in need of replacement.

- 76 are electromechanical, 3 are static and 18 relays are microprocessor type.
 - The electromechanical type and Static type relays that have significant limitations with regards to spare part availability and fault data collection and retention. In addition, these relays lack vendor support. Where as the microprocessor relays that are of legacy design and/or utilize legacy firmware

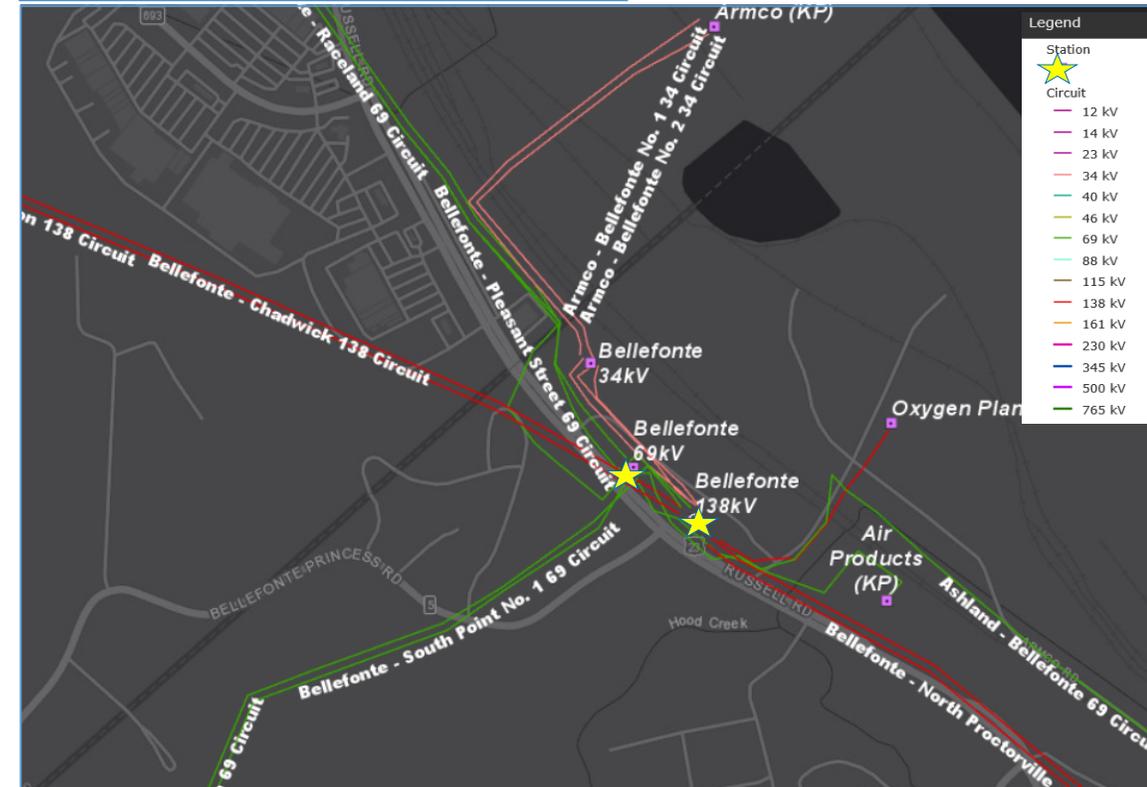
- Bus Tie Breaker H: 1960s vintage, Manufactured in 1965, Type: Oil , Fault Ops: 3,
- Circuit Breaker T: 1960s vintage, Manufactured in 1967, Type: Oil , Fault Ops: 1,
- There is no vendor support for this family of circuit breakers and spare parts are increasingly more difficult to obtain.
- This model family has experienced major malfunctions associated with their OA-3 hydraulic mechanism, which includes low-pressure readings, hydraulic leaks, pump lockouts, and failure to shut off. These mechanism malfunctions have led to several failures to close and other types of mis-operations across the AEP fleet.

69kV circuit switcher KK is a Mark V type , without gas monitor. The neutral shift device is heavily corroded.

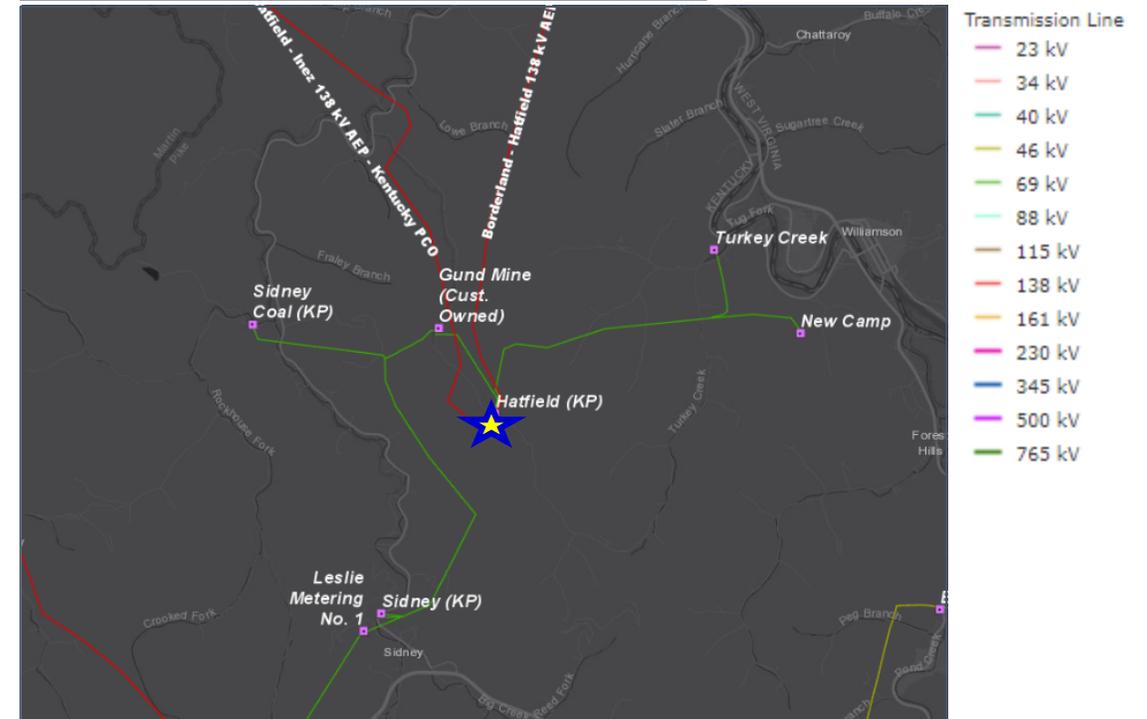
- Grounding Transformer for station service
- 1990 Vintage unit
- DGA indicates elevated levels of CO2 gas concentration
- Bushings are at a greater risk of failure due to capacitive layer deterioration and change in bushing power factor.
- High decomposition of the paper insulating materials.
- Wood tie foundations
- Worn down Oil containment

- GND TR-2 is an artifact from the previous station setup that has been preserved as a source of station service. The grounding bank and associated bus work increases the exposure for failure in order to provide station service.

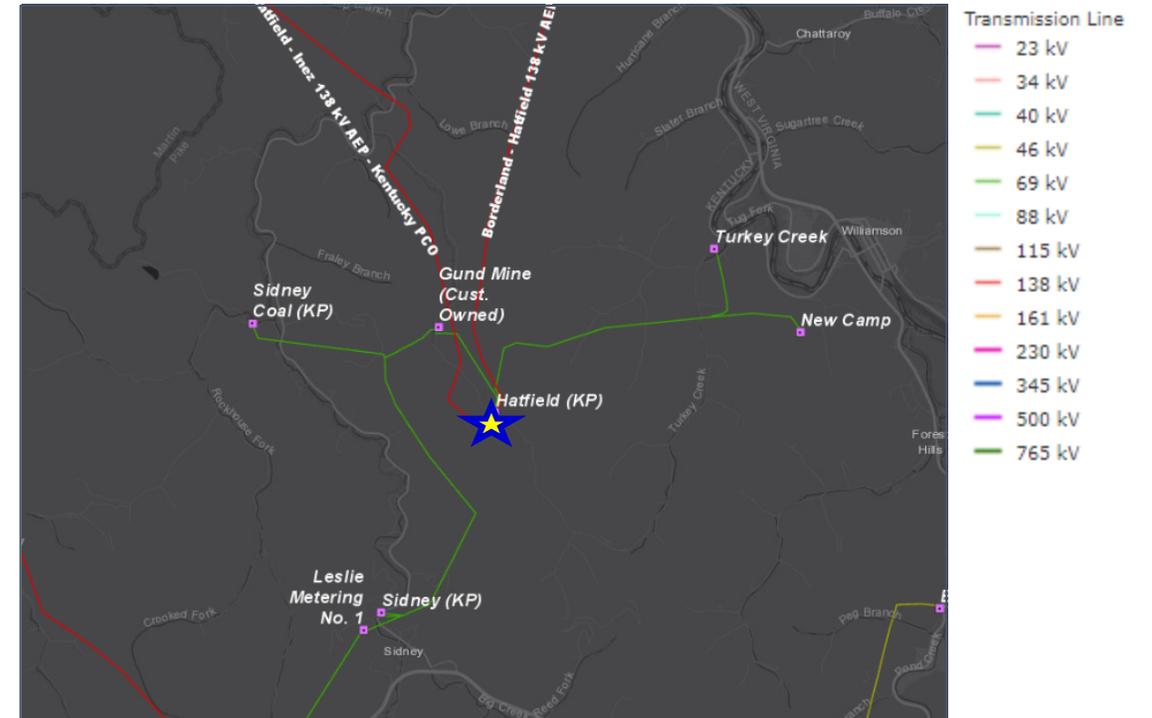
- Breaker Age: B 1990,
- Interrupting Medium: (SF6)
- Fault Operations:
 - Number of Fault Operations: B 65
- **Additional information on this breaker:** This particular breaker has had 35 reported malfunctions related to gas leaks. In addition, its CTs have previously been removed and dried.

- The driveway is unsafe due to its short length and close proximity to the road. The 69kV Bus from TR-1 goes underground to circuit breaker B. Because of this configuration, the TR-1 low side breaker CB B is not in a “normal” position. This introduces opportunities for HP errors.
- the station service “transfer” cabinet is in poor condition the requires manual wiring or fuse changes to transfer to the alternate distribution source. The sources are out of phase and break-before-make action is entirely manually performed with normally open fuses. Arc flash hazards and HP error prone design complicate transferring between sources and making emergency settings.

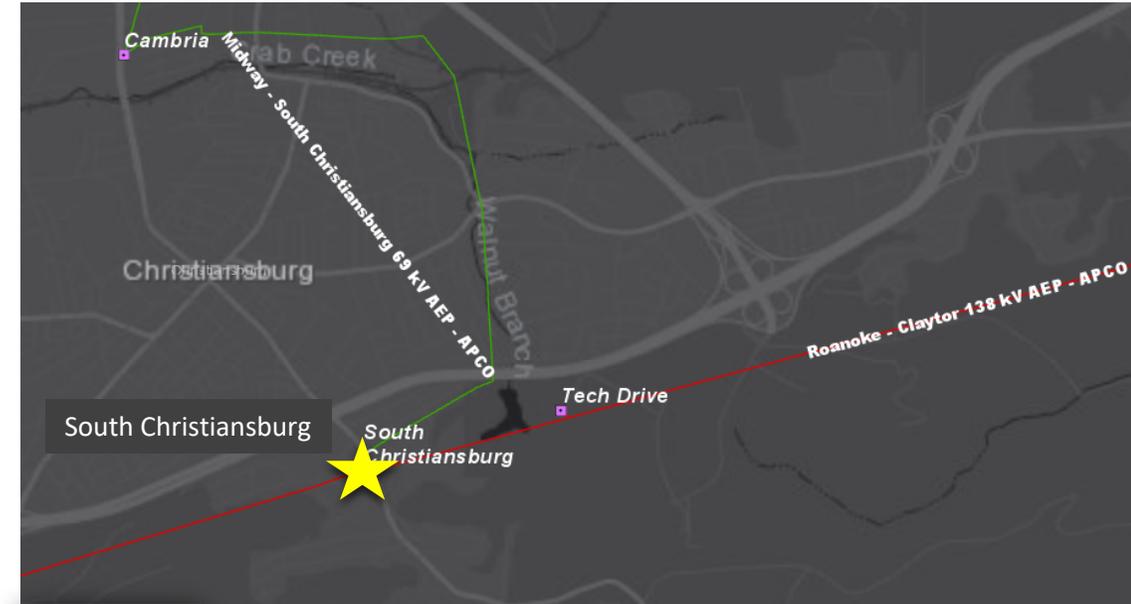
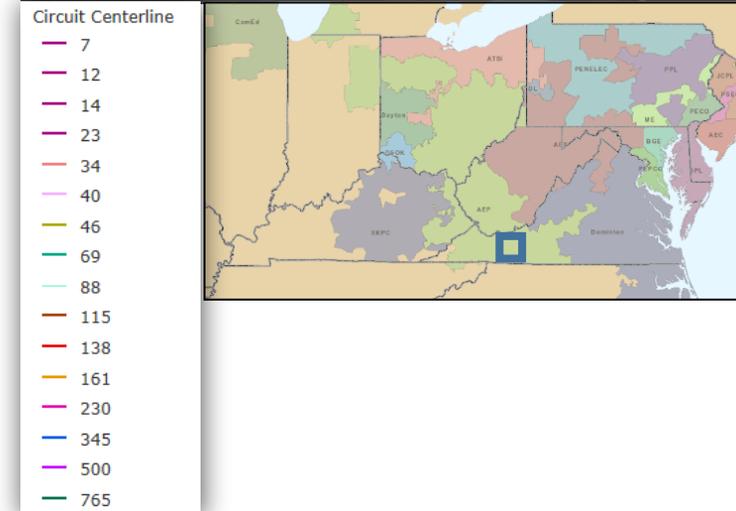
- Rising power factor and decreasing dielectric strength are both indications of an increase in particles within the oil. This decreases the ability of the oil to withstand fault events, which can further damage the paper insulation. The values of dielectric strength and power factor indicate the dielectric strength of the insulation system (oil and paper) is in declining condition, which impairs the unit's ability to withstand electrical faults.

- There are oil leaks around the temperature wells.
- The 69kV circuit breaker at South Christiansburg station is 1965 vintage and is oil filled without oil containment. This circuit breaker has exceeded the manufacturer's designed number of full fault operations. The manufacturer provides no support for this type of breaker and spare parts are not available. As of March 24, 2021, there are 54 remaining FK-69-2500-5 circuit breakers on the AEP system, including the 1 at this station.

- The transformers use obsolete 138kV MOAB/ground-switch protection systems, which require remote-breaker tripping for isolating transformer faults

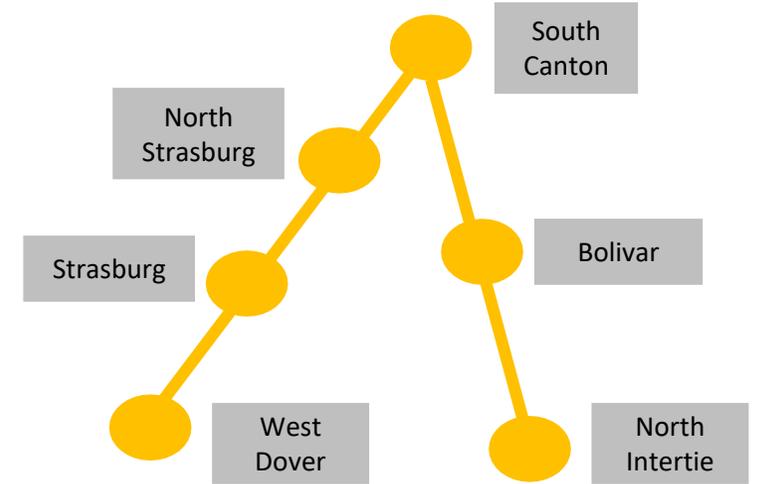
Existing:

AEP Transmission Zone M-3 Process Dover to South Canton Line Rebuilds

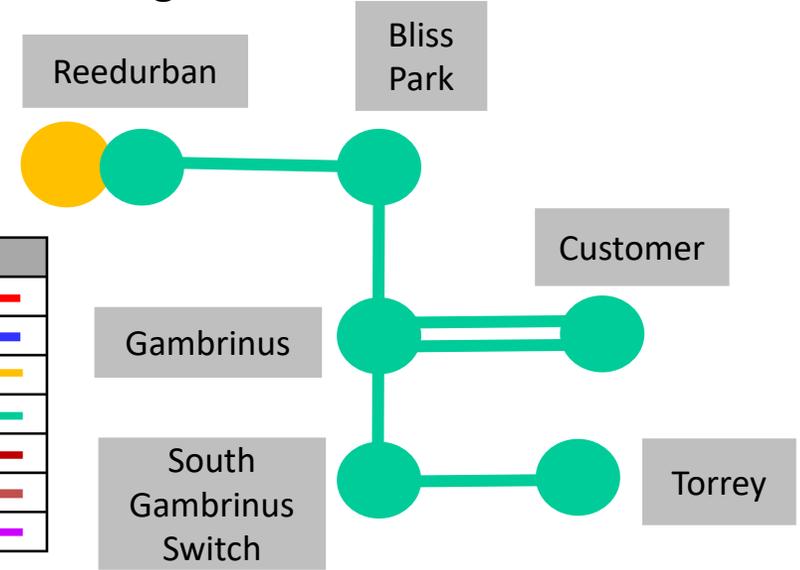
Existing:

AEP Transmission Zone M-3 Process Gambrinus & Reedurban Station Upgrades

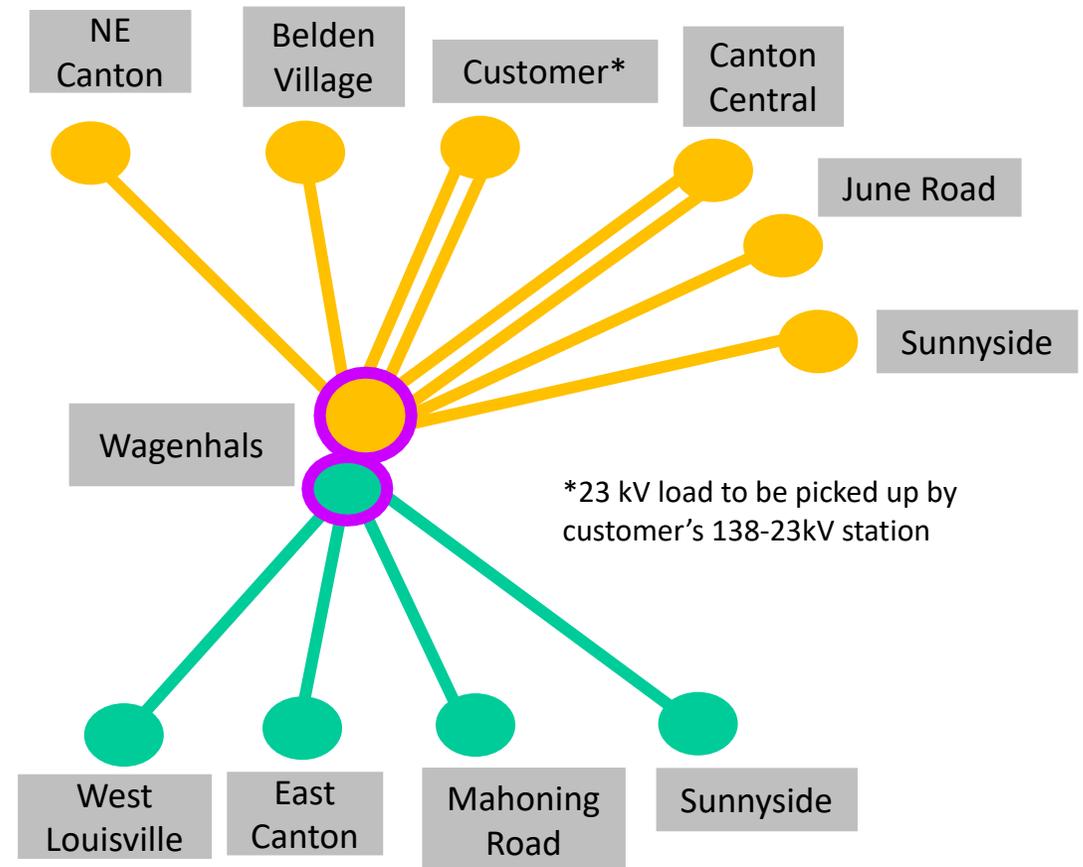
Proposed:

AEP Transmission Zone M-3 Process
Wagenhals Station Upgrade

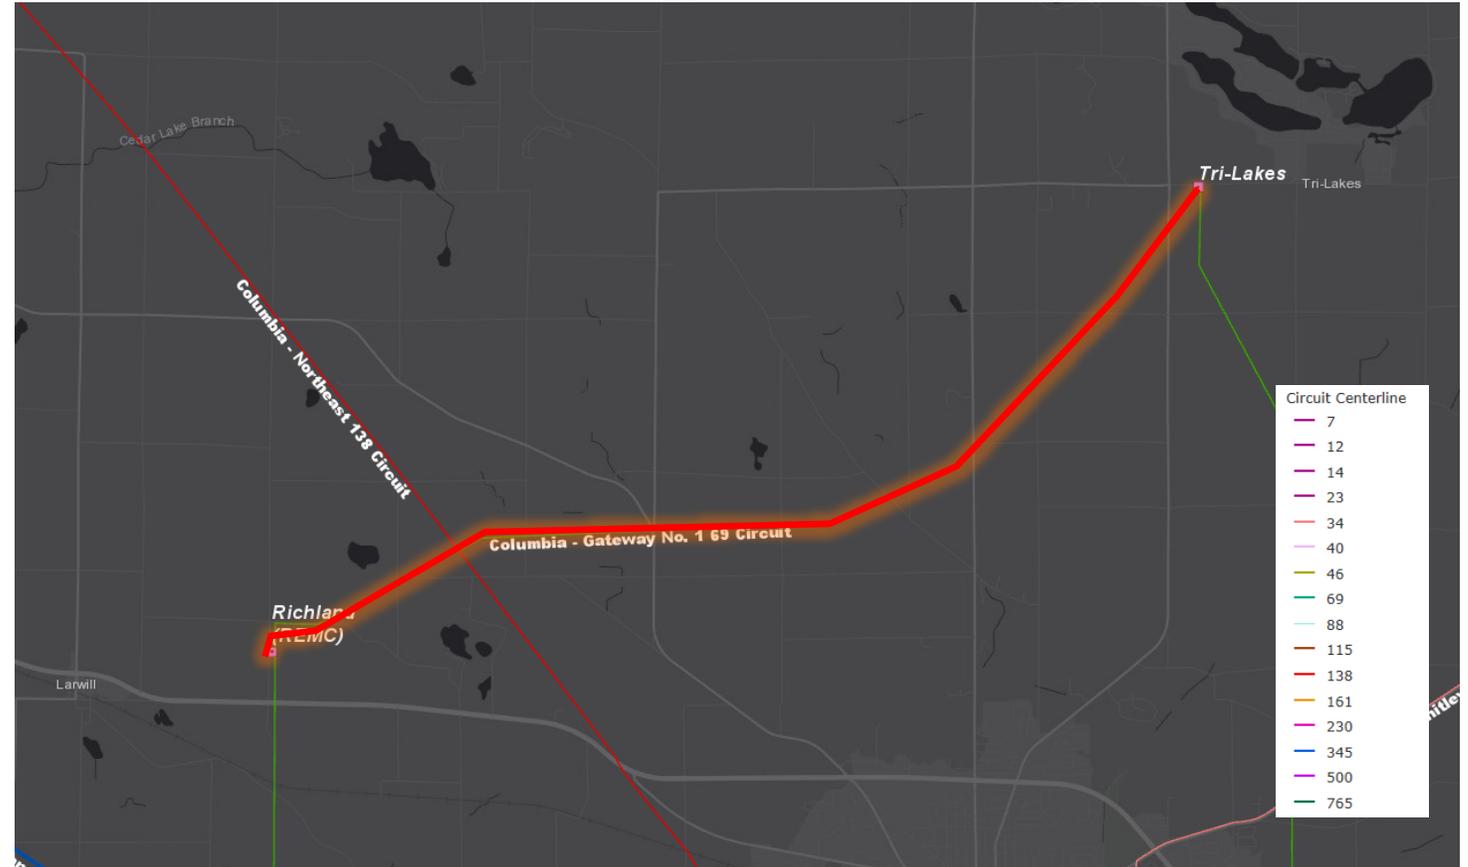
Original Install Date (Age): 1965

- Length of Line: 8.66 Miles
- Total structure count: 122
- Original Line Construction Type: 1960s Wood Pole
- Conductor Type: 4/0 ACSR
- Outage History since 2015
 - Momentary/Permanent Outages and Duration:
 - 20 Momentary and 6 Permanent
 - CMI: 125,904
- Condition Summary
 - 71 structures (58%) have at least one open condition including cracked, rotten, woodpecker damaged and leaning poles; Chipped, Loose, Contaminated and rusted Insulators.
 - 40 representative structures were assessed by drone with 12 assessed by a ground crew. Of these the following was observed
 - Wood decay was moderate to advanced on structures at ground line and poles have rot top.

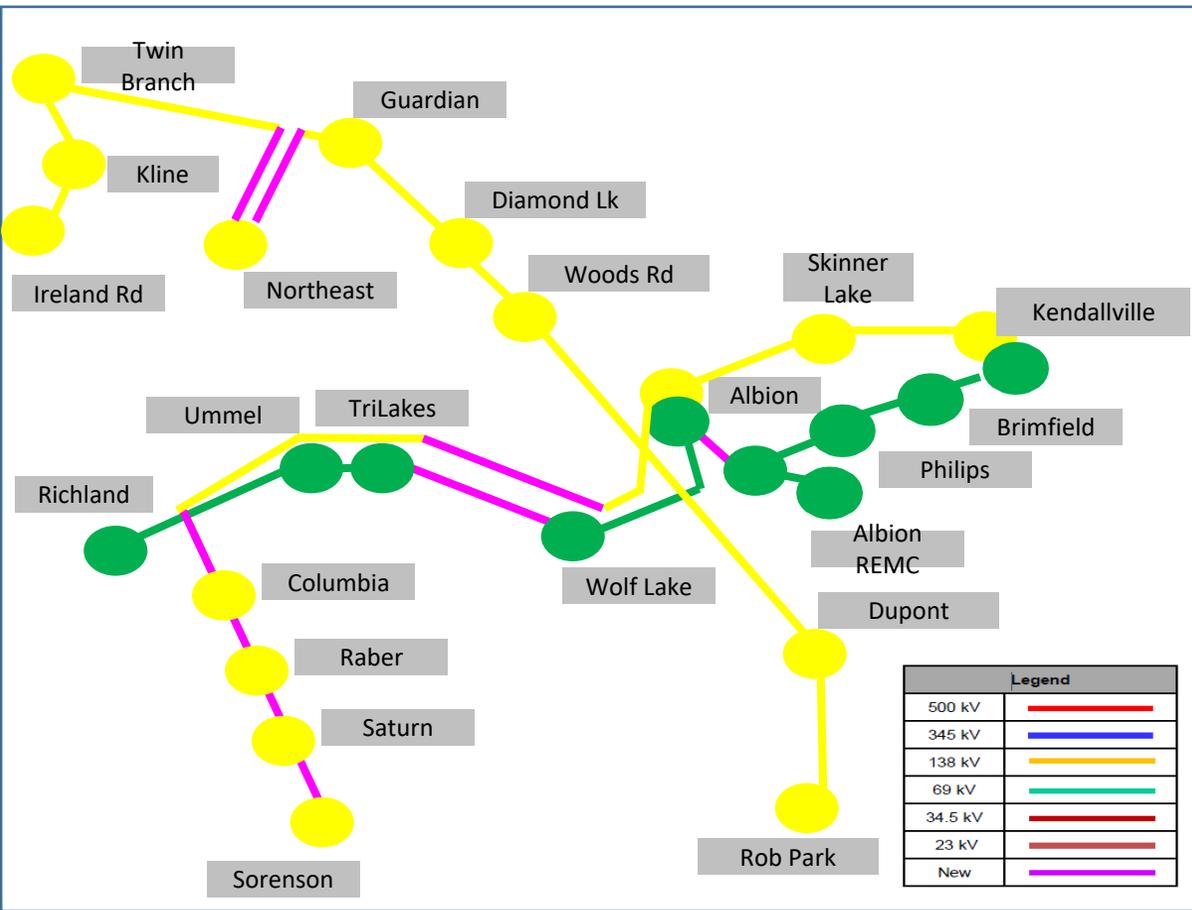
138kV Plan summary

Twin Branch – Sorenson is a 65.1 mile 1940’s line that AEP can retire due to other improvements made in the area and multiple paths on both 138 kV and 345 kV lines. By building Richland – Tri Lakes and Wolf Lake tap to 138kV double circuit standards in phase 1, the network is set up so that in phase 2, AEP will not need to rebuild the full 65.1 miles that exist currently and can instead retire a good portion of it.

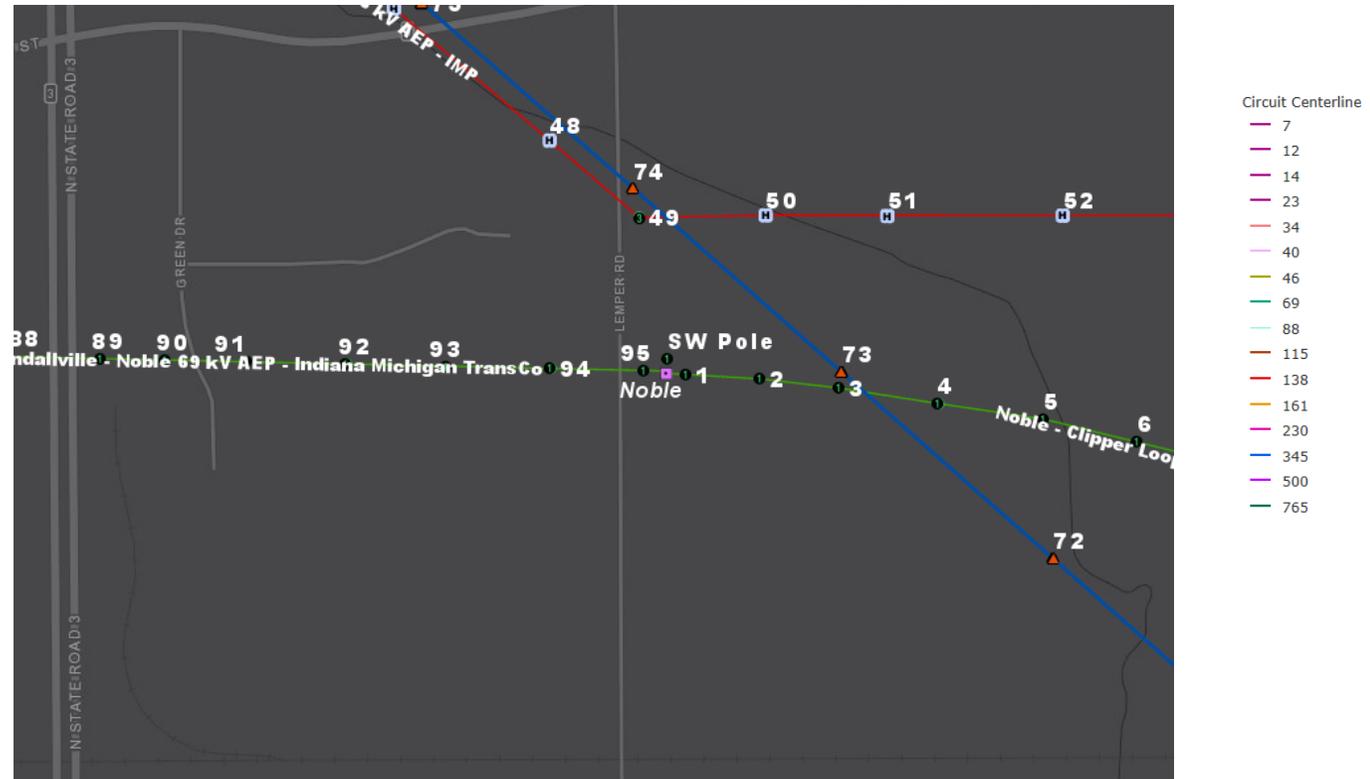
Noble Station is a vintage 1950's wood pole station that is currently loaded beyond its capacity. The peak 2021 loading reached 12.04MVA which is 103% over the transformer's capacity.

Because of this, I&M Distribution has requested a new delivery point in this area.
