Submission of Supplemental Projects for Inclusion in the Local Plan

AMPT Projects in ATSI/AEP Transmission Zone M3 Process Brewster, OH

Need Number: AMPT-2021-006

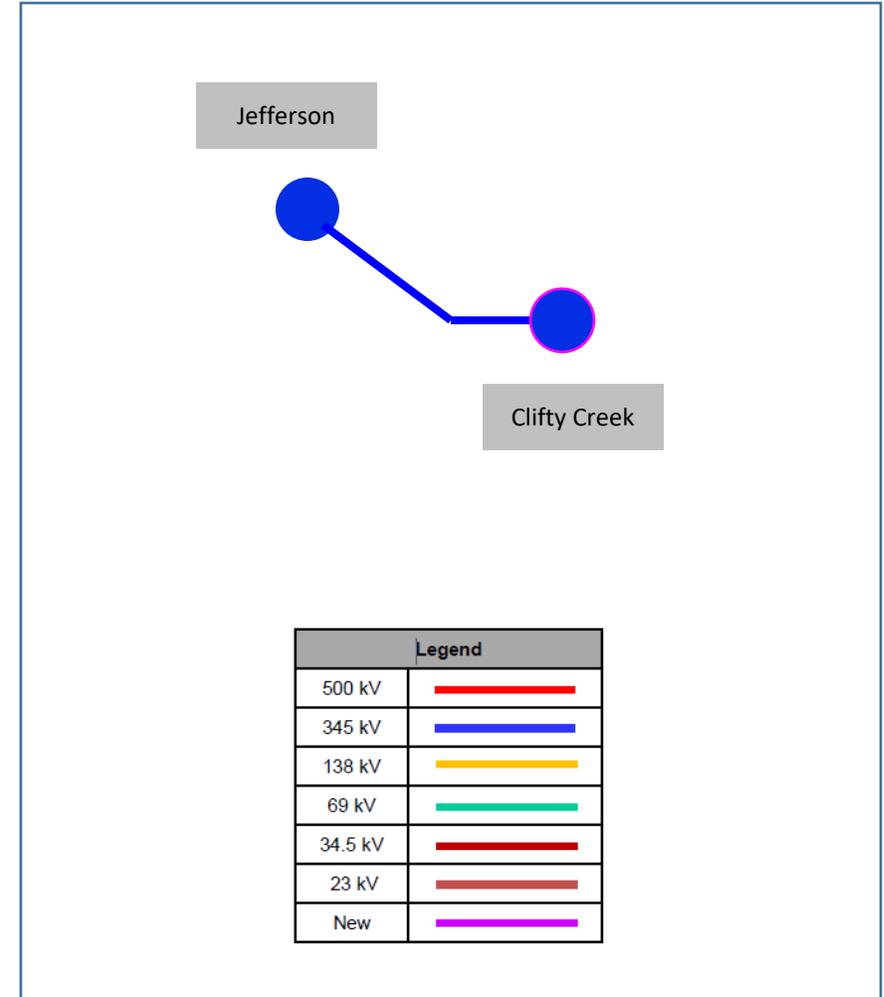
Clifty Creek 345 kV: Replace 345 kV circuit breakers “R” and “S” with 5000 A, 63 kA circuit breakers. **(S2832.1)**

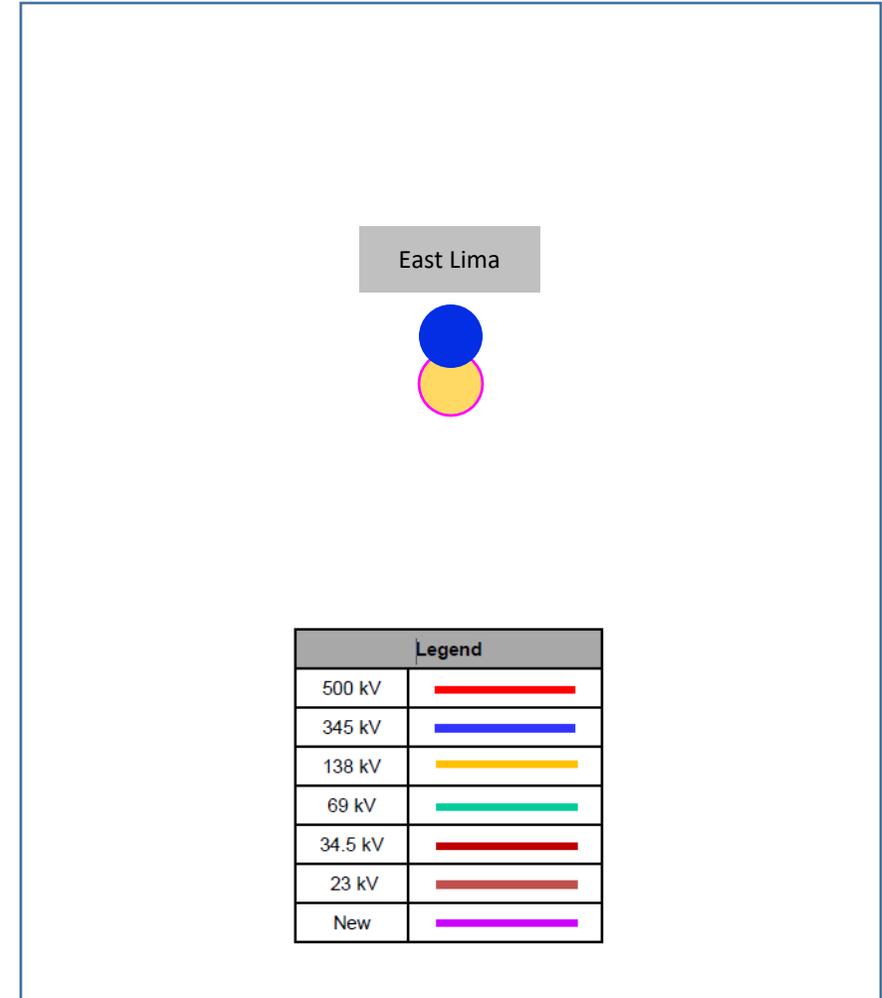
AEP Transmission Zone M-3 Process East Lima Bus Conductor Replacement

East Lima 138kV: Replace 1000MCM, 1590 AAC bus and riser conductors on the 'B' string and Bus 2 with 2-2000 MCM AAC. (s2832.2)

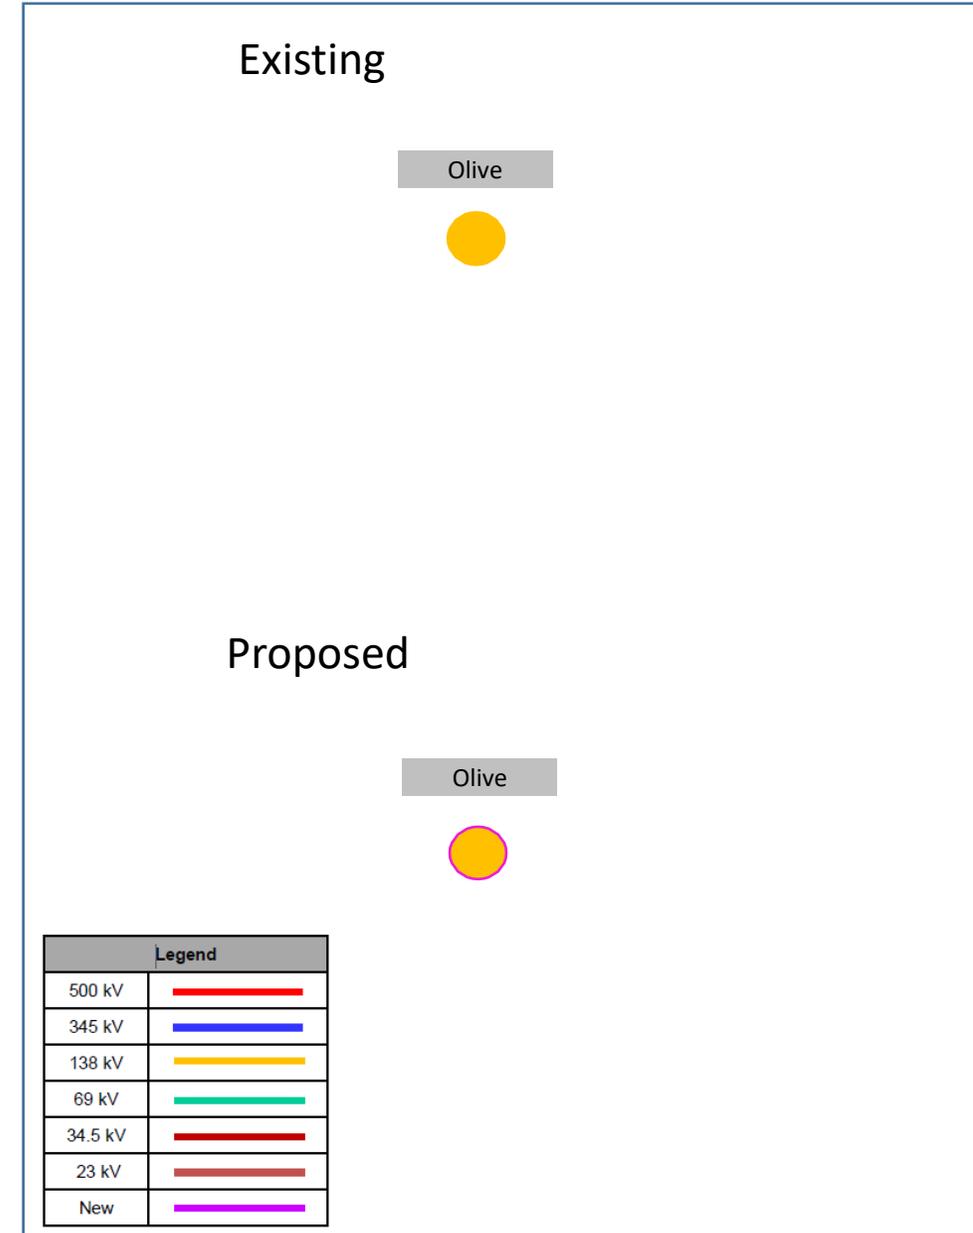
Replace the 1590 station conductor at Olive 138kV station on the Olive – New Carlisle 138kV line and increase the CT Thermal Limit above 606 MVA WE. (s2832.3)

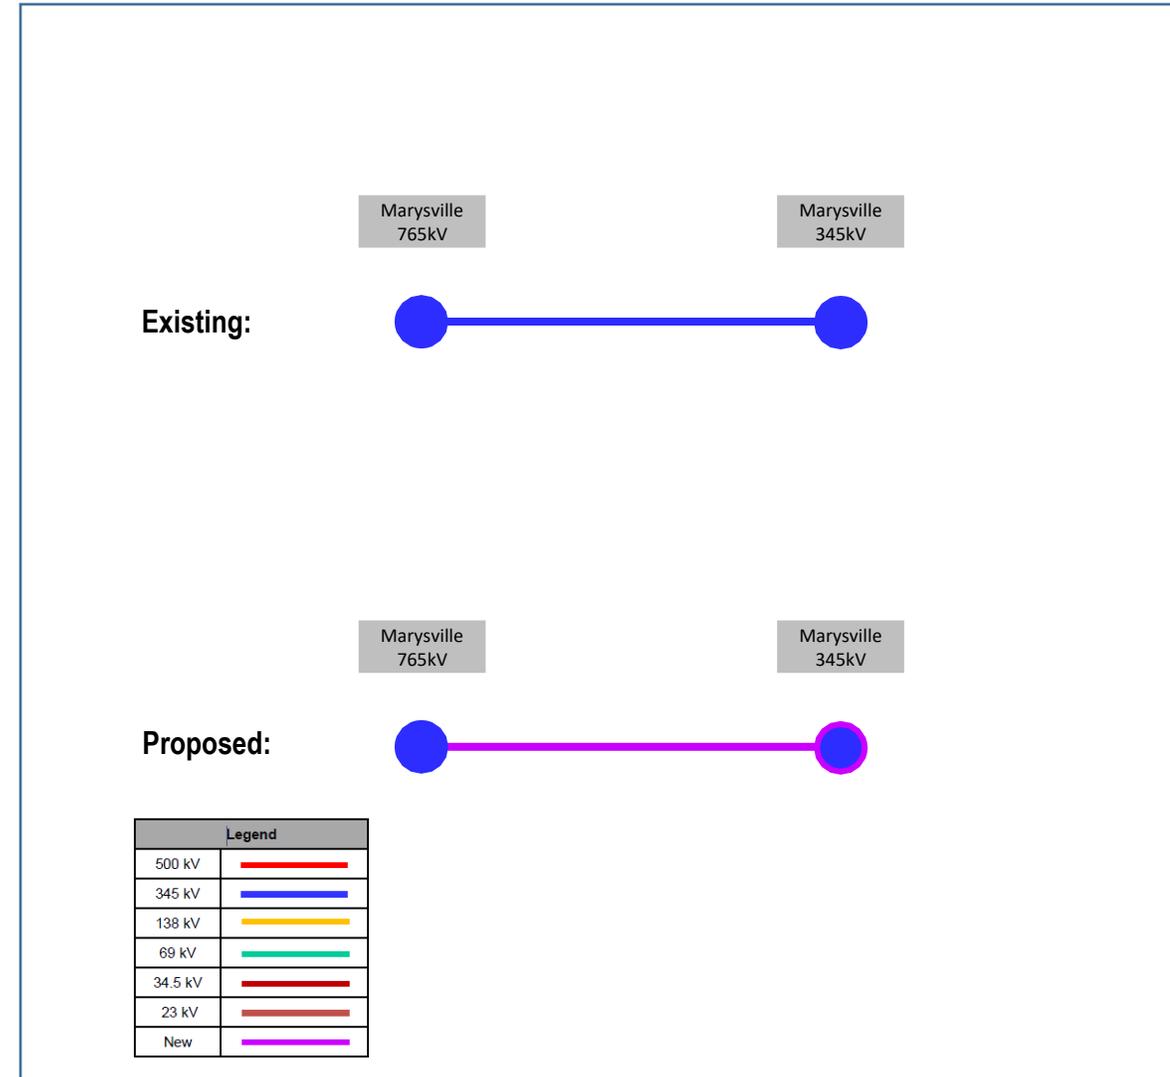
Marysville 345kV station: Replace (2) 345 kV 5000A 63kA circuit breakers and associated sub conductor and switches on the H string to eliminate the lower-rated equipment. **(s2832.4)**

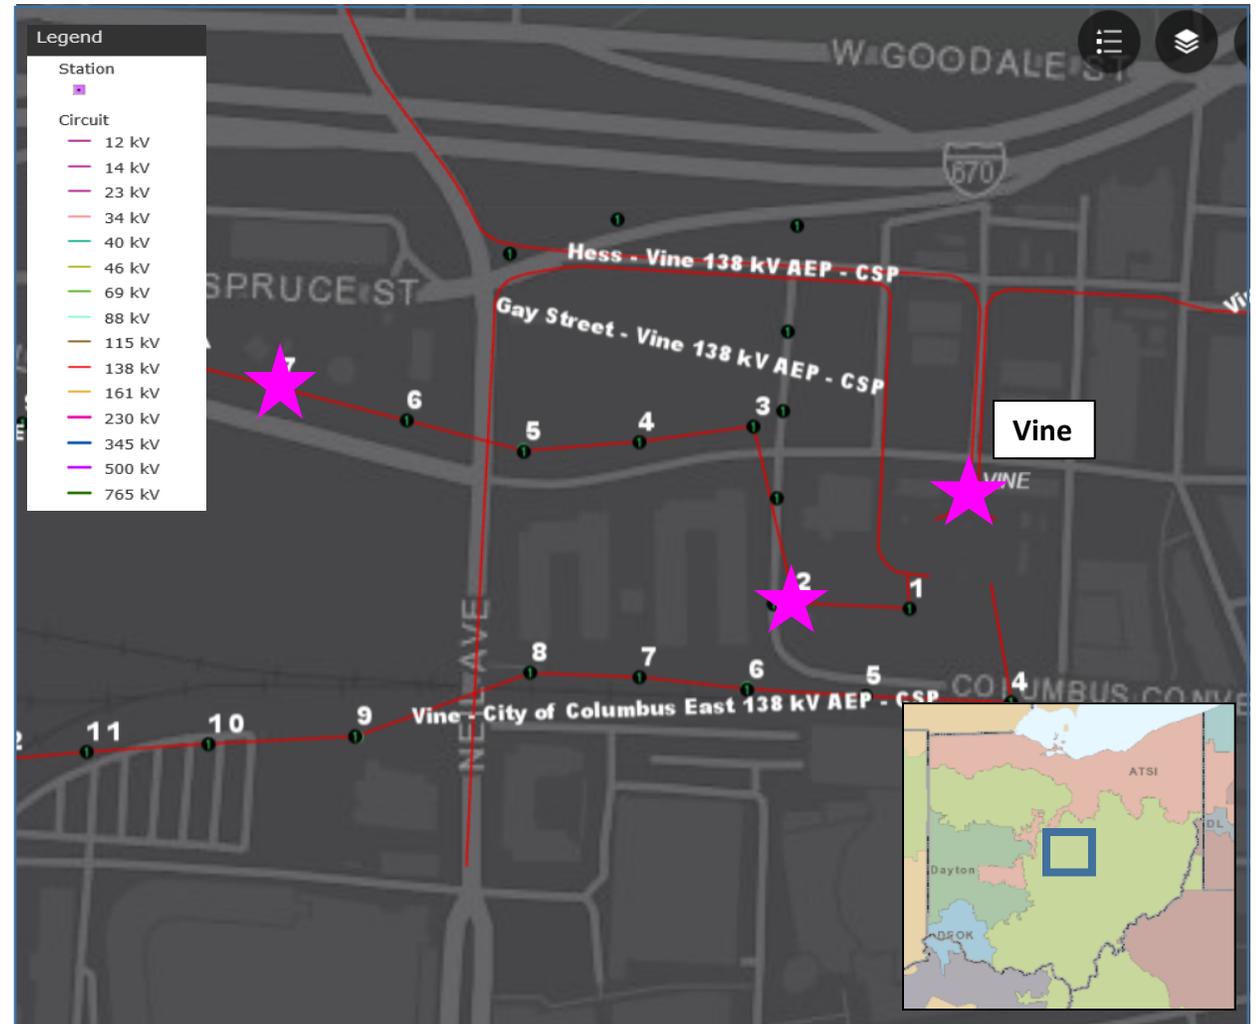
Vine- City of Columbus West 138kV Line:

- A customer has requested that AEP relocate the section from structures 2 to 7 of the Vine - City of Columbus West 138kV line from overhead to underground in a duct bank to accommodate development in the area.
- Service is requested by June 2023.

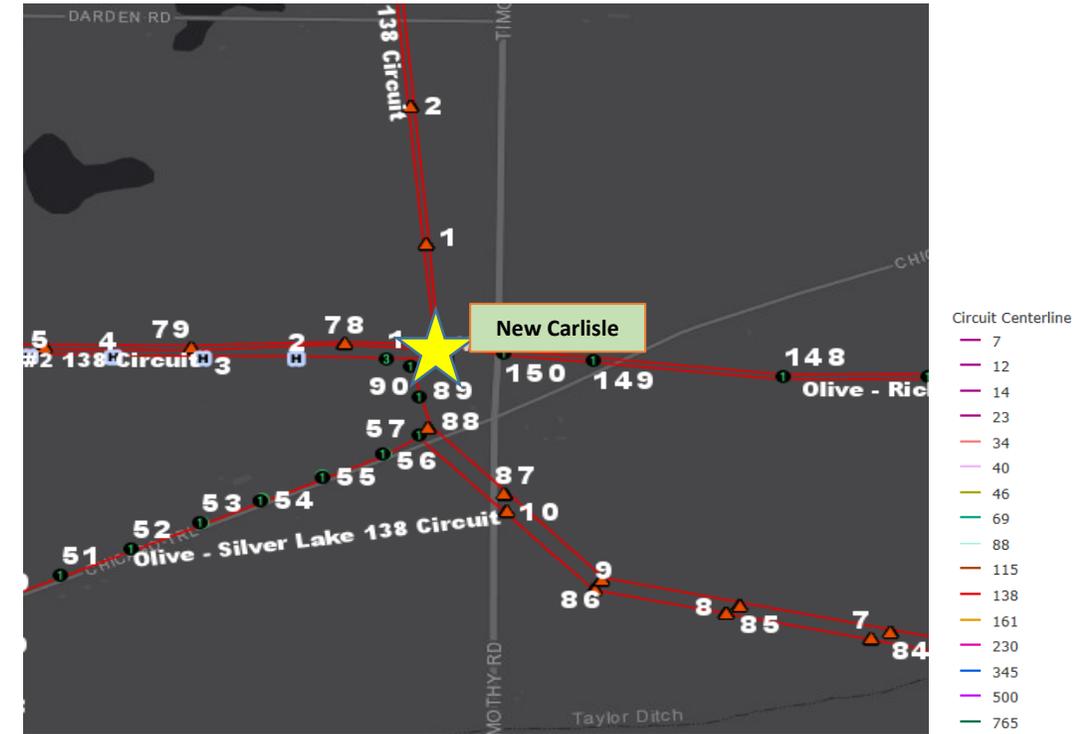
New Carlisle 138kV Circuit Breaker A:

- Only air trip breaker remaining at the station and is not preferred due to potential large air leaks which will cause the breaker to not trip before a lockout situation occurs. The air system is not designed to produce dry air, which in turn means that rusting and damaging components are common. Field services have been called out numerous times in a lockout position due to frozen airlines.
- Only remaining 2000A 40kA breaker left at the station
- Trip timing results are beginning to increase and major maintenance will soon be required. Trip timing results are roughly 9ms higher than what the manual recommends (less than 33 milliseconds).

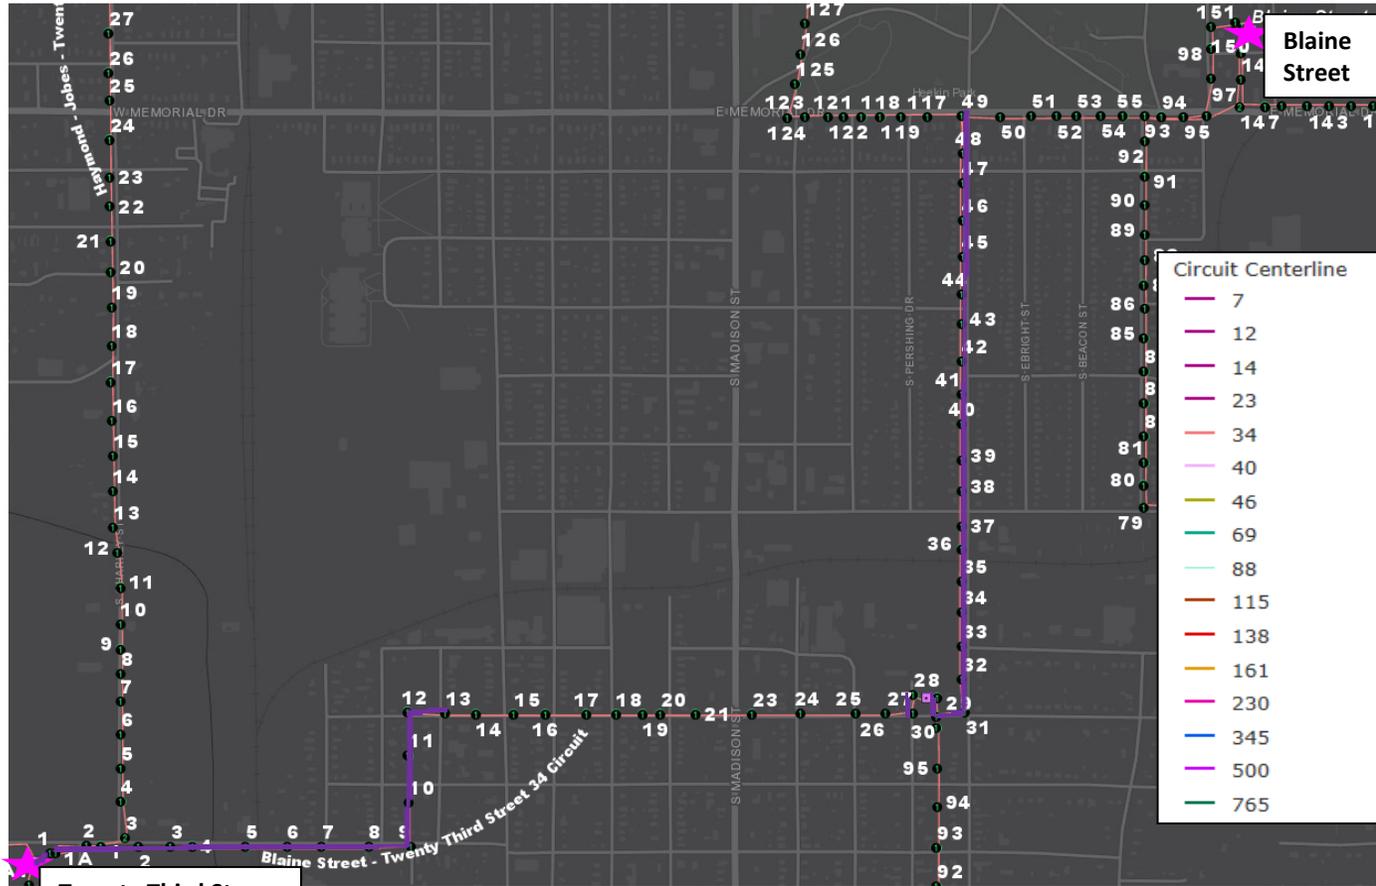
- Porcelain vertical post insulators
- Conductor Type:
 - 556,500 CM ALUM/1350 19 Dahlia
 - 795,000 CM ALUM/1350
- Condition Summary
 - Number of open conditions: 5 structure open conditions

- Open conditions include broken pole, shielding grounding improperly installed and missing ground lead wires.
 - Based on the ground crew assessment , for 30 structures, approximately 67% of the poles assessed have moderate to heavy shell damage, insect damage or woodpecker damage. Approximately 50% of the poles assessed have heart rot. Some structures are near buildings or railroad right of way. Access likely limited to railroad right of way that can result in restoration delays for access permission and flagging protection. Wires attachment and distribution equipment are heavy on some structures. Slow wood pole restoration.

- The grounding method utilizes butt wraps on every other structure, providing reduced lightning protection for the line.

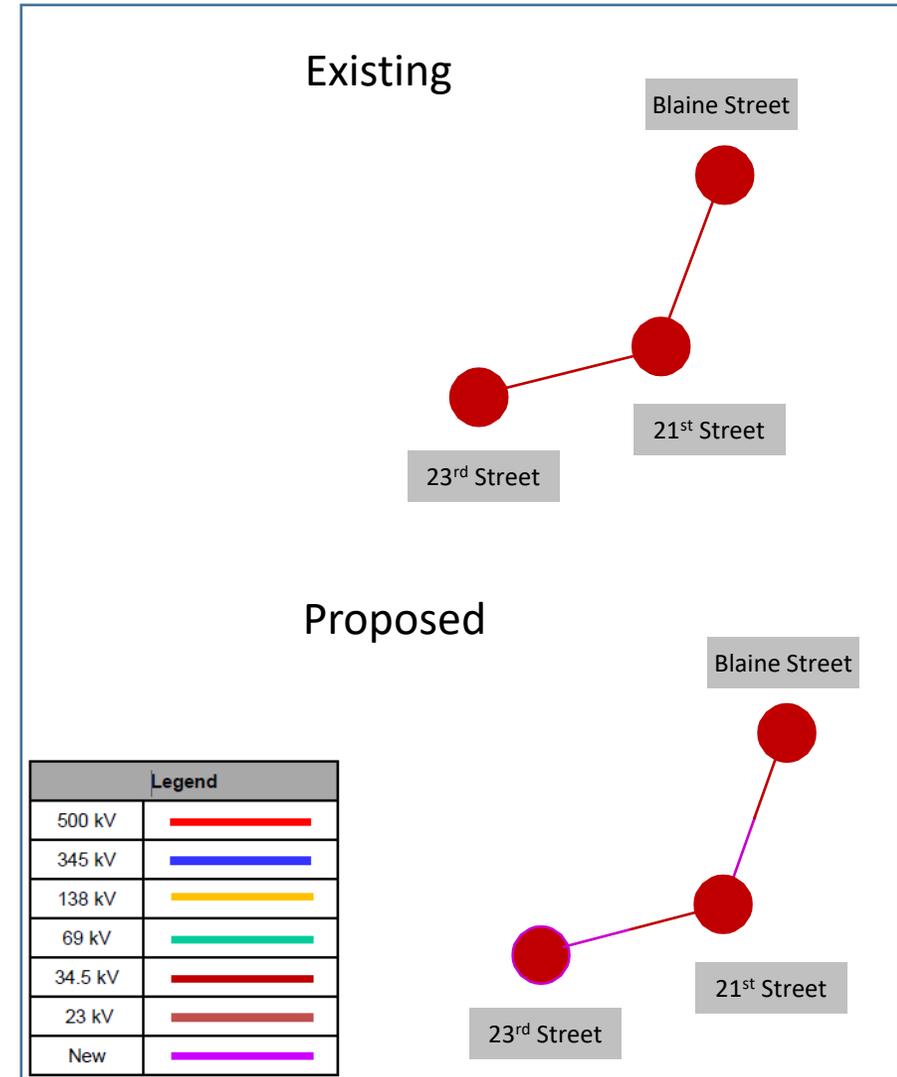
Replace the Twenty Third Street 138/34.5 kV transformer #1 and transformer #2 with two 138/69/34.5 kV 90 MVA transformers. The following cost includes install and removal.

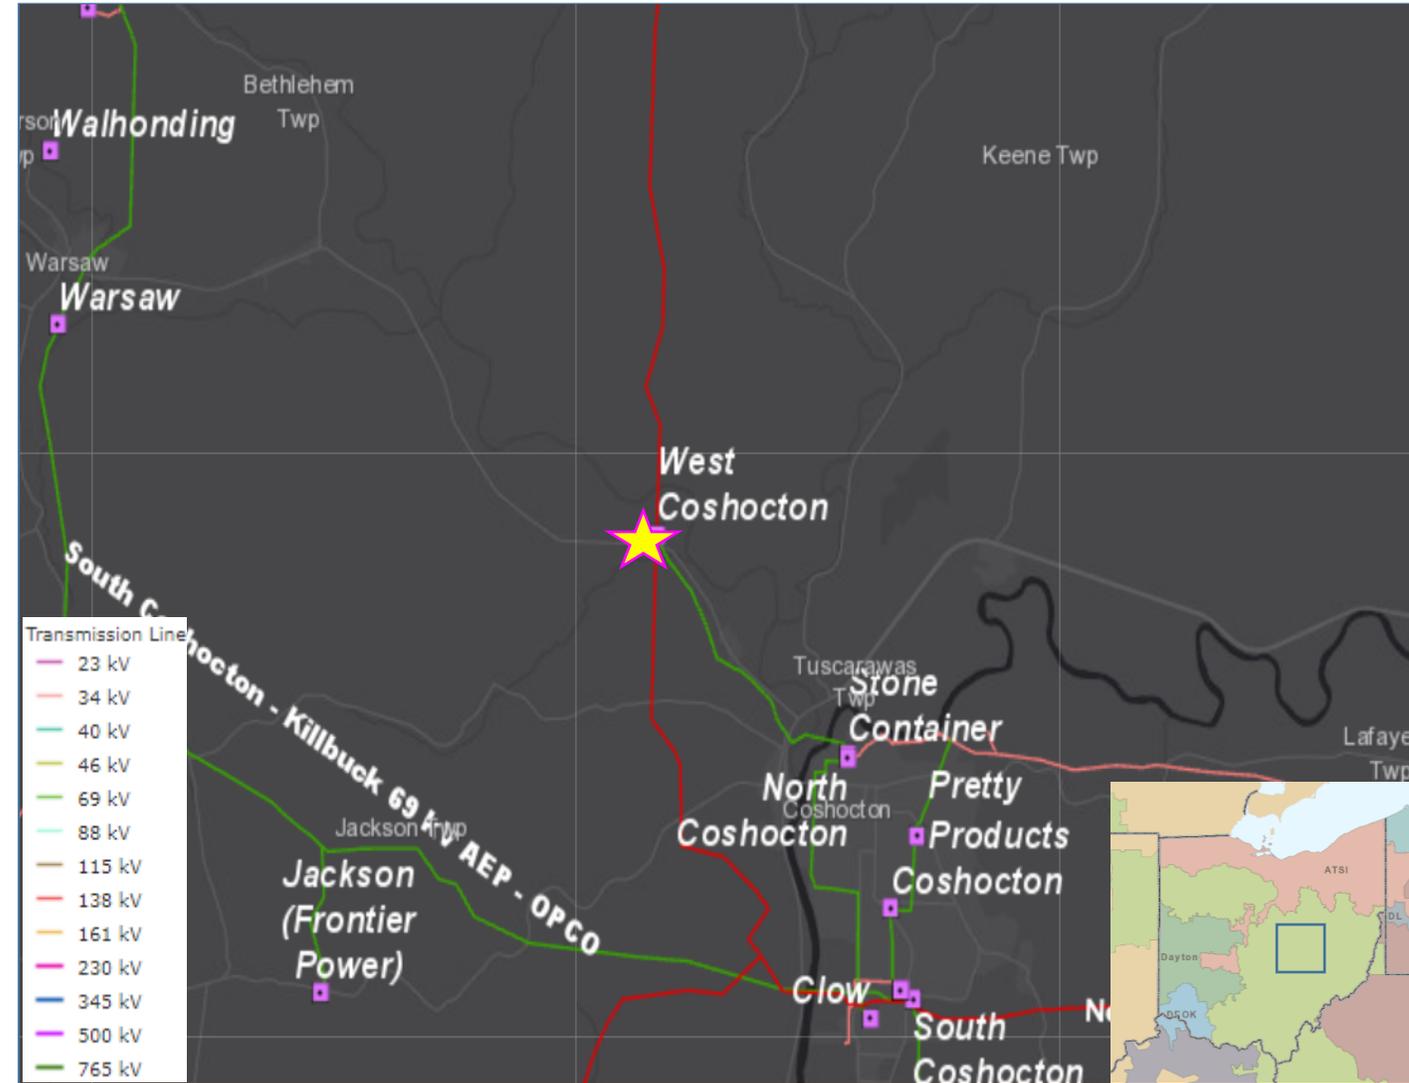
- Breaker Age: 1975
- Interrupting Medium: SF6
- Fault Operations: 40 (manufacturer recommended limit is 10)
- Additional: The 138 kV Mark III circuit switcher CS – 1A have limited spare part availability and are no longer vendor supported. These models have experienced 47 recorded malfunctions from July 2001 to August 2019. Failed operational components including high contact resistance, gas loss, and interrupter failure represent the majority of these malfunctions. The expected life span of bushing gaskets and door inspection ports on these units based on AEP experience is only 25 years. The current age of this remaining fleet indicates that the existing gaskets and door inspection ports are at risk for increasing gas loss over time.

- Transformer Age: 1966
- Additional: The tertiary bushing needs replaced. The cooling fans are open cage, which is not OSHA rated. Pumps are leaking and rusted. There is no oil containment. Asbestos has been found in the internal wiring. The oil needs drained, gaskets on the radiators and pumps need replaced, and flange valves need repacked as they are leaking

- Currently, 26 of the 27 relays (96% of all station relays) are in need of replacement. All 26 of these are of the electromechanical type which have significant limitations with regards to spare part availability and fault data collection and retention. In addition, these relays lack of vendor support.

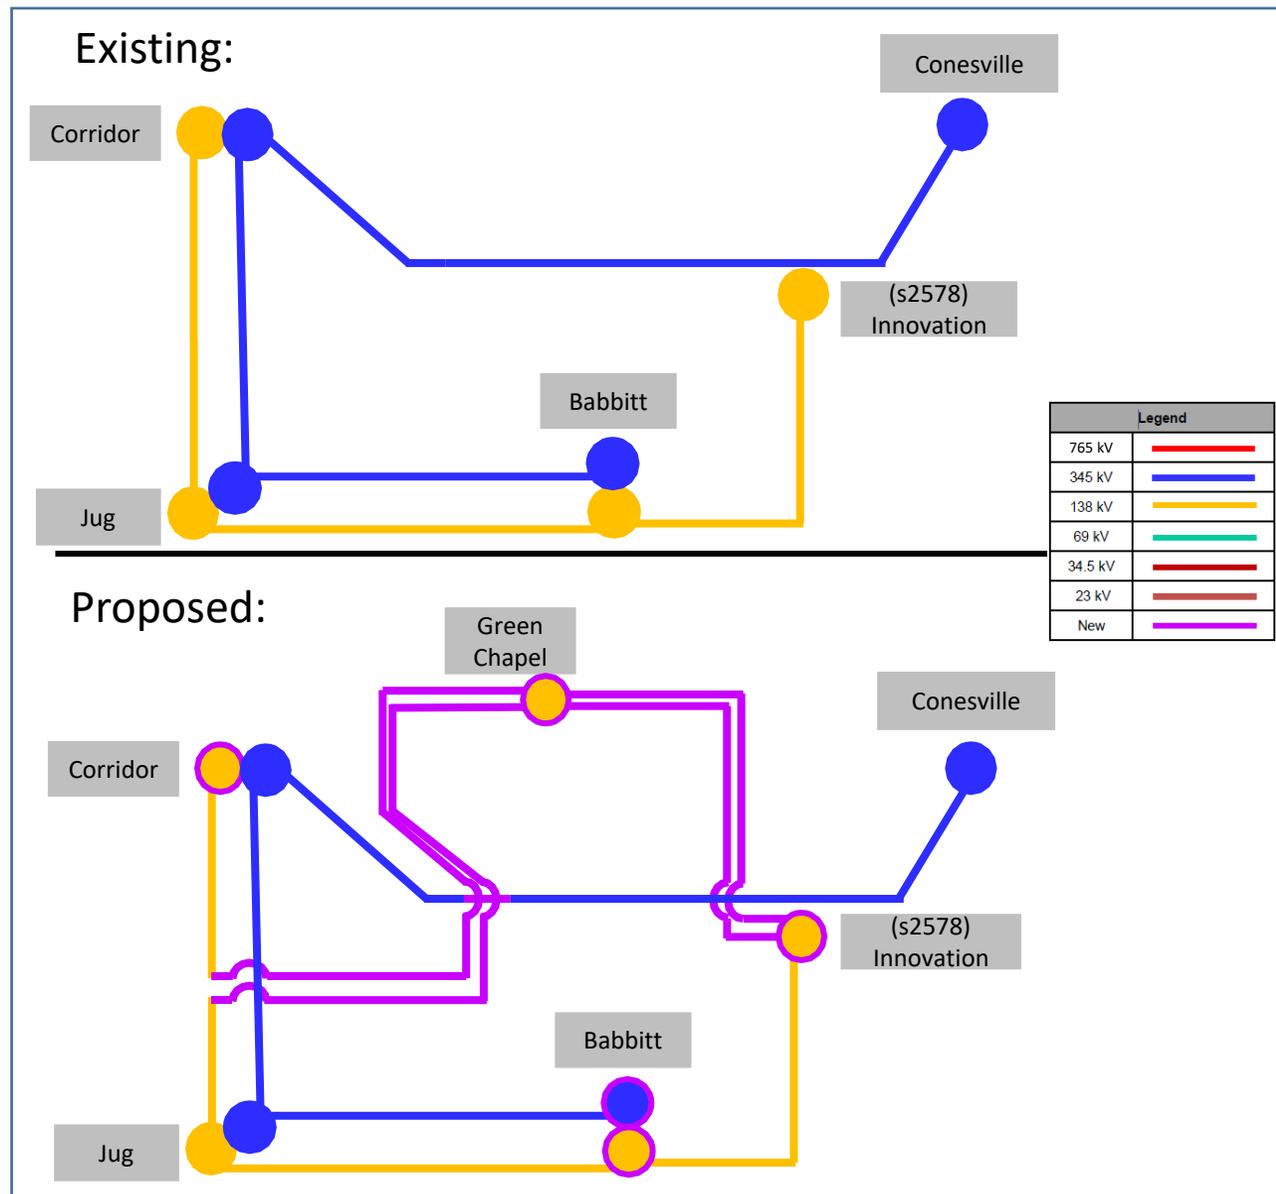
- **Jug – Corridor 138/345 kV:** Additional structures and dead ends will be required on the existing Jug – Corridor double circuit line to accommodate the extension eastward to Green Chapel as the 138 kV circuit is on the west side of the structures. **Estimate Cost: \$3.6 M (s2857.5)**

- **Conesville - Corridor 345kV:** Modify the existing 345kV line structures to enable appropriate height for the new line to Green Chapel Station. **Estimated Cost: \$1.97 M (s2857.6)**

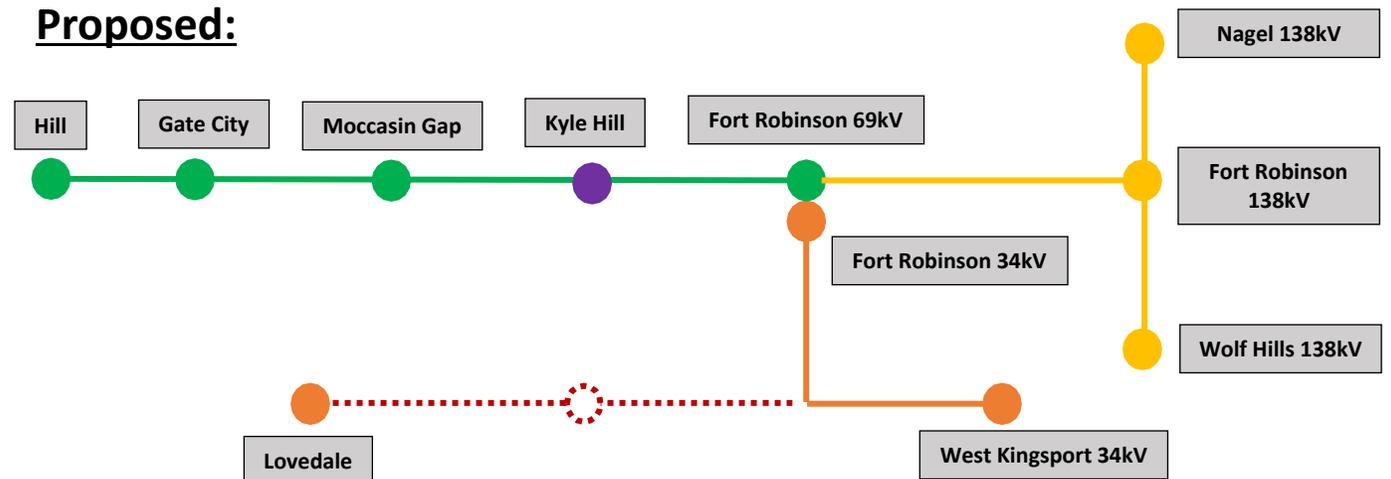
Proposed:

- Build a new Kyle Hill Station behind the existing station. Establish a 69KV in/out from Fort Robinson – Hill 69KV line. Install one (1) 1200A 69KV rated line MOAB switches towards Hill station. Install one (1) 1200A 69KV rated line switches towards Fort Robinson station. Replace Ground MOAB with a high-side circuit switcher. Replace existing 34.5/12KV transformer #1 with 69/12KV transformer. Install new 12KV bus. Reuse existing Kyle Hill 12kV Breakers. Install 16x19 DICM. **Estimated Trans. Cost: \$0 M (s2913.3)**

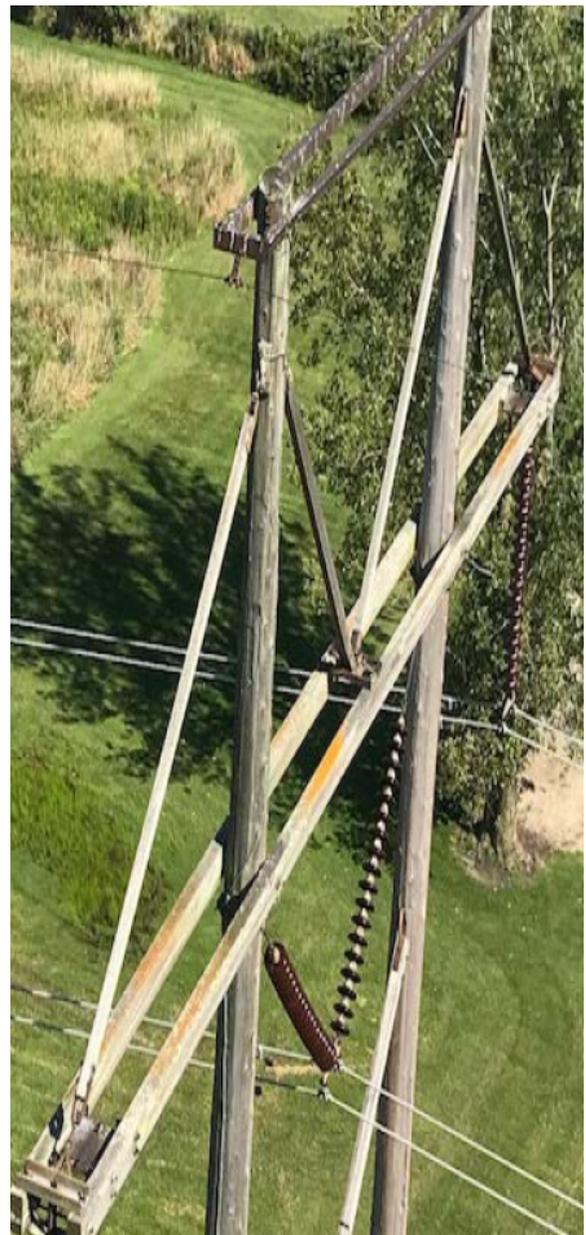
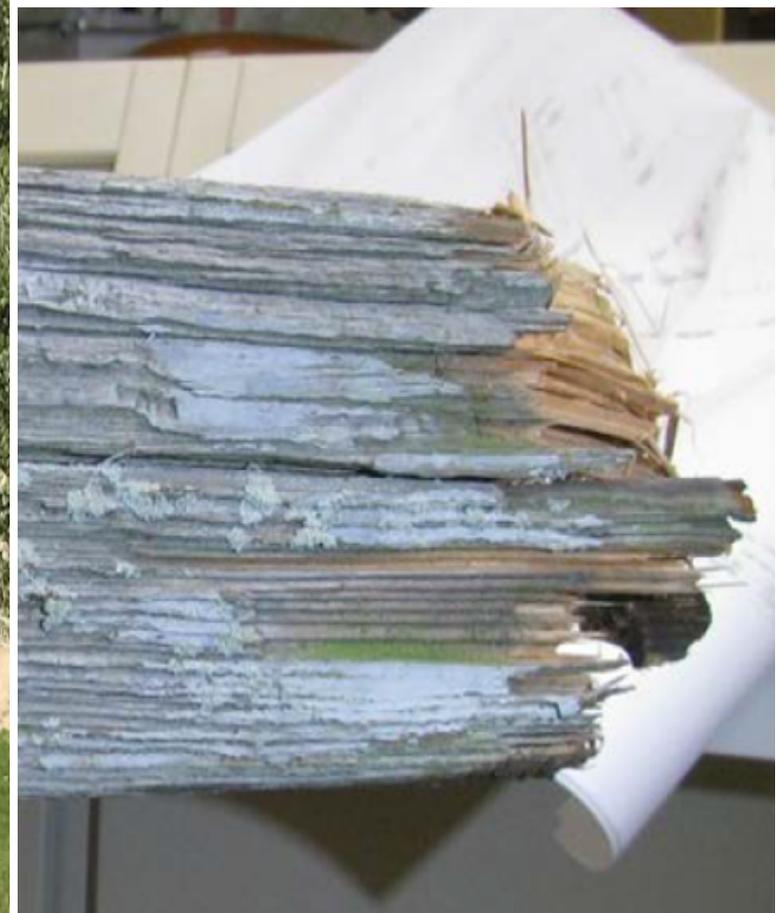
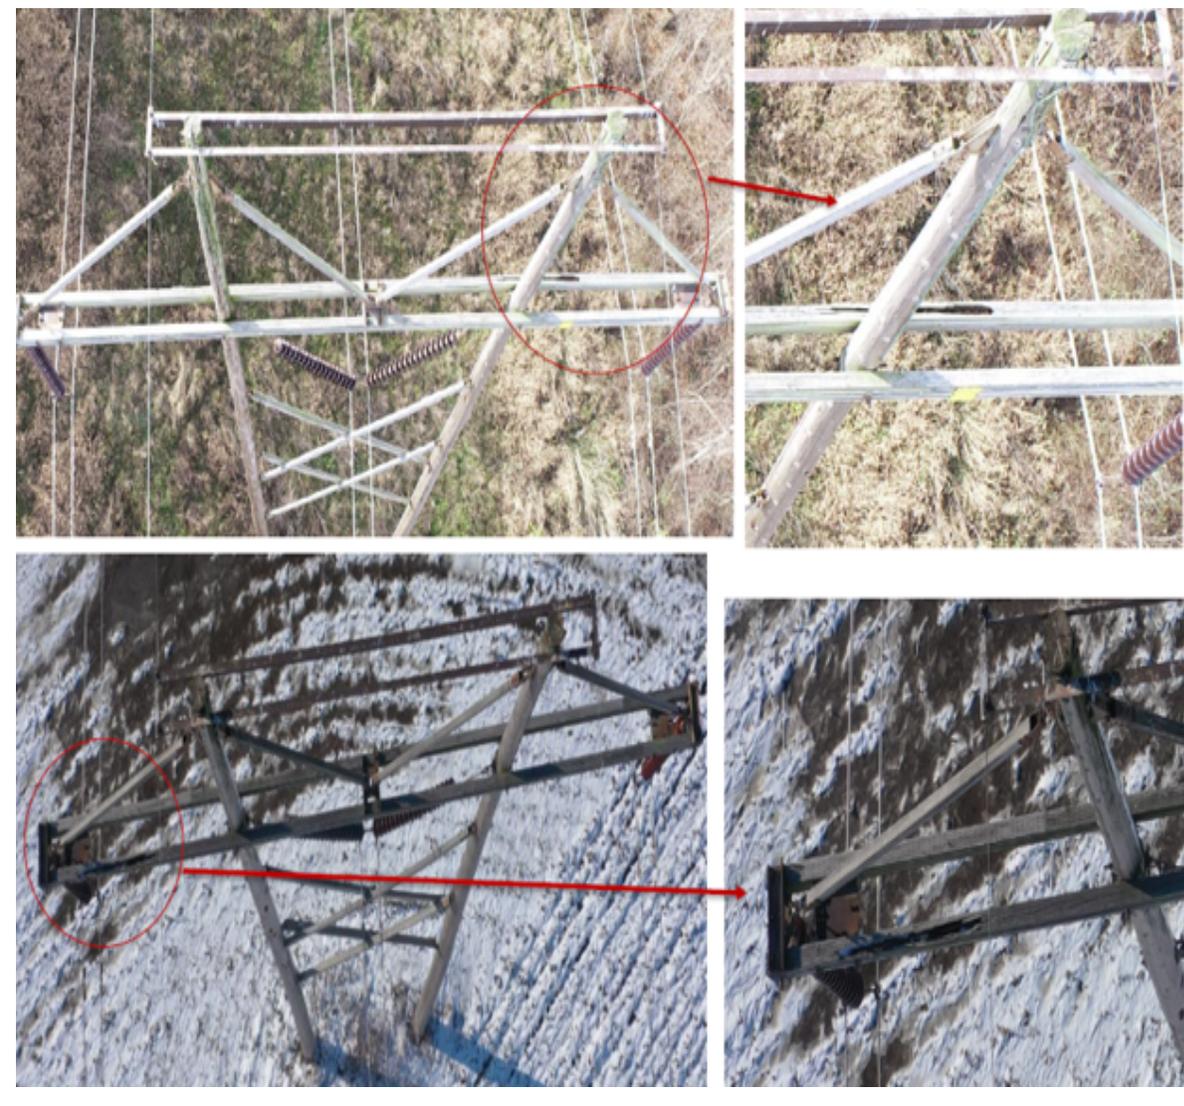
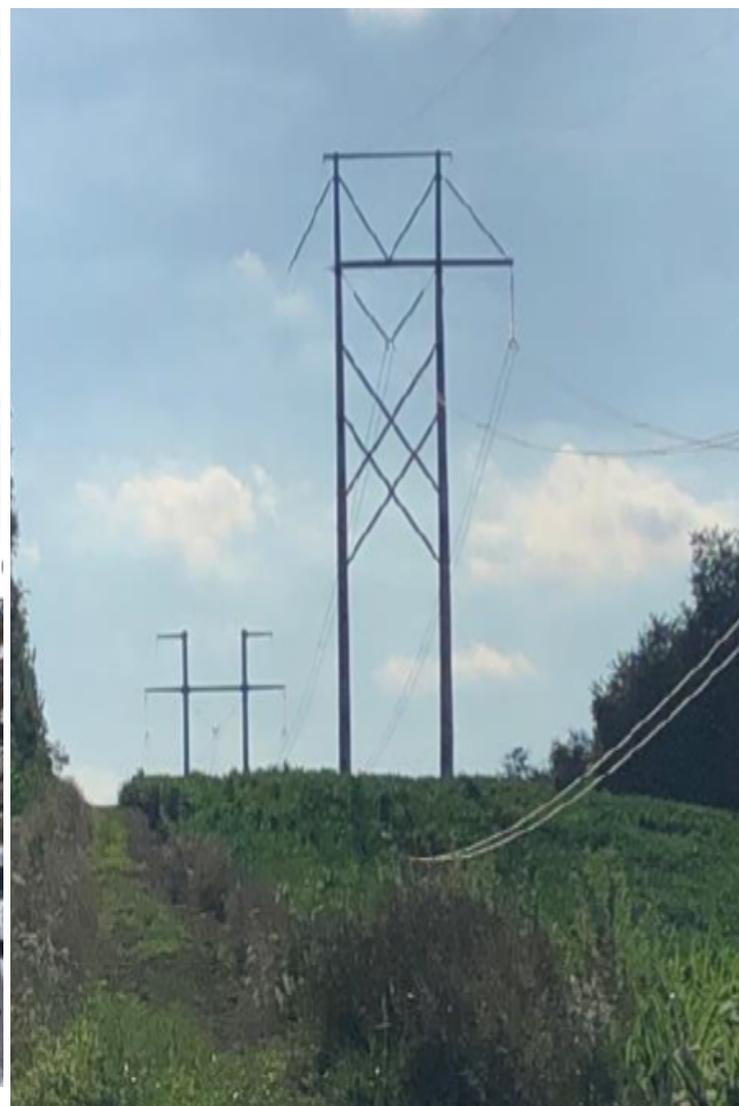
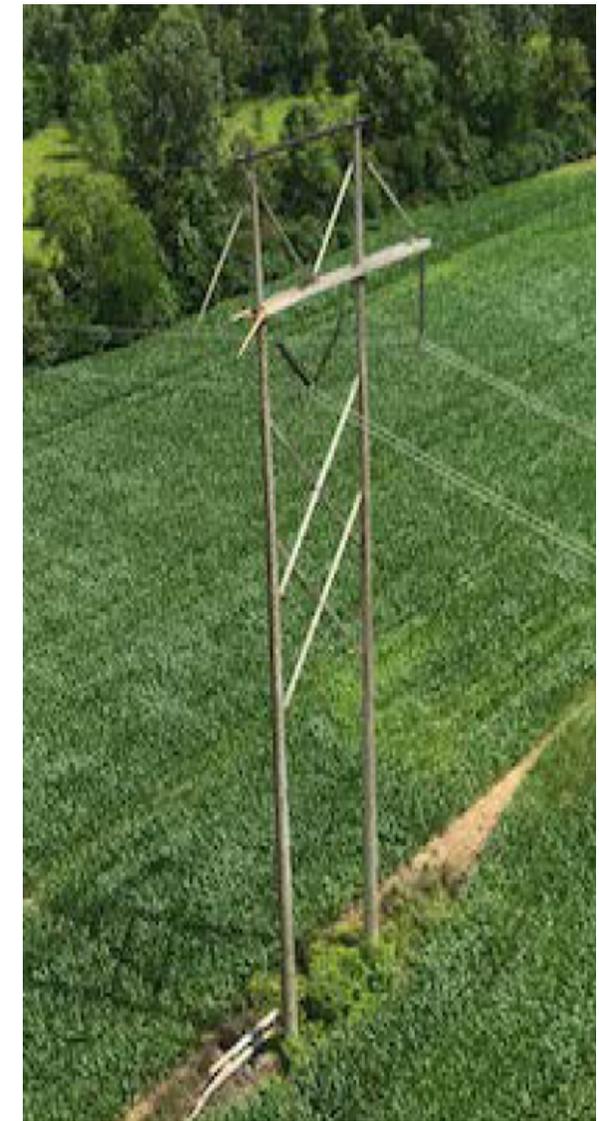
AEP Transmission Zone M-3 Process Conesville – Bixby 345 kV

When the 345 kV line was constructed in the 1970's, it was done so utilizing an H-frame design with wood poles that involved the use of laminated crossarms rather than solid wood crossarms. Recent inspections have revealed signs of noticeable deterioration of the laminated crossarms. The green decay and orange rot as shown in the pictures is irreversible wood decay on the laminated crossarms.

There are limited inspection techniques available to identify areas of concern in laminated crossarms before a loss in functionality occurs and causes a permanent outage. Various industry organizations have attempted to analyze the stages of crossarm decay with varying degrees of success. This is the last line left on AEP's eastern footprint with this type of crossarm design.

AEP's experience with these laminated cross arms is that over time, due to the decay and delamination issues associated with the crossarm design, along with limitations to determine loss of functionality, failures on the line have historically been catastrophic in nature.

There are currently 30 structure based open conditions consisting of rot heart, rot shell, broken knee/vee brace, heavy rust, broken/burnt/damaged poles, leaning transverse poles sitting in water, and woodpecker damage. There are additional concerns over delamination of crossarms on the line as detailed in the next slides.

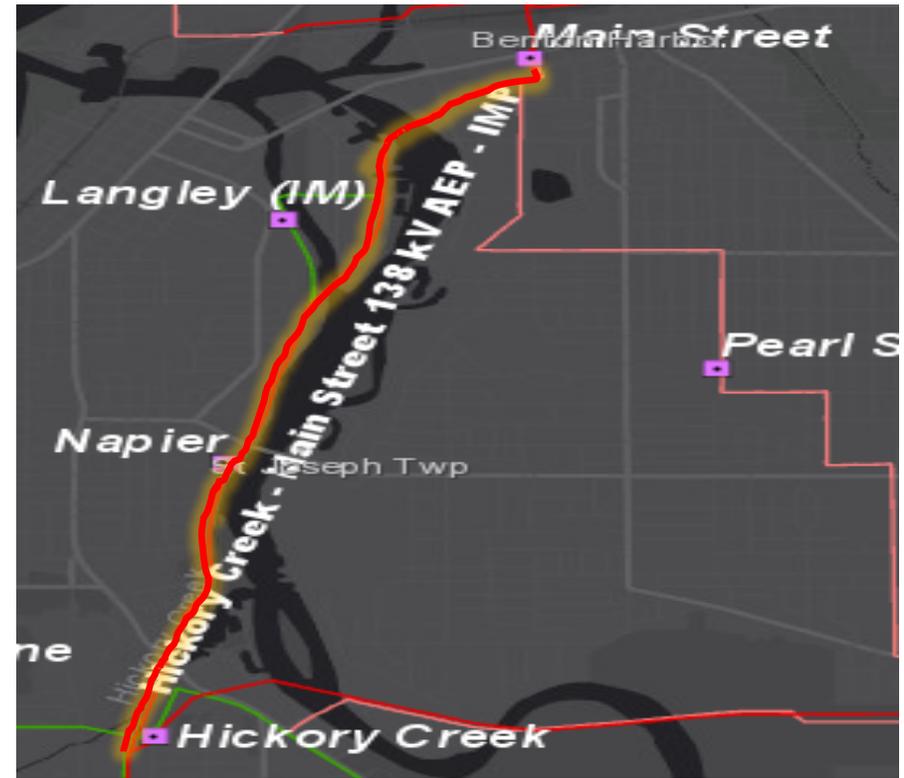
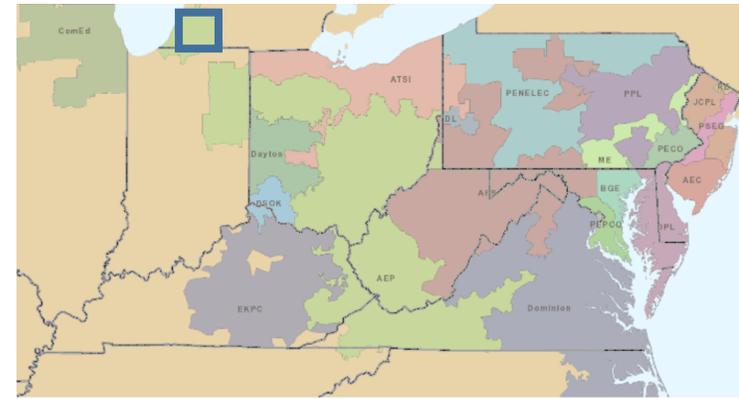
- Structures fail NESC Grade B and AEP Strength requirements. Grounding methods utilize butt wraps on every other structure, which is inadequate for current AEP standards

- 40 representative structures were assessed by ground and drone
 - 50% have ground line heart and/or shell rot
 - High percentage of wood poles have woodpecker damage and moderate to advanced wood decay from insect and bird damage

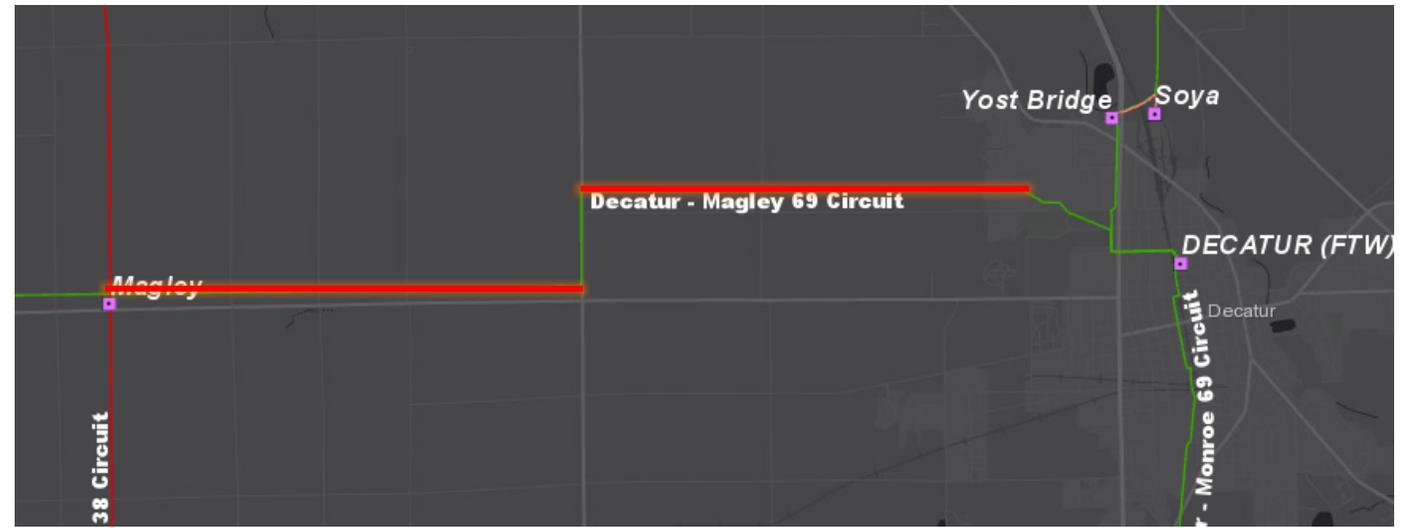
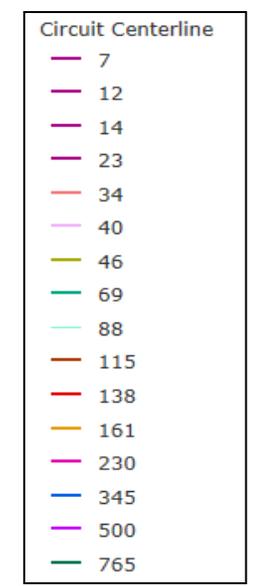
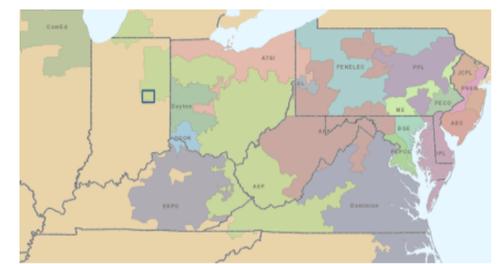
- H Frame structures had moderate shell damage with some heavy checking.
 - Wood structures on this line are subject to high number of woodpecker and insect damage.

- Multiple instances of decay, pole split, rot top, crossarm split, pole cavity, brace splitting and flashed/split insulator.
 - Structures fail NESC Grade B, ASCE structural strength requirements, AEP grounding standards, AEP structural strength requirements and the H Frame portions fail AEP shielding angle standards.

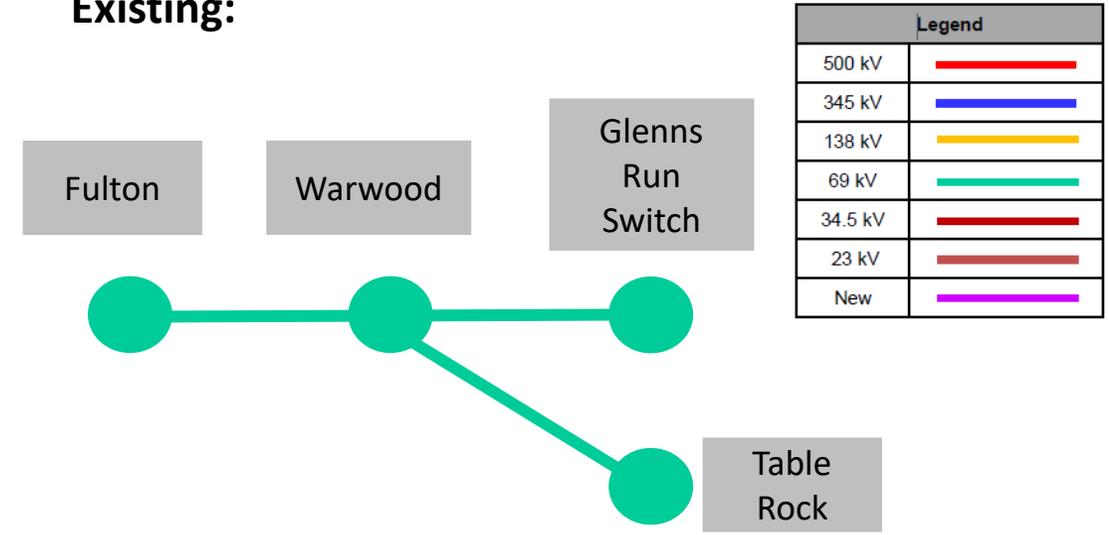
Existing:

AEP Transmission Zone M-3 Process Warwood Station Upgrade

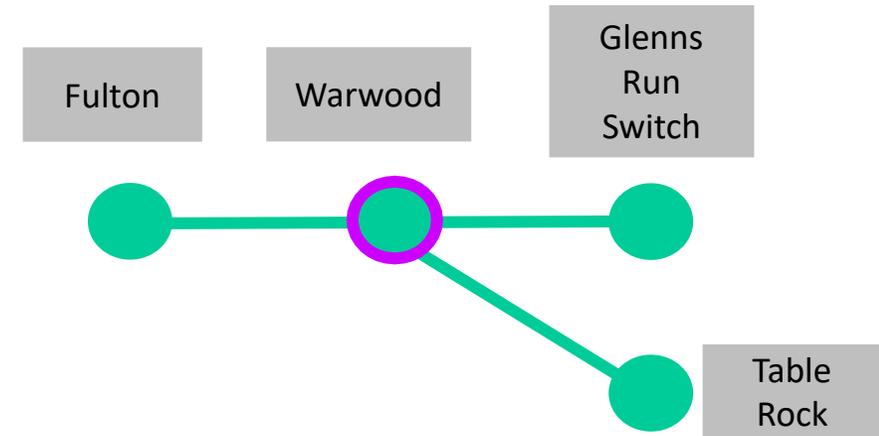
Proposed:

Replace the 3- 69kV oil circuit breakers with new SF6 gas breakers. Replace the electromechanical 69kV line relays and bus differential relays with microprocessor-based relays. (s2944)

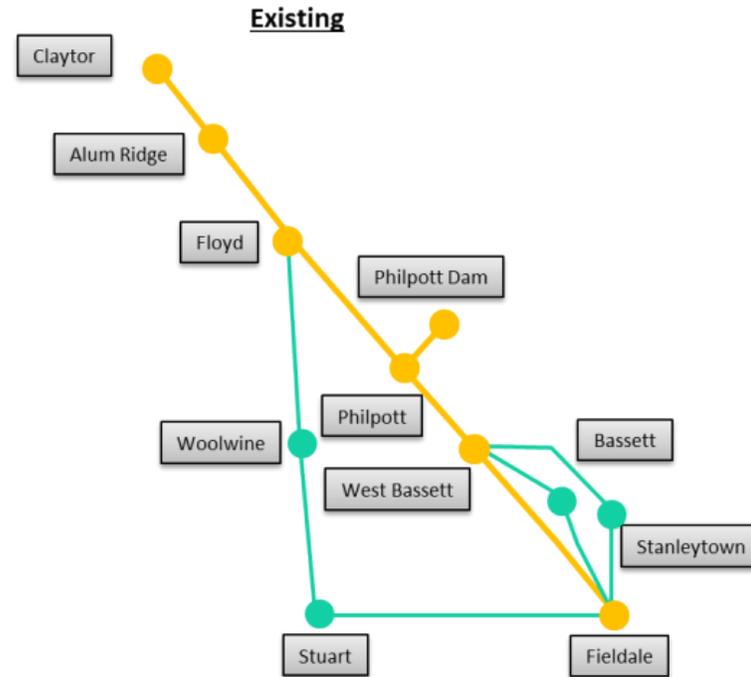
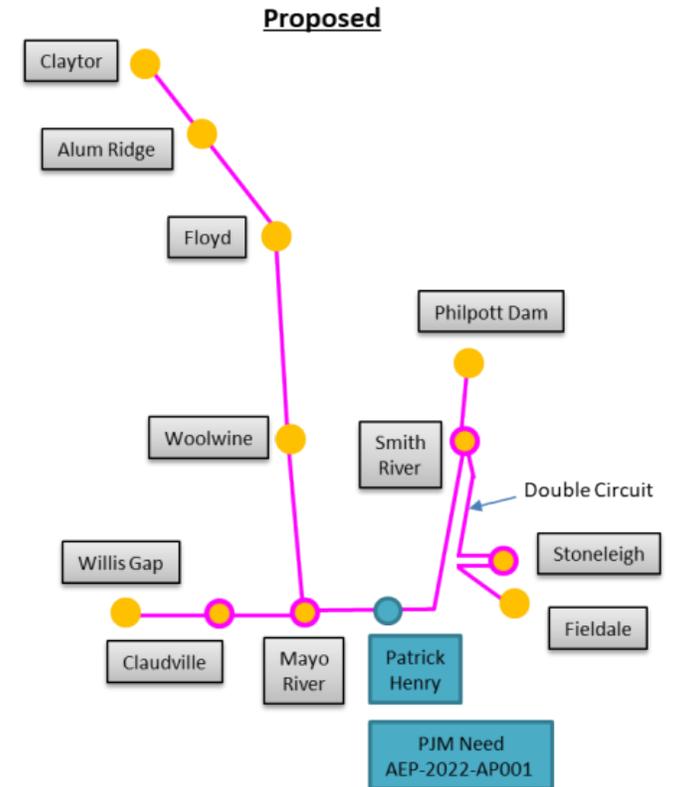
- As the Stuart Area Improvements Project has moved through functional and detailed scoping, updates to the scope of work have been made, although the electrical solution has remained the same. The lack of availability of new station property has impacted some of the scope of work. The replacement and conversion of the existing Stanleytown and Bassett substations has evolved into combining the substations into a new Stoneleigh station that will serve the former Stanleytown distribution load and Bassett distribution load will be served from the new Smith River substation. In addition, the former Salem Highway station has been renamed to Mayo River and the former Fairystone station has been renamed to Smith River.
