Submission of Supplemental Projects for Inclusion in the Local Plan

AMPT Projects in ATSI/AEP Transmission Zone M3 Process Brewster, OH

Need Number: AMPT-2021-006

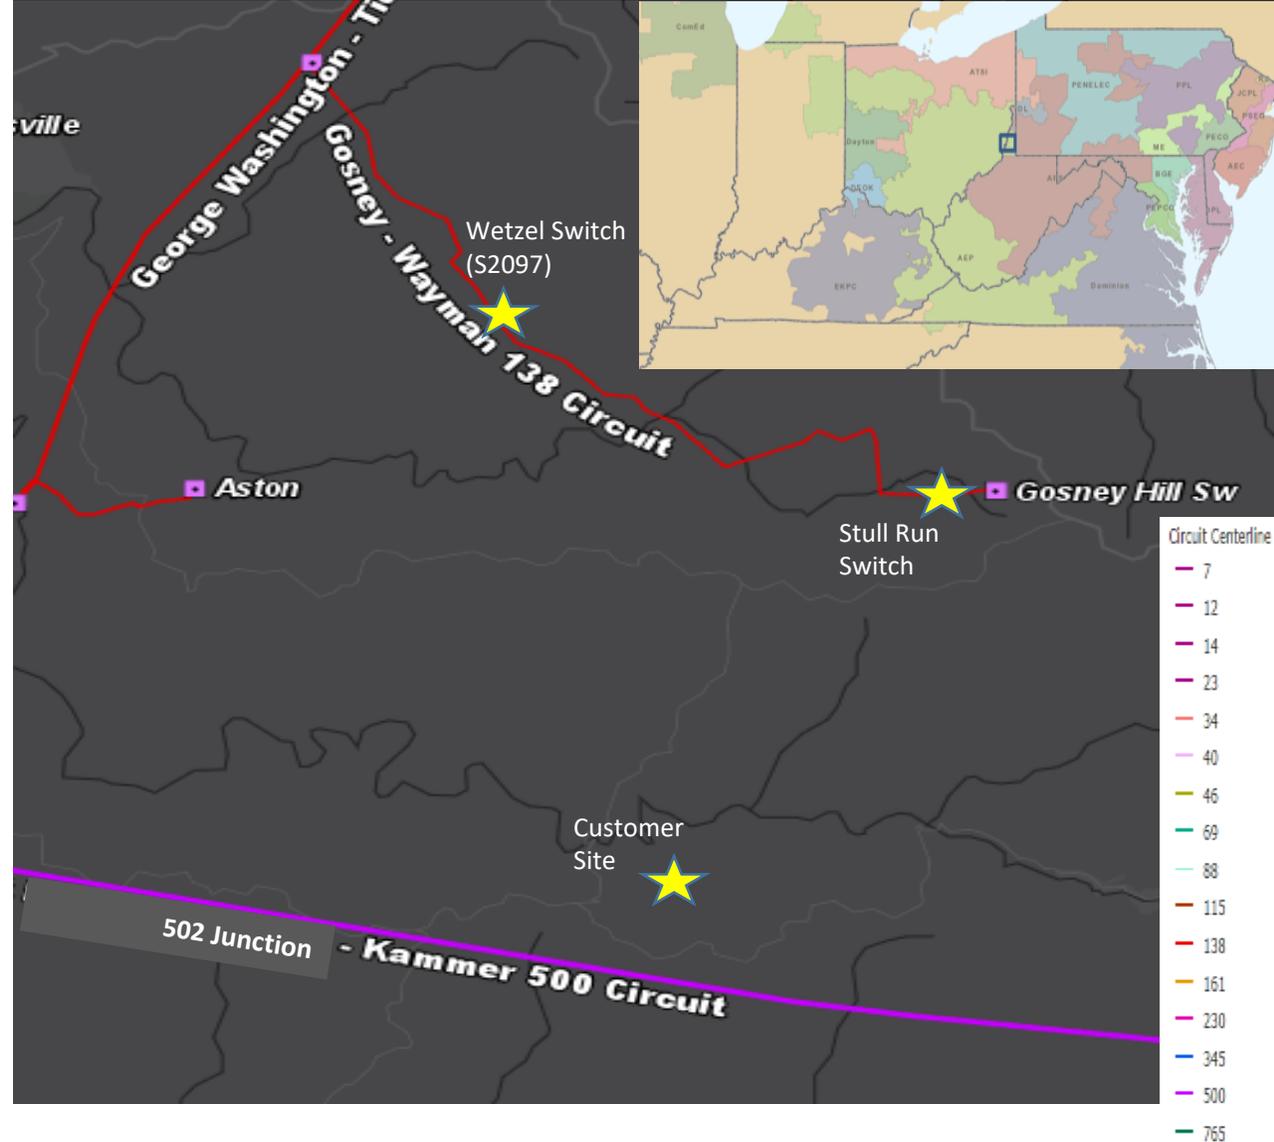
~~Construct a new 500-138kV station (Panhandle), connecting to the Kammer 502 Junction 500kV circuit (~10.3 miles from Kammer, 31.7 miles from 502 Junction). Install a 3-breaker 500kV ring bus; 450 MVA 500-138kV transformer; 3-breaker 138kV ring bus. **Estimated Cost: \$25.0 M (s2270.1)**~~

At Gosney Hill, install a new 138kV breaker toward Nauvoo Ridge. Update station protection. Replace the 795 kcmil AAC risers and strain bus with 2000 kcmil AAC risers. **Estimated Cost: \$1.3 M \$1.0 M (s2270.3)**

The reason for the scope change: After further site exploration and preliminary engineering for the Panhandle 500-138kV station, the cost estimates increased significantly, due to the large amount of civil grading scope required, in this very hilly area of West Virginia. The total station cost estimate rose to \$105.5 million for a traditional, open-air design. AEP also evaluated a hybrid GIS station design, which used GIS for the 500kV portion of the station; this cost estimate was \$95.0 million. In addition, the cost estimate to modify the 500kV transmission line increased to over \$4 million. Overall, Panhandle was no longer a cost-effective system upgrade, so alternatives were studied.

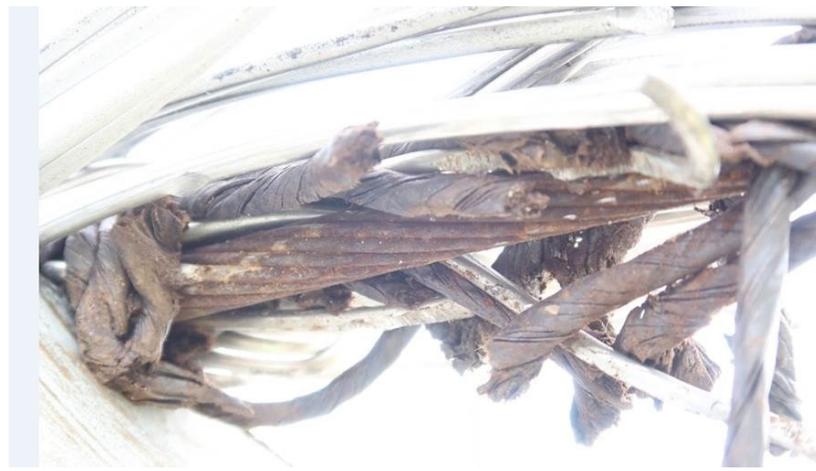
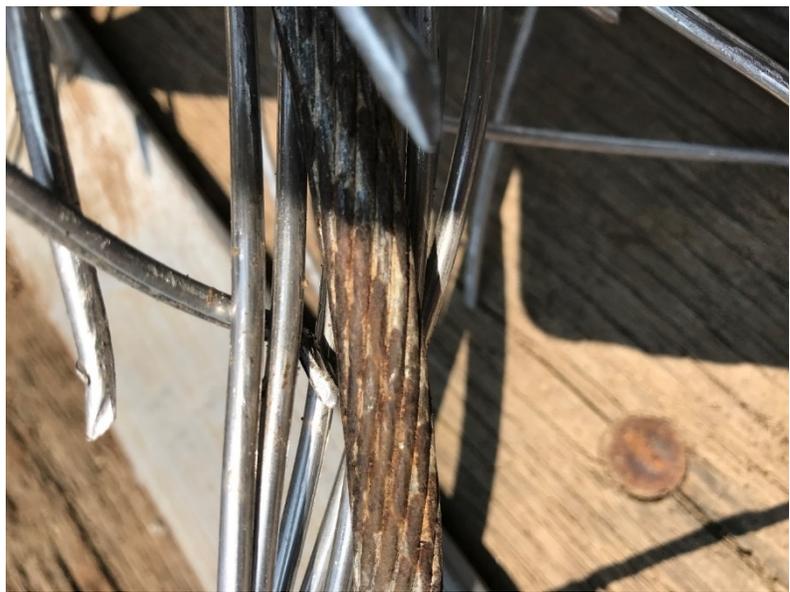
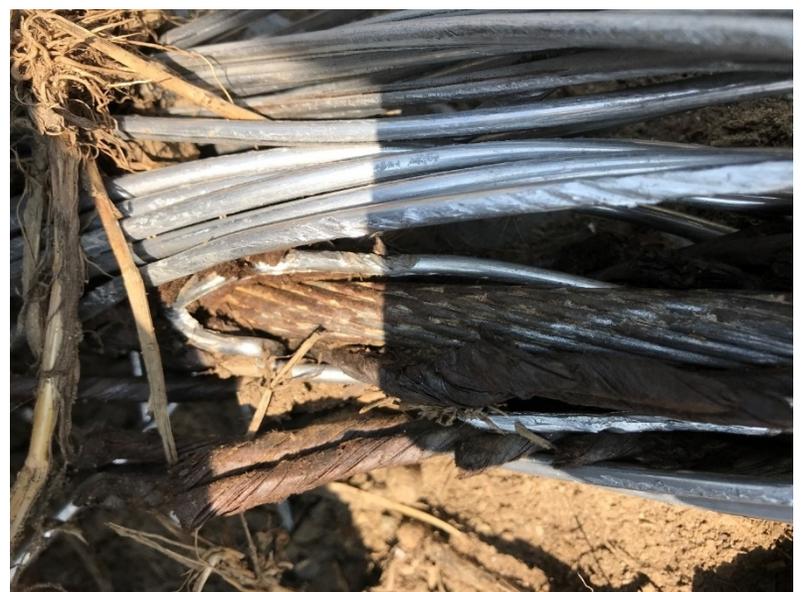
Paper Expanded conductor samples were observed following the 2019 Memorial Day Tornadoes in the Indiana and Michigan footprint. Corrosion of the cores can be seen in the pictures below.
