Subregional RTEP Committee – Mid-Atlantic FirstEnergy Supplemental Projects

April 18, 2024

Need Number: JCPL-2024-012

JCPL Transmission Zone M-3 Process EH Werner – Freneau – Keyport 34.5 kV E31 Line

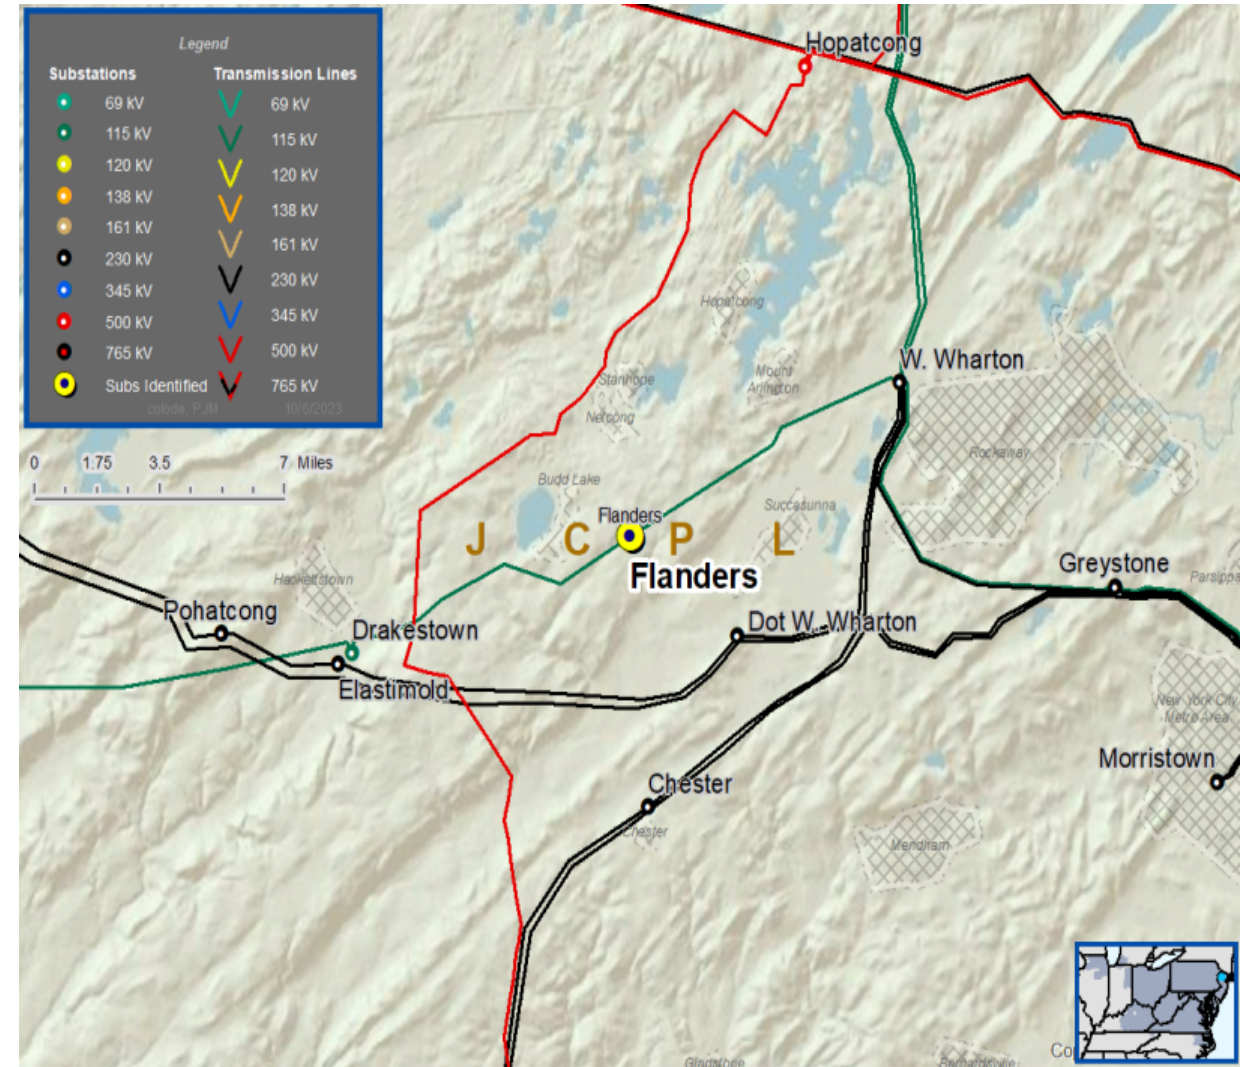
Need Number: JCPL-2023-039

- The 115-34.5 kV No. 1 Transformer at Flanders Substation is approximately 50 years old and is approaching end of life. Recent analysis shows combustible hot metal gasses have developed.
- Existing Transformer Ratings:
 - 76 / 80 / 96 / 97 MVA (SN/SSTE/WN/WSTE)

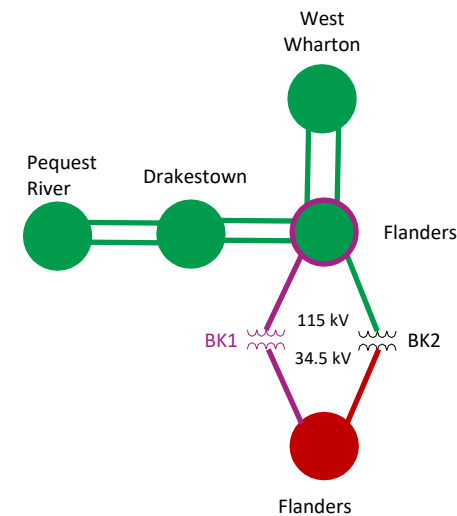
Need Number: JCPL-2023-039

- Replace the 115-34.5 kV No. 1 Transformer at Flanders Substation.
- Replace the 115 kV circuit switcher with a circuit breaker.
- Upgrade the transformer relaying.
- Install new control enclosure.

- Flanders 115-34.5 kV No. 1 Transformer:
 - Before Proposed solution: 76 / 80 / 96 / 97 MVA (SN/SSTE/WN/WSTE)
 - After Proposed Solution: 161 / 161 / 175 / 175 MVA (SN/SSTE/WN/WSTE)

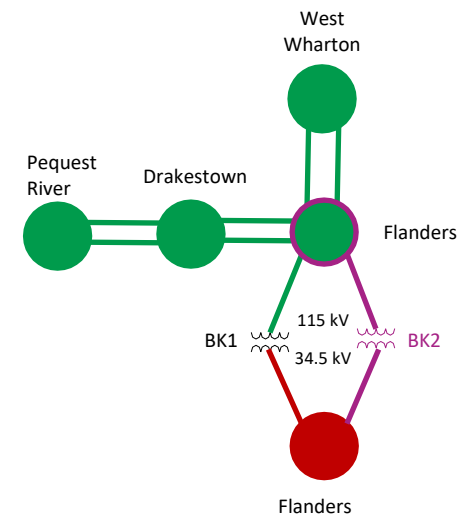
Need Number: JCPL-2023-057

- Replace the 115-34.5 kV No. 2 Transformer at Flanders Substation.
- Replace the 115 kV circuit switcher with a circuit breaker.
- Upgrade the transformer relaying.

- Flanders 115-34.5 kV No. 2 Transformer:
 - Before Proposed solution: 61 / 66 / 81 / 85 MVA (SN/SSTE/WN/WSTE)
 - After Proposed Solution: 161 / 161 / 175 / 175 MVA (SN/SSTE/WN/WSTE)

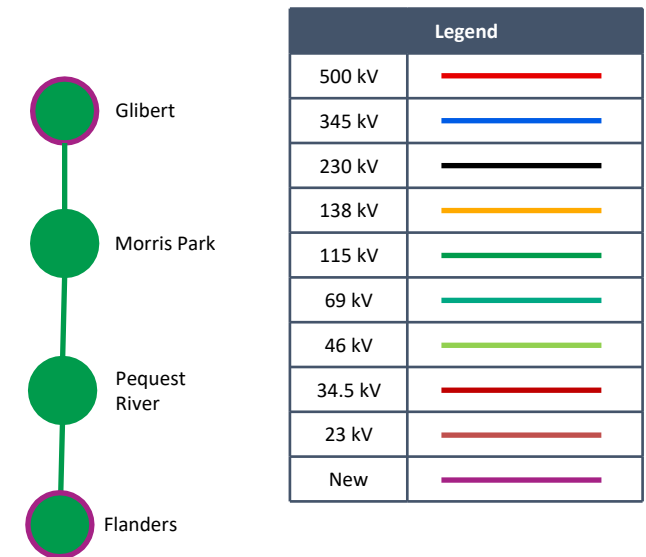
Need Number: JCPL-2024-007

- Replace relaying and limiting substation conductor at Gilbert Substation.
- Replace circuit breakers and disconnect switches at Flanders Substation.

- Gilbert – Morris Park 115 kV S919 Line
 - Before Proposed Solution: 118 / 152 / 168 / 189 MVA (SN/SE/WN/WE)
 - After Proposed Solution: 184 / 223 / 208 / 264 MVA (SN/SE/WN/WE)

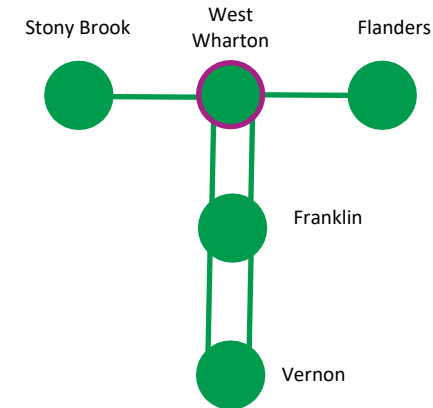
- Install a new control building at West Wharton Substation to provide adequate space needed for relay panel upgrades.
- Replace relaying and limiting substation conductor at West Wharton Substation.
