# Sub Regional RTEP Committee PJM West

March 27, 2018

## Baseline Reliability and Supplemental Projects

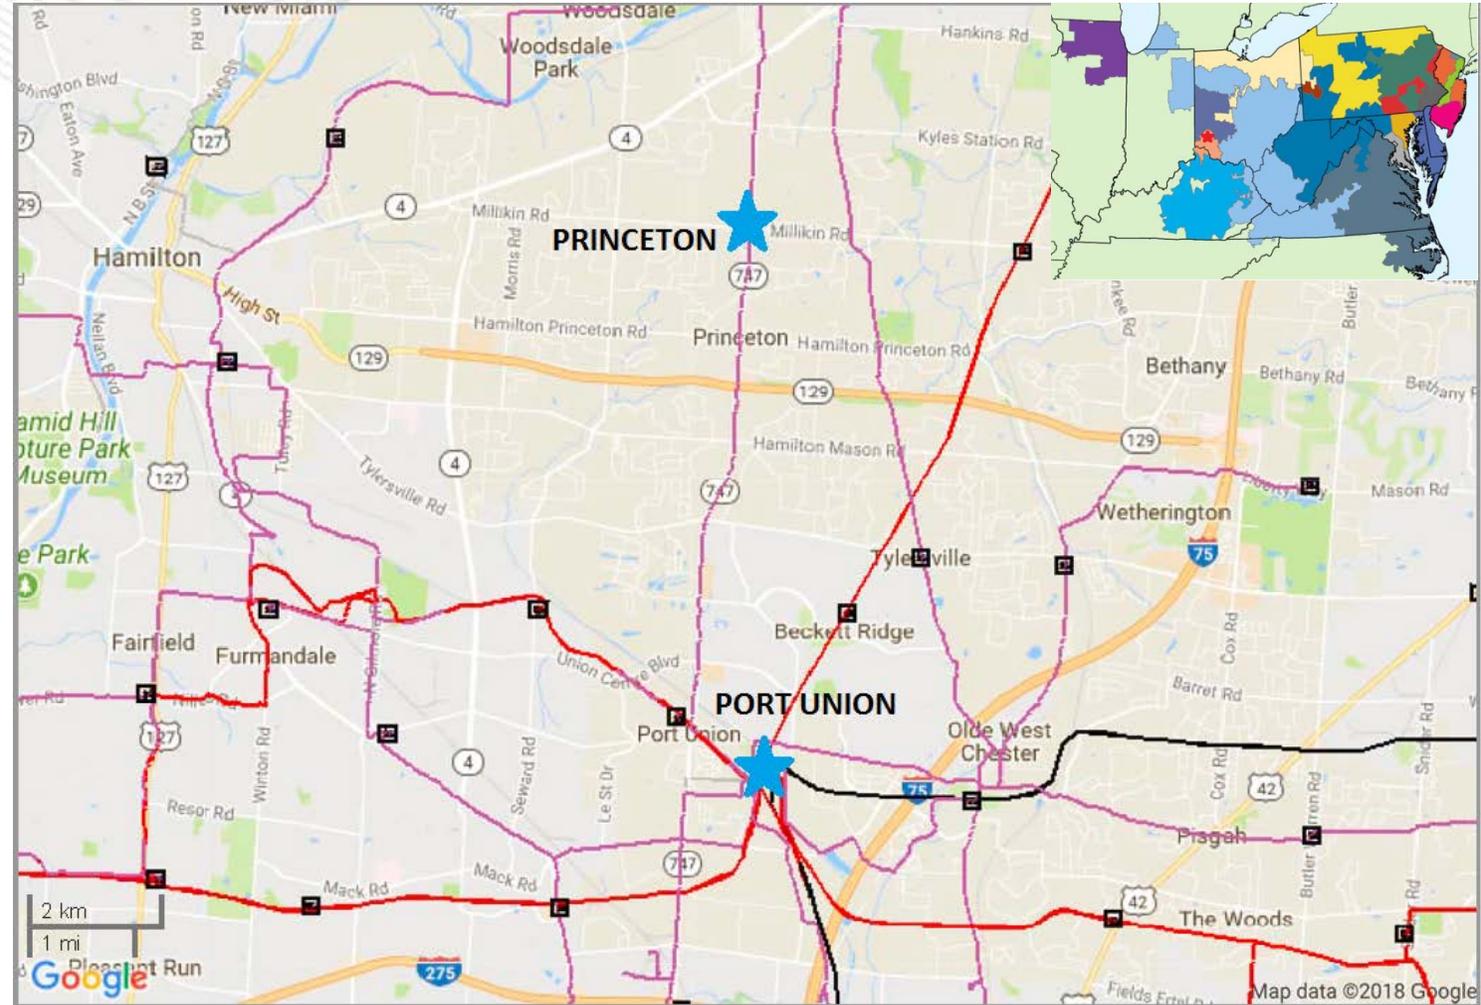
Rebuild 5.8 miles of feeder between Princeton and Port Union substations with 161 new structures, hardware, and conductor. Capacity of the line will increase from 99 MVA to 121 MVA (terminal eq. limited).

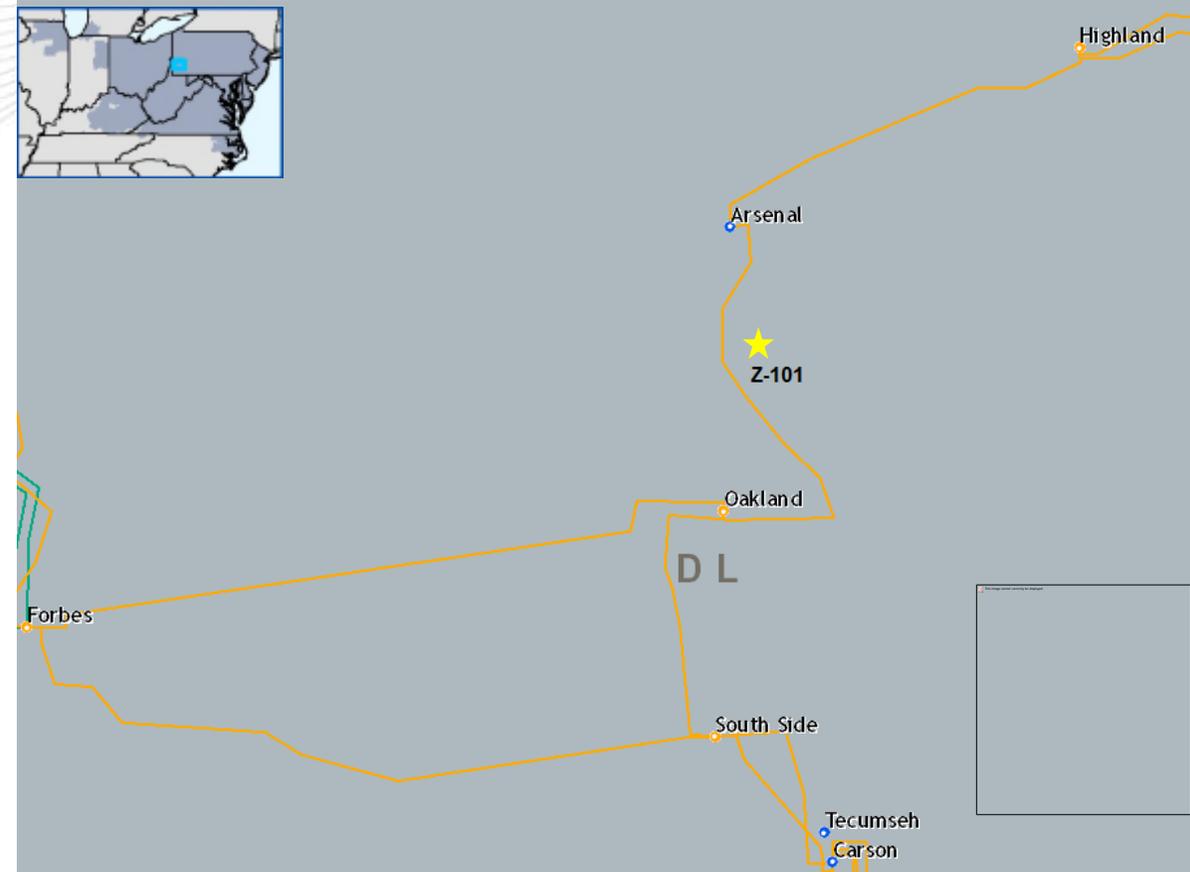
Establish a new 138-23kV substation (Panther Hollow) utilizing the existing Arsenal-Oakland (Z-101) 138kV circuit as a looped transmission source.

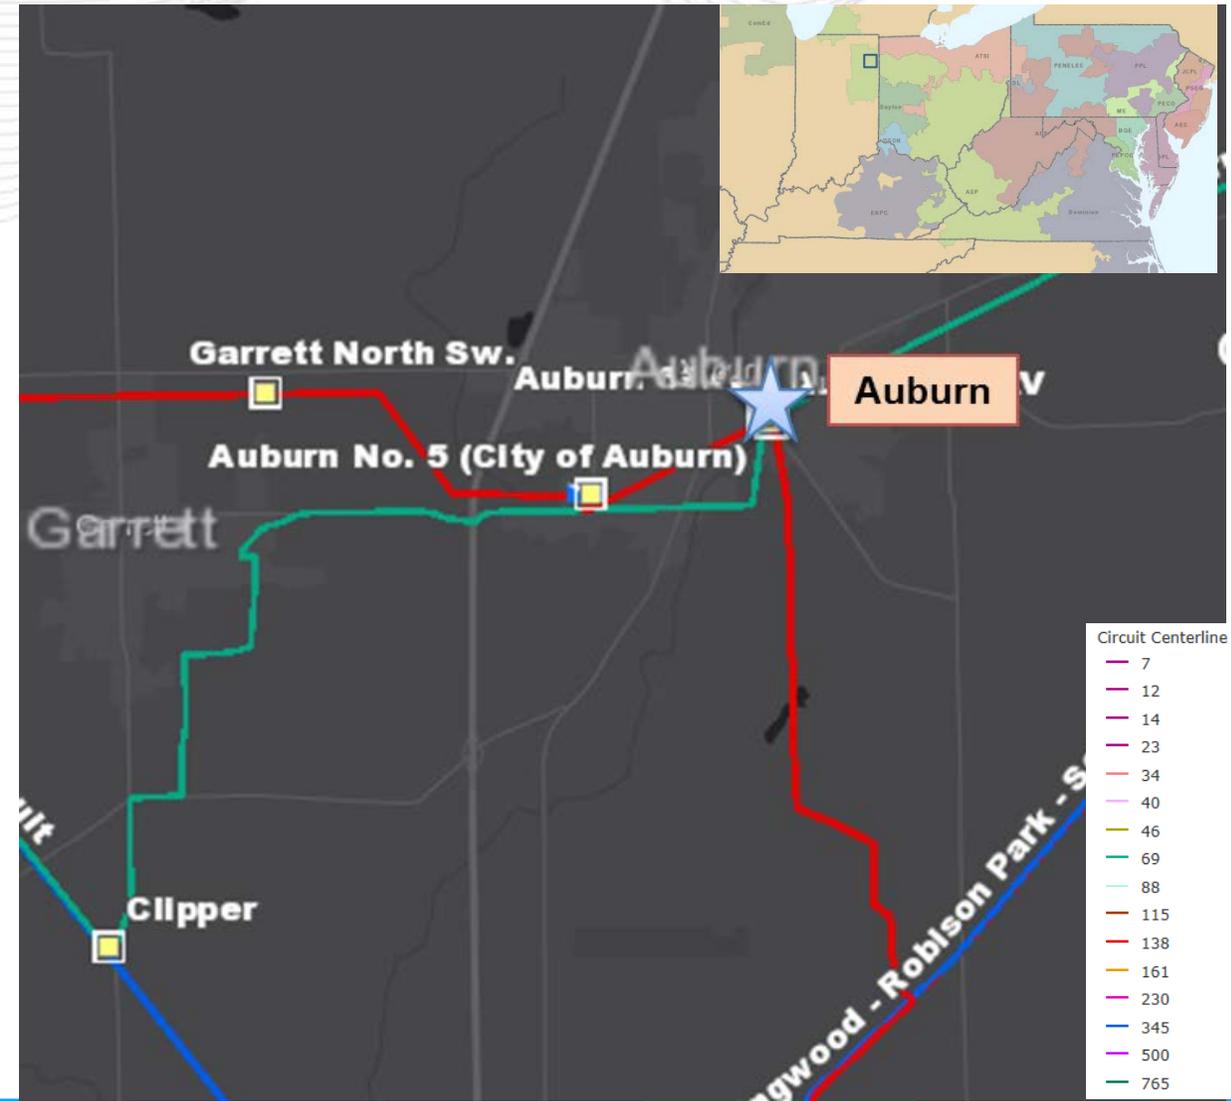
At Auburn station, replace 69 kV breakers "A" and "D" with 40 kA, 3000 A, 69 kV circuit breakers.

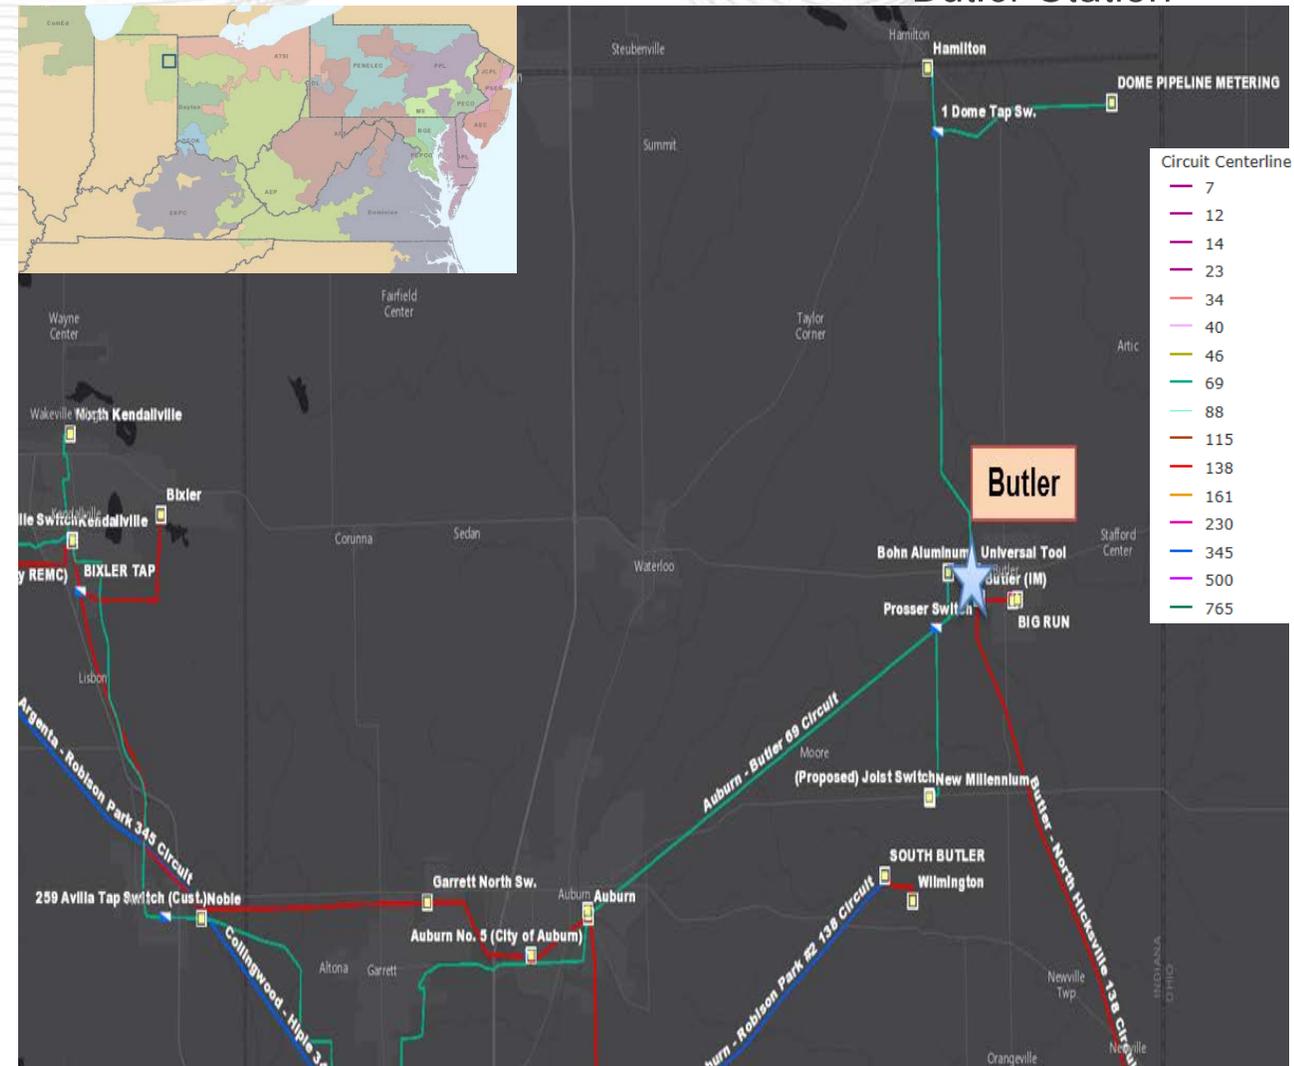
At Butler station, replace 69 kV breaker "A", replace 69 kV MOABs "X" and "Y" with 69 kV breakers, replace 69 kV cap switchers "AA" and "BB" (S&C Mark V) with 3000 A, 40 kA circuit breakers.

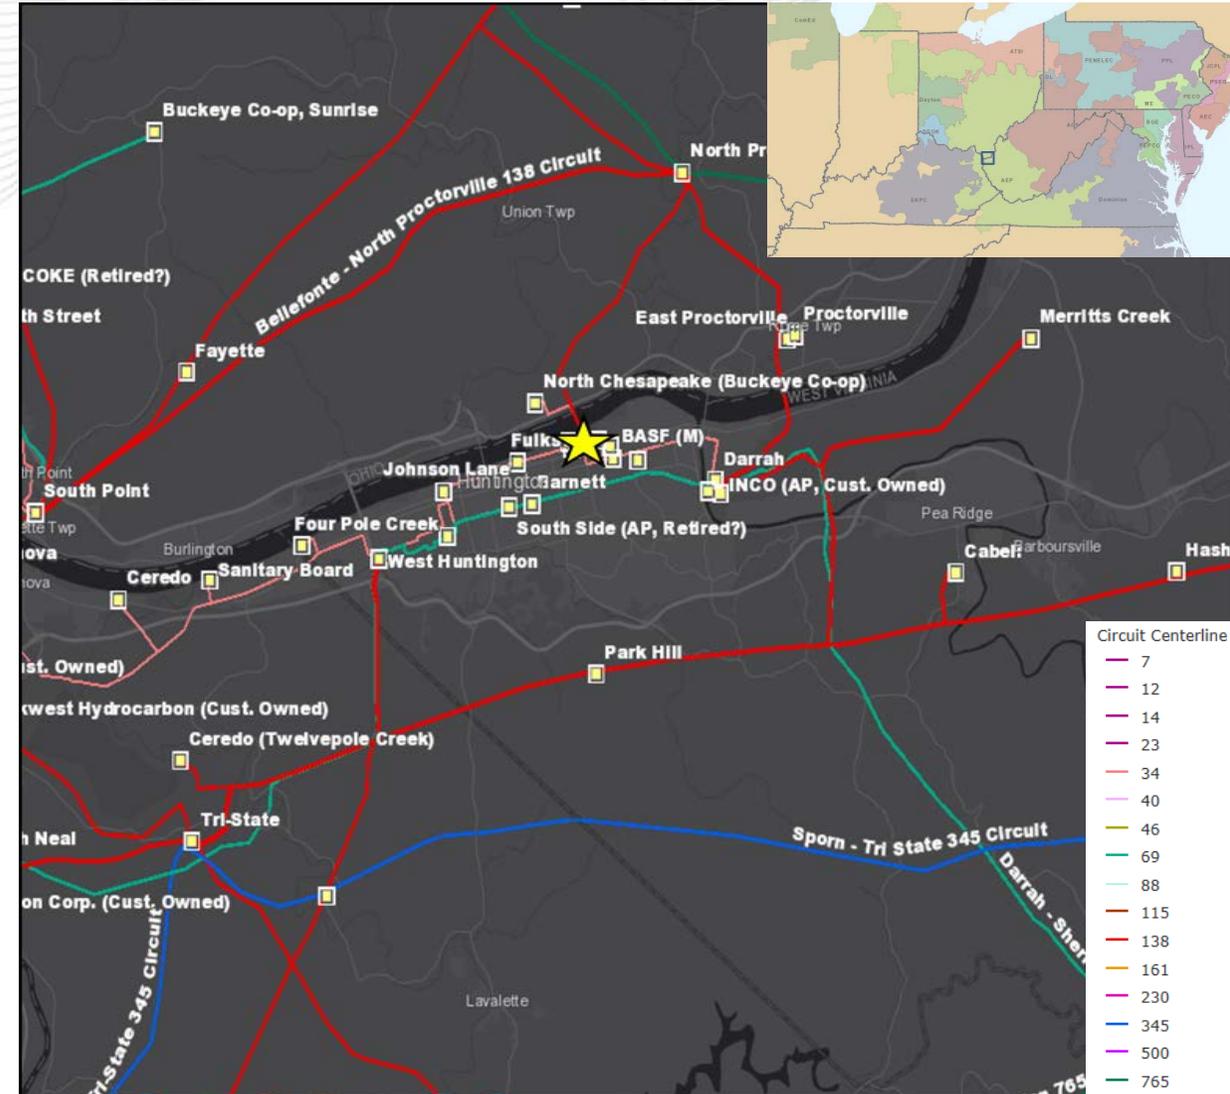
At East Huntington station, replace 34.5 kV circuit breakers "A", "D", "E", "H", and "I" at East Huntington with new 3000 A 40 kA 34.5 kV circuit breakers. 3000 A 40 kA 138 kV circuit switchers will be added to the high side of East Huntington transformers #1 and #4 to replace the existing Ground Switch MOAB's. A new 3000A 40 kA 138 kV circuit breaker will be installed to split the existing single 138 kV bus. A fuse will be added to the high side of the 34/12 kV transformer #2.

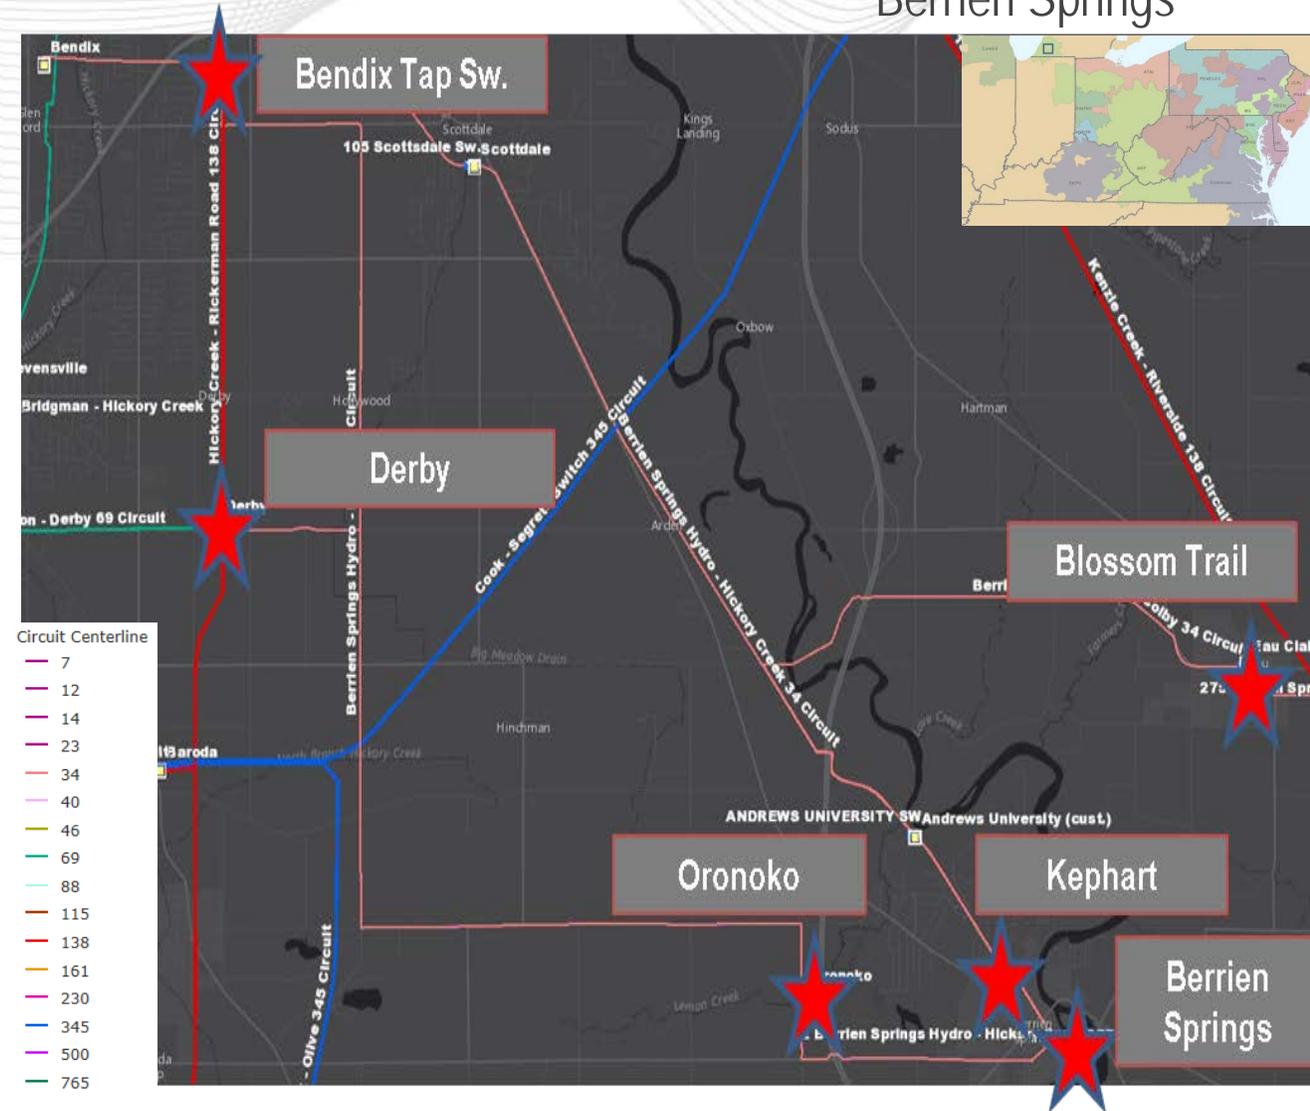
Derby - Bendix: Relocate line exits and eliminate the need for underground 69/34kV lines at Derby. Replace Bendix Tap Sw. Pole. **Estimated Cost: \$2.5M**

At Berrien Springs, retire existing 34.5kV yard, concrete platform and associated transmission equipment. Install (2) 69kV CBs and replace 69kV CB "H" on the primary side of T1. **Estimated Cost: \$2.5M**

Replace Bendix tap switch with 1200A 69kV phase over phase switch. **Estimated Cost: \$0.6M**

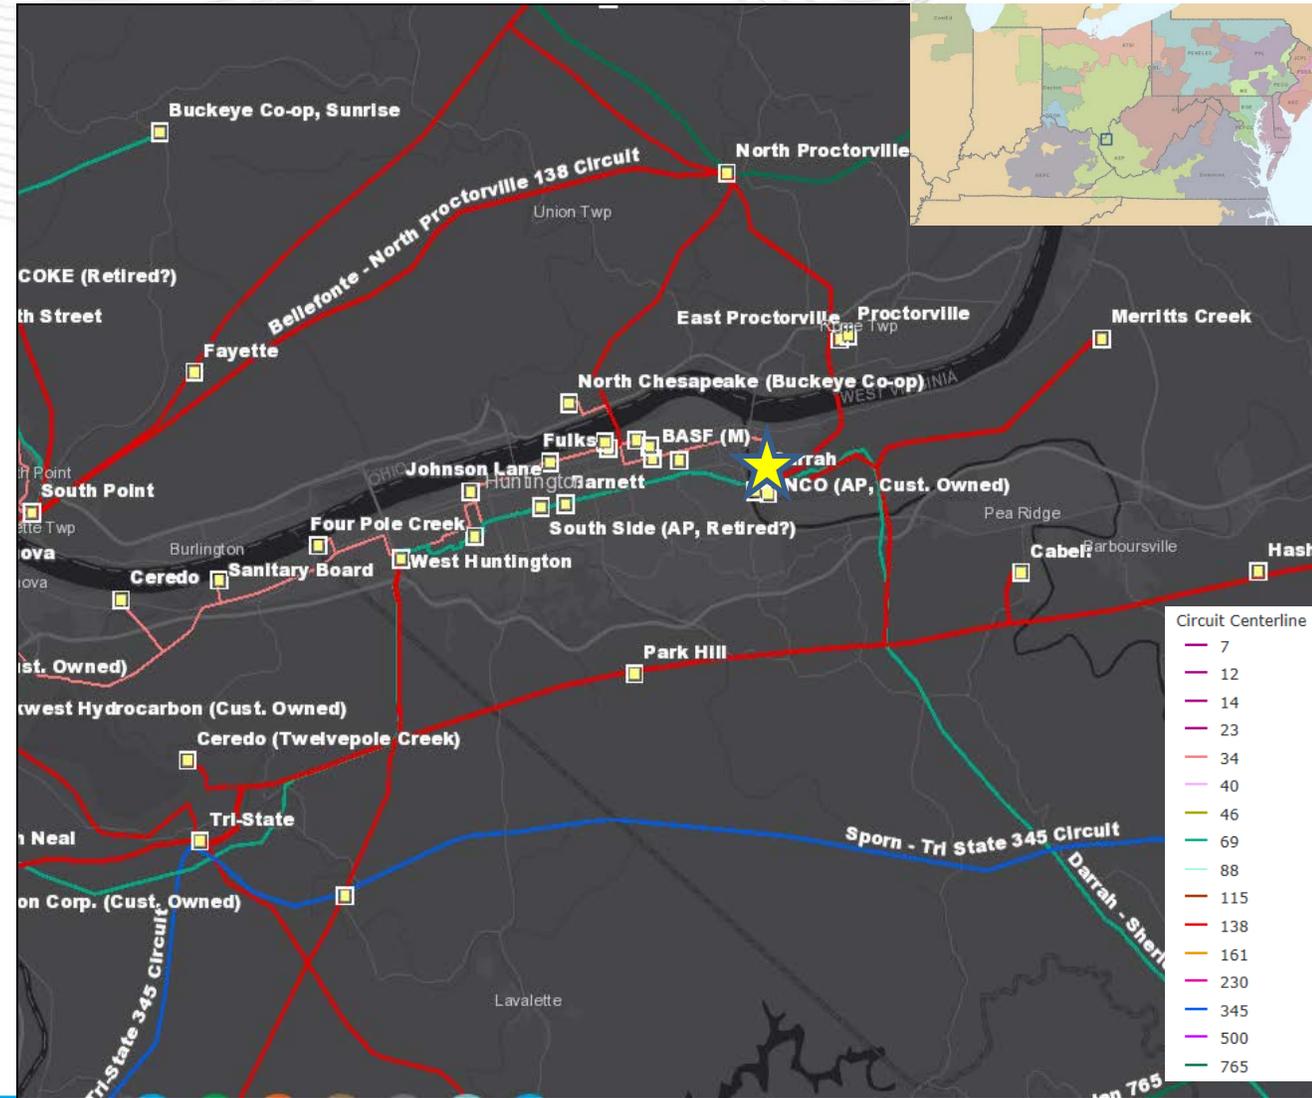
At Darrah station, replace the existing 1600 A 42 kA 138 kV circuit breaker "T" with a new 3000 A 40 kA 138 kV circuit breaker. Replace the existing 1200 A 17 kA 34.5 kV circuit breakers "C", "D", "F", and "I" with new 3000 A 40 kA 34.5 kV. Replace the existing 1800 A 27 kA 34.5 kV circuit breakers "J", "G", and "N" with new 3000 A 40 kA 34.5 kV circuit breakers. 138 kV circuit switchers will be added to the high side of Darrah transformers #1, #2, #3, and #4. The existing 45 MVA 138/34.5 kV transformer #1 will be replaced by 138/69/34.5 kV transformer with a 50 MVA tertiary.

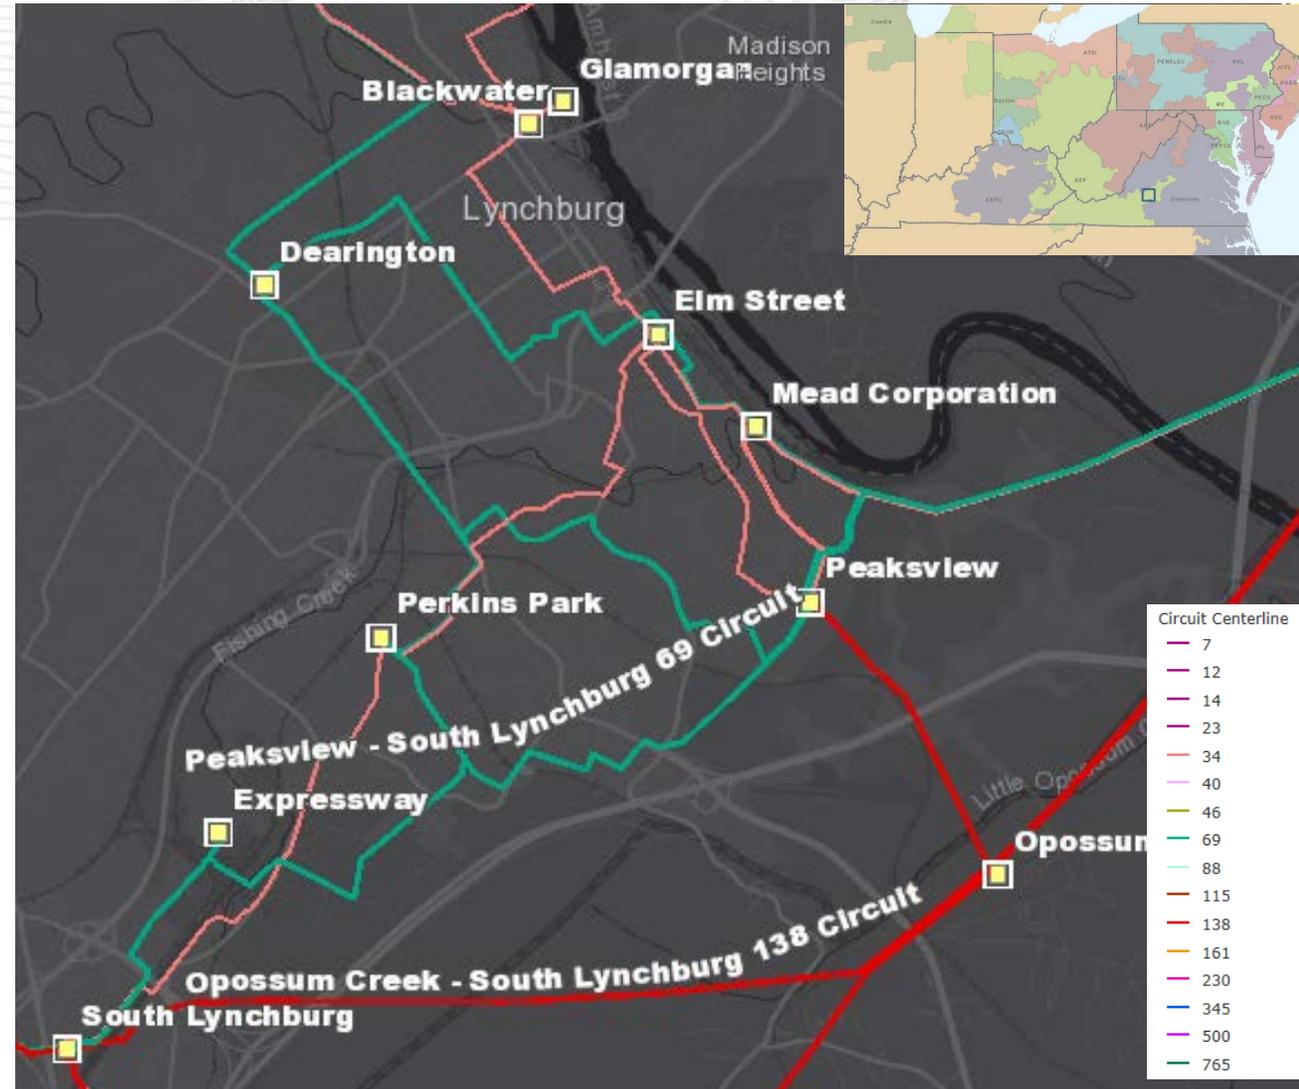
At South Lynchburg station, replace the existing 69 kV/1200 A/21 kA CB "C" and the 69 kV/1200 A/11.3 kA CB "D" with 3000 A/40 kA circuit breakers. Install new control relays for breakers. Retire pilot wire from the Peaksview and Skimmer 69 kV line relays and install new line relays. **Estimated Cost: \$1.3M**

At Dearington station, replace the existing 69 kV/1200 A/21 kA CB 's "L", "M", and "K" with 3000 A/40 kA circuit breakers. Install a new 69 kV/3000 A/40 kA bus tie breaker. Retire pilot wire from the Peaksview #1 & #2 and Reusens lines and install new line relays. Replace existing 69 kV/400 A/40 kA circuit switcher "AA" with a new 420 A/18 kA circuit switcher. Install new DICM to accommodate all new relays and RTU.

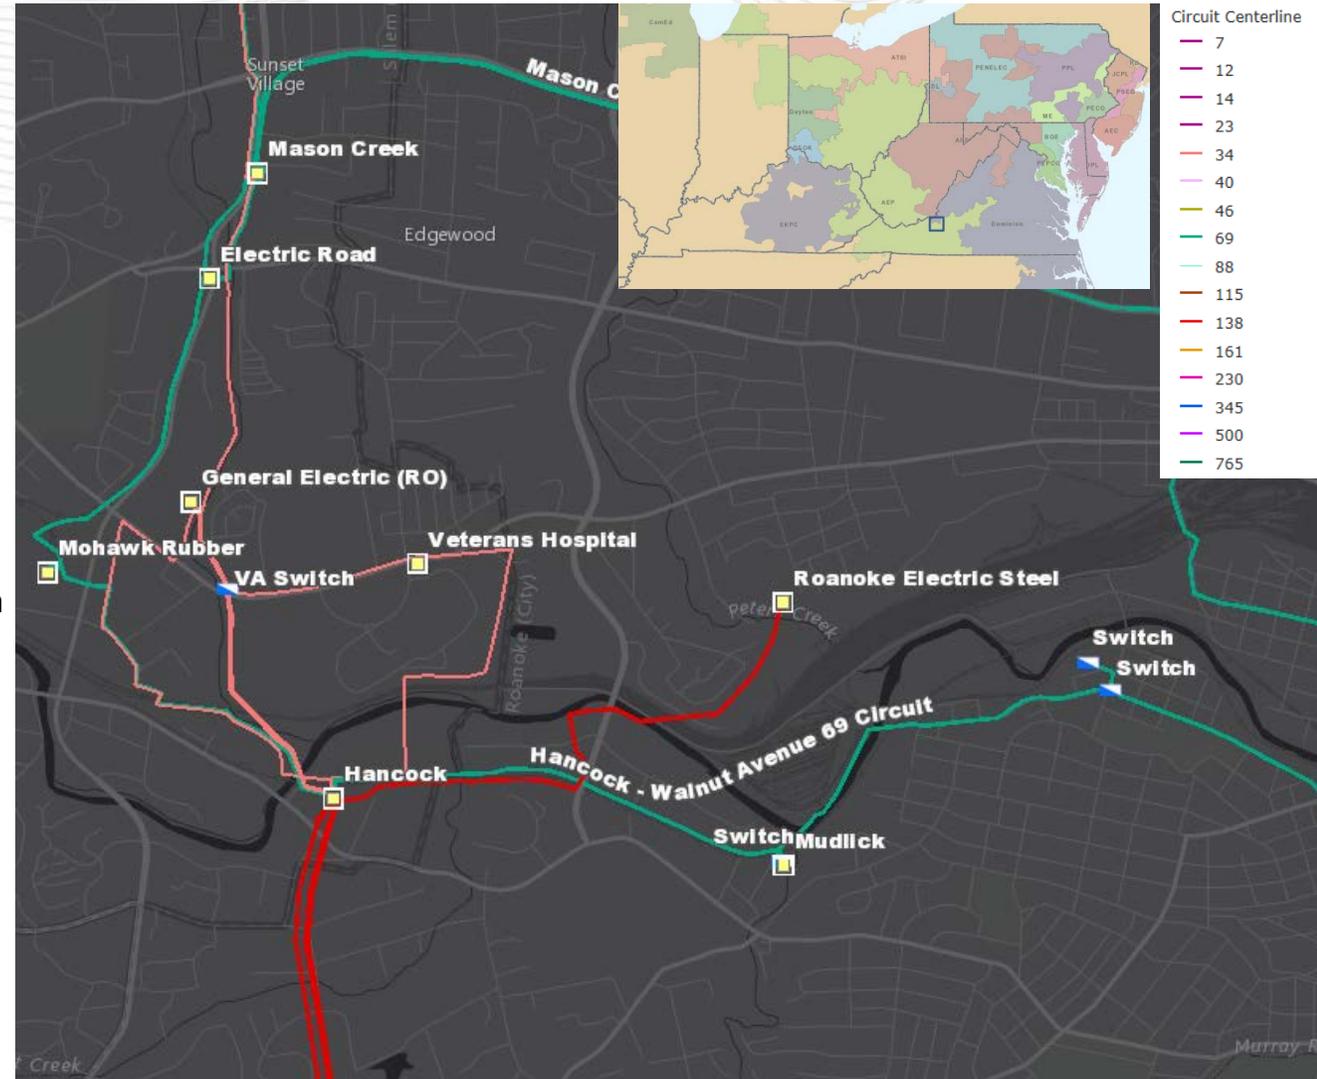
At Hancock station, build a new 138 kV breaker and half configuration with 3 strings. Install 9 new 3000 A/40 kA circuit breakers. Replace the existing 69 kV/27 kA/1800 A CB "N" and "CA", 1200 A/21 kA CB "M" and 2000 A/31.5 kA CB "Q" with 3000 A/40 kA circuit breakers. Replace the existing 34.5 kV/560 A/12 kA CB "R" and "S", 1200 A/16.8 kA CB "I" with 1200 A/25 kA circuit breakers. Install new DICM. Replace 138/34 45 MVA Transformer #2 with new 138/69/34.5kV 130MVA. Add new 138/34.5 kV 30 MVA Transformer #3 with high side Circuit Switcher (3000 A, 40 kA). Replace the existing 138 kV 1200 A/61 kA Circuit Switcher "BB" with new 650A, 31.5 kA CS. Replace 138kV Bus #1, 34.5kV Bus #1 and 34.5kV Bus #2 CCVT's. Replace 34.5 kV Circuit Breakers "P" and "J" with new 34.5 kV, 3000 A, 40 kA CB's. Replace 34.5 kV Capacitor Bank Circuit Switcher "AA" with new 40 kA CS. Install Bus Regulators on 34.5kV Bus #3. Replace remote end line relaying. **Estimated Cost: \$30.0M**

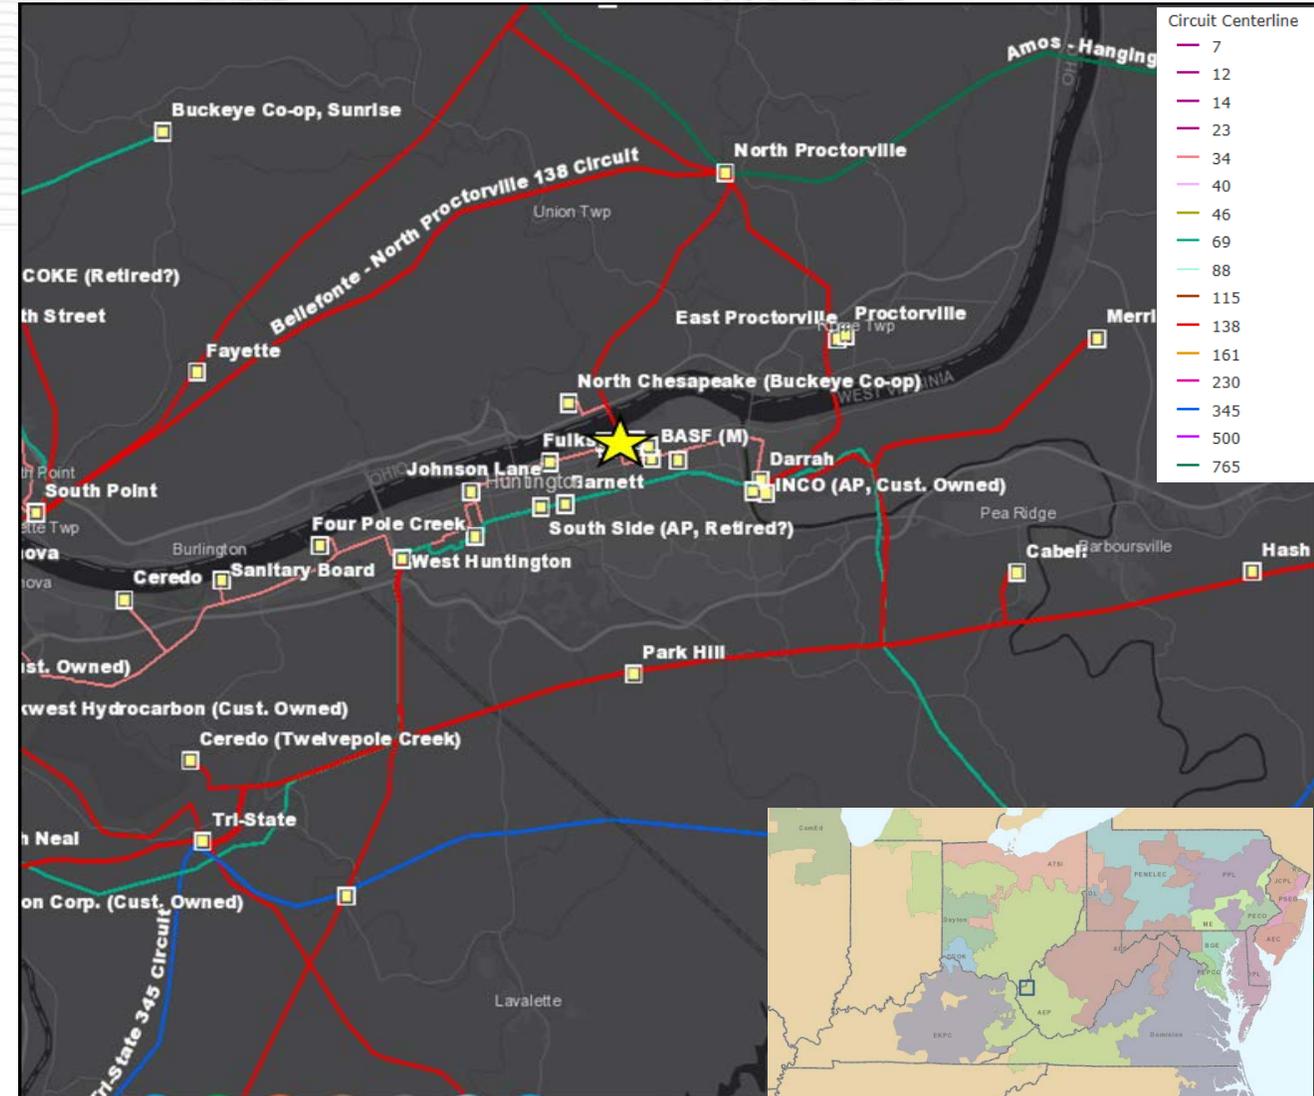
Retire the existing 1200 A 17 kA 34.5 kV bus tie circuit breaker "E" at Johnsons Lane. Install a new 3000 A 40 kA 34.5 kV circuit breaker on the high side of transformer #1. Replace the existing 1800 A 27 kA 34.5 kV circuit breakers "F" and "W" at Johnsons Lane with new 3000 A 40 kA 34.5 kV circuit breakers.

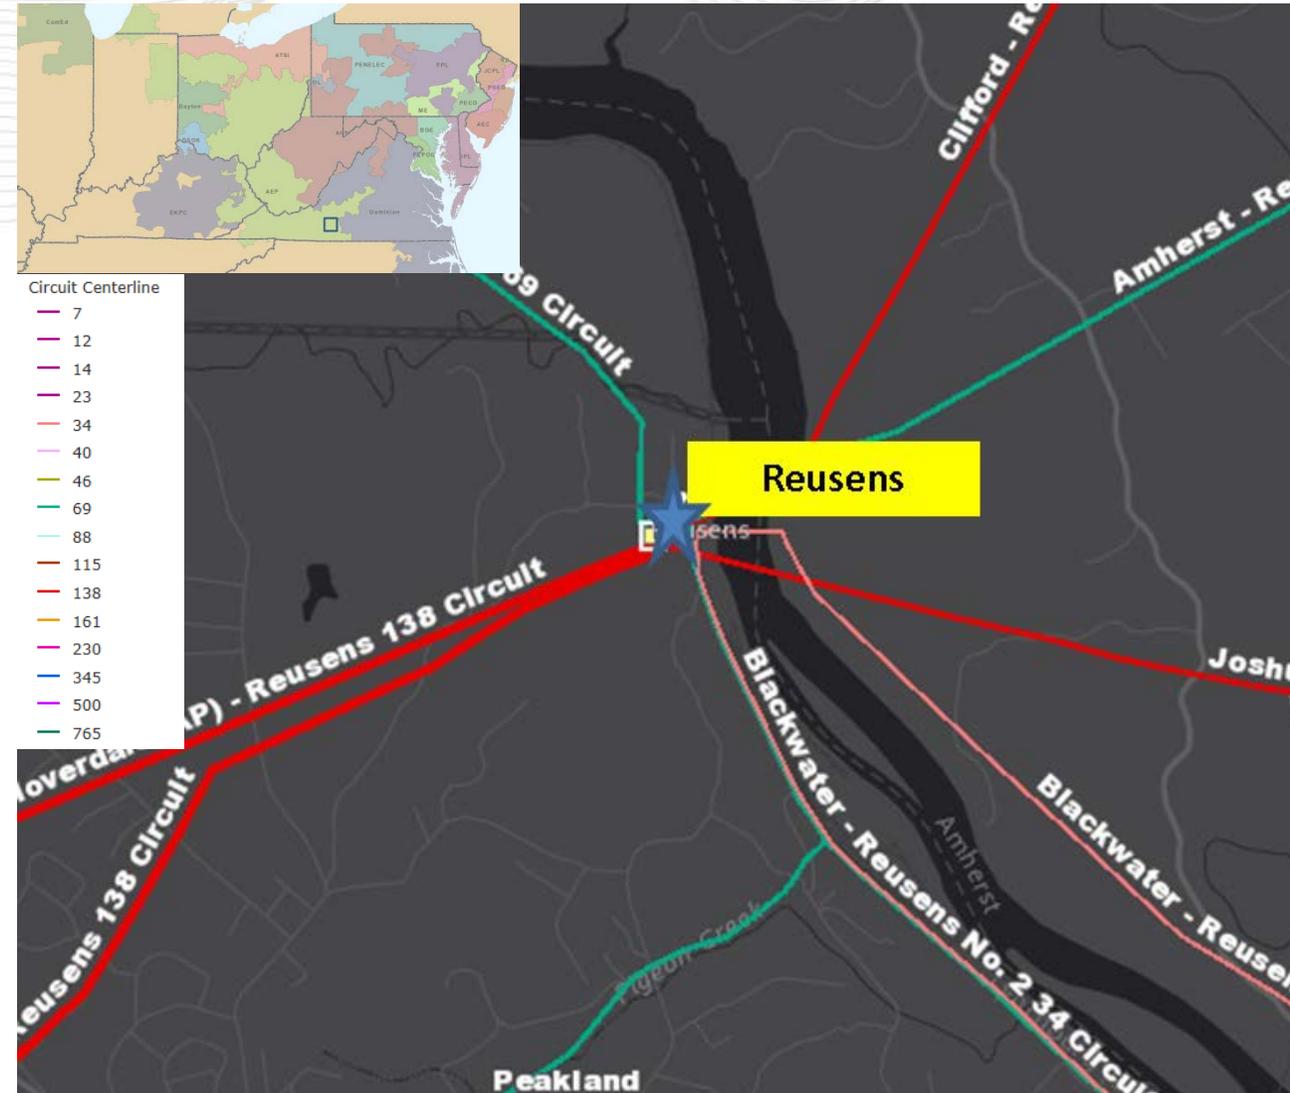
At Reusens station, replace existing 3000 A 40 kA 138 kV CB's "AB" & "D" with new 3000 A 40 kA CB. Replace existing 138/34.5 kV 130 MVA XF's #1 & XF #2 with new 138/34.5 kV 130 MVA XF's. Add new 3000 A 40 kA 138 kV circuit switchers "XT1", "XT2", "XT4" on the high side of their respective transformers. Replace existing 1200 A 61 kA 138 kV cap switcher "AC" with new 650 A 31.5 kA cap switcher. Replace existing 300 A 12.5 kA 69 kV cap switcher "DD" with new 420 A 15 kA cap switcher. Install a new 3000 A 40 kA 69 kV CB "XB4L" to the low side of XF #4. Replace existing 1200 A 69 kV CBs "AA", "BB", & "CC" with new 3000 A 40 kA CB's. The 138/69 kV 60 MVA XF #4 failed and was replaced with a new 138/70.5/13 kV 130 MVA transformer. **Estimated Cost: \$12.6M**

At Mosely station, replace existing 800 A 17.5 kA 138 kV CB "A" with new 3000 A 40 kA CB. Add a new 3000 A 138 kV 40 kA line CB "B" on the Roanoke exit. Replace existing 1200 A 69 kV CB "E" with new 3000 A 40 kA CB. Replace the existing 1200 A 61 kA grounding switch MOAB "Z1" with new 3000 A 40 kA circuit switcher "XT1". **Estimated Cost: \$4.7M**

At Clifford station, Replace existing MOAB "Y" with new 3000 A 40 kA 138 kV CB "F" on the Boxwood line exit. replace grounding switch MOAB "Z1" with new 3000 A 40 kA circuit switcher "XT1". 138/46 kV Transformer #3 ground switch MOAB will be retired on a separate baseline project. **Estimated Cost: \$3.4M**

**Moseley Station:** The addition of CB "B" & Transformer # 1's high side circuit switcher are being installed to break up dissimilar zones of protection on the 138 kV system, which causes misoperations and over tripping. The 138 kV CB "A" is 1959 vintage oil filled breaker without oil containment and has experienced 176 operations. The 69 kV CB "E", which feeds the Town of Bedford, is a 1967 vintage oil filled breaker without oil containment and has experienced 101 operations. In general, oil breakers have become increasingly difficult to maintain due to the oil handling associated with them. Oil spills are frequent with failures and routine maintenance which is also an environmental hazard.

**Clifford Station:** The 138 kV CB "F" and Transformer #1's high side CB "XT1" are being added to break up dissimilar zones of protection on the 138kV, which could cause misoperations and over tripping.

Ground switch MOAB's are being replaced to prevent intentional induce a faults on the system, tripping remote breakers for a transformer fault, reducing the life of the transformer and increasing relay coordination complexity for the transformer protection.

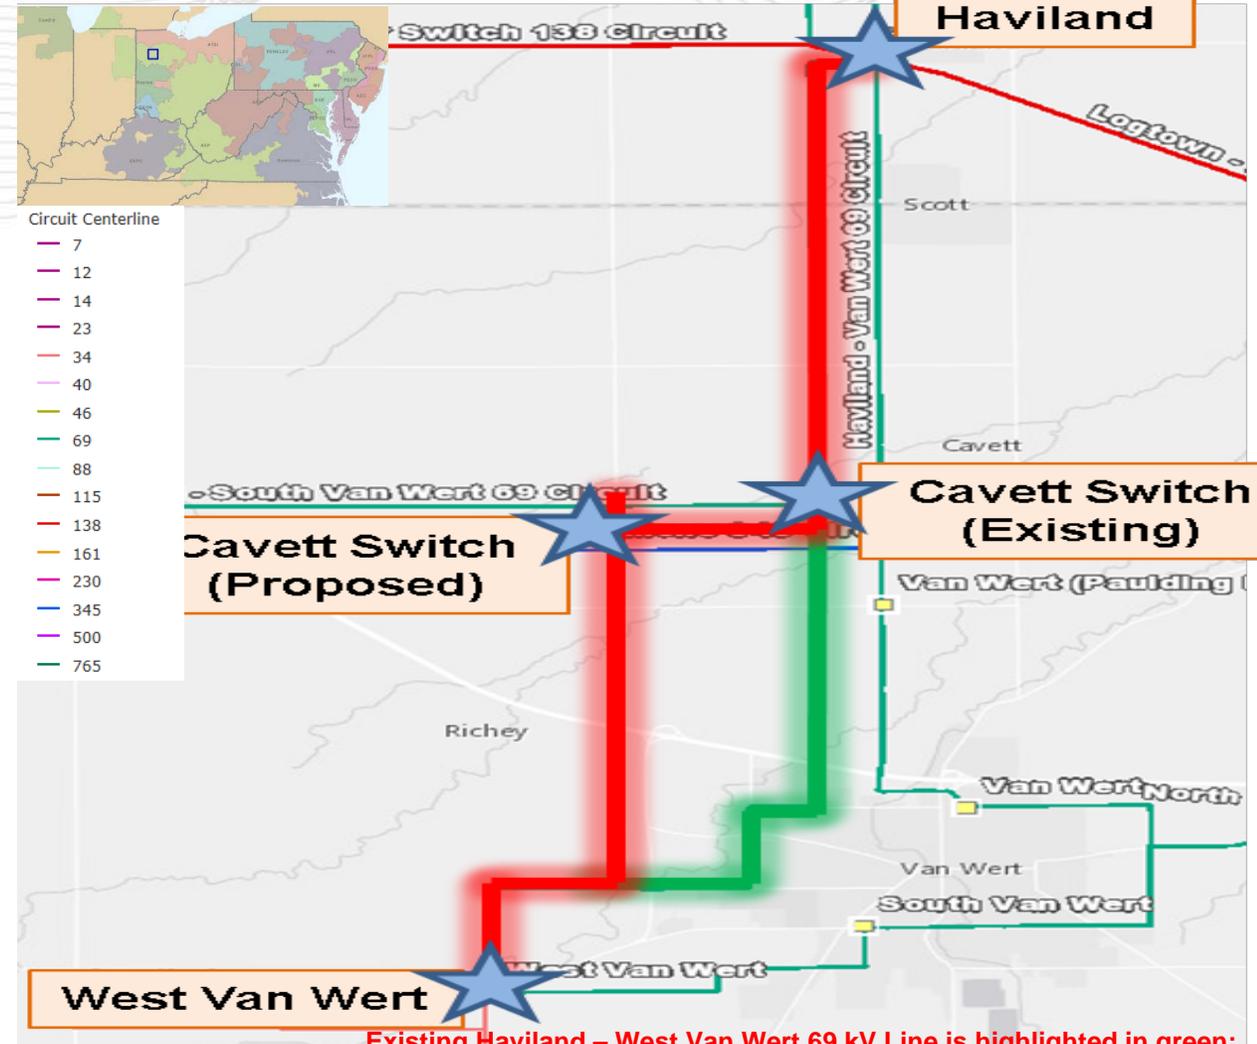
Existing Haviland – West Van Wert 69 kV Line is highlighted in green; Proposed rebuild is highlighted in red.

There are 332 open conditions on the Haviland – S. Van Wert circuit, the majority of which are on the Haviland – W. Van Wert line section.

Since January 1, 2002 there have been at least eight (8) instances of cascading pole failures during adverse weather, each resulting in a long-duration sustained transmission line outage which interrupted the transmission source to two (2) AEP Ohio distribution stations (South Convoy and Ohio City) and one (1) Paulding-Putnam Electric Cooperative substation (Convoy). These two AEP Ohio distribution stations supply approximately 1350 retail customers. In addition to the cascading pole failure events there have been other sustained outages due to broken insulators, broken crossarms, and broken shield wires.

The majority of the original-vintage tangent wood poles are insulated with 66 kV rated brown porcelain horizontal post insulators. This type of insulator is no longer standard on the AEP system. AEP's experience has shown that this size and type of insulator is subject to base and end fitting separation from the porcelain body when subjected to climatic thermal cycling. They are also prone to electrical backflash.

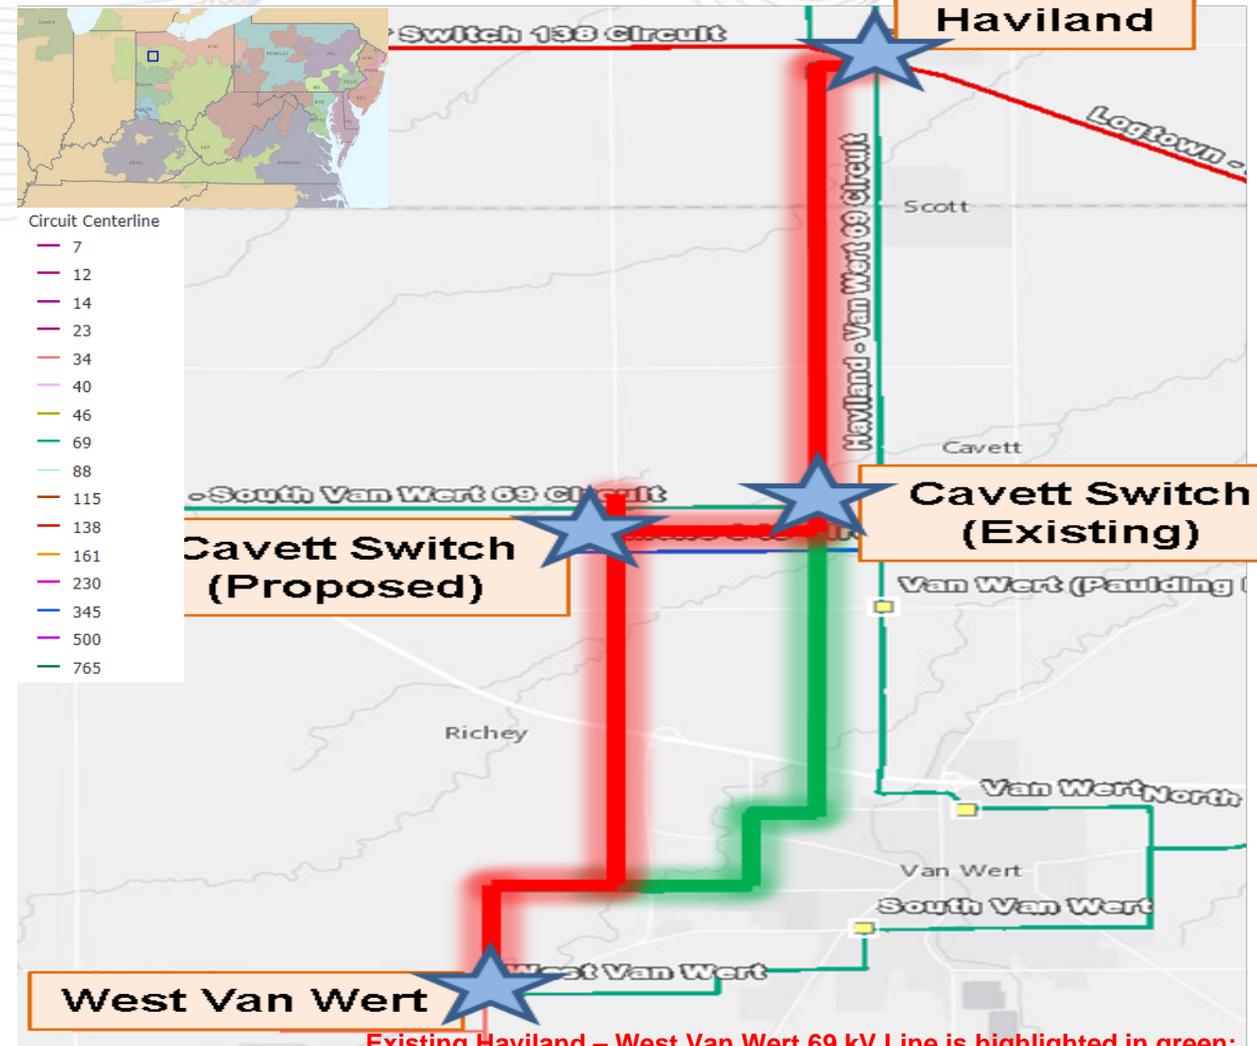
Existing Haviland – West Van Wert 69 kV Line is highlighted in green; Proposed rebuild is highlighted in red.

Some original vintage poles utilize wood crossarm construction with either vertical post insulators or suspension insulator strings. The life expectancy of wood crossarms is far less than that of wood poles, meaning the required timing of the replacement of the major structural components is not synchronized. This results in the inspection failure rate of crossarms being higher than the inspection failure rate of poles. The cost to access poles in an environmentally responsible way to replace defective crossarms can result in the decision being made to prematurely replace older poles too, prior to the poles actually being judged as defective. Construction types that do not utilize crossarms resolve this issue.

A portion of the line utilizes 4/0 copper phase conductors (50 MVA rating). This size and type of conductor is obsolete on the AEP system, meaning it can be difficult to splice and repair due to lack of available stock materials.

The majority of the shield wire on the line is either 5/16" EHS steel or No. 1 copper 3-strand. Both of these shield wire sizes and types are obsolete on the AEP system, meaning they can be difficult to splice and repair due to lack of available stock materials.

Many of the original-vintage wood poles utilize non-standard crossarm-type bay-o-nets extending from the pole top to support the shield wire. Bay-o-nets decay at the same rate as wood crossarms, meaning bay-o-net replacement is typically required prior to the pole itself needing to be replaced. Bay-o-net top rot and splitting also poses the risk of dropping the shield wire into the top or center phase conductor, and resulting sustained outage to the circuit.

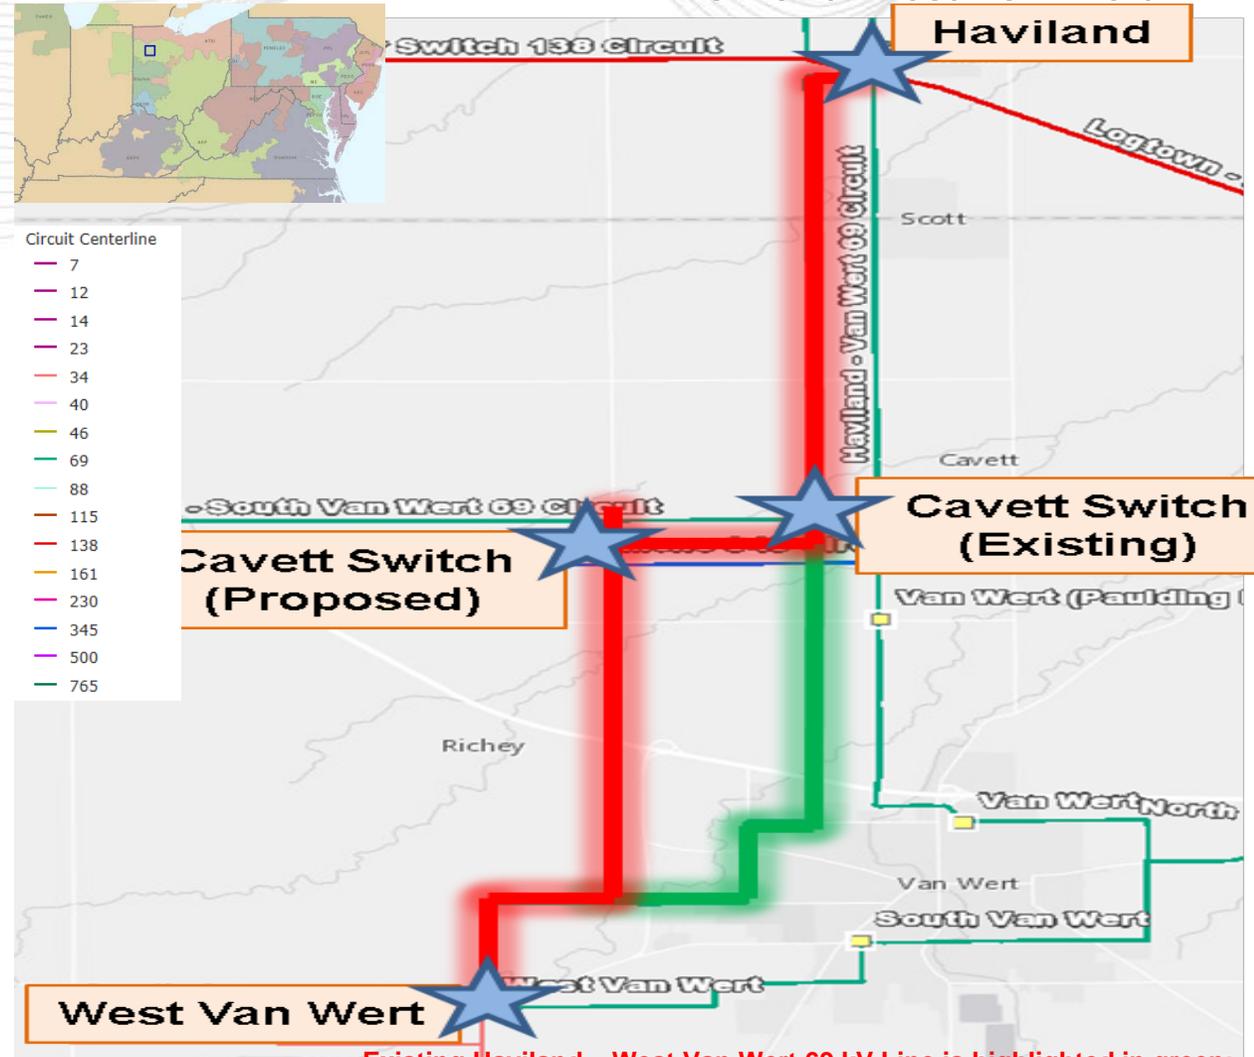
Existing Haviland – West Van Wert 69 kV Line is highlighted in green;  
Proposed rebuild is highlighted in red.

Some of the line has distribution underbuilt. Distribution underbuilt mechanical loads consume pole strength, adding to the risk of future cascading pole failure events.

Retire existing Cavett 2-way line switch. Replace with 3-way line switch on new route with MOAB facing West Van Wert. **Estimated Cost: \$0.3M**
