# Sub Regional RTEP Committee PJM West

March 27, 2018

## Baseline Reliability and Supplemental Projects

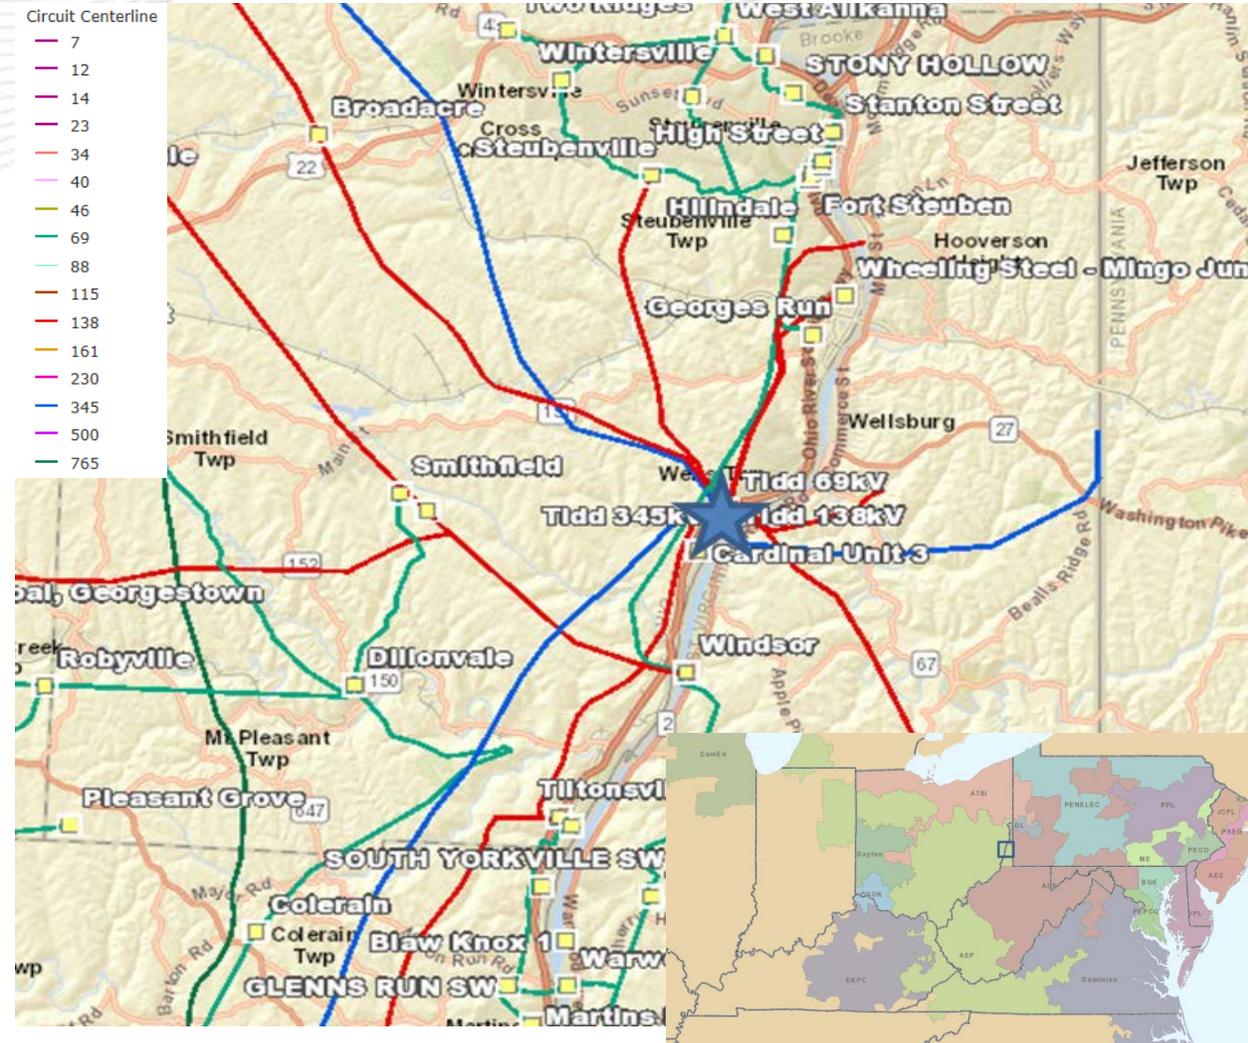
The 5- remaining 1600A 50 kA 138kV 'ATB' air-blast breakers at Tidd were manufactured in 1966. These units are overall in poor condition and a safety hazard to field personnel, due to the violent manner in which they tend to fail. Air-blast breakers are being replaced across the AEP system due to their catastrophic and violent failures. Sharp pieces of porcelain from their bushings are typically expelled from the breakers and can be a potential safety hazard to field personnel. Other factors driving the replacement are age (52 years), scarce availability of spare parts, and system impact upon failure. The breakers lack real-time condition monitoring, but instead require a de-energized test for evaluation

The existing control house is in poor condition and has experienced flooding in the basement, placing protection and telecom equipment at risk numerous times. There are various safety concerns in the deteriorating building, including lighting and heating/cooling issues. The DC system in the building has failed due to degraded cables.

The majority of the relays being replaced are electromechanical or solid-state units, which are aging and prone to failure; these also lack modern fault-location and event-recording functionality. The 138kV bus PT's are rusting and leaking oil, along with deteriorated foundations. The 138kV bus-work utilizes cap-and-pin insulators, which are prone to failure.

The 138kV switches are in a hard-to-access location, due to the station being retrofitted from double-bus double-breaker to breaker-and-a-half over the years. Any work on the 12- incoming T-Line entrances or Transformer leads requires a full bus outage due to necessary safety clearances over the bus extensions. The placement of the current switches is very complex (in a stacked arrangement on the bus), which can lead to switching errors by field personnel or safety issues.

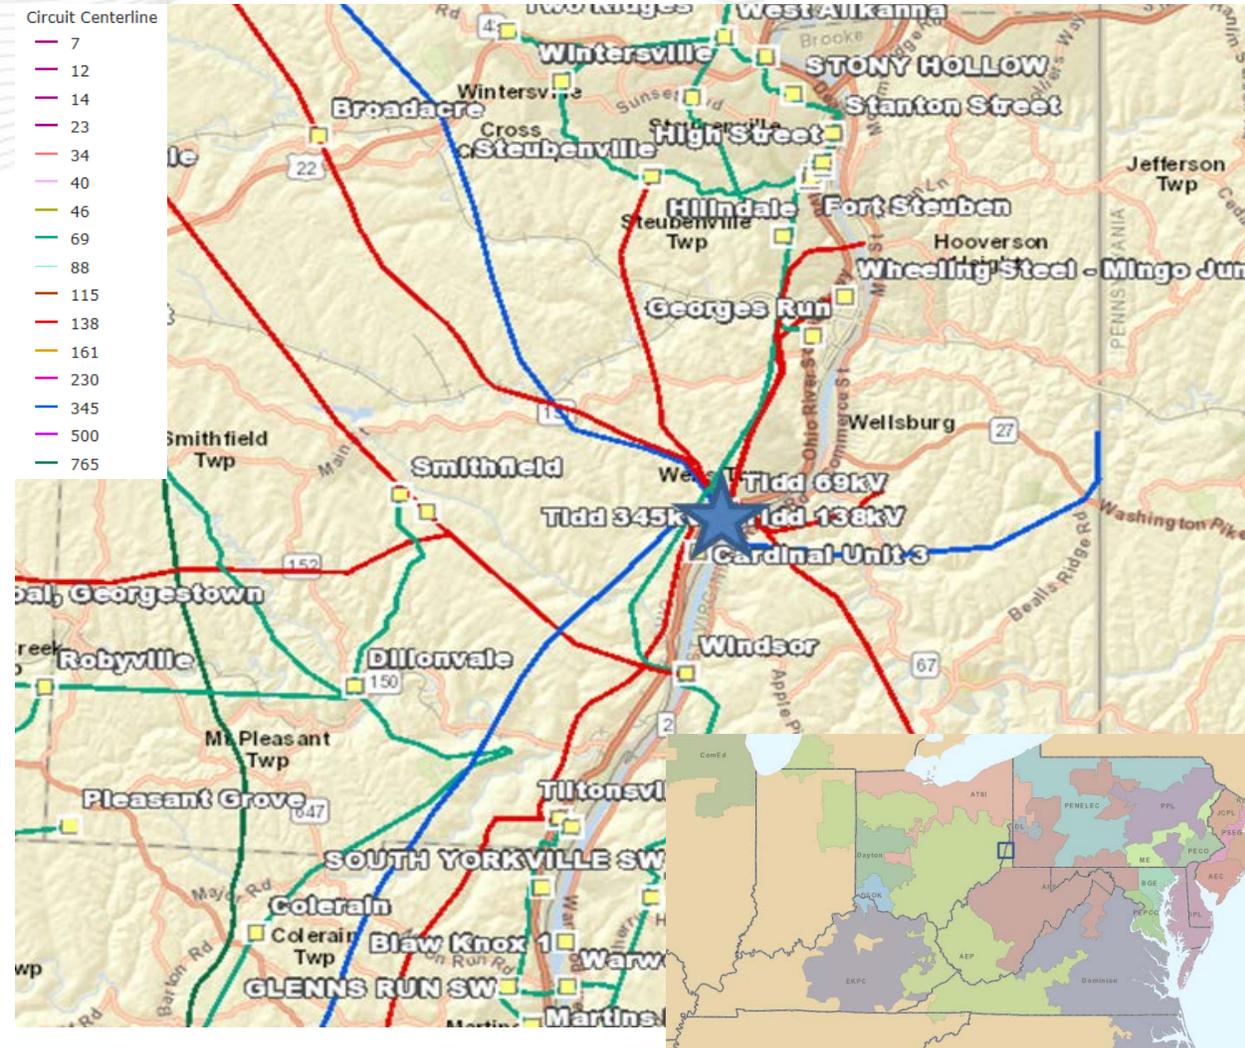
Currently, the two 138kV straight buses at Tidd have significantly more than the recommended amount of connected breakers. A fault on Bus 1 requires the tripping of 9 breakers and the loss of a source of station service power. A fault on Bus 2 requires the tripping of 9 breakers, the loss of an 86 MVAR cap bank, and the loss of a source of station service power. Furthermore, when either bus must be taken out of service for maintenance or project commissioning, it takes significantly longer than necessary to isolate the bus. AEP's general recommendation is to limit the amount of breakers tripped for a bus fault to 6 or less. To remedy the situation, two 138kV bus-tie breakers will be installed, to split the two buses into four.

Tidd provides two direct 138kV feeds to a steel-making customer, which will benefit from the Tidd station reliability improvements. This customer has significant expansion plans in the future.

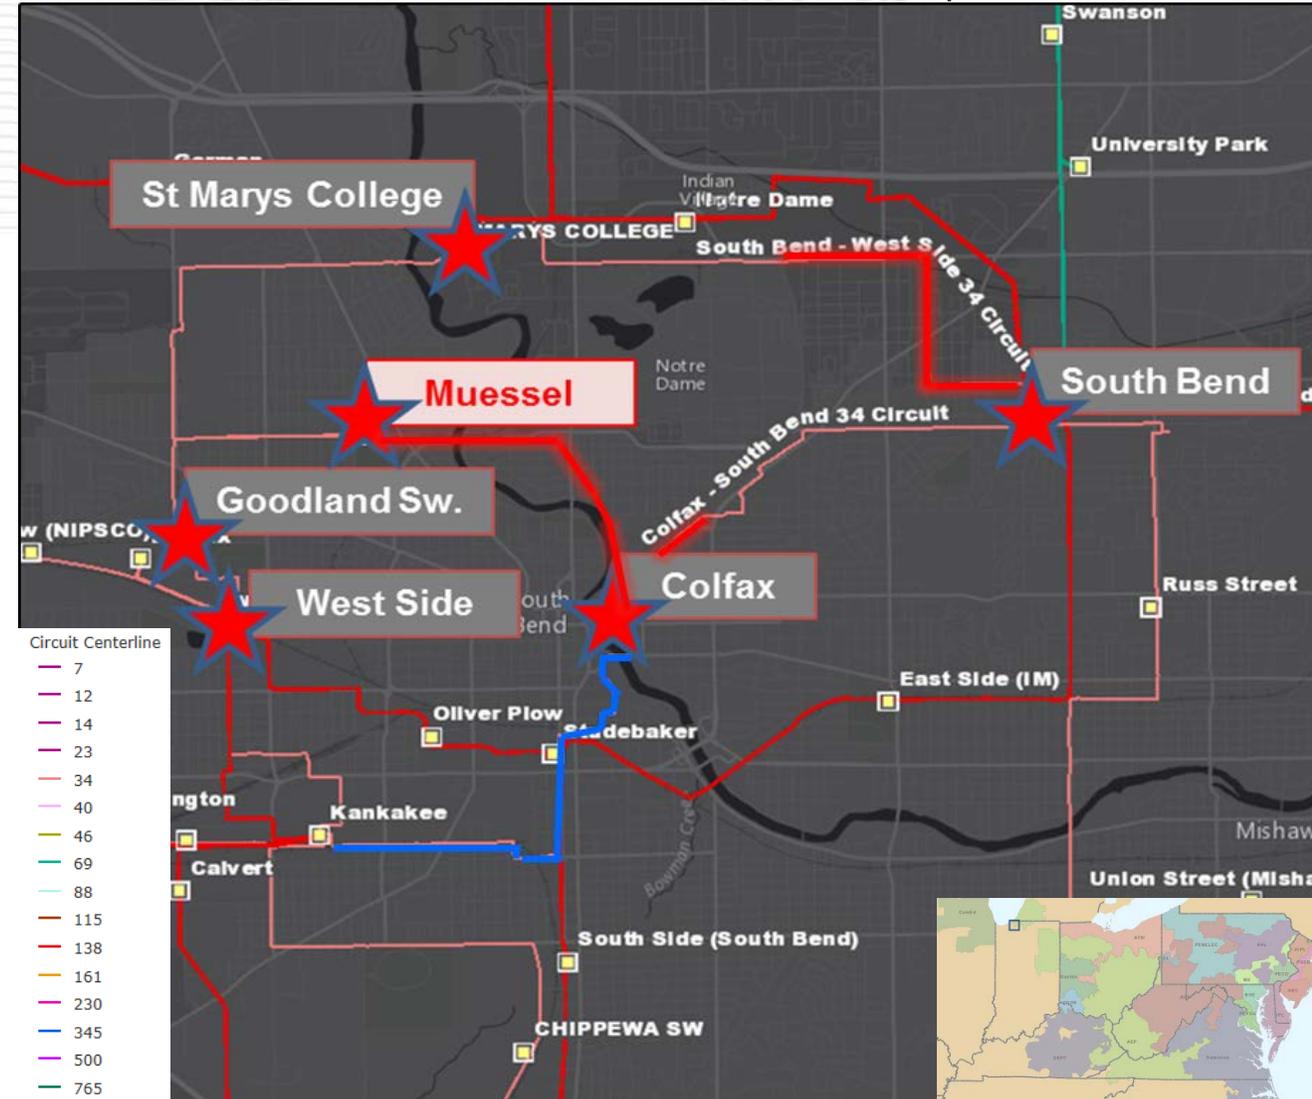
AEP has identified multiple rehab needs at Colfax, Drewry's and Saint Mary's stations. Colfax station is a cubicle switch gear type construction, is obsolete, and spare parts are unavailable. Mobile transformer can't be installed on site due to physical space limitations and complete station outage can only be taken during off-peak months (Sep-May). The 34.5 kV CB C and D at Colfax Station are GE FK oil-filled breakers manufactured in 1950s, have operated through 12 and 20 fault operations, exceeding the manufacturer recommendation of 10. These breakers are oil breakers. Oil breaker maintenance has become more difficult due to the oil handling required to maintain them. Oil spills are frequent with breaker failures and routine maintenance and can become an environmental hazard. The drivers for replacement of these breakers are age, number of fault operations, and a lack of repair parts. The 34.5/12 kV Transformer at Colfax was manufactured in 1974 and is also showing significant signs of deterioration. It has a load tap changer (LTC) and therefore distribution voltage regulation is difficult. Drivers for replacement of the transformer include dielectric strength breakdown (winding insulation), short circuit strength breakdown (due to the amount of through fault events), and accessory damage (bushings).

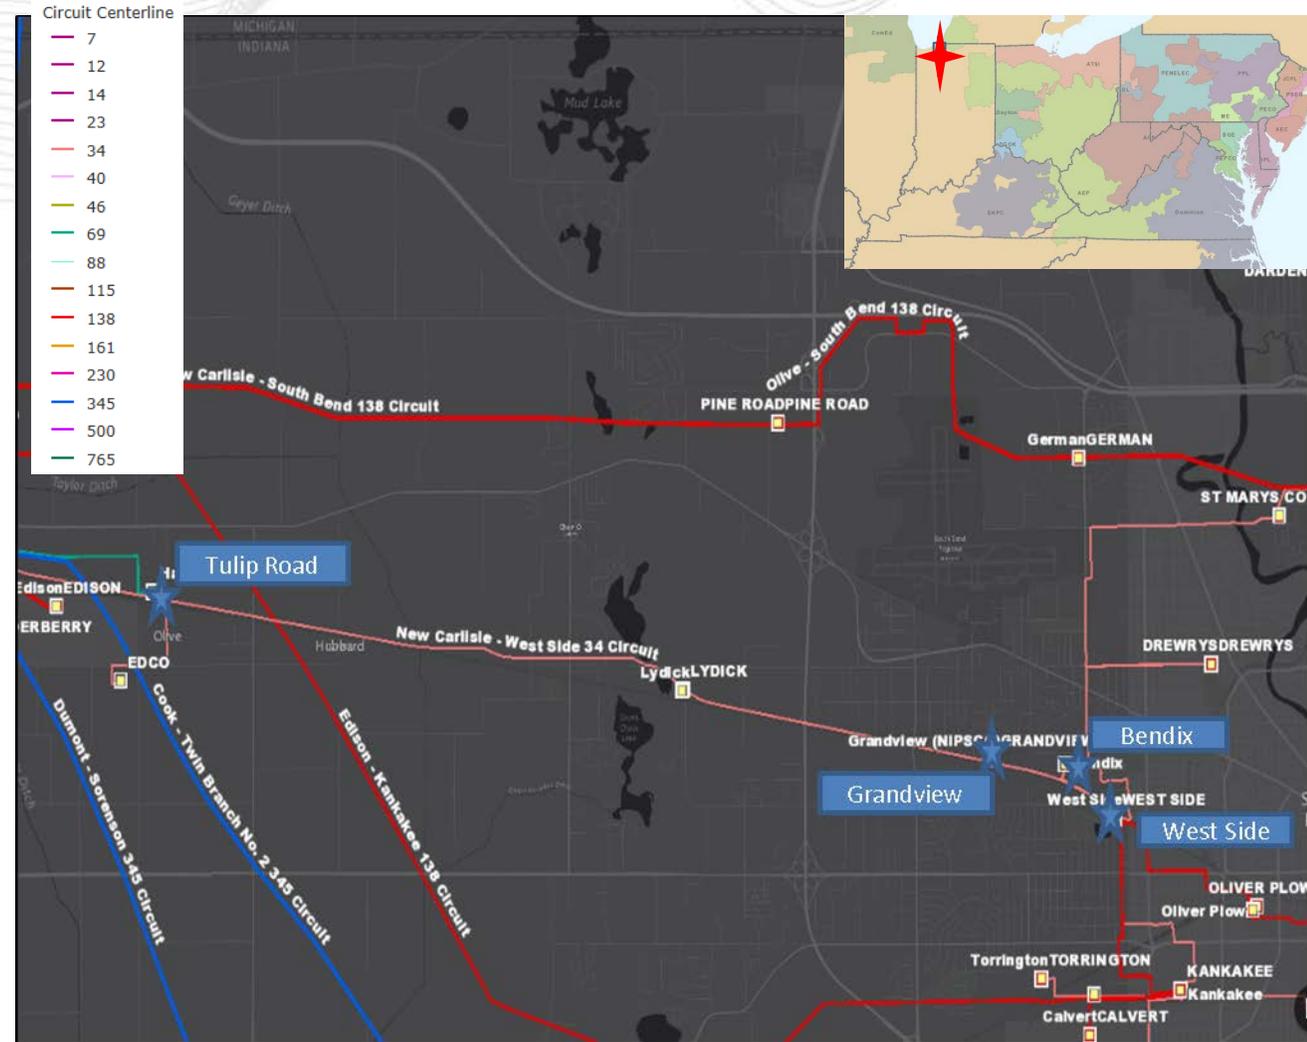
On the Tulip Road-West Side 34.5 kV line is estimated to be around 1934 vintage, constructed with 4/0 copper and 336 aluminum conductor (27 MVA rating). It is constructed from wood poles which are currently subject to 160 conditions including but not limited to, broken conductor hardware; broken, top rotted, split and twisted crossarms; broken and missing ground lead wires; damaged insulator; and damaged, leaning, rotted and split poles;

Grandview is currently hard tapped on the Tulip Road – West Side line. This means that any time AEP wants to maintain this line, the Grandview interconnection would have to be disconnected. While this project does not eliminate the tap, it sets the line up so that it can be replaced with a switching structure in a future project while simultaneously reducing the length of the line exposed to the hard tap.

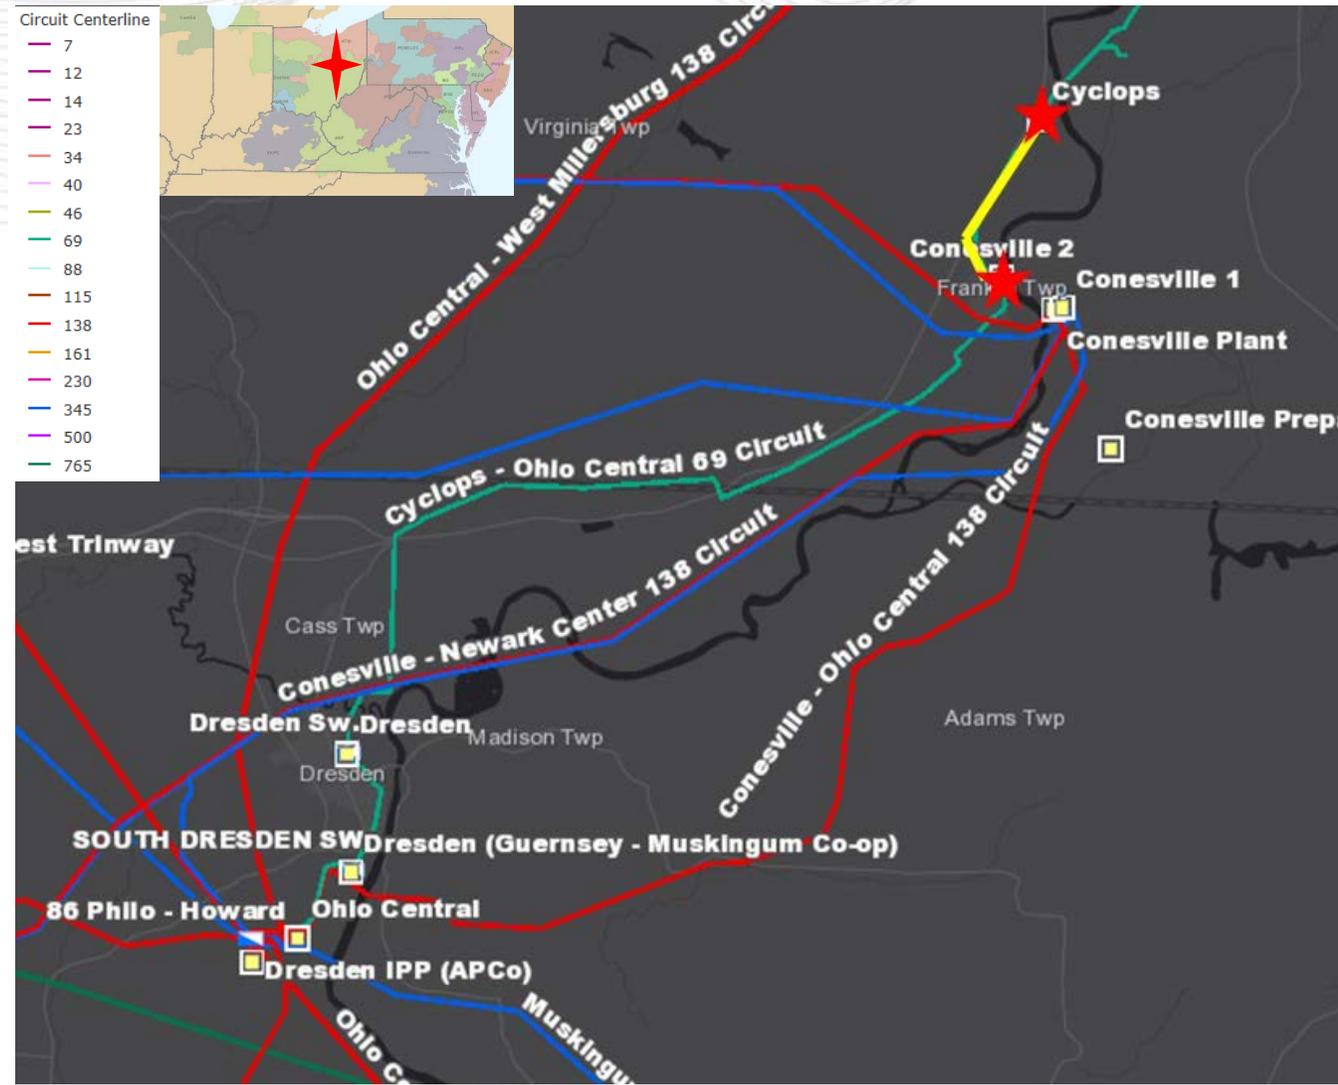
This project is an extension of the adjacent Ohio Central-Conesville 69kV transmission line rebuild (11.8 miles) and Ohio Central 138-69KV transformer upgrade, which resolve thermal overloads (PJM Baseline #B2797). This project will rebuild the remaining 1.8 miles of the 69kV circuit between Conesville-Cyclops. After the associated Baseline line rebuild, this 1.8 mile section is loaded to 96% SE for the worst contingency (70 MVA loading/73 MVA rating, leaving only 3 MVA of margin for future area load growth). Cyclops station serves a stainless steel plant.

This 1.8 mile line section was built in 1948 on wood poles that are in poor condition with 336 ACSR conductor (73 MVA rating). The T-line currently has five reported conditions. Proactively upgrading this 1.8-mile line section at the same time as the adjacent Baseline rebuild results in construction and outage-scheduling synergies.
