# Sub Regional RTEP Committee PJM West

July 27, 2018

# First Review

## Baseline Reliability and Supplemental Projects

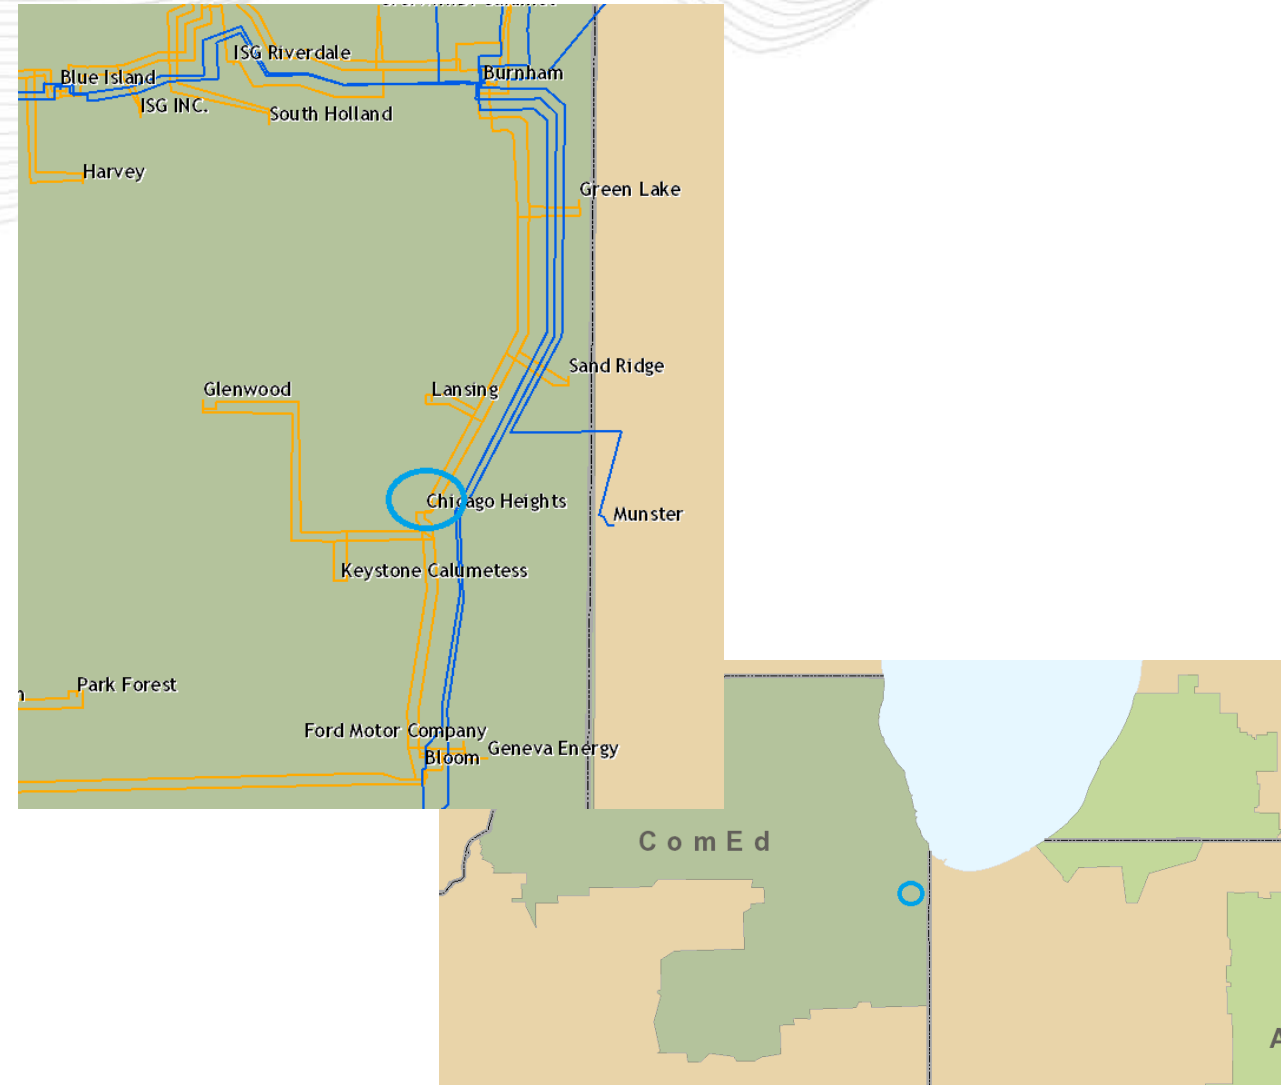
2017 emergent project to replace failed 138kV line 11712 breaker  
 moved Chicago Heights transformer 79 from line 11712 to line 7306  
 Transformer 79 is still connected to a transmission line  
 Chicago Heights substation is a straight bus with multiple elements on the same bus

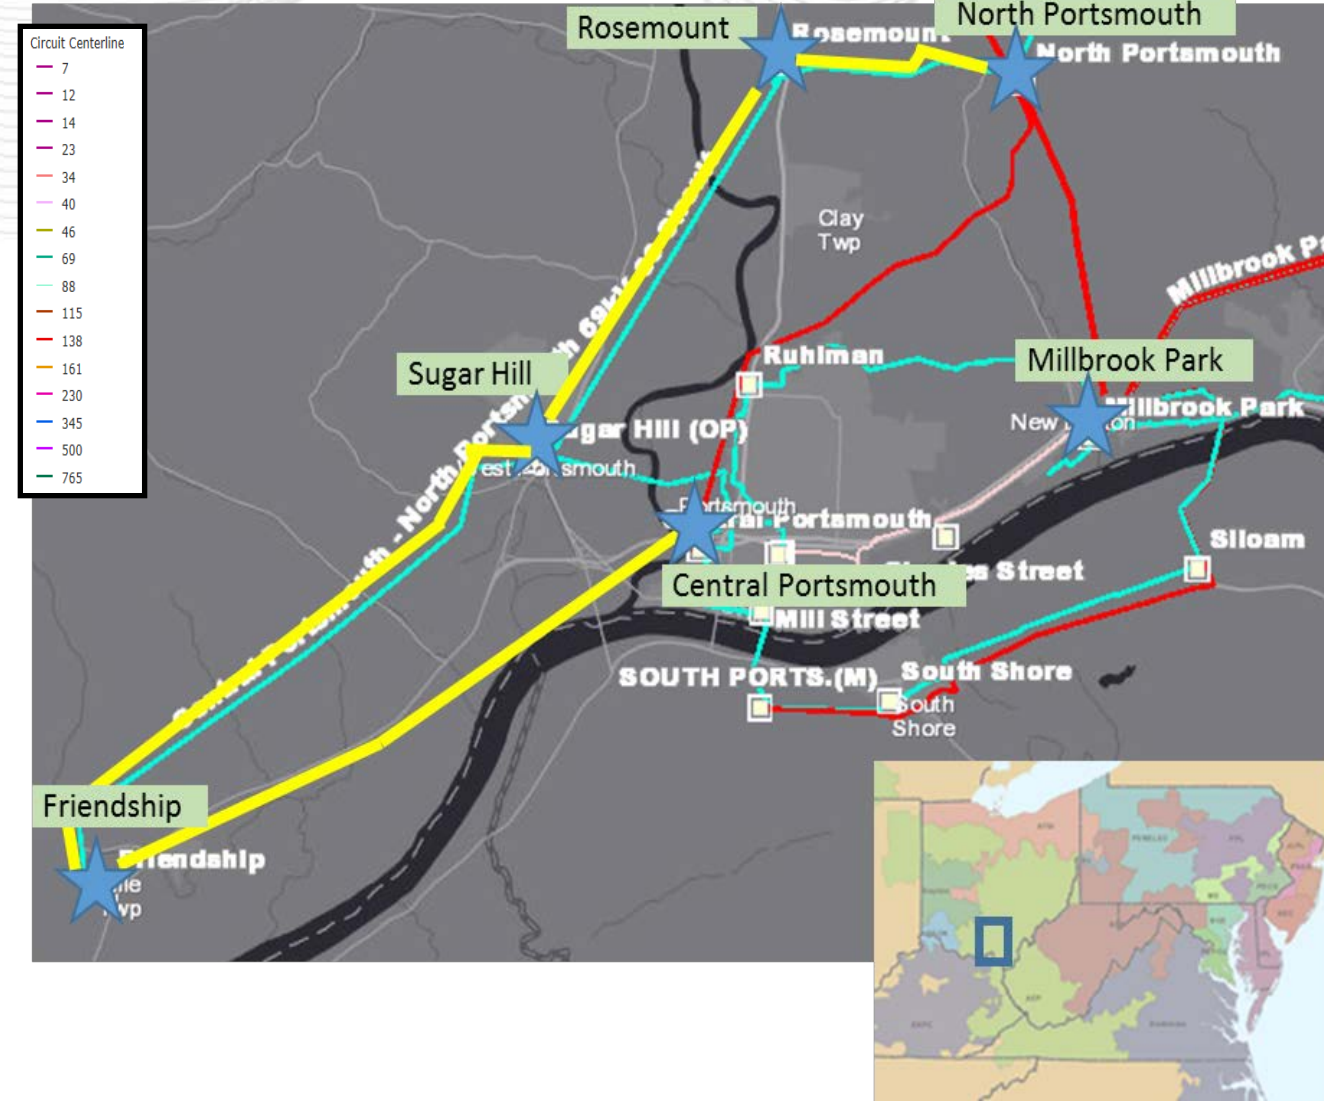
The 17-mile long 69 kV Central Portsmouth-North Portsmouth line was built between 1959 and 1966 using wood-pole structures with a combination of 176.9 ACSR and 336 ACSR conductor, with a 41 MVA summer thermal rating. The 176.9 ACSR is an uncommon conductor used in the past and spare parts are an issue. There are 192 open A conditions distributed among the 139 poles on this line. The conditions include: rotten cross-arms, burnt/broken insulators, and loose/broken conductor hardware. The Central Portsmouth-North Portsmouth 69 kV circuit has an MPOI of 350 with 2,141,467 customer-minutes of interruption over the last three years.

At North Portsmouth the 138-69 kV transformer T1 (installed 1958) is recommended for replacement with factors such as moisture content, oil quality, and age. The 138 kV oil-filled breakers C (installed 1948), D (installed 1975) and 69 kV CB A (installed 1954) are at over 80% of their fault interrupting capability for 3-phase faults, and have experienced 27, 7 and 53 operations respectively, with C and A exceeding the manufacturer recommended limit of 10 fault operations. Other factors driving the replacement are age and scarce availability of spare parts.

The central Portsmouth breakers G and H are both 1975 oil-filled breakers with 29 and 25 operations respectively, exceeding the manufacturer recommendation of 10 fault operations. The breakers both exceed AEP's threshold for replacement with conditions including: age; bushing problems; unavailability of spare parts; lifetime fault operations count; and high moisture readings. In general, oil breakers have become increasingly difficult to maintain due to the oil handling associated with them. Oil spills are frequent with failures and routine maintenance which is also an environmental hazard.

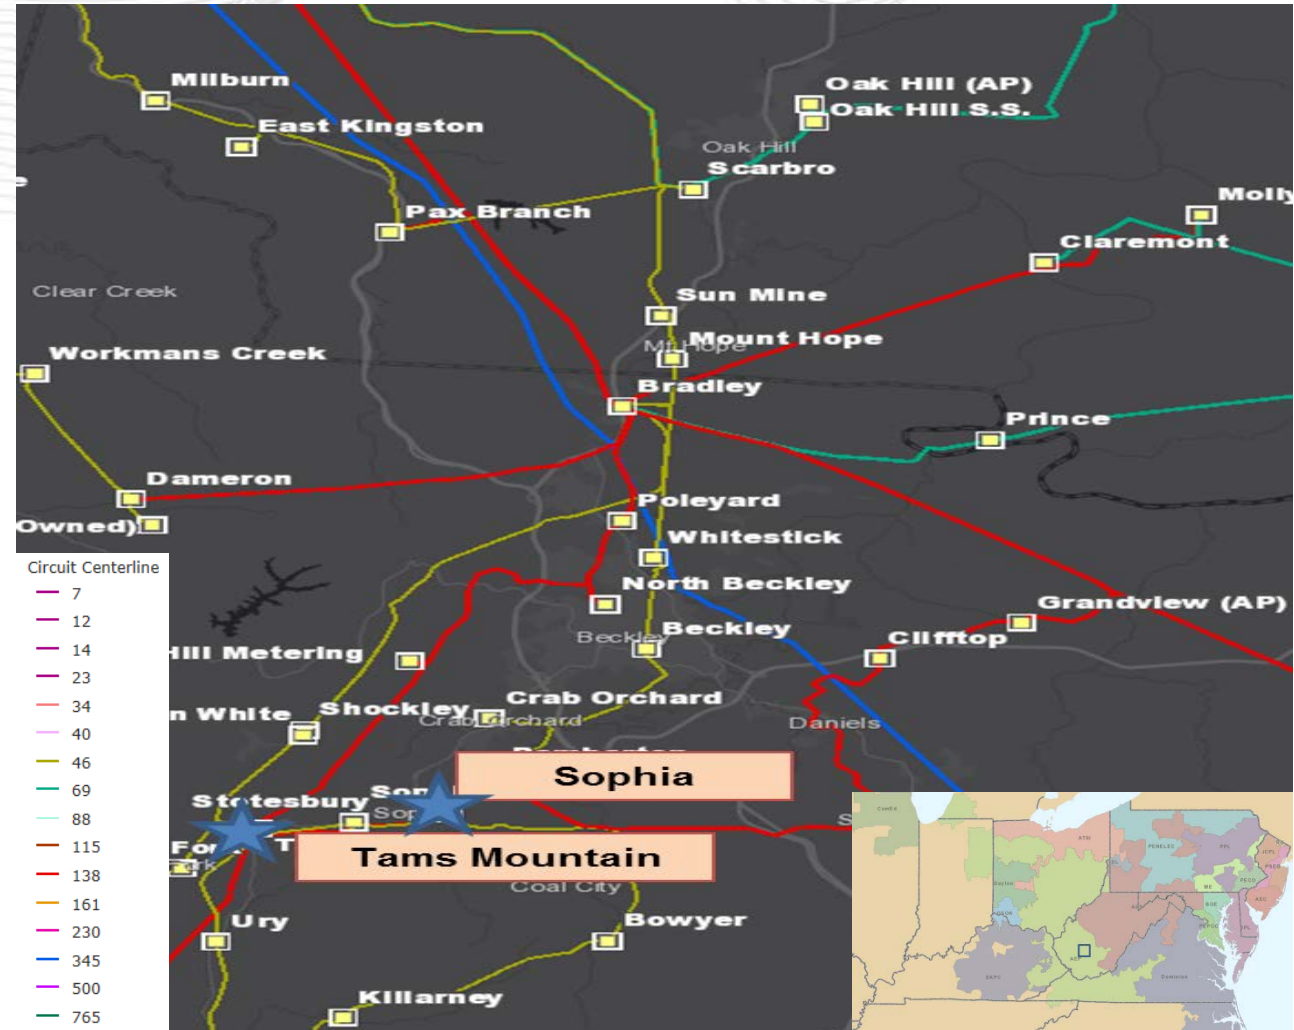
Tams Mountain 46 kV circuit breakers A, B, C, D and E are all oil-filled breakers installed in 1965. In general, oil breakers are difficult to maintain. Oil spills are frequent with failures and routine maintenance which is also an environmental risk. All five 46 kV breakers have exceeded the manufacturer's expected number of 10 fault operations; A: 237 fault ops, B: 248 fault ops, C: 113 fault ops, D: 84 fault ops, E: 63 fault ops.

Tams Mountain 138/69/46 kV XFR #1 (vintage 1965) is showing rising ethane, ethylene, and methane levels. All three gas concentrations are trending upwards. Despite decreasing moisture content, the dielectric strength has continued to decline. The short circuit strength has been deteriorated by the amount of thermal through faults.

Sophia 46 kV circuit breaker C is an oil-filled breaker manufactured in 1965. In general oil breakers are difficult to maintain. Oil spills are frequent with failures and routine maintenance which is also an environmental risk. Breaker C has experienced 41 fault operations which exceeds the manufacturer's expectation of 10 fault operations.

The Tams Mountain – Mullens 138 kV and Tams Mountain – Pemberton 138 kV lines currently connect and create a three terminal line at Tams Mountain 138 kV bus #2. Two new 138 kV breakers will be installed and the station will be re-configured into a ring bus to eliminate the three terminal line at the station. The Ground-Switch MOAB on the high side of the 138/69/46 kV transformer at Tams Mountain is obsolete and creates an overlap in the zones of protection.
