SRRTEP Committee: Western AEP Supplemental Projects

August 14, 2020

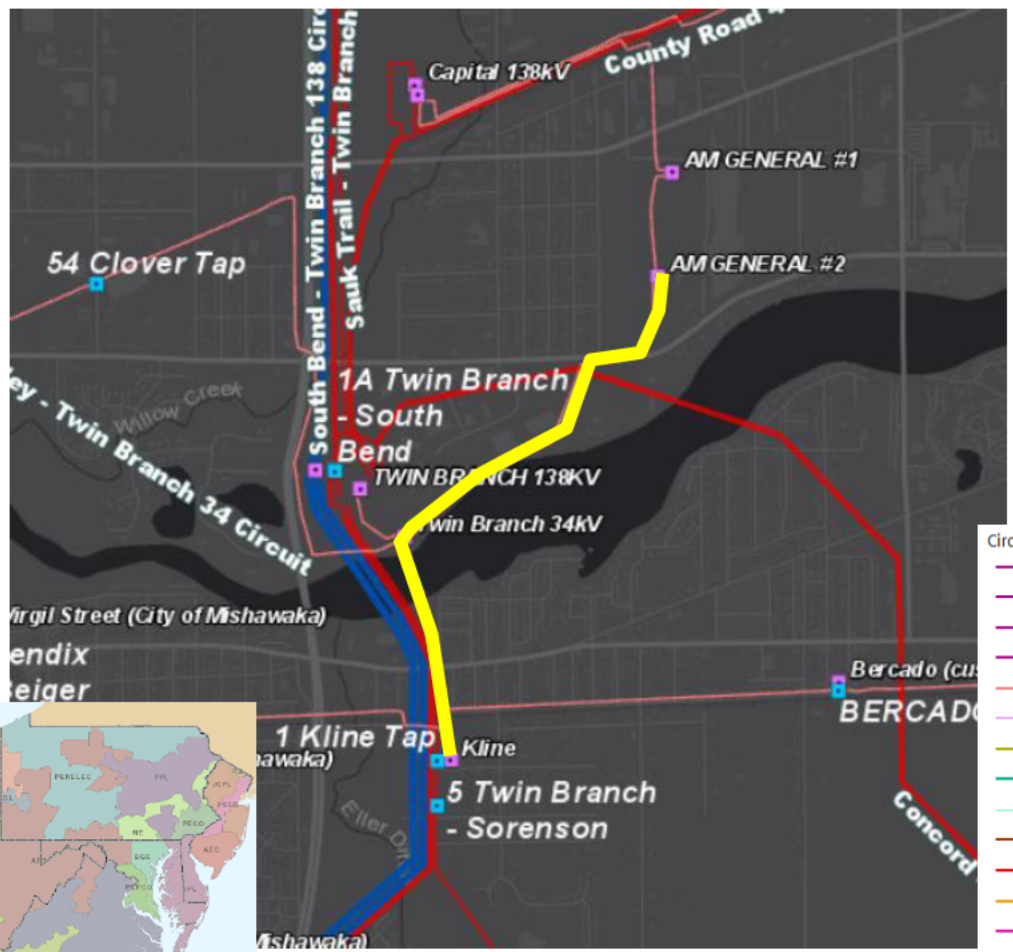
AM General-Twin Branch-Kline 34.5kV

- 1 mile of 1950's wood pole cross arm construction
- 7 structures, 28% of the line, with open conditions
 - Open conditions include: pole rot, broken or missing ground lead wires
- The grounding method utilizes butt wraps which is not current AEP standards
- During field assessment structures were found with vertical pole splitting, decay to cross arms, rot top, and upper pole decay

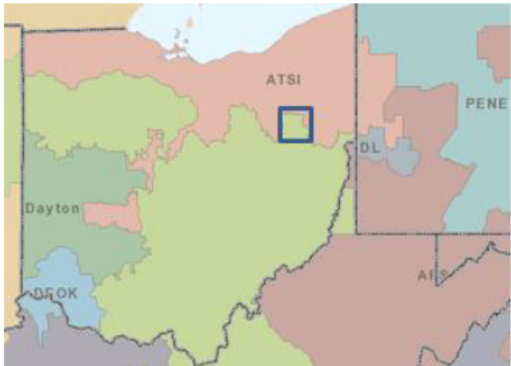
Station Name: Reedurban

- The 138-69kV transformer has failed and has been temporarily replaced with a mobile 138-69kV transformer.
- Manufactured and installed in 1988.
- 60 MVA nameplate, Westinghouse unit.
- Failure attributed to significant deterioration of transformer windings

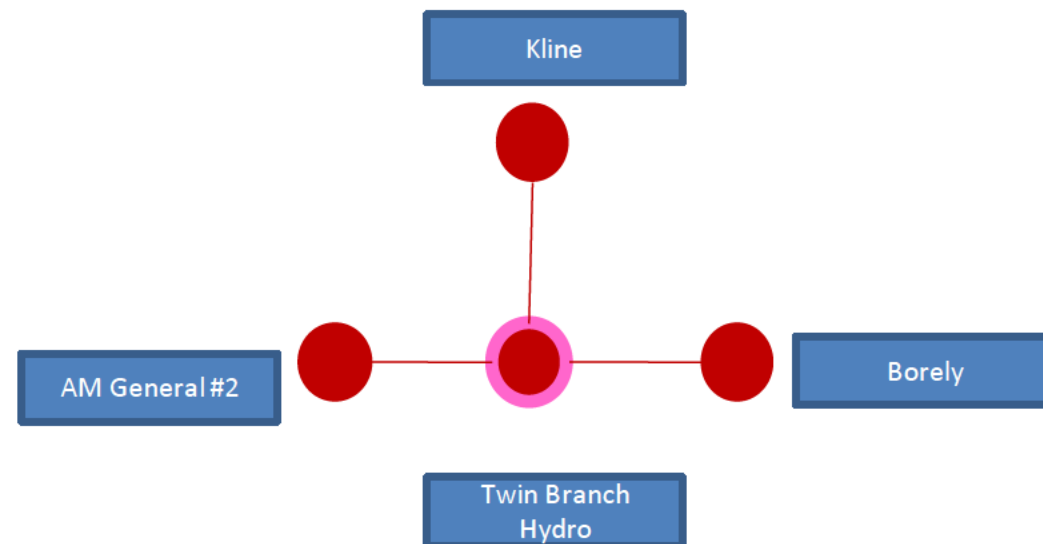
AEP Transmission Zone M-3 Process
Twin Branch Hydro 34.5kV Solution

Replace 34.5kV Breakers BB, CC, DD, HH, NN and 34.5kV/4kV Transformer #4
