# Sub Regional RTEP Committee: Western AEP Supplemental Projects

May 19, 2022

## AEP Transmission Zone: Supplemental Sturgis Area Improvements (\$2584) Revision

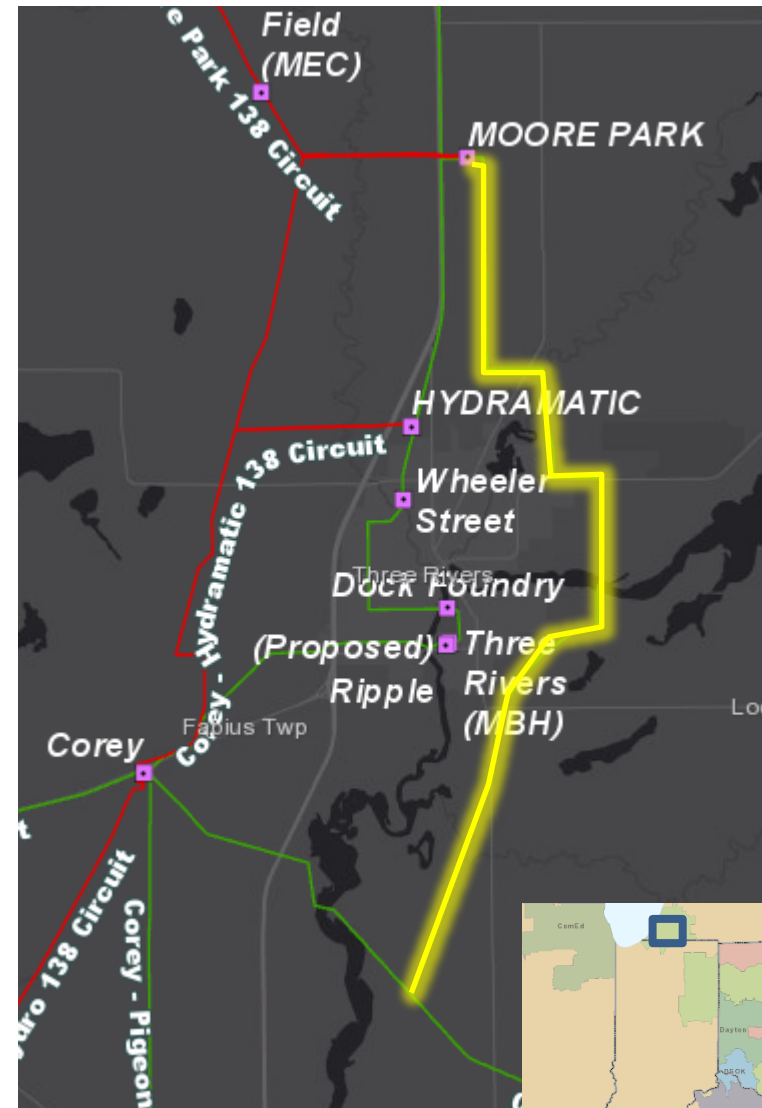
Moorepark 69kV Tap line:

- 9.02 miles of 1967 wood pole structure with horizontal insulators
- 94 structures with at least one open condition (52% of the line)
  - Open conditions include pole damage such as cracked, insect damage, rot heart and woodpecker holes, shielding/grounding conditions related to broken, missing or stolen ground wires, and broken or burnt insulators
- Since 2014 8 momentary and 1 permanent outages
  - 7 due to weather (lightning/thunderstorm) demonstrating poor shielding
- This line is a three terminal line which is hard to coordinate from a relaying perspective and is prone to misoperations

Moorepark (138/69kV) Station:

- 69kV circuit breaker (1) installed in 2006 with 41 documented malfunction records due to low SF6. This breaker has exceeded the designed number of fault operations.
- (1) 2030-69 Cap Switcher with no gas monitor. The AEP system has experienced numerous malfunctions of this type of cap switcher due to gas loss, interrupter failures, operating mechanism failures and trip or reclose failures.
