# Western Sub Regional RTEP: AEP Supplemental Projects

November 17, 2023

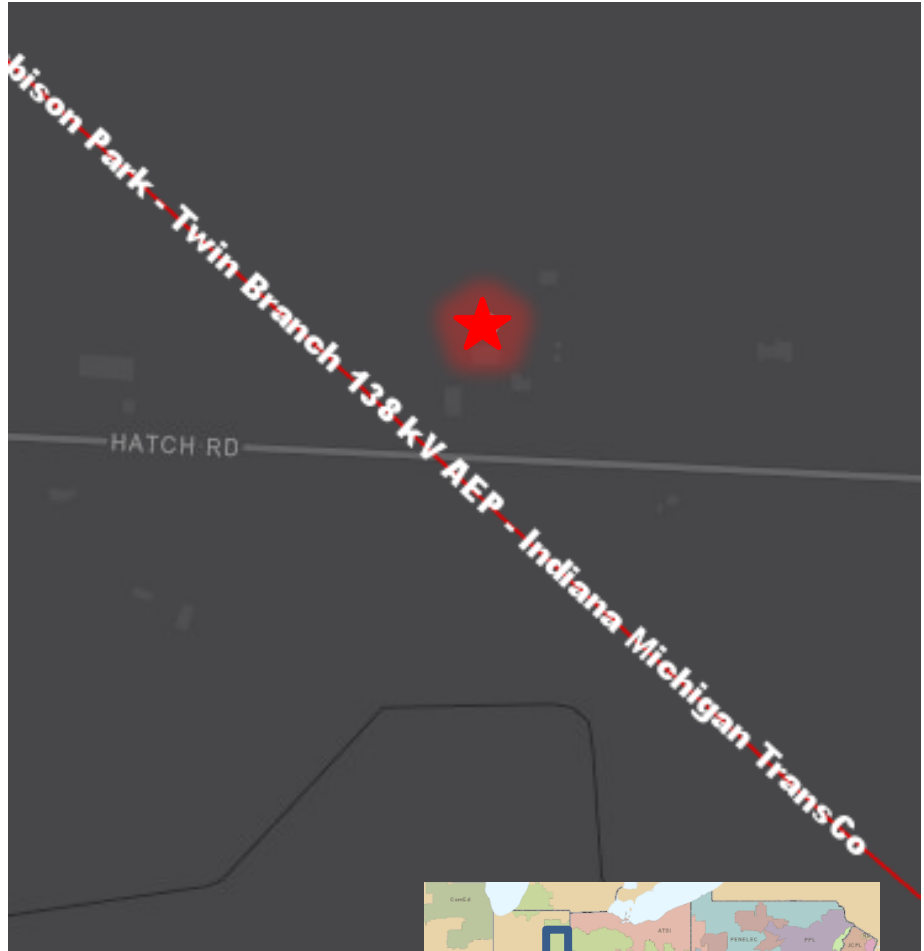
**Problem Statement:**  
NEREMC has requested a new delivery point for a peak load of 6MW in Huntertown, Indiana.

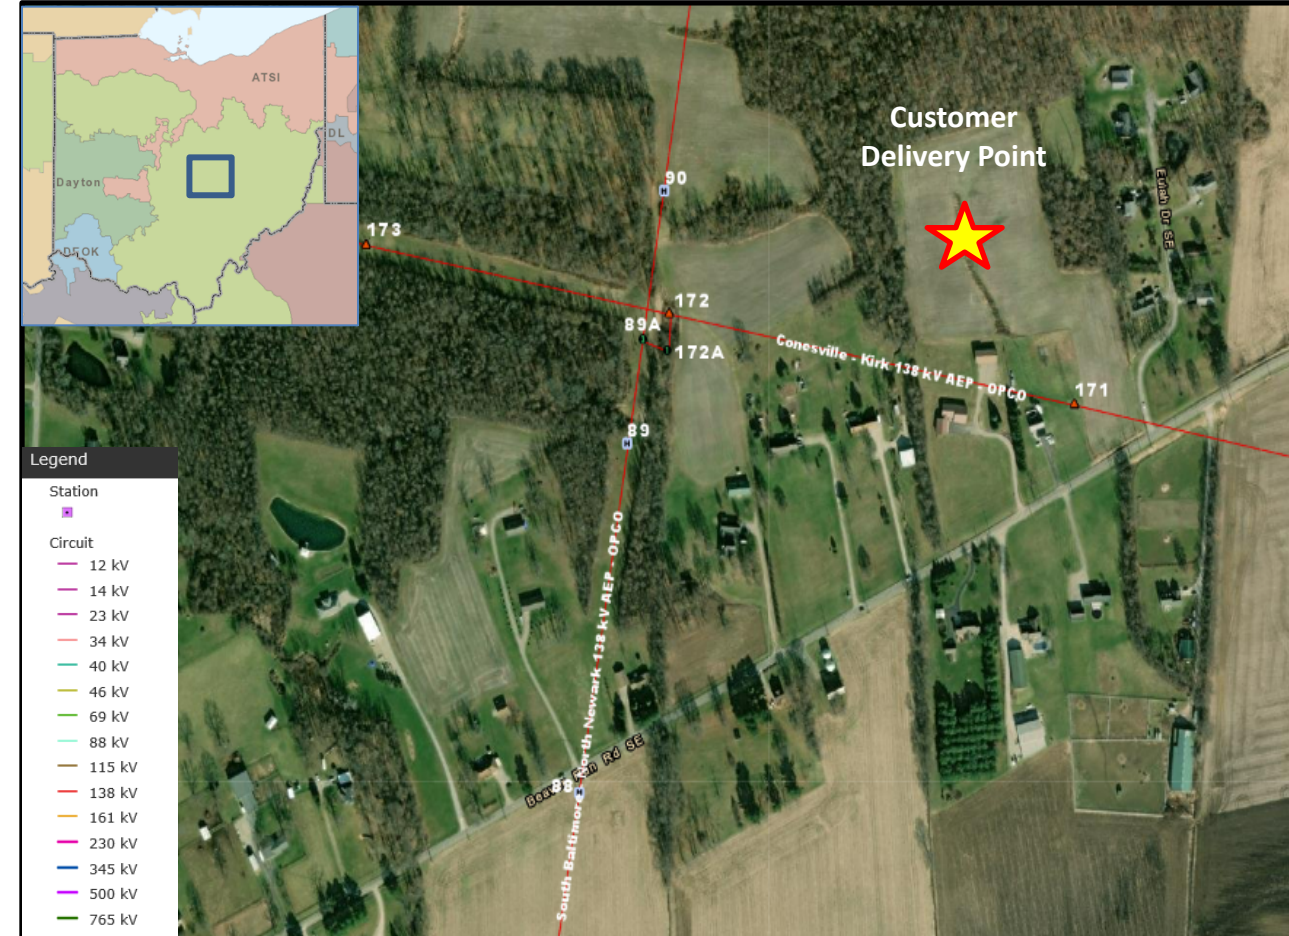
- A wholesale customer has requested service to a new delivery point in Licking County, Ohio.
- The projected demand for the site is projected to be 2 MW in 2024 with future growth of 2% expected per year.
- Service is requested by Spring 2024.

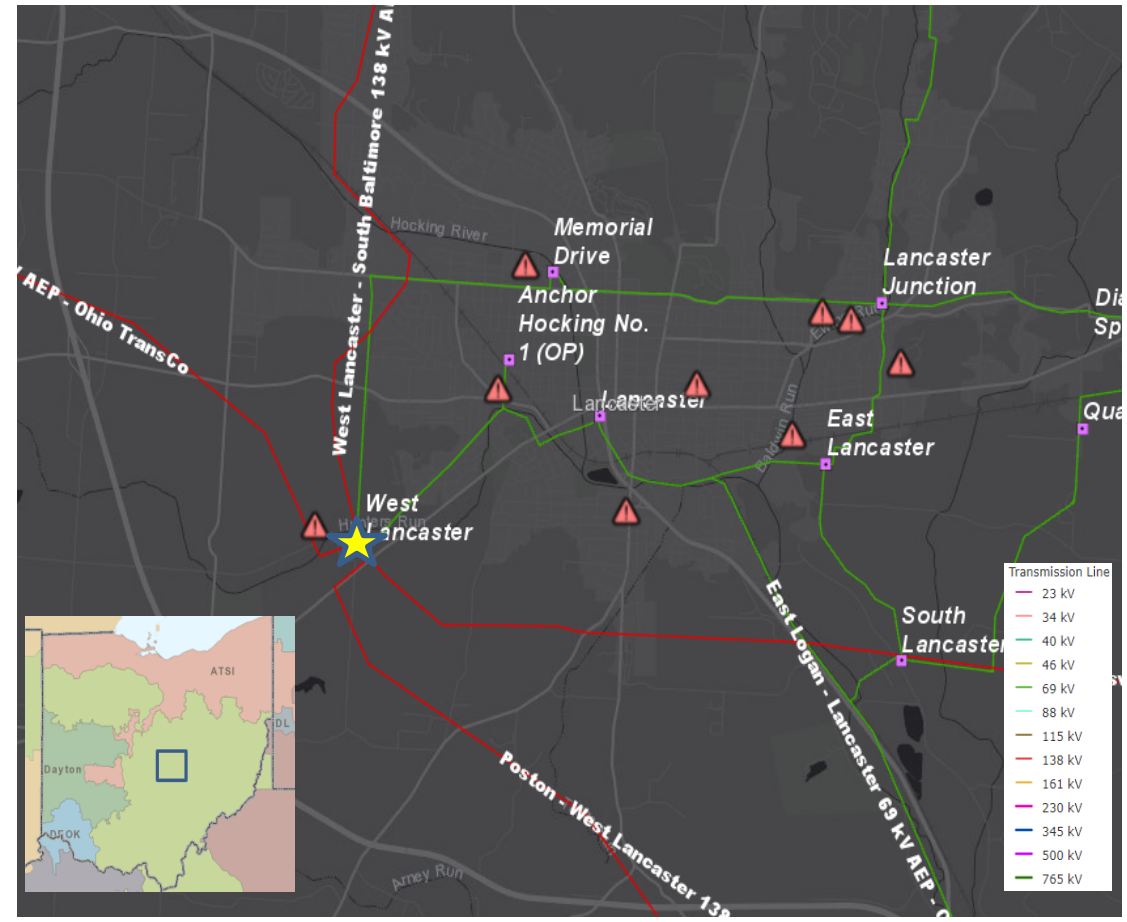
- Breaker Age: 1991: D & E
- Interrupting Medium: (SF6)
- Fault Ops: D: 40 & E: 8 (Manufactured recommended number of fault ops is 10)
- Additional Info: This type of breaker has had 411 malfunction records (mostly gas leaks and contact resistance concerns) and most problems reported with loss of SF6 and miss-operations.

- Breaker Age: 1966: C & 1963: J
- Interrupting Medium: (Oil)
- Fault Ops: C: 87 & J: 5 (Manufactured recommended number of fault ops is 10)

Additional Info: . These breakers are McGraw-Edison CF/CG/CGH/CH family of oil filled breakers without oil containment; Oil filled breakers have much more maintenance required due to oil handling that their modern, SF6 counterparts do not require. This model family has experienced major malfunctions associated with their OA-3 hydraulic mechanism, which includes low-pressure readings, hydraulic leaks, pump lockouts, and failure to shut off. These mechanism malfunctions have led to several failures to close and other types of mis-operations across the AEP fleet.

Circuit Switcher: BB (69 kV)

- Switcher Age: 1989
- Interrupting Medium: (SF6)
- Additional Info: This switcher is a Mark V type that has no gas monitor and currently in-service units on the AEP system have experienced 110 malfunctions from May 2000 to August 2019. Failed operational components including high contact resistance, gas loss, and interrupter failure represent half of these malfunctions. Two malfunctions of note were catastrophic equipment failures involving failures to trip.

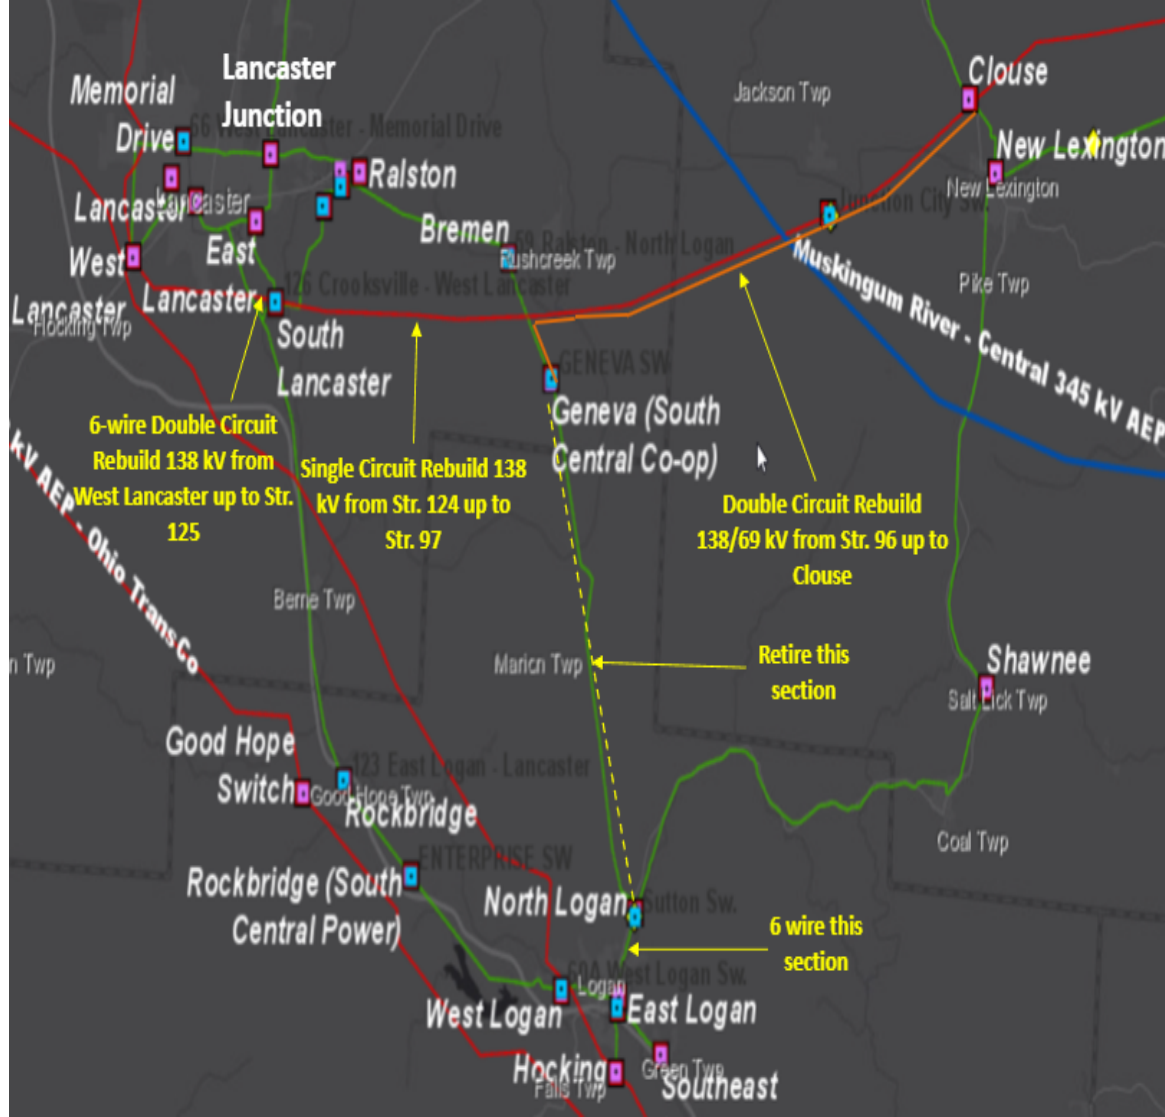
**Geneva Sw 69 kV:** Replace & relocate the existing PoP Switch with a 3-way 1200A PoP Switch. Cost: \$0.95M

**Junction City 138 kV:** Replace the existing 2-way POP with a 3-way 2000A POP. Cost: \$1.15M

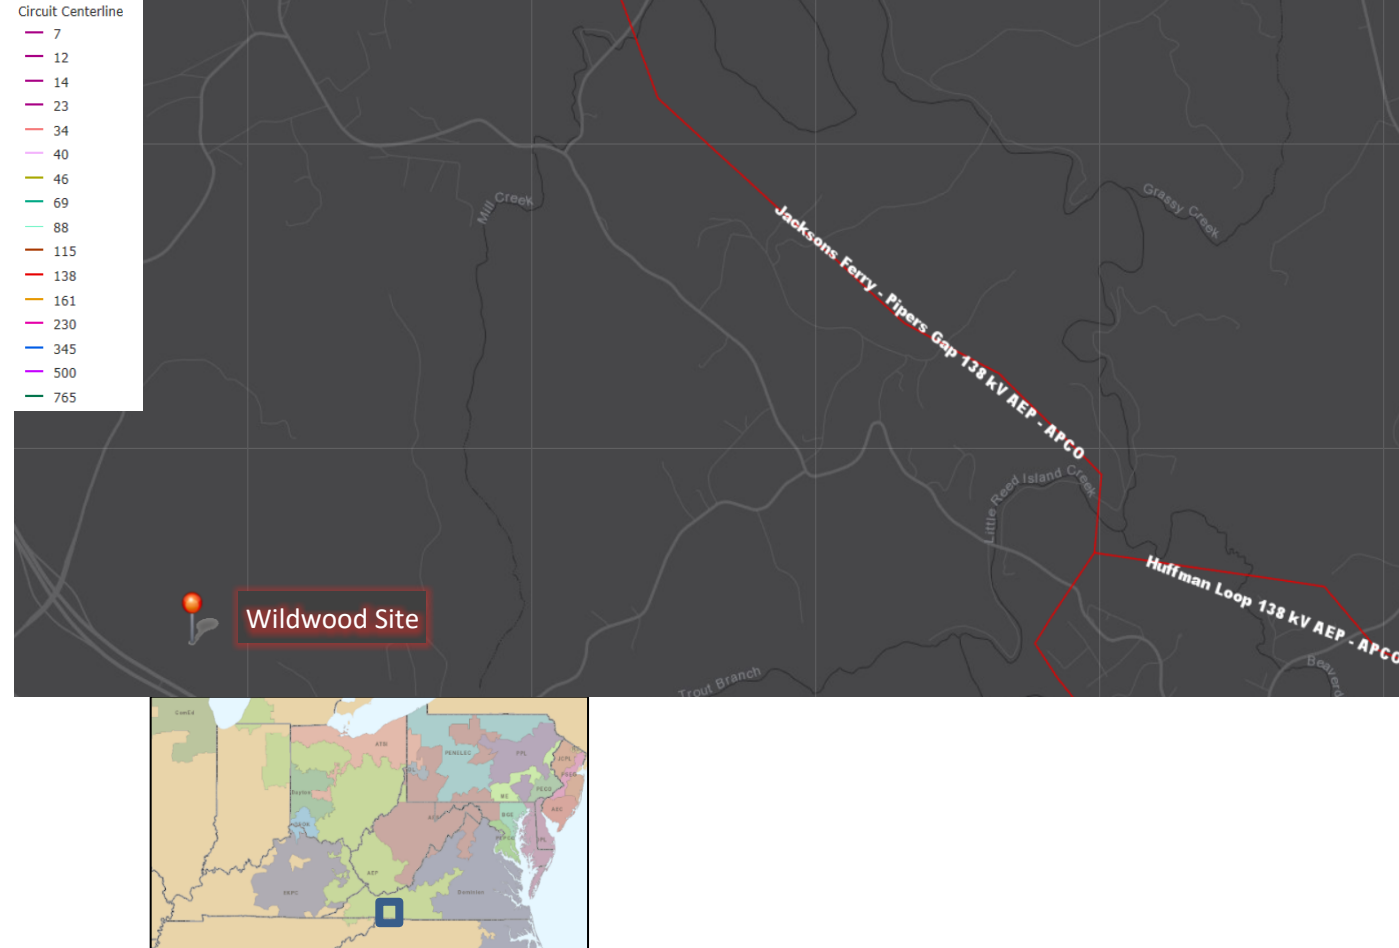
- A customer has requested service for the establishment of a new distribution station located at the Wildwood Commerce Park site in Hillsville, VA.
- This station is the result of VA House Bill 1840 (HB1840) (Electric Utilities: Pilot Programs for Transmission Facilities Serving Business Parks).
