Subregional RTEP Committee - Western FirstEnergy Supplemental Projects

August 16, 2024

APS Transmission Zone M-3 Process Albright Substation

Need Numbers: APS-2024-072

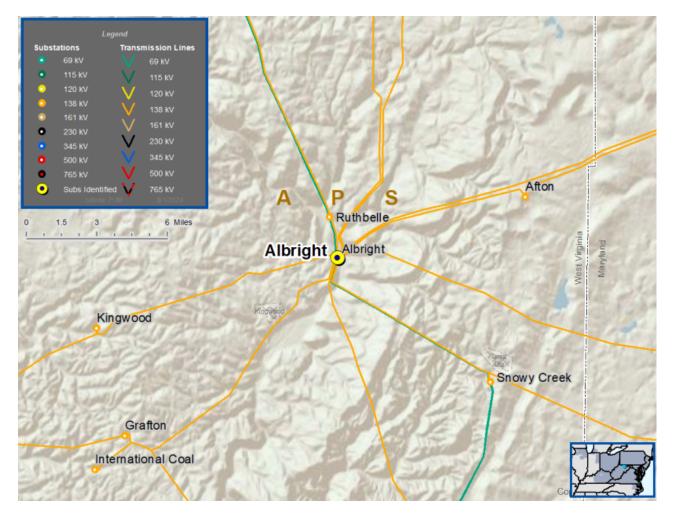
Albright – Snowy Creek Tap 138 kV Line

- Existing line rating: 195 / 209 / 217 / 229 MVA (SN/SE/WN/WE)
- Existing conductor rating: 221 / 268 / 250 / 317 MVA (SN/SE/WN/WE)

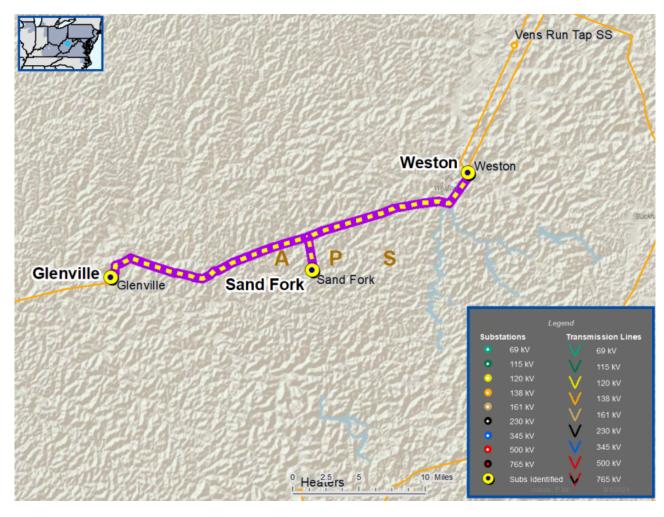
APS Transmission Zone M-3 Process Weston – Glenville 138 kV Line

- The Weston Glenville 138 kV Line was constructed approximately 44 years ago. It is approximately 31 miles long with 30 miles of wood pole structures and one mile of steel transmission line structures.
- The line has experienced six unplanned sustained outages over the last five years. Four outages related to failure of polymer insulators on the line.
- Per recent inspections, 124 of 130 wood pole structures utilize the polymer insulators related to recent failures.

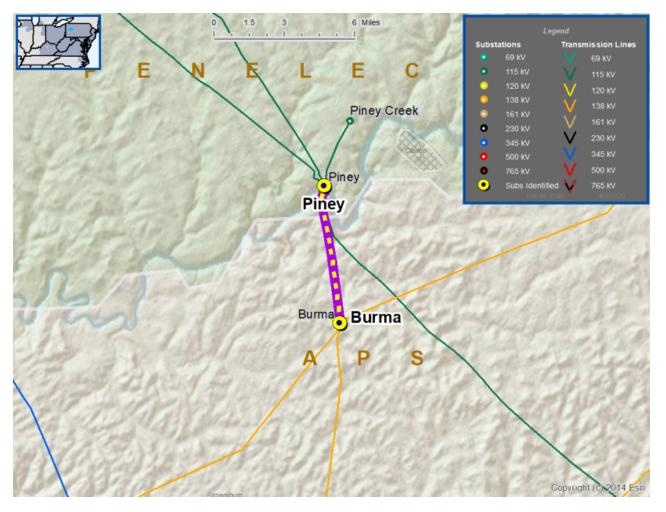
APS Transmission Zone M-3 Process Misoperation Relay Project

Need #	Transmission Line / Substation Locations	New MVA Line Rating (SN/SE/WN/WE)	Scope of Work	Estimated Cost (\$ M)	Target ISD
APS-2020-003 PN-2020-004	Burma – Piney 115 kV Line	232 / 282 / 263 / 334	At Burma, replace line trap, substation conductor and relays.	\$1.9	10/31/2025
