Reliability Analysis Update

Transmission Expansion Advisory Committee December 14, 2017

2017 RTEP Reliability Analysis Update

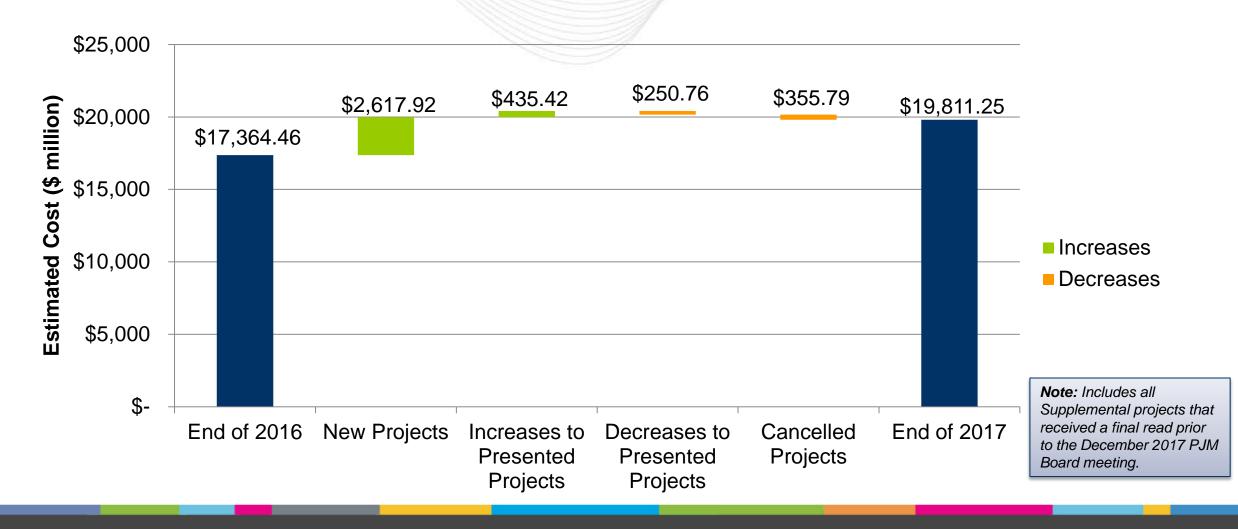
2017 Supplemental Projects Presented by TOs to TEAC/Subregional TEACs
