PECO 2024  
Submission of Supplemental Projects for  
Inclusion in the Local Plan

**Need Number:** PE-2023-009

**Process Stage:** Submission of Supplemental Project for inclusion in the Local Plan 4/11/2024

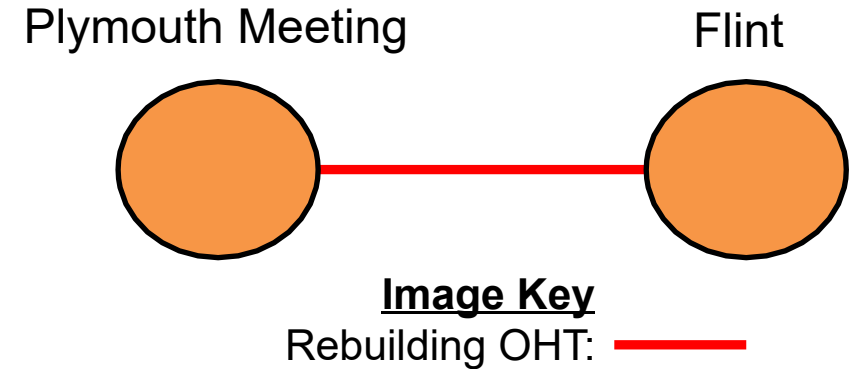
- Rebuild approx. 2.5 miles with new dual circuit, weathering steel monopole structures and 959.6 kcmil ACSS conductor.
- Replace various substation equipment at Plymouth Meeting and Flint substations to make the conductor the limiting element.

<b>Existing ratings (MVA):</b>	SN/SE	WN/WE
220-47 Plymouth – Flint	418/519	518/597
<b>New ratings (MVA):</b>	SN/SE	WN/WE
220-47 Plymouth – Flint	762/884	799/922

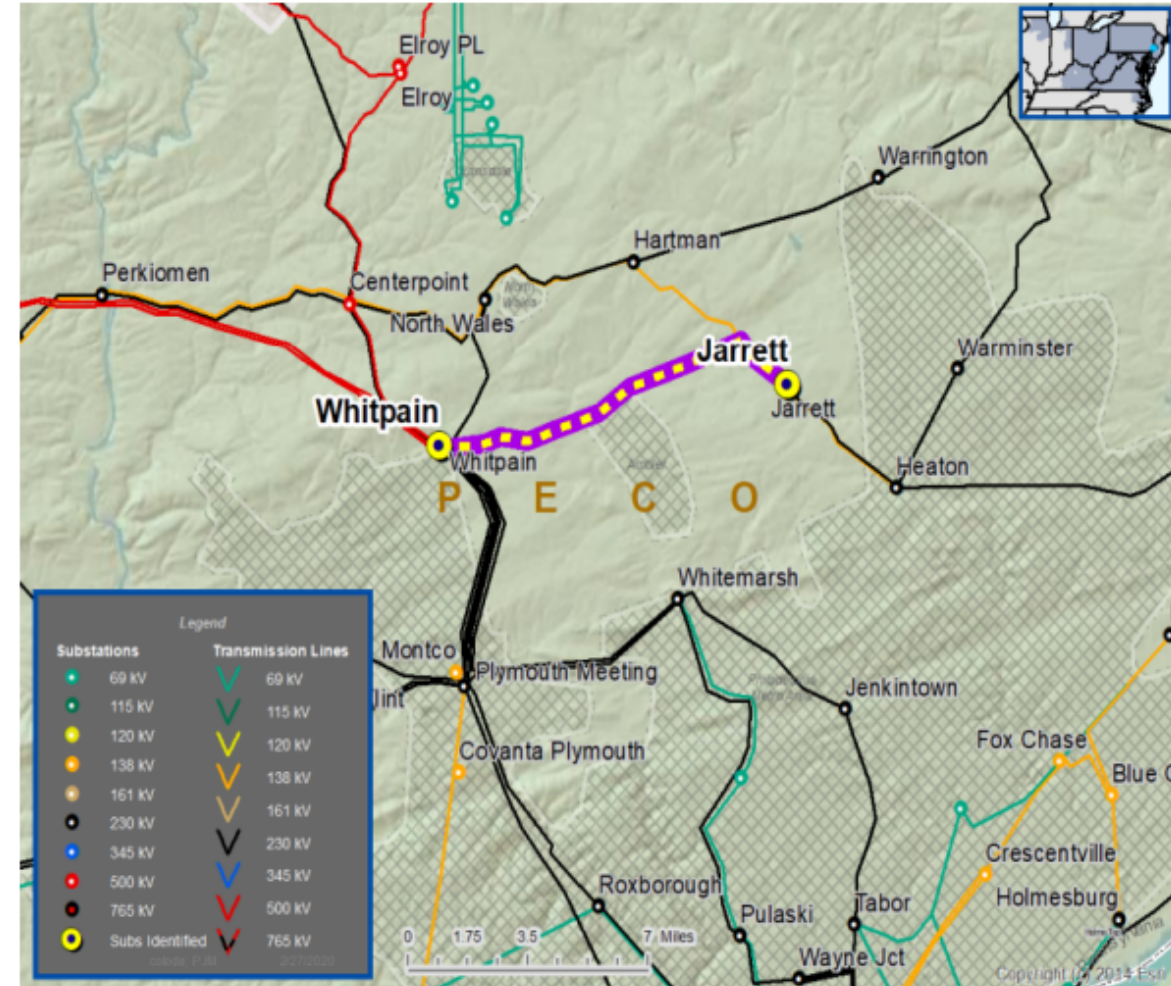
- Replace existing 1590 ACSR station cable adjacent to breaker 875 within Warrington Bus Tie 7-8 Facility with new 2-2000 AAC station cable.

<b>Existing ratings (MVA):</b>	SN/SE	WN/WE
Warrington Bus Tie 7-8	563/702	700/808
<b>New ratings (MVA):</b>	SN/SE	WN/WE
Warrington Bus Tie 7-8	1217/1380	1418/1560

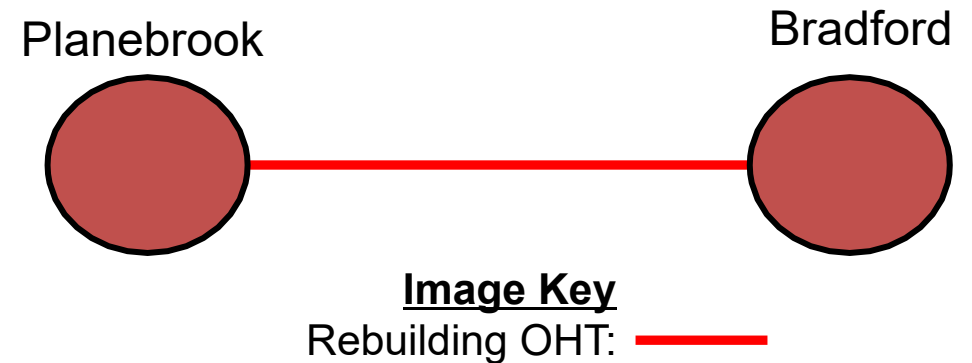
M-3 Process  
 PECO Transmission Zone  
 220-31 Planebrook – Bradford 230 kV Line Rebuild

- Rebuild approx. 6.24 miles of the 220-31 Planebrook – Bradford 230kV line with new dual circuit, weathering steel monopole structures and 959.6 kcmil ACSS/TW conductor
- Replace various substation equipment at Planebrook and Bradford substations

<b>Existing ratings (MVA):</b>	SN/SE	WN/WE
220-31 Planebrook – Bradford	525/640	575/692
<b>New ratings (MVA):</b>	SN/SE	WN/WE
220-31 Planebrook – Bradford	762/884	799/922

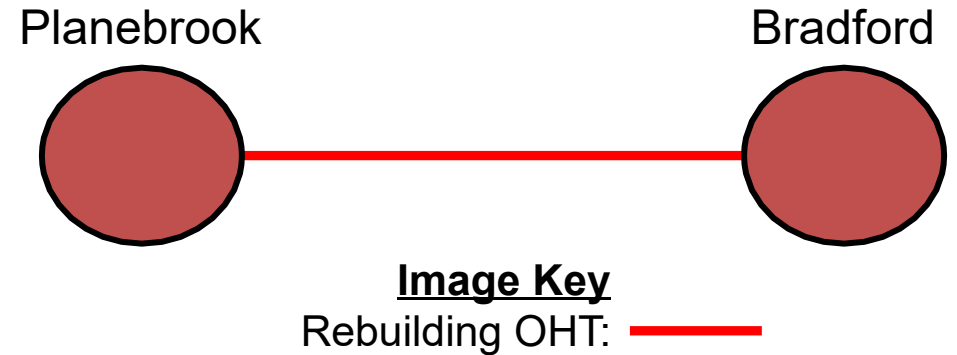
- Rebuild approx. 4.5 miles of the 220-02 Planebrook – Bradford 230kV line with new dual circuit, weathering steel monopole structures and 959.6 kcmil ACSS/TW conductor
- Replace various substation equipment at Planebrook and Bradford substations

<b>Existing ratings (MVA):</b>	SN/SE	WN/WE
220-02 Planebrook – Bradford	525/640	575/692
<b>New ratings (MVA):</b>	SN/SE	WN/WE
220-02 Planebrook – Bradford	762/884	799/922
